National Transportation Safety Board

Natural Gas Distribution Pipeline Leak and Resulting Multi-Story Structures Explosion
Harlem, New York

Operations Group Factual Report

DCA-14-MP-002

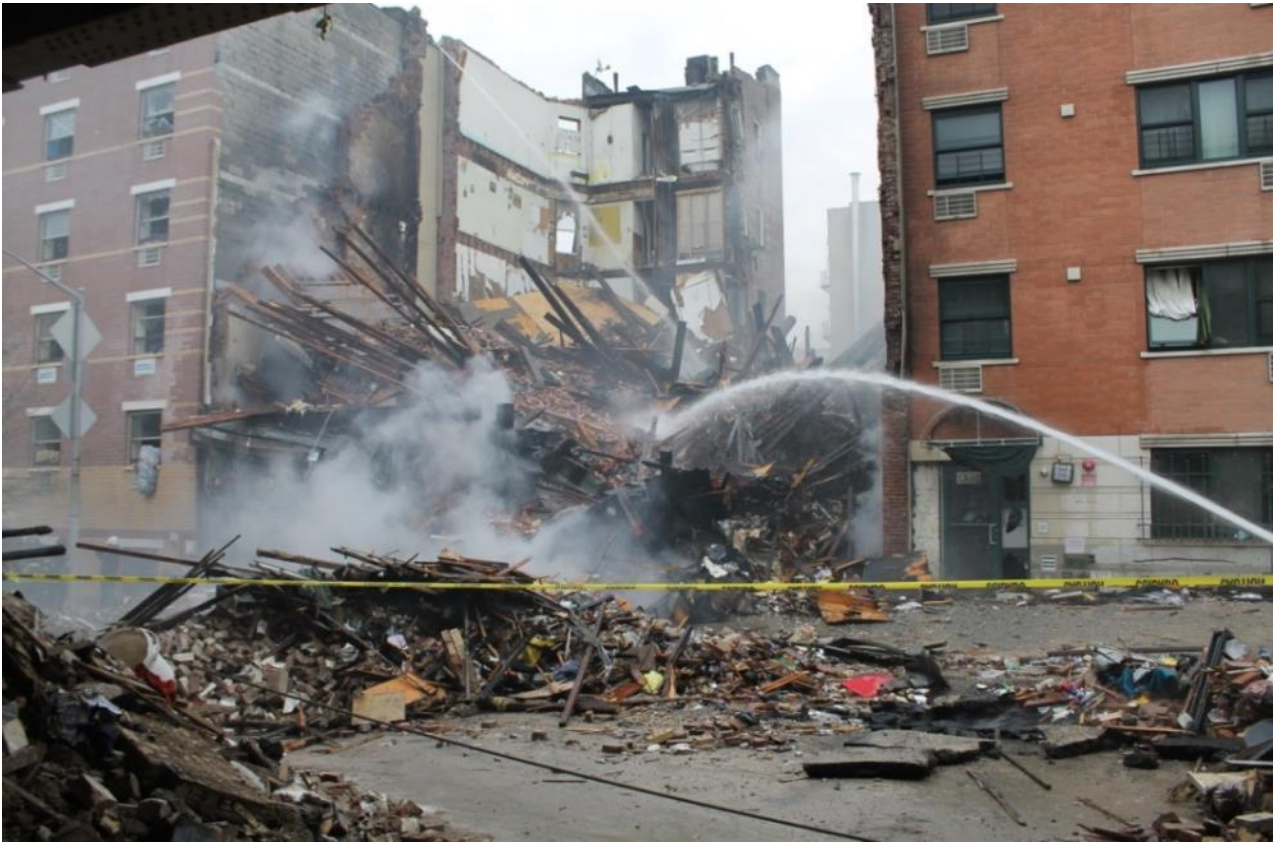
Figure 1. Explosion damage to 1644 and 1646 Park Avenue.

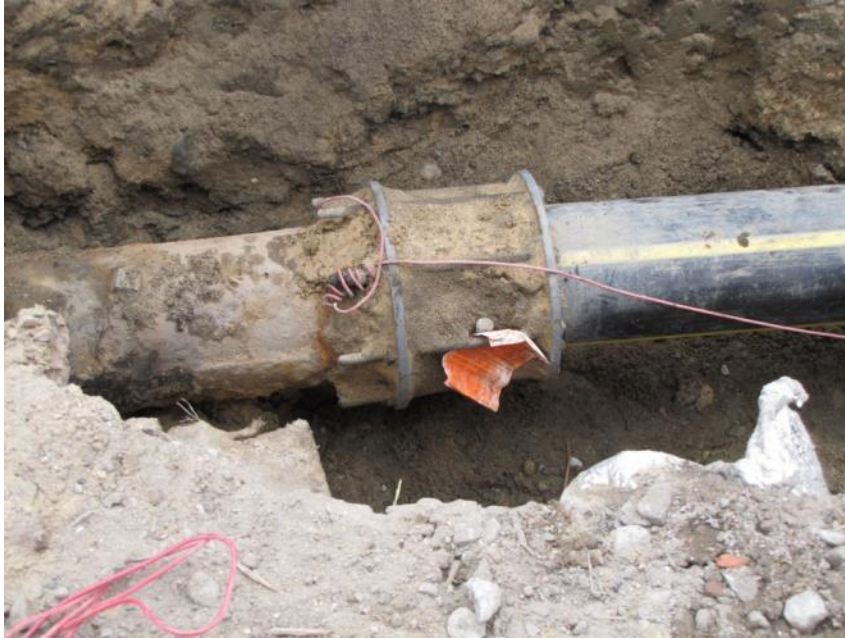
Figure 3: North end of 8-inch HDPE gas main joined to 8-inch cast iron pipe to the left with 8-inch steel mechanical coupling in front of 1644 Park Avenue.

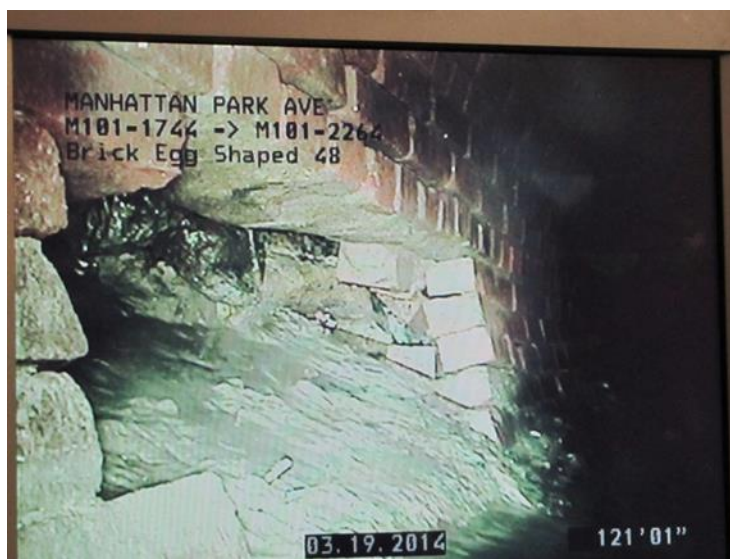
Figure 6: Damaged east side of sewer main wall (12 inches by 40 inches) in front of 1644 and 1646 Park Avenue. Source: NYCDEP

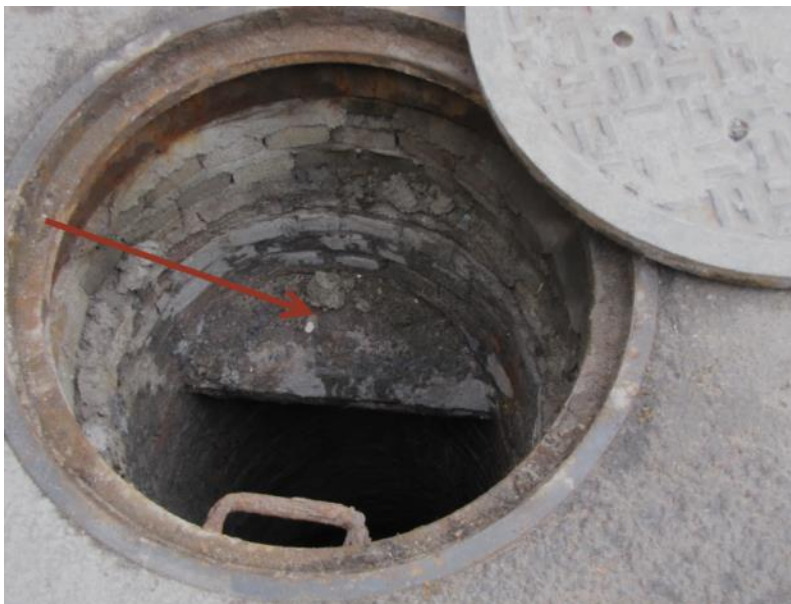
Figure 7: 8-inch cast iron pipe that travel through upstream manhole sewer main at 1652 Park Avenue, as indicated with red arrow at about 1.5 feet below manhole lid and roadway grade.

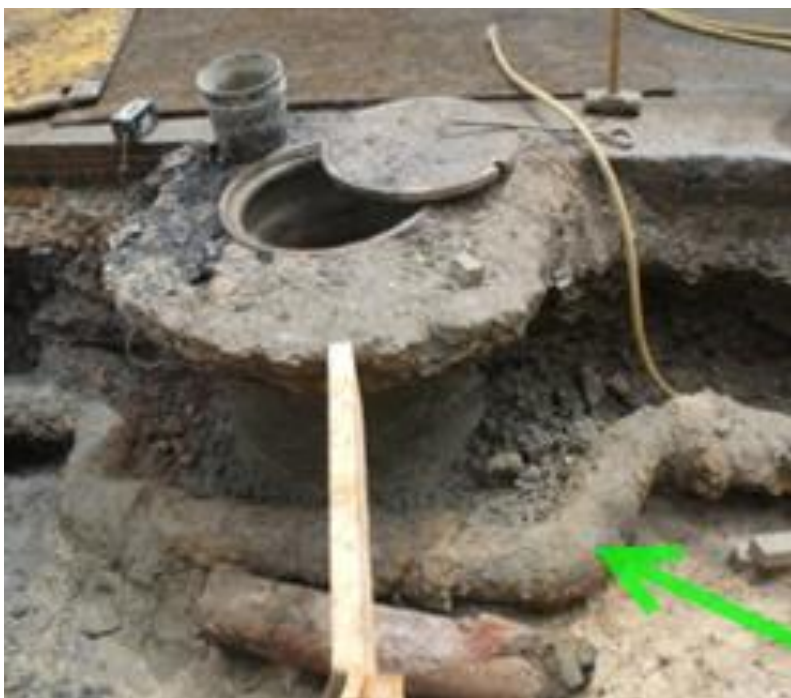
excavations and re-construction on May 5, 2014, to be an abandoned gas main while the cast iron gas main in service at the time of the accident was by-passed at the upstream manhole as shown in figure 8 with green arrow.

Figure 8: 8-inch cast iron gas main of Con Edison by-passed at upstream manhole of sewer main on Park Avenue, as indicated with green arrow. Source: NYPSC

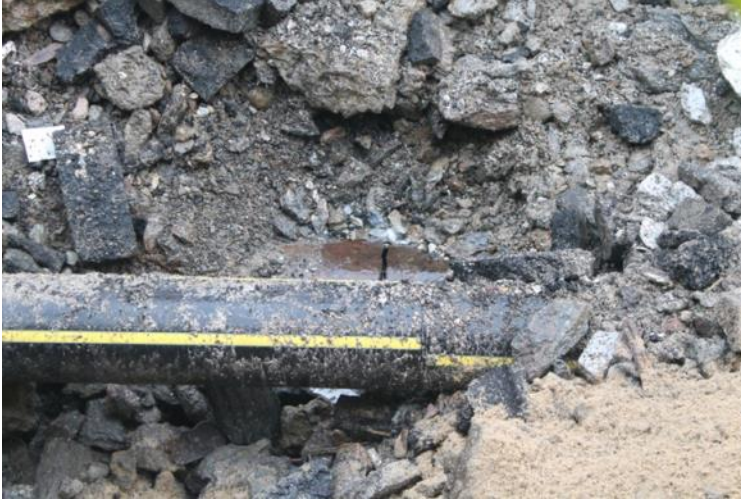
Figure 9: The exposed 8-inch HDPE gas main and 12-inch cast iron water main cracked location.

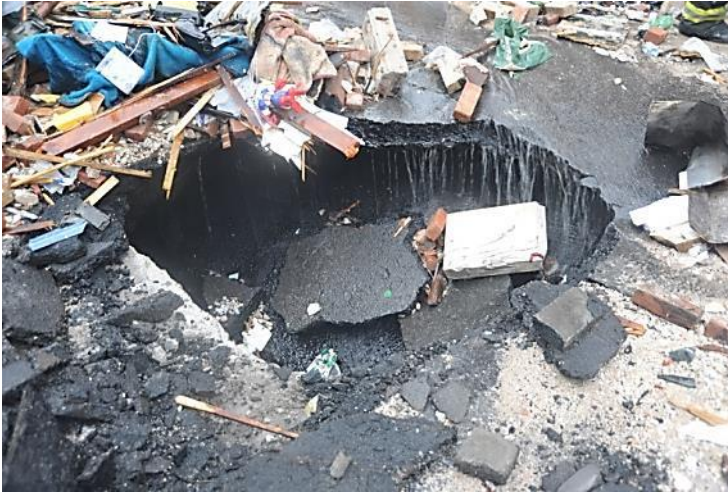
Figure 10: Sink-hole at the location of the 12-inch cast iron water main break. Source: FDNY

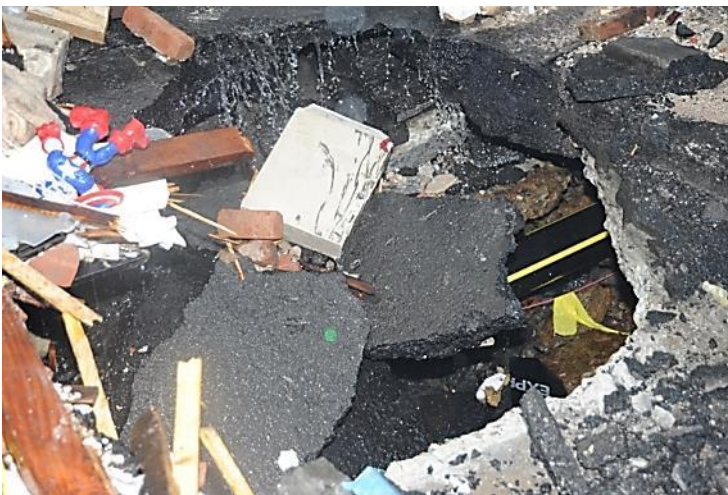
Figure 11: Sink-hole at 12-inch cast iron water main break location showing 8-inch HDPE gas main. Source: FDNY

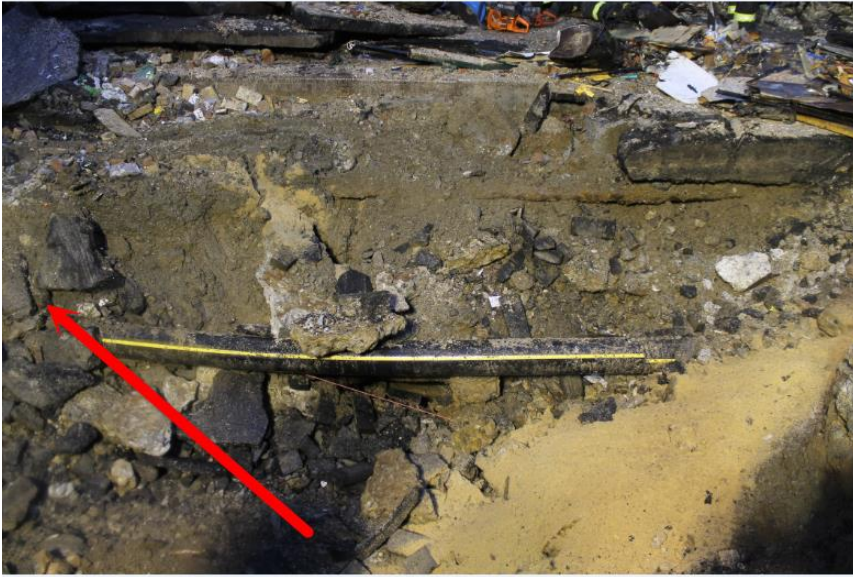
Figure 12: The exposed 8-inch HDPE gas main and top of 2-inch HDPE service saddle tee indicated with a red arrow, in front of 1642 Park Avenue. Source: NYPSC.

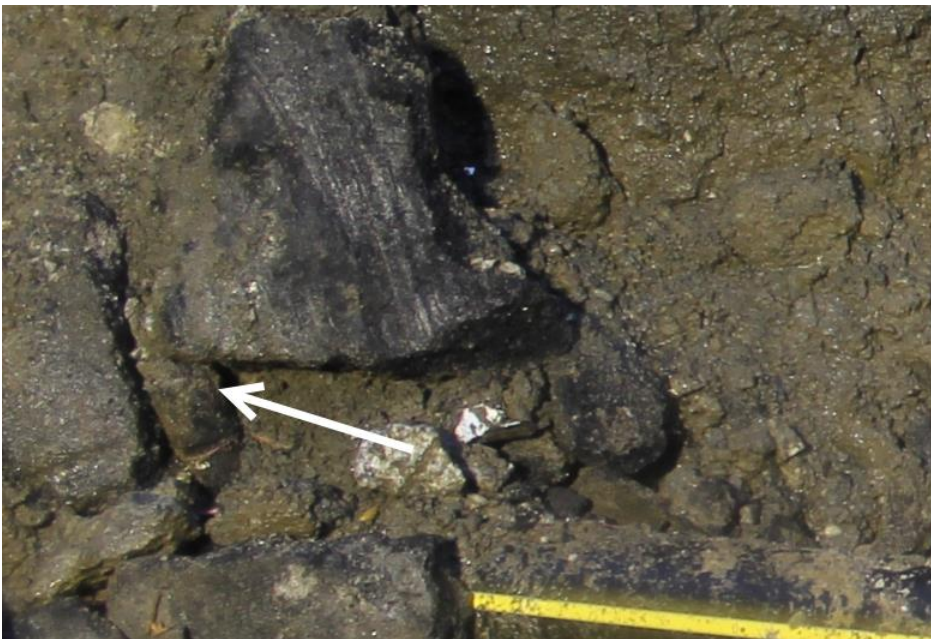
Figure 13: Close view of exposed 8-inch HDPE main and top of 2-inch HDPE service saddle tee indicated with a white arrow, in front of 1642 Park Avenue. Source: NYPSC.

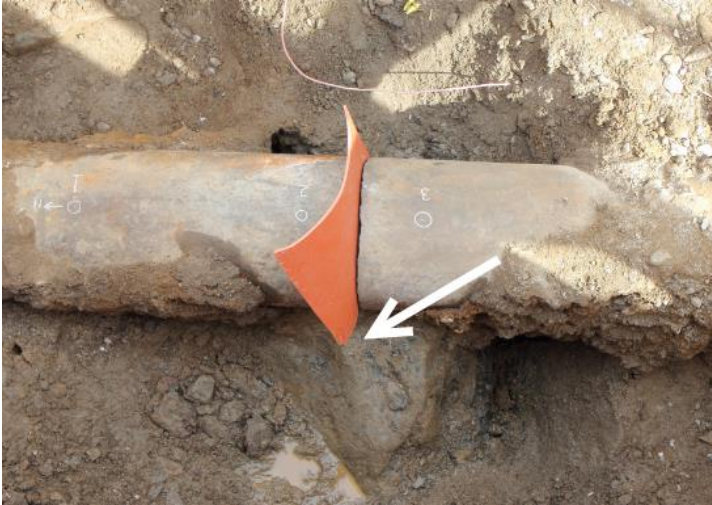
Figure 15: 12-inch water main cracked location directly located on top of rock.

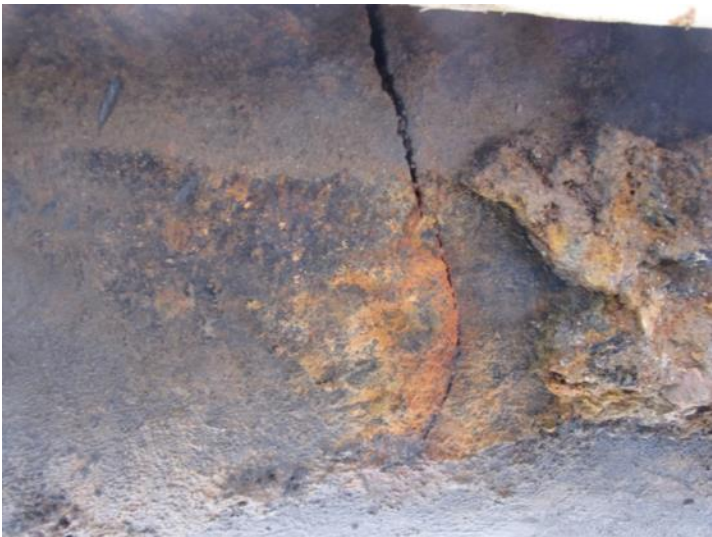
Figure 16: 12-inch water main pipe with circumferential crack bottom view.

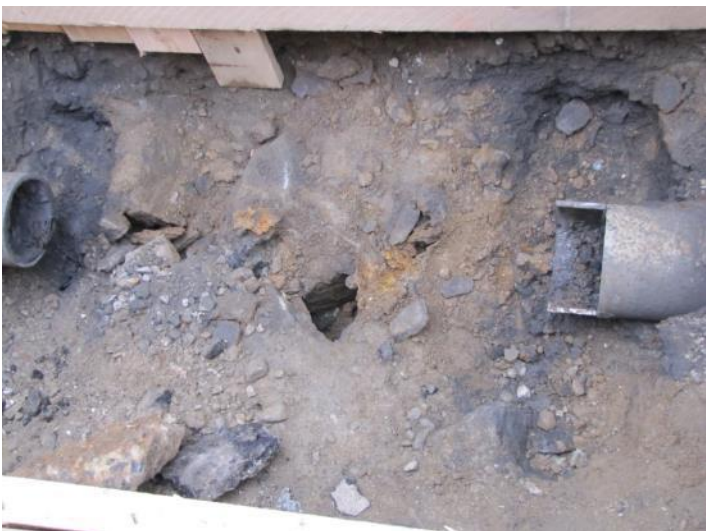
Figure 17: Holes (hole-A) exposed in the rocky soil after water main pipe segment was removed.

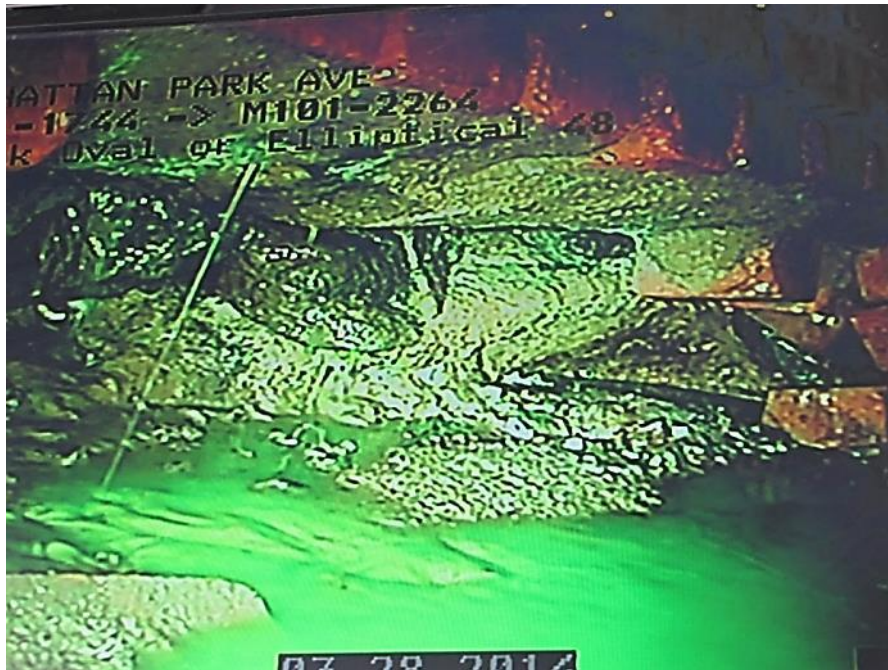
Figure 18: Florescent Green dyed water solution entering the sewer main at (hole-B) the damaged east sidewall. Source: NYCDEP

The water flow test established the fact that the holes in the ground under the water pipe in front of 1642 Park Avenue provided a direct, unimpeded water flow path into the sewer main.

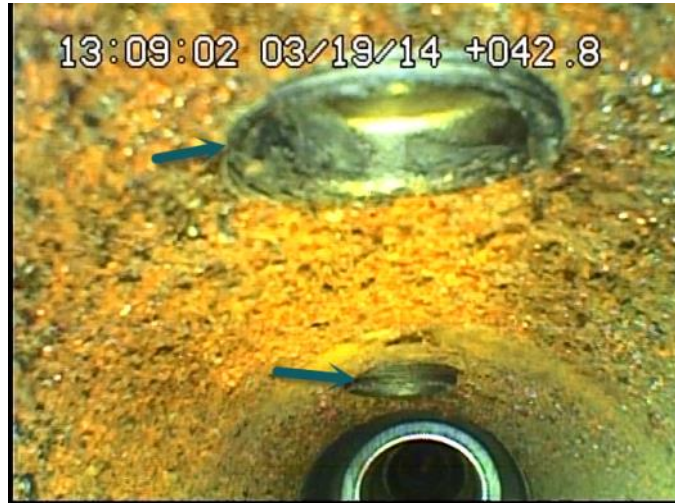
Figure 19: Internal camera inspection of 8-inch gas main pipe shows two 2-inch plugs at about 43 feet and 44 feet. Source: Con Edison

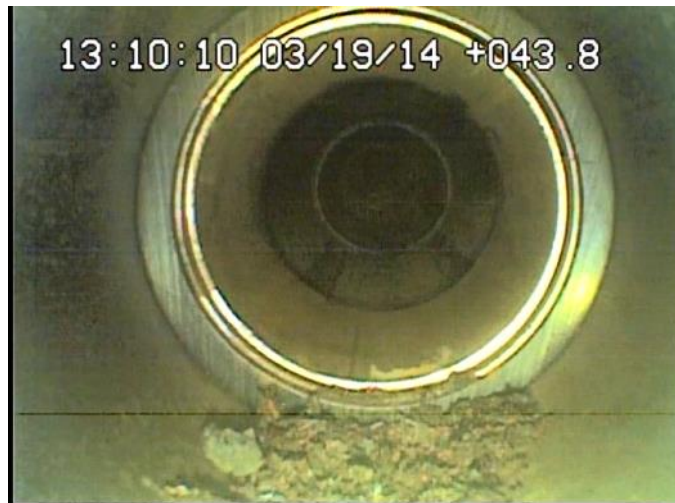
Figure 20; shows the internal view of the cast iron to PE pipe transition in the 8-inch HDPE gas main. The joining material was by means of the steel mechanical compression coupling (manufactured by Dresser).

Figure 20: Internal camera inspection of 8-inch gas main pipe shows transition from cast iron to HDPE. Source: Con Edison

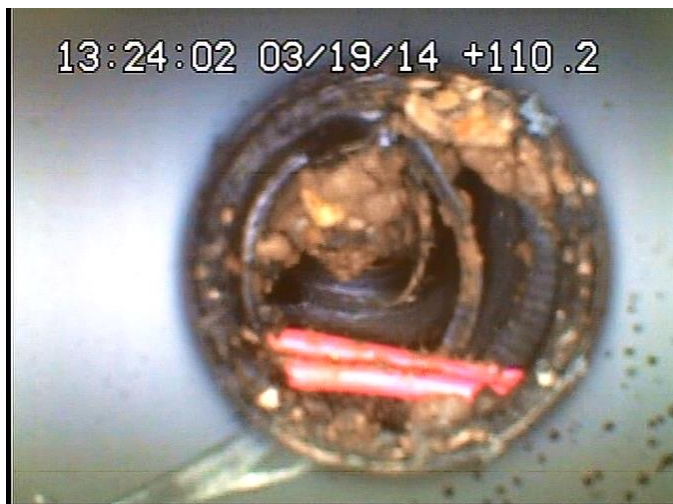
Figure 21; shows the internal view of the separated service saddle tee to 1642 Park Avenue. The inspection was conducted using a robotic camera inserted into the 8-inch gas main at Pit#2. The service tee was located at about 110.2 feet from Pit #2. Soil and other earth materials penetration were shown to have entered inside the 8-inch HDPE gas main and 2-inch service tee through the separation of the service saddle tee fusion from the main. The red colored tracer wire was observed in the gap between the service saddle tee fusion surface and the gas main. This condition was present on March 19, 2014, before the re-excavation of the gas main and service pipeline connection at this address on March 20, 2014.

Figure 21: 8-inch HDPE gas main disconnected 2-inch service tee on the main HDPE and red tracer wire. Source: Con Edison

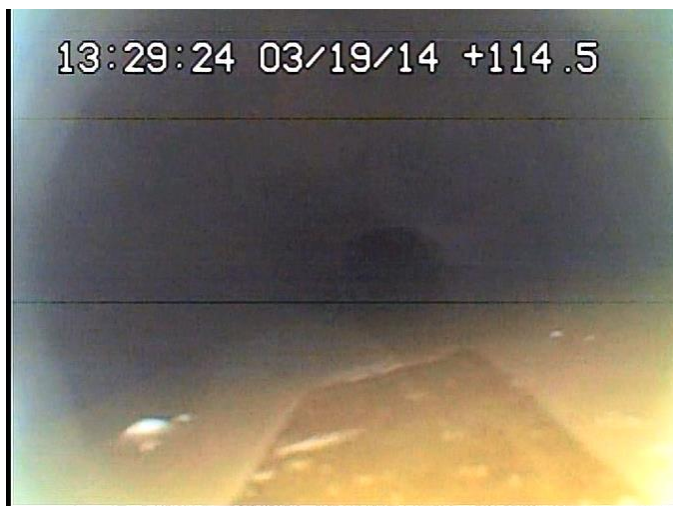
Figure 22 of the internal view of the 8-inch HDPE gas main is shown filled with water⁷³ at about 114.5 feet from Pit #2. The water and debris contents prevented the robotic camera to move beyond that point during the gas main inspection. Relevant information about the gas main attributes before 1644 and 1646 Park Avenue service tees was however, gathered.

Figure 22: 8-inch gas main pipe with pool of water in the main PE pipe. Source: Con Edison

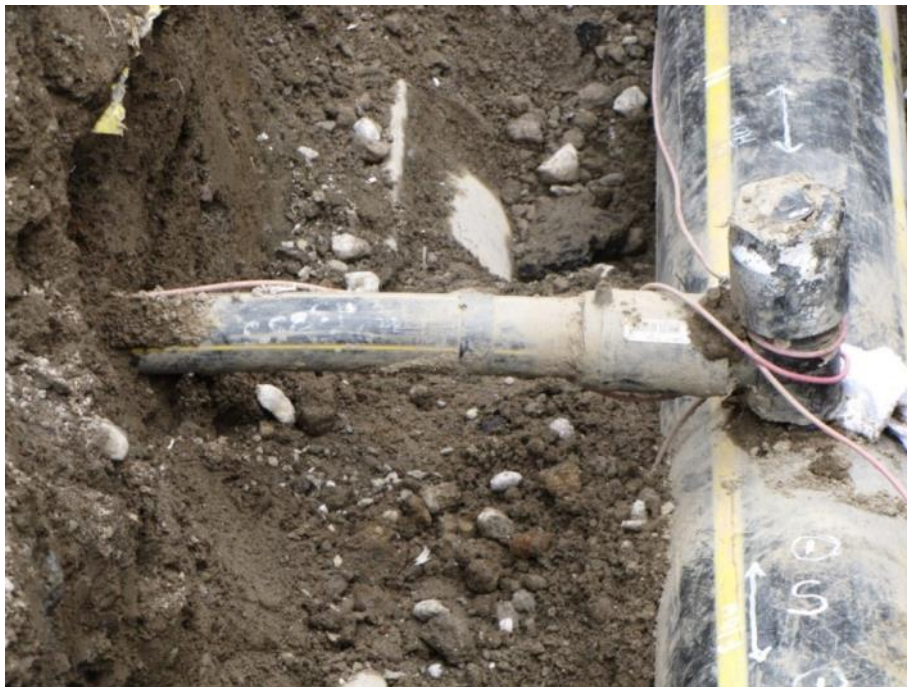
Figure 24 shows further excavations around the 2-inch HDPE gas service saddle and the 8-inch HDPE gas main. The 2-inch HDPE gas service line to 1642 was observed from west to east direction with the service saddle tee over the 8-inch HDPE gas main.

Figure 24: 2-inch separated HDPE service line at saddle tee.

The 2-inch HDPE gas service saddle tee curved from the service line over the 8-inch HDPE pipe gas main. There was a gap of about $\frac{1}{4}$ -inch between the main and saddle tee. This $\frac{1}{4}$ -inch gap continued to increase as the service line recovered from the downward curvature as the backfill was removed, and then lifted up as seen in figure 25. The 8-inch HDPE gas main was observed to have moved downward, going south to north from the service saddle tee location on the main.

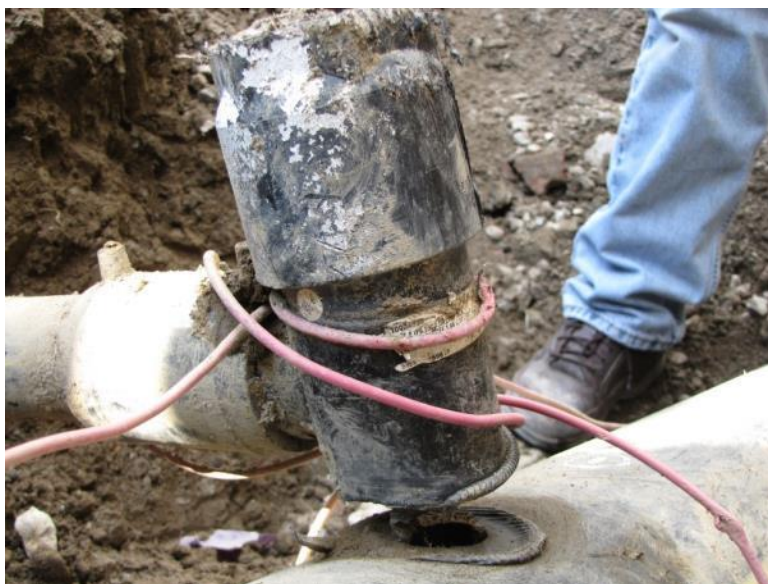
Figure 25 shows the completely separated 2-inch HDPE service saddle tee from the 8-inch HDPE gas main. The service saddle tee contains dents and gouges. The photo also shows the tracer wire wrapped around the service line and service tee, down to the 8-inch HDPE gas main.

Figure 25: Separated 2-inch saddle tee from the HDPE main.

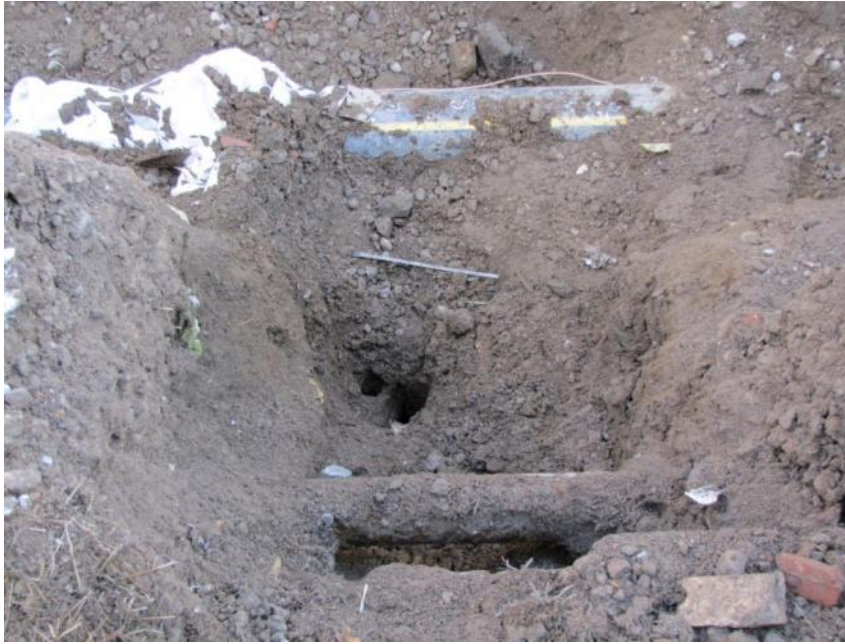
Figure 26 shows the surrounding excavated area to the 1642 Park Avenue near the 2-inch HDPE gas service line connection (covered with off-white colored nylon material). The 8-inch HDPE pipe gas main is seen as a black colored and yellow striped pipe. These areas were observed to be made of porous soil and small diameter gravel (crush and run) backfill materials⁷⁴, and had large holes below and near the gas main and water main.

Figure 26: Porous soil and large holes at 1642 Park Avenue near the gas main.

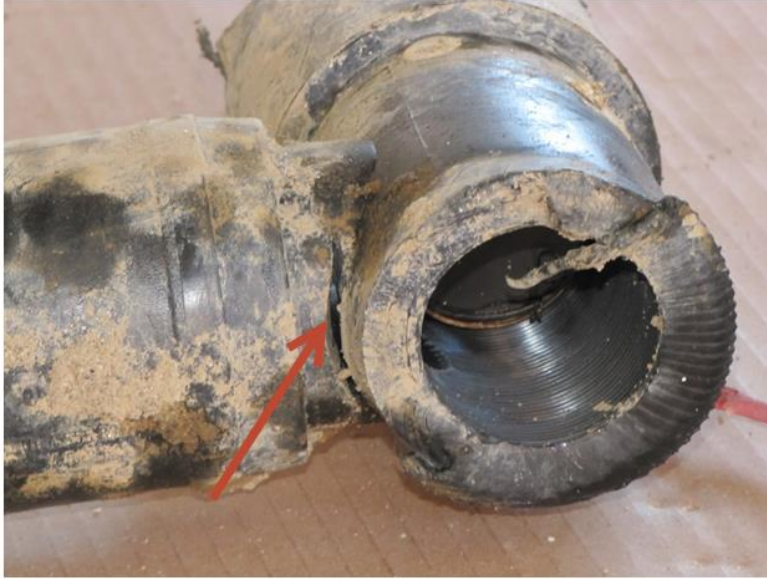
Figure 27 shows the underside of the service tee after it was removed from the excavation. A large crack at the junction between the main body of the service tee and the outlet fitting is indicated with a red arrow.

Figure 27: Underside of the saddle tee showing the tee to gas main fusion surface and crack in the service line connection port (red arrow).

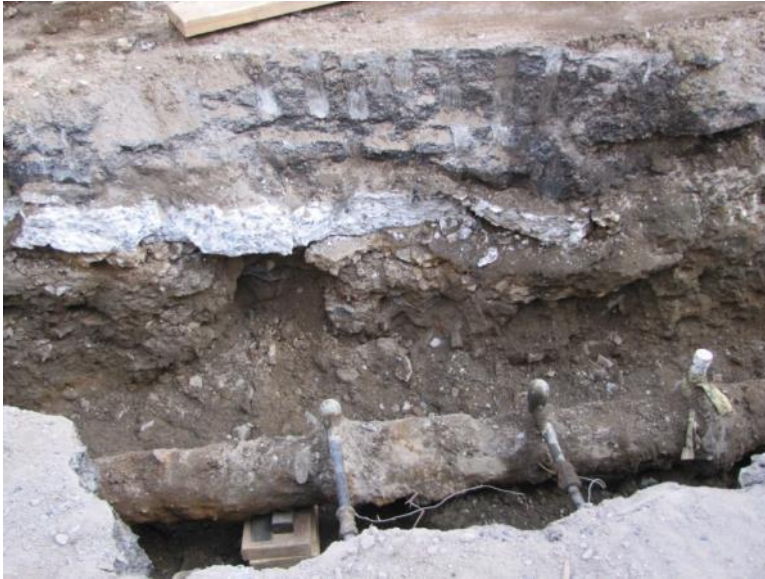
Figure 28: Service tees to 1646 and 1644 Park Avenue below about 12 inches of concrete road underlay with about 18 inches thick asphalt paving.

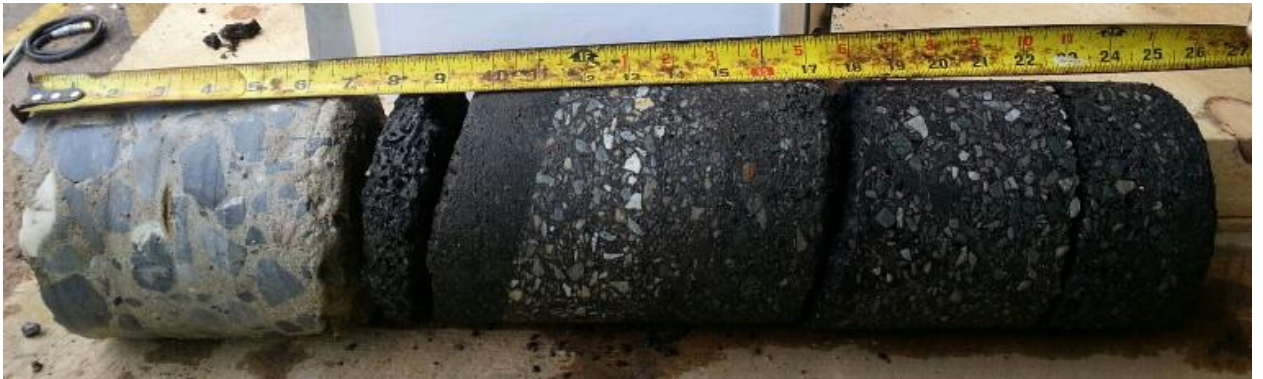
Figure 29: Core #4 road pavement sample from front of 1646 Park Avenue near incident properties service tees. Source: Con Edison.

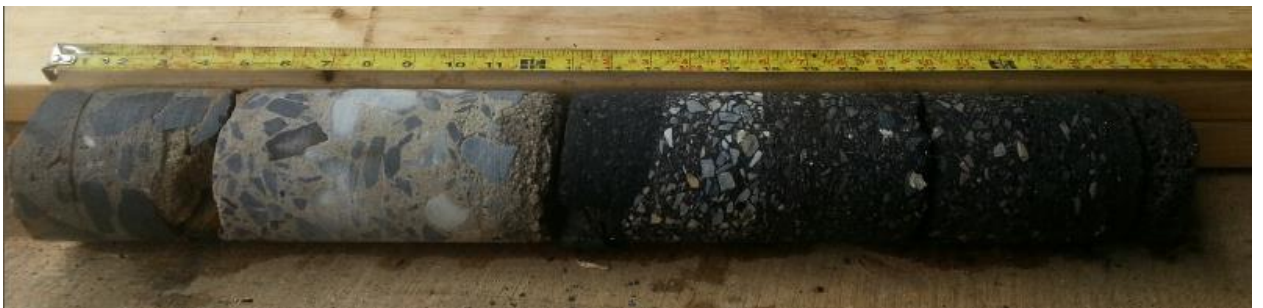
Figure 30: Core #6 road pavement sample from front of 1646 Park Avenue near incident properties service tees. Source: Con Edison.
