## EVALUATION REPORT OF LIQUID PIPELINE CONSTRUCTION

| Inspection Report | | Post Inspection Memorandum | |
|---|---|---|---|
| Name of Operator: | TransCanada Oil Pipeline Operations Inc. | | OPID #: 32334 |
| Name of Unit(s): | Keystone Gulf Coast Pipeline North / Keystone Gulf Coast Pipeline South | | Unit #(s): 74979,83245 |
| Inspection Type: | Construction | | Inspection Date(s): 2011-2014 |

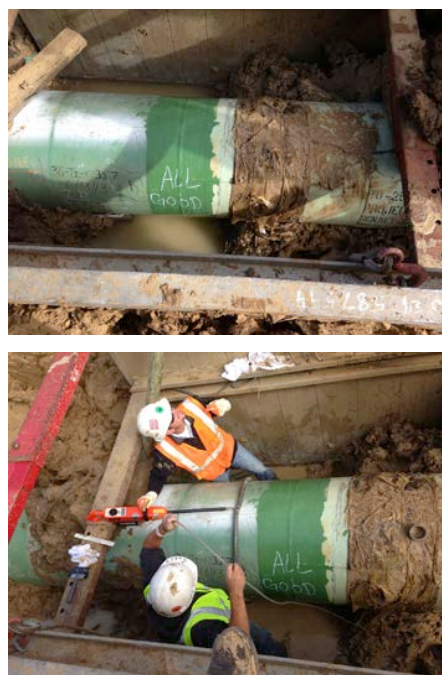
**Figure 25 and 26: DCVG dig site (recoated)**

TransCanada conducted a Direct Current Voltage Gradient (DCVG) survey of the entire Keystone Gulf Coast Pipeline to check for any coating damage. After the survey, TransCanada submitted the findings of any coating damage found along with repairs made on anomalies. There were a total of 127 anomalies on Spread 1, 83 anomalies on Spread 2, and 43 anomalies on Spread 3 found by the survey. None of the anomalies found met the repair criteria of 35% IR, the highest was 32%. TransCanada performed verification digs on the highest IR readings on all three spreads to assure accuracy of the DCVG Survey. They made 8 digs in Spread 1, 8 digs in Spread 2, and 4 digs in Spread 3 and made repairs accordingly. The reports were reviewed by PHMSA to assure compliance with their procedures and the regulations. PHMSA conducted field inspections to verify dig sites identified by the DCVG survey. Figures 25 and 26 depict two locations identified by the DCVG survey during a PHMSA field inspection.
