U.S. Department of Transportation Pipeline and Hazardous Materials Safety Administration	Original Report Date:	06/08/2011	
	No.	20110171 - 16159 ----- (DOT Use Only)	
ACCIDENT REPORT - HAZARDOUS LIQUID PIPELINE SYSTEMS			
A federal agency may not conduct or sponsor, and a person is not required to respond to, nor shall a person be subject to a penalty for failure to comply with a collection of information subject to the requirements of the Paperwork Reduction Act unless that collection of information displays a current valid OMB Control Number. The OMB Control Number for this information collection is 2137-0047. Public reporting for this collection of information is estimated to be approximately 10 hours per response (5 hours for a small release), including the time for reviewing instructions, gathering the data needed, and completing and reviewing the collection of information. All responses to this collection of information are mandatory. Send comments regarding this burden estimate or any other aspect of this collection of information, including suggestions for reducing this burden to: Information Collection Clearance Officer, PHMSA, Office of Pipeline Safety (PHP-30) 1200 New J

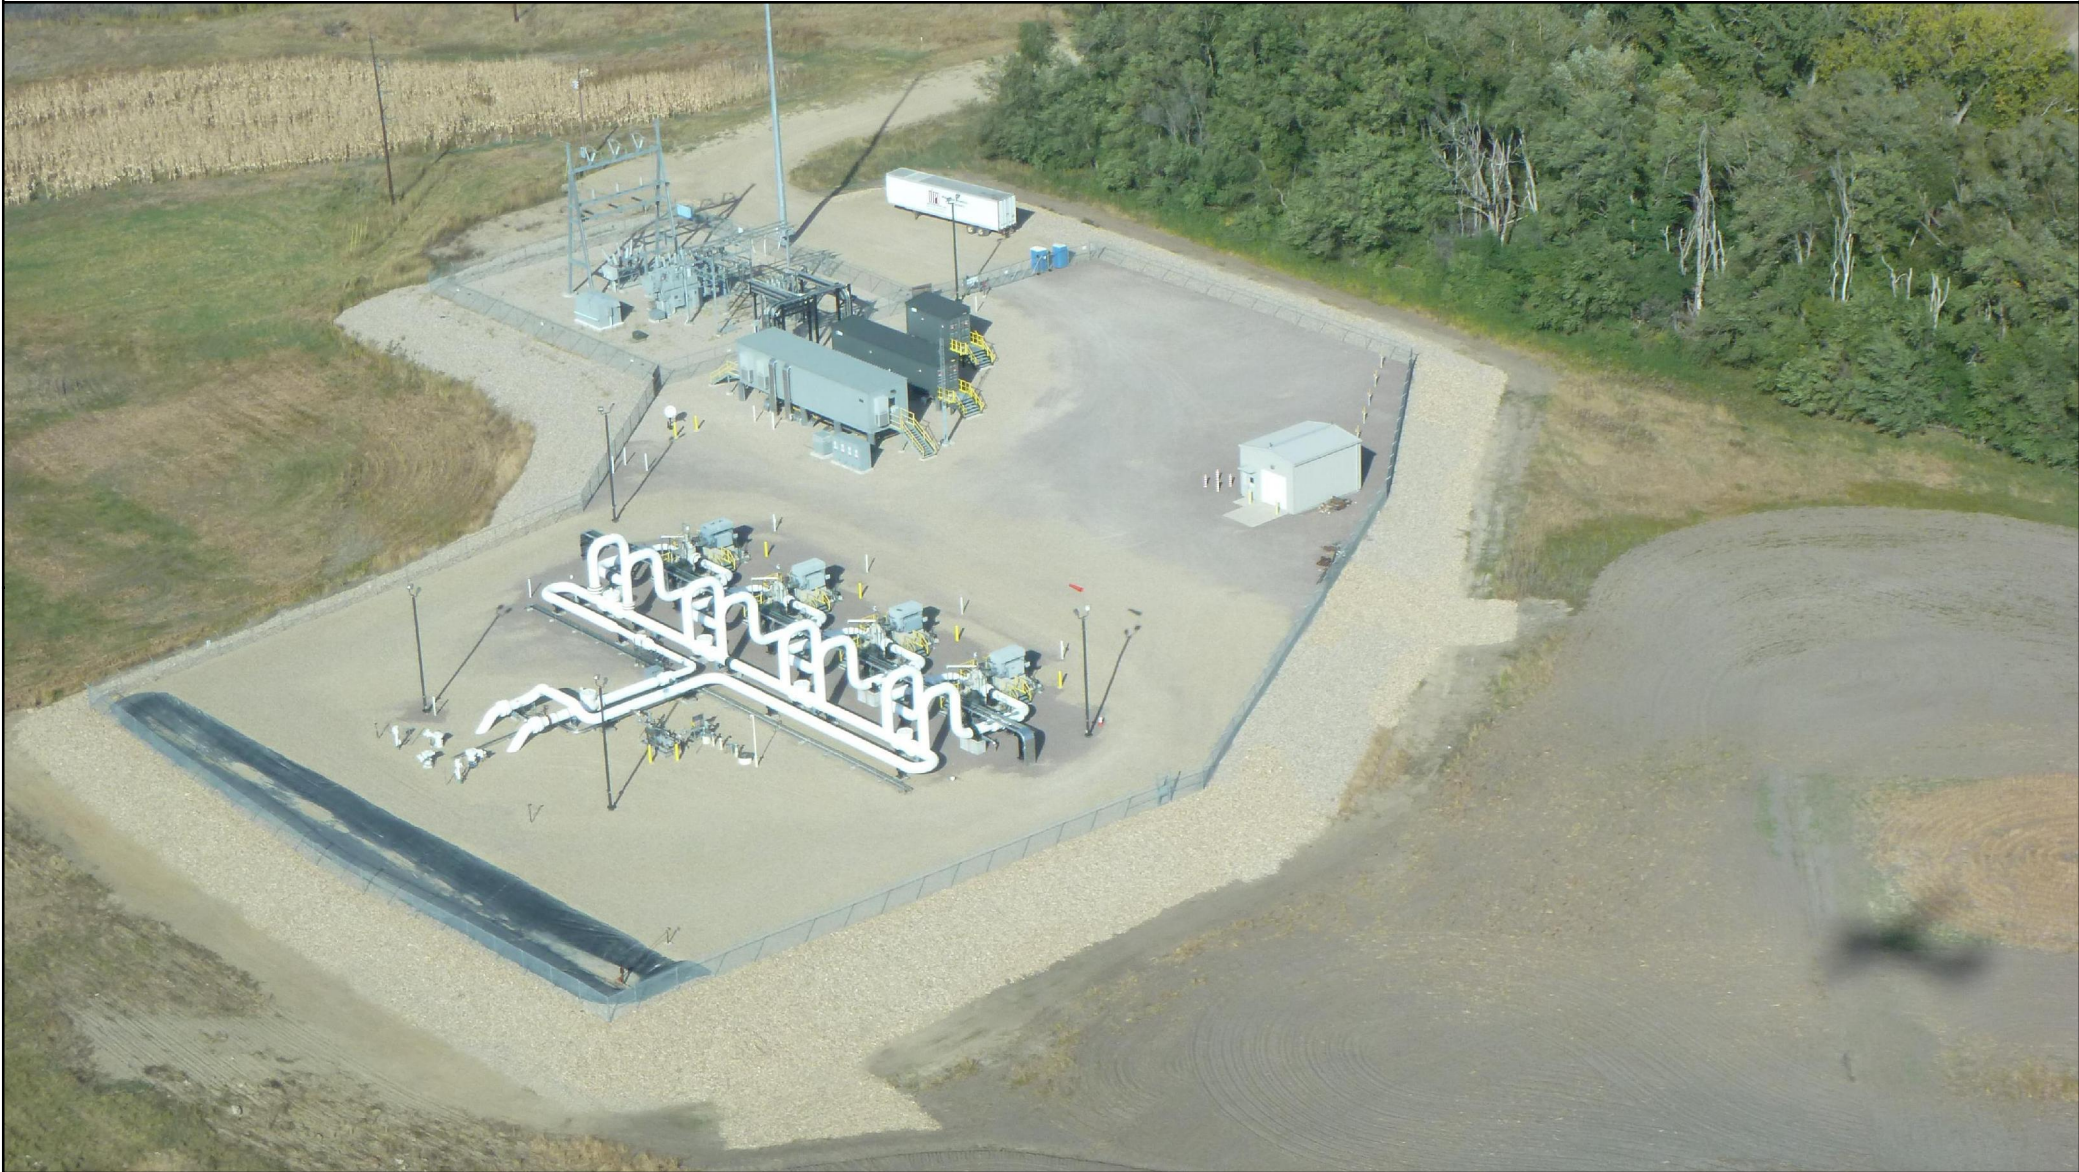
The crops in the farmed area had been destroyed prior to the October 20, 2011 site visit and the field had been tilled. See attached aerial photograph from October 5, 2011 (Figure 3) showing site and land farm restoration condition.

Based on current conditions at the TransCanada Ludden Pump Station site and your correspondence dated October 26, 2011, we request that no further investigation or remediation be required and that the site be considered for closure.
