# U.S. Department of Transportation

## Office of Pipeline Safety

### Daily Construction Inspection Report

Date : 01/30/2013 Hours Worked : 9  
 Weather: Sunny Temp. Low 45 High 65  
 Owner/Operator: Transcanada/Keystone XL Spread 2  
 Contractor Michels

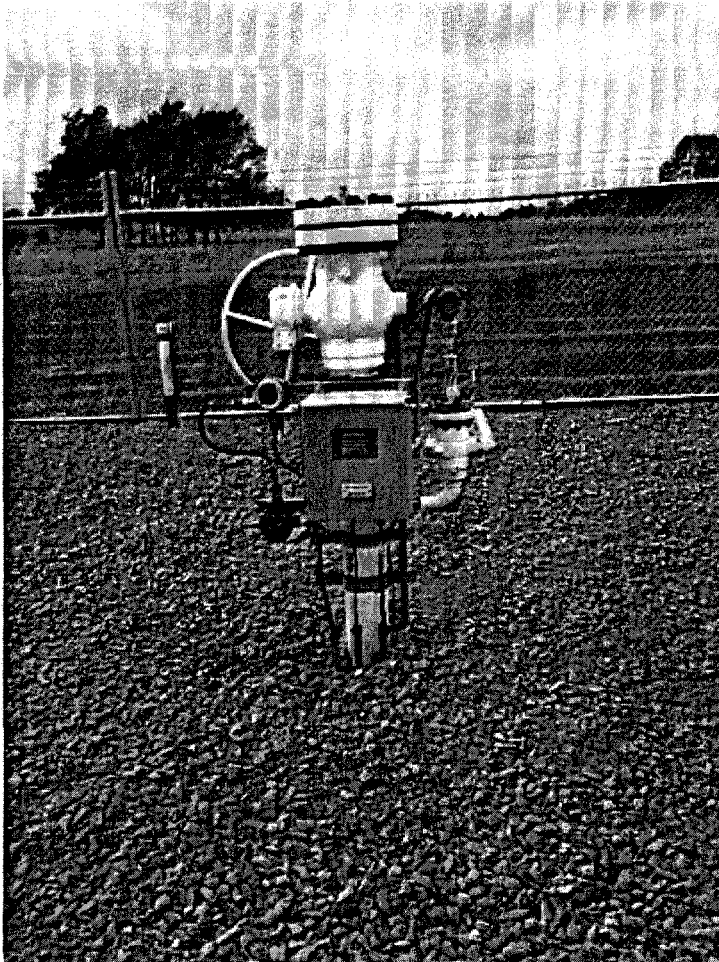
All MLV Comments Observed MLV CRM WL-03A # 239 @ MP 77.65 on South Side of Canadian River. Valve was equipped for automation. See Pictures 1-4. (All MLV on Keystone Pipeline did not have a position indicator as required by 195.116(c)) Observed MLV CRM WL-02A #240 @ MP 73.14 on North Side of Canadian river. Valve is equipped for automation. See pictures 5-10. Observed MLV CSHSP-04A #273 @ South Side of North Canadian River. This valve is a manual valve not equipped for automation. I check valve is installed on upstream side of MLV. See pictures 11-13. Observed MLV CSHSP-03A #280 on North Side of North Canadian River. Valve is equipped with automation. See pictures 14-17. Observed MLV CSHSP-02A- 287 on South Side of Deep Fork River. Valve is not equipped for automation. See picture 18. Observed MLV CSHSP-01A- #295 on North Side of Deep Fork River. Valve is equipped for automation. See pictures 19-22. Observed final line tie in at pump station #32. Tie in consisted of transition at road crossing from .618 WT to .564 and reversed at pump station tie in.
