U.S. Department of Transportation Pipeline and Hazardous Materials Safety Administration	Original Report Date:	08/05/2010
	No.	20100166 - 17790 ----- (DOT Use Only)

ACCIDENT REPORT - HAZARDOUS LIQUID PIPELINE SYSTEMS

3. Zip Code:	57349
4. City:	Howard
5. County or Parish:	Miner
6. Operator-designated location:	Milepost/Valve Station
Specify:	358.3
7. Pipeline/Facility name:	Roswell Pump Station

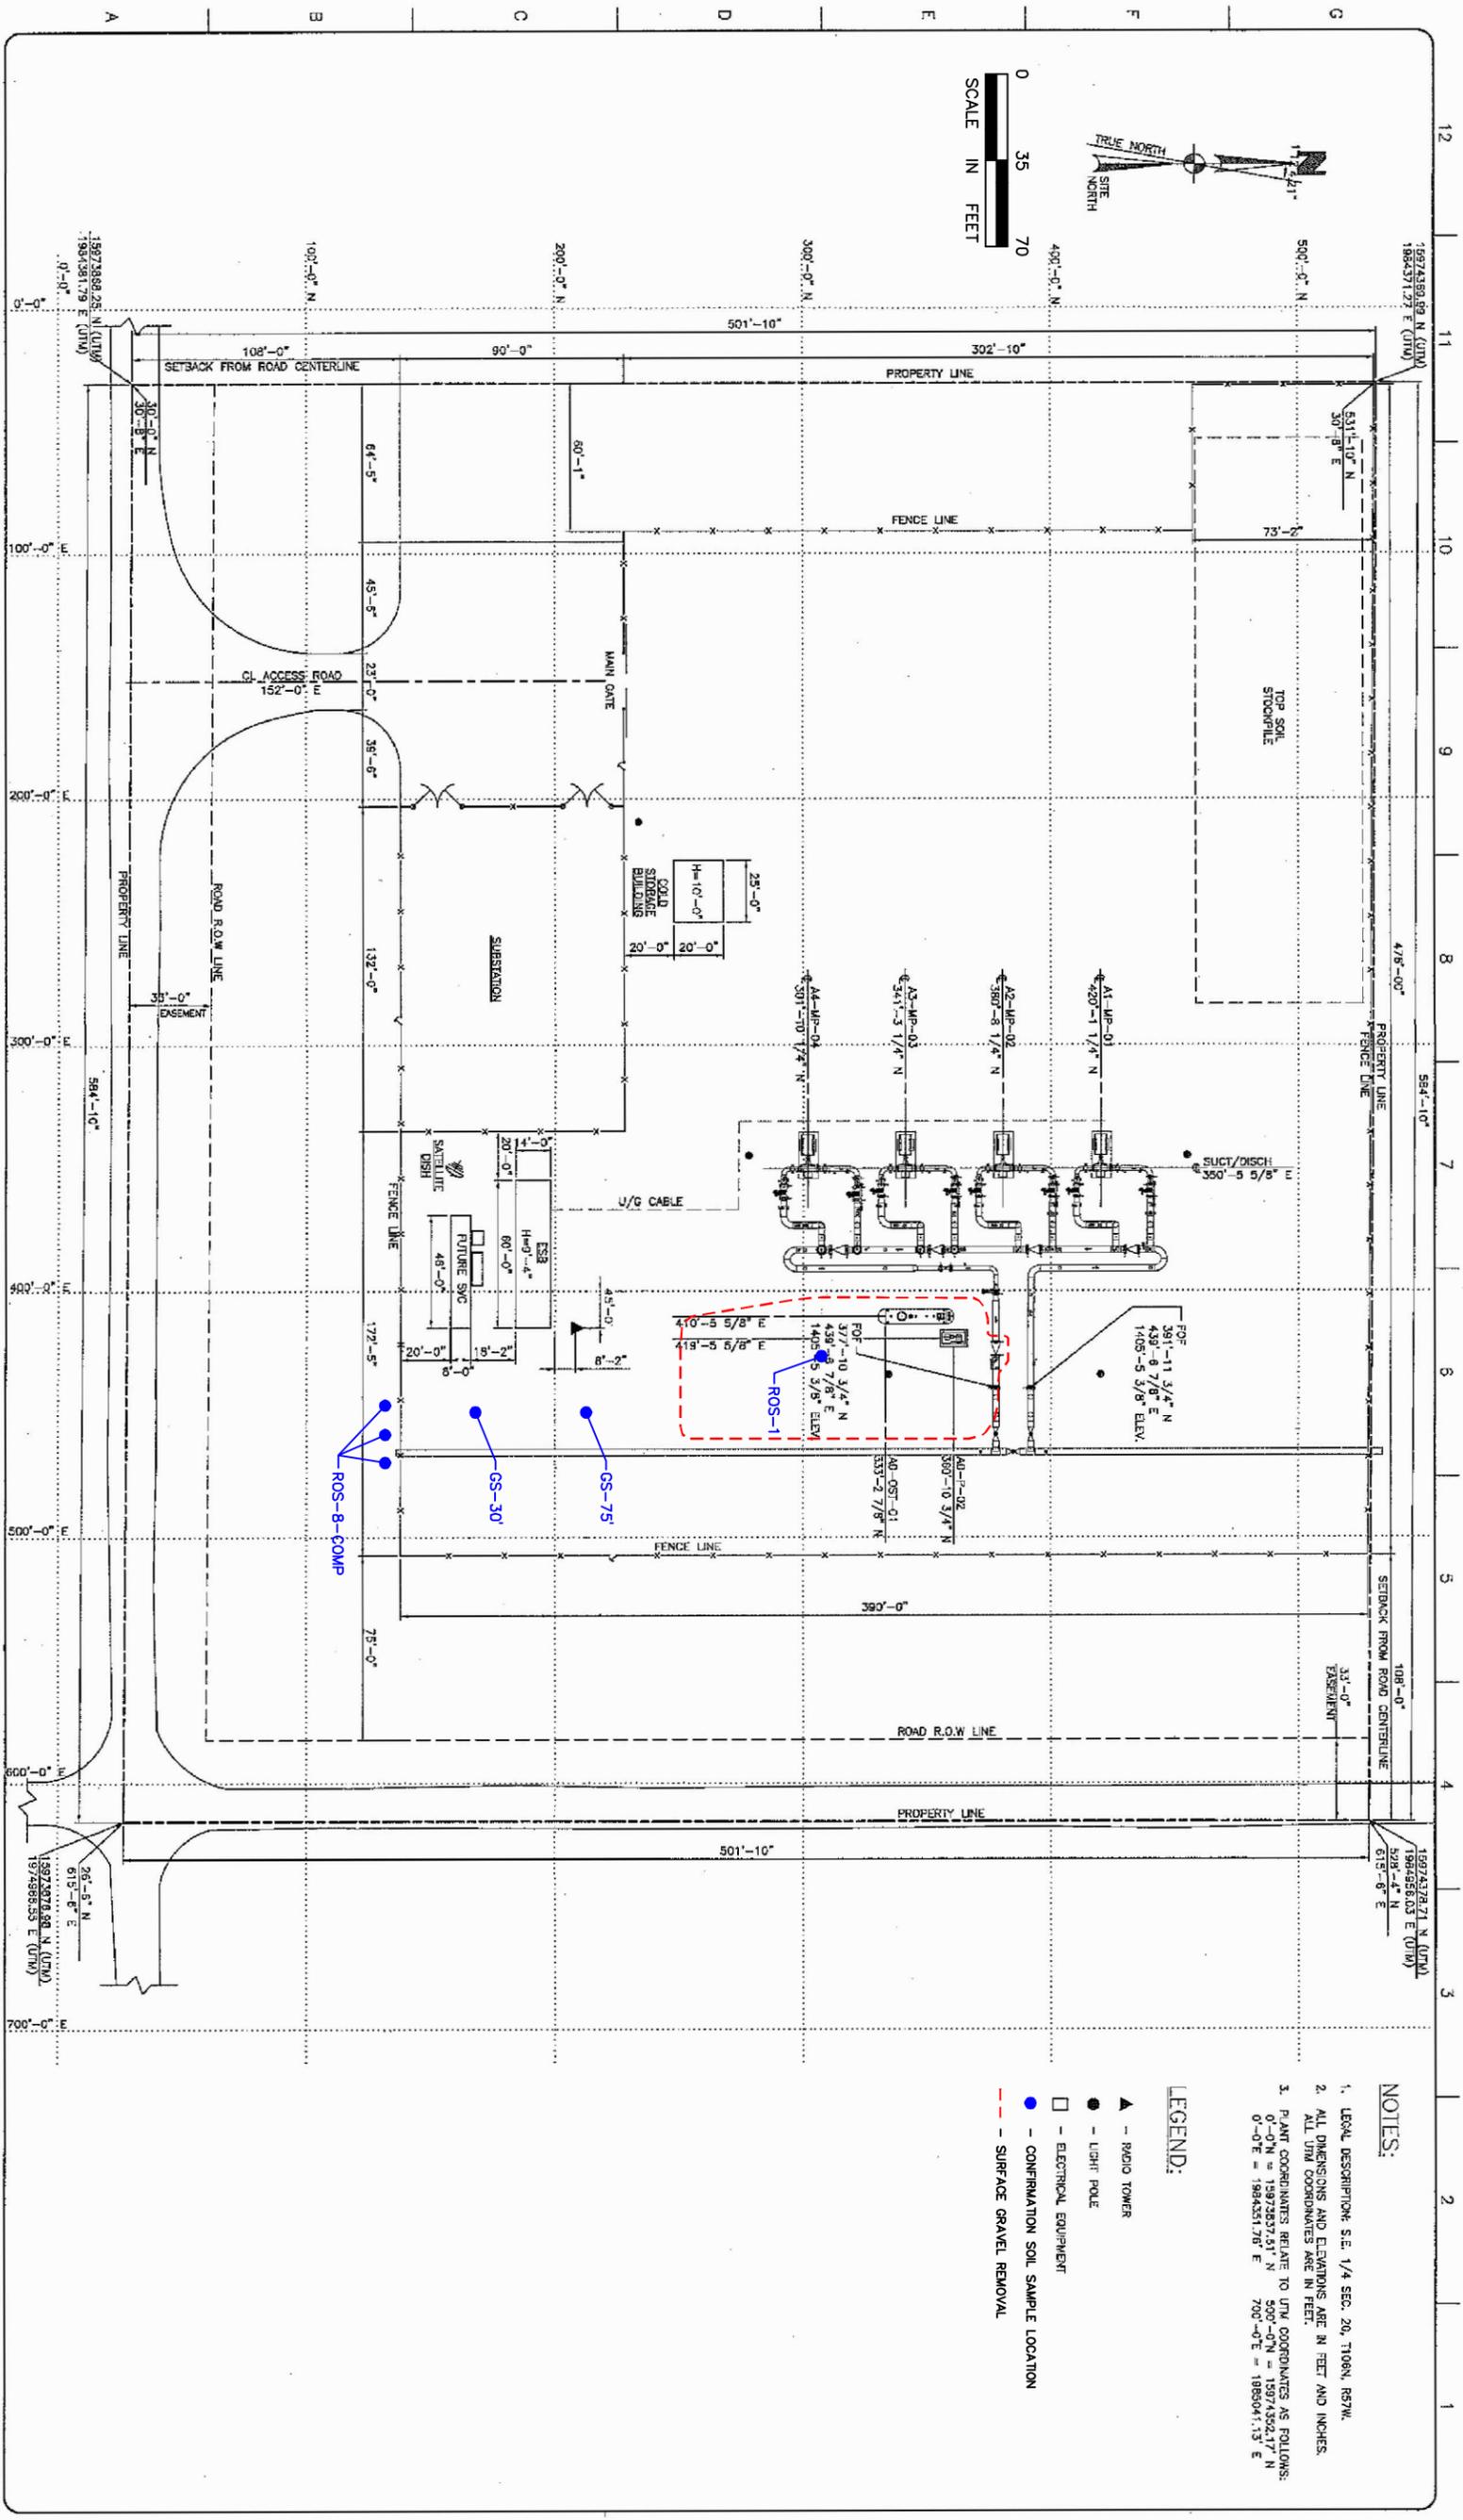
FIG NO. 2

Soils were screened using a photoionization detector (PID) with 10.6 eV lamp after excavation and hydrovac removal activities to determine the required limits of excavation. In addition, the scraped surface yard was screened using the PID. This included four potholes locations dug to confirm clean conditions. Confirmation soil samples were collected at eight locations after excavation was completed. Sampling and PID screening locations and excavation areas are shown in Figures 2 and 3. Confirmation sample ROS-8 is a composite of three discrete samples collected in the south grass mowed area as shown in Figure 2.
