**ACCIDENT REPORT - HAZARDOUS LIQUID
PIPELINE SYSTEMS**

3. Zip Code:	58017
4. City:	Brampton
5. County or Parish:	Sargent
6. Operator-designated location:	Milepost/Valve Station
Specify:	MP ND 216.7
7. Pipeline/Facility name:	Ludden Pump Station

A release occurred at the Ludden Pump Station on the 3/4" pipe nipple under the thermal relief valve located on the facility discharge piping. A root cause analysis has been conducted and the failed fitting investigation performed. The fatigue failure of the 3/4" pipe nipple occurred as a result of excessive vibratio. Results have been provided to PHMSA.

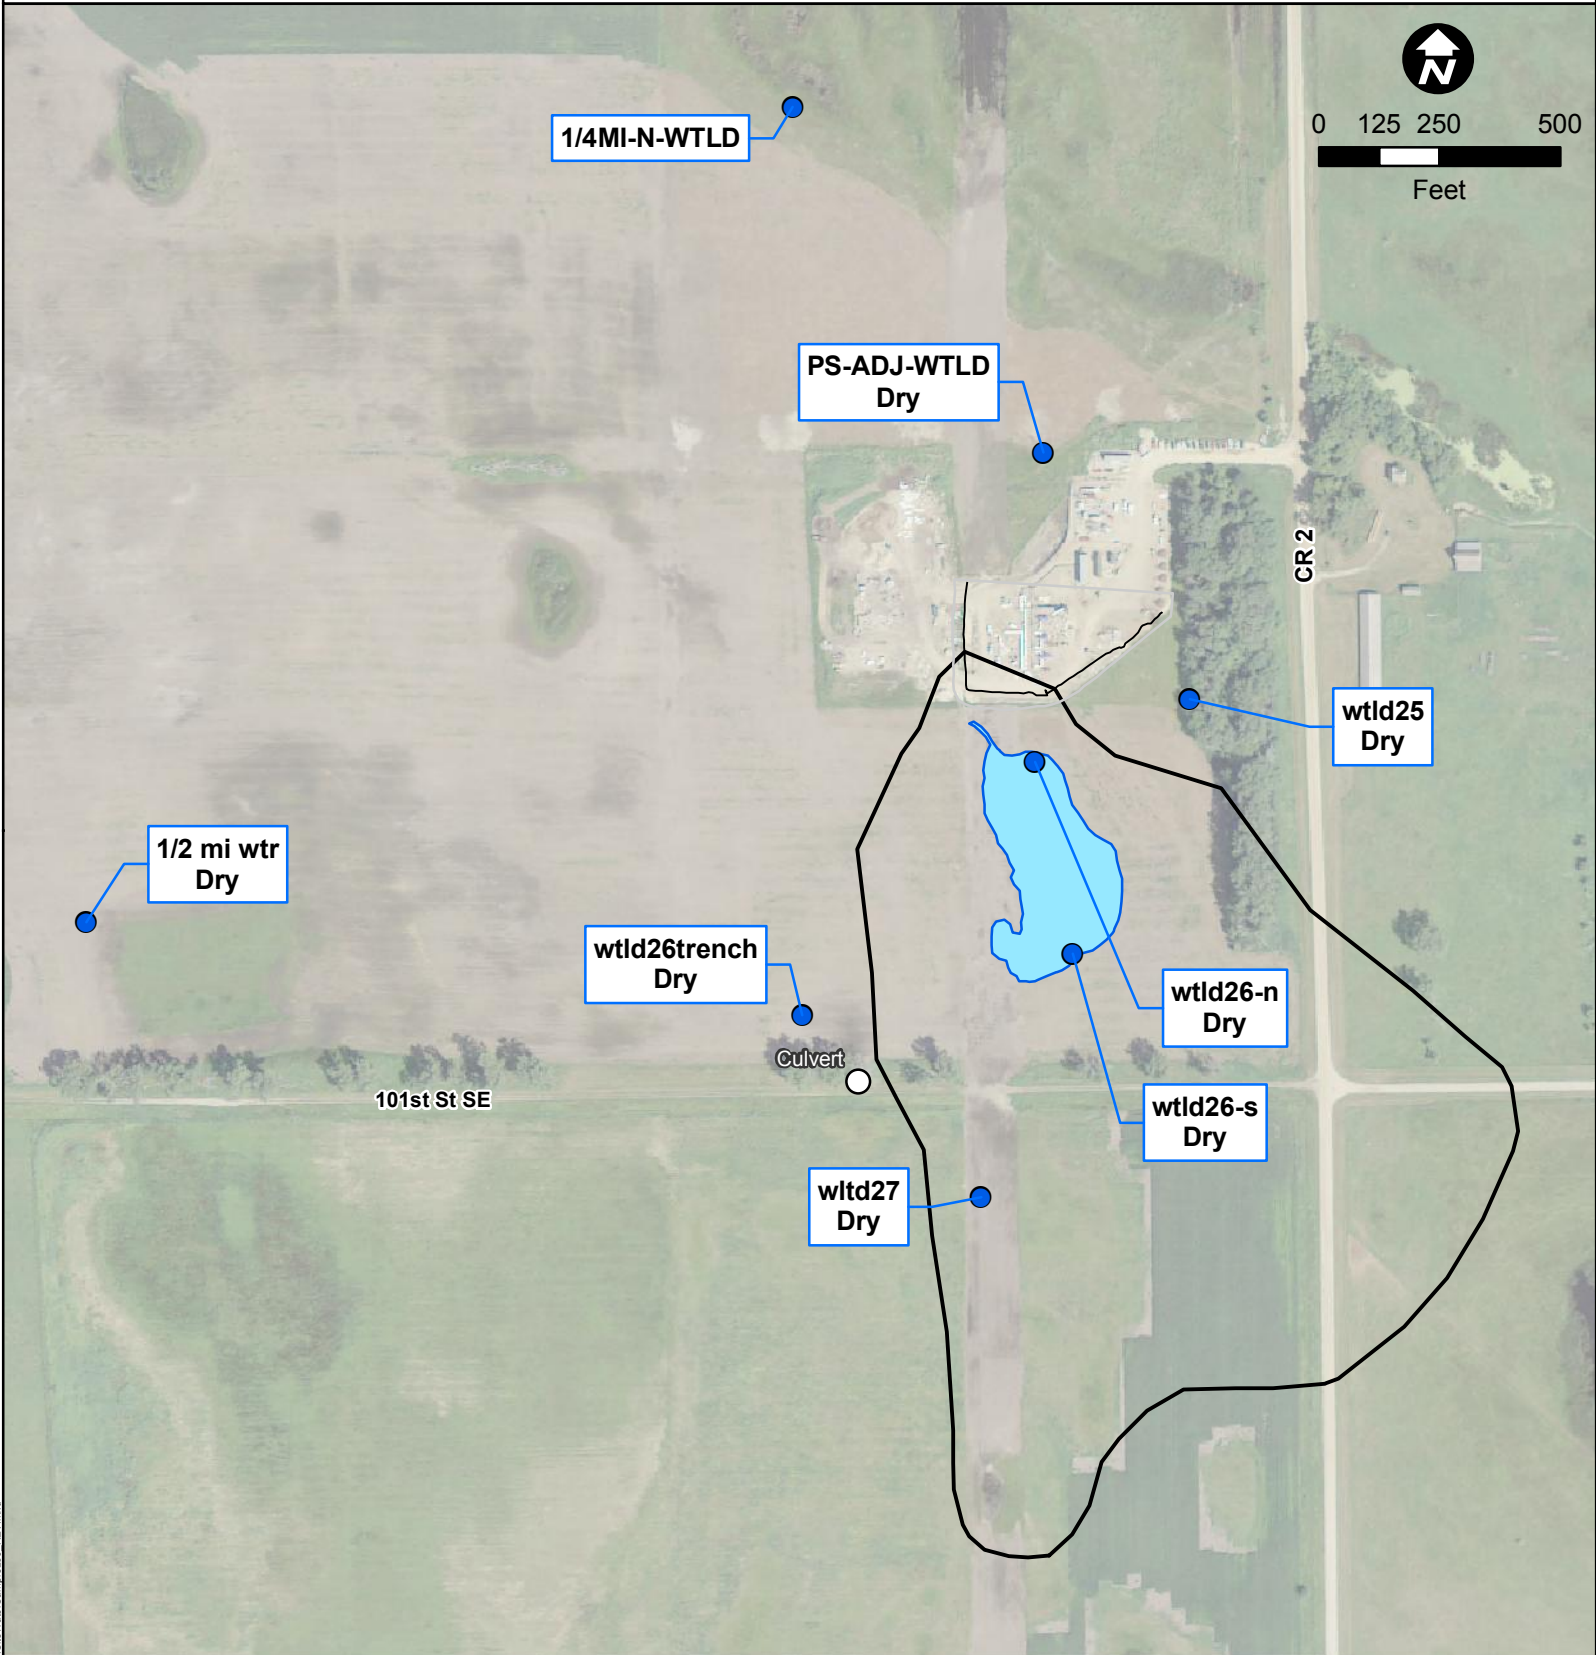
Figure 2. Off-Site Water Sampling Locations - October 20, 2011

The majority of the wetlands previously sampled were found to have no standing water on October 20, 2011, with the exception of the background sample location ¼ mile north of the pump station. The sample location is shown on Figure 2 and the results are summarized on Table 2.

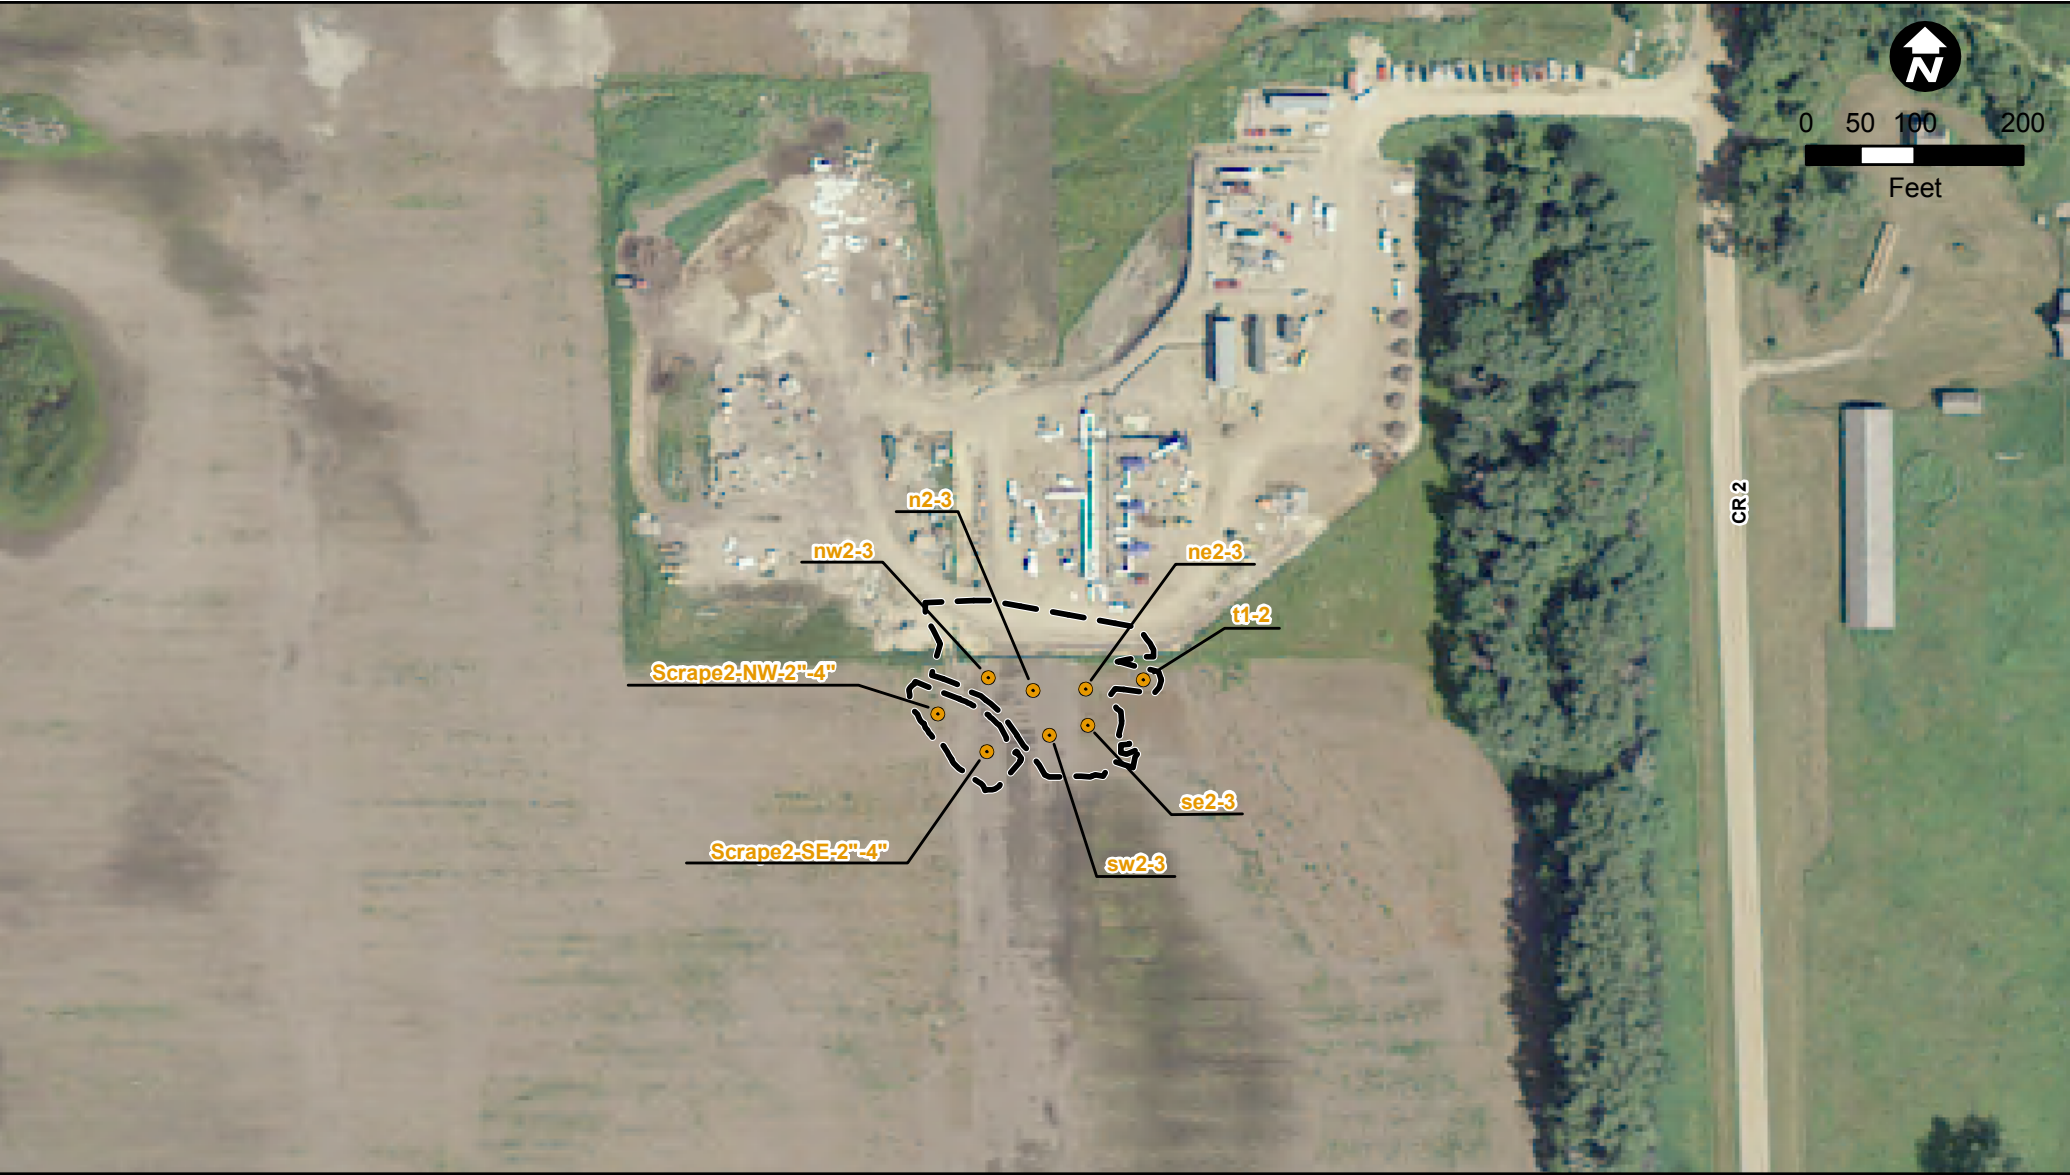
Figure 5. Off-Site Soil Excavation

During the initial response, on May 13 and 15, 2011, a backhoe was used to remove a two inch layer of soil in the field to the south of the pump station that was covered with crude oil (**Figure 5**). The excavation resulted in the removal of approximately 175 tons of oily soil. A narrow trench was also dug in the bottom of the excavation in an area where there was rainbow sheen observed and shallow pooling of oil in a relic tracker track.

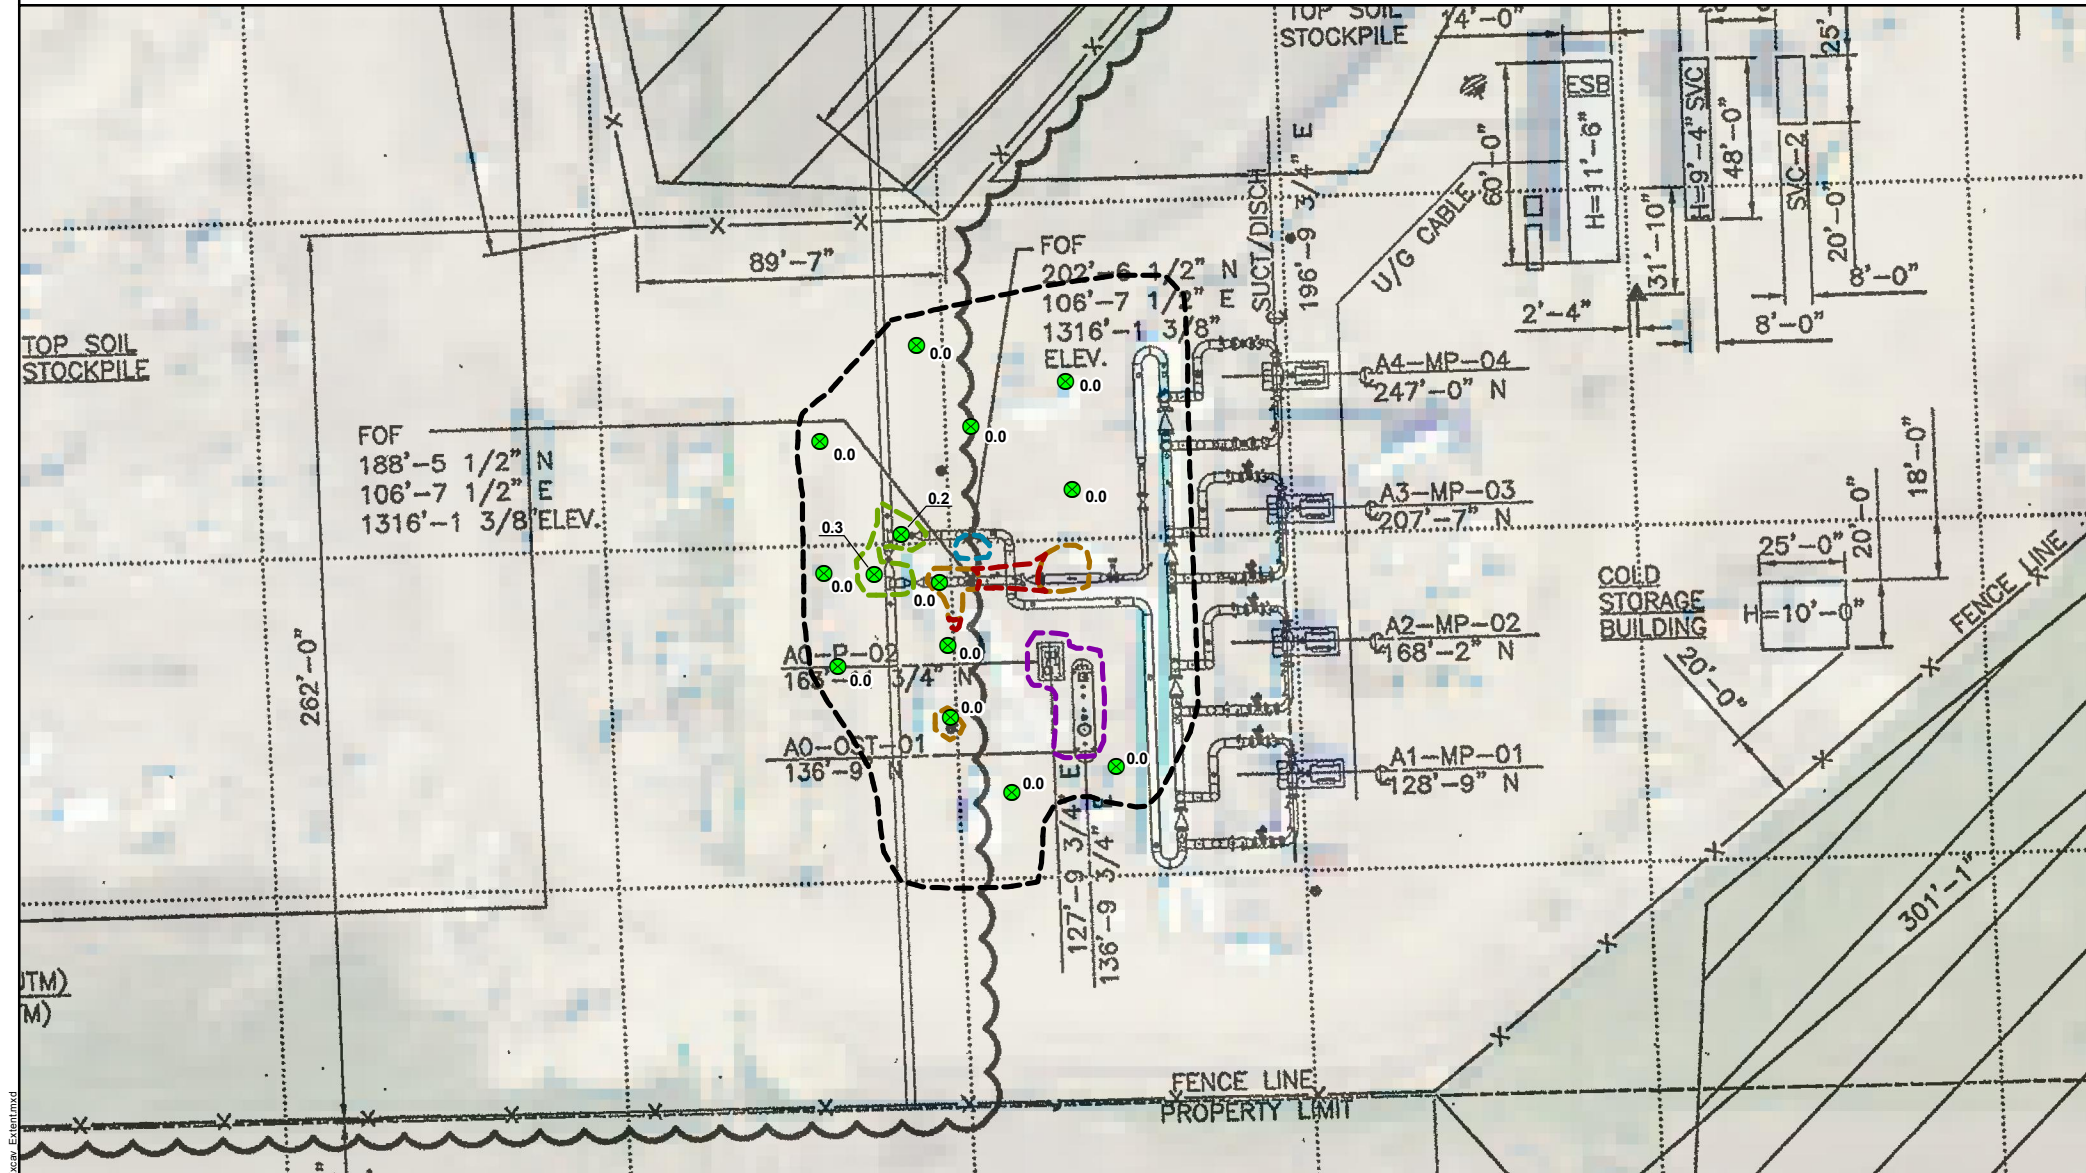
Figure 3. On-Site Excavation Extent

Excavation Depth		PID Reading in PPM
	-1'	0.0
	-2'	0.2
	-3'	0.3
	-4'	0.0
	-5'	0.0
	-6' to -8'	0.0
