Intensive Historic Building Survey and Evaluation for the Brookings County Substation to SD/MN Border Segment of the CapX 2020 Brookings County to Hampton 345 kV Transmission Line Project

Volume 1 of 2

Prepared by:
Kevin (Lex) Palmer – Principal Investigator
HDR Engineering, Inc.
701 Xenia Avenue South, Suite 600
Minneapolis, MN 55416

September 2013

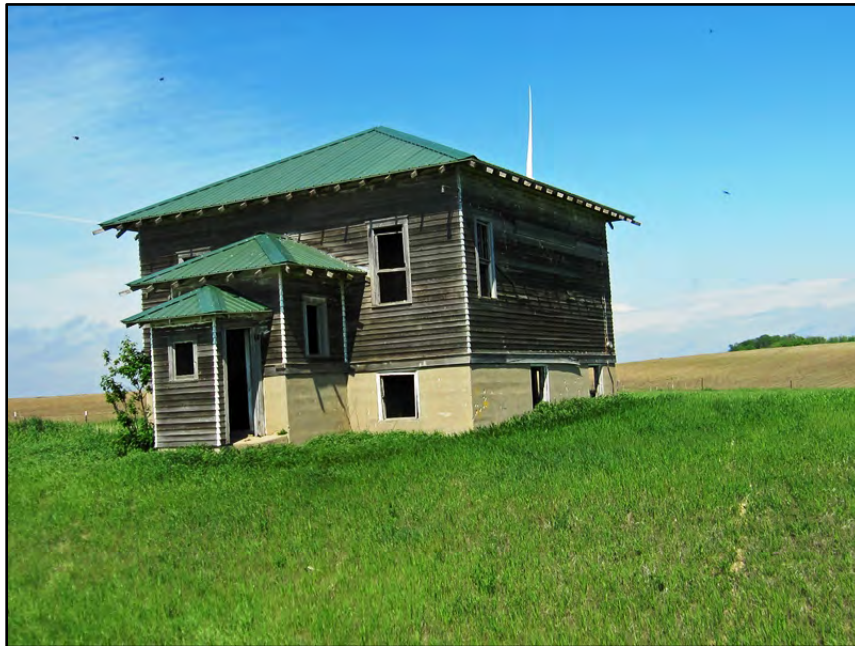
Figure 3–3. View to northeast of schoolhouse/meeting hall Building 1 west primary façade and south elevation.

elevation comprised of deteriorated fixed wood framing and missing glazing. The roof has deep eaves and extended rafter tails. Each corner of the wood clapboard wall cladding is covered with bolted metal caps at the end of each board.

The north elevation fenestration is comprised of one opening with missing sash and glazing. The east elevation fenestration features seven tall openings in a 2-3-2 arrangement with glazing and single-sash wood framing missing or in various states of decay. Two openings bear parts of replacement metal framing and glazing, three are partially covered with weathered plywood, and one is completely covered with weathered plywood. The south elevation fenestration is comprised of one opening with single wooden sash, mullions, and glazing present.

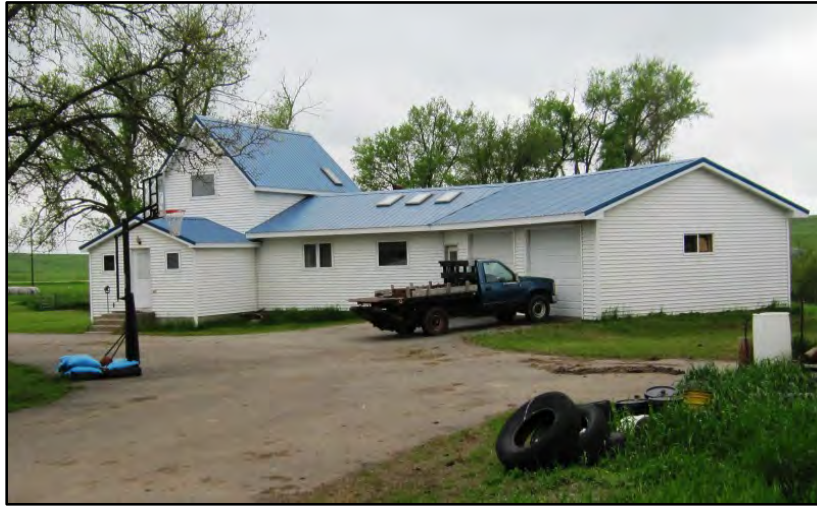
The two-story farm residence (Figure 3-13, Building 5 on site map) is a rural vernacular style building with a 1971 single-story addition on the east portion. The original segment (on the south) was constructed circa 1918 on a concrete foundation, and the addition was constructed on a concrete masonry unit foundation. The residence floor plan is three rectangular blocks angled to the northeast that are clad with vinyl siding. The cross-gable roof is clad with standing seam metal panels, is punctured with five skylights, and features boxed eaves. The east primary façade ground floor wall openings are from left to right: one single-leaf metal door with a single upper light, fronted by a 5-step concrete stoop, and flanked by two square vinyl fixed windows; one paired vinyl window; one fixed vinyl window; one metal door with an upper light; and two single-bay vehicle metal doors. The east primary façade second story has a vinyl fixed window in the gable end. The south elevation ground floor wall openings include one metal sliding glass door flanked by two vinyl fixed windows. The south elevation second story wall openings comprise two vinyl fixed windows. The west elevation ground floor wall openings include two glass block windows in the foundation, and three square vinyl fixed windows, a metal sliding glass door, and one vinyl fixed window in the upper wall. The north elevation has a vinyl sliding window.

Figure 3–13. View to southwest of historic age residence Building 5 east primary façade and north elevation. The original farmhouse is the two-story segment on the left. The remaining portions are additions.

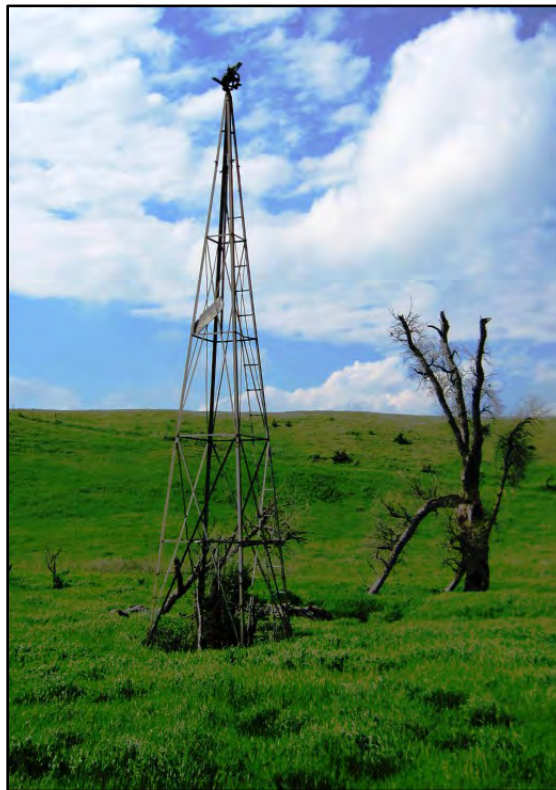
Site BK00000195 is a windmill structure (Figure 3-23, Building 1 on site map) dating from 1900 to 1930. The structure is utilitarian and lacks a cardinal orientation.

Figure 3–23. View to north of windmill with missing vane.

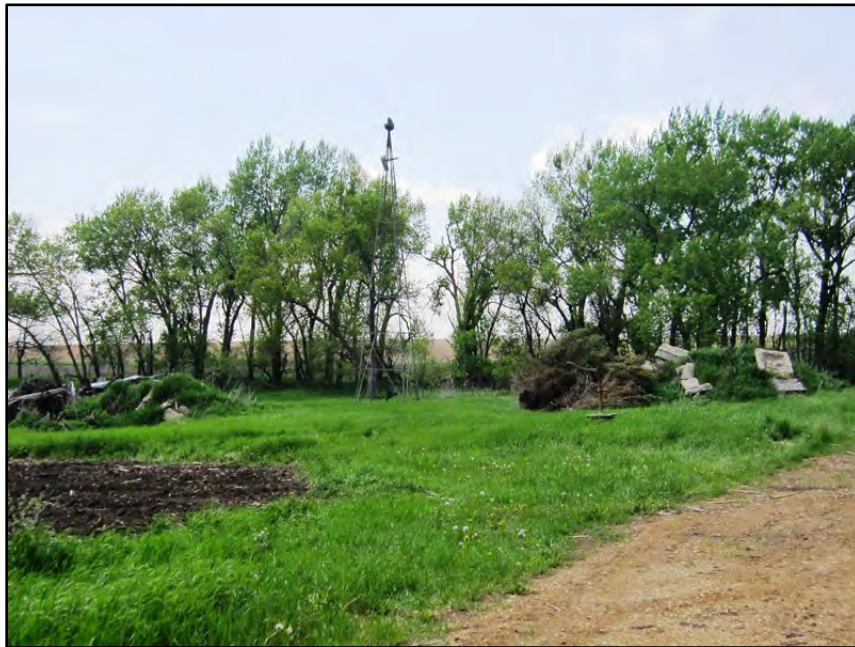
Figure 3–24. View to west of demolished buildings and windmill.

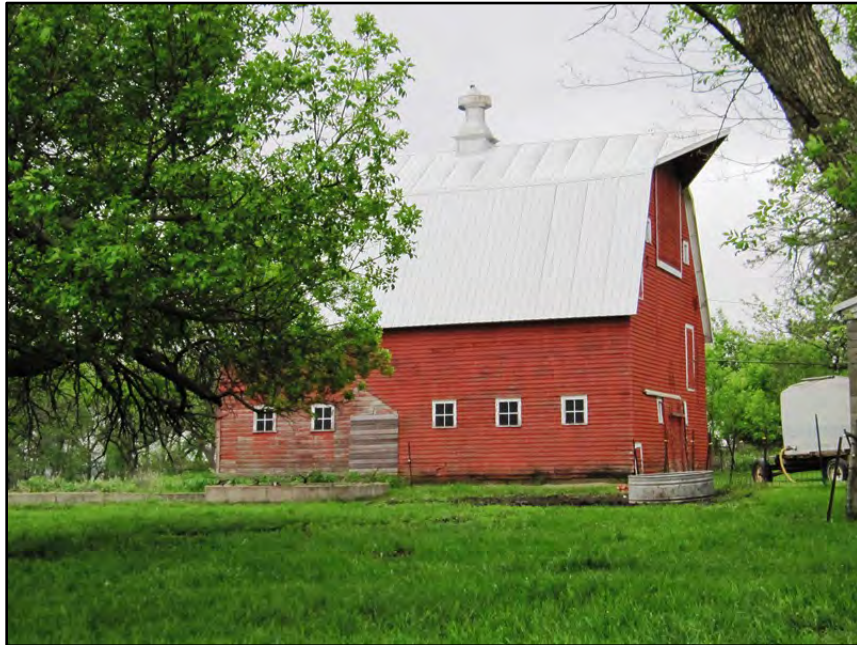
Figure 3–55. View to east of Hexem Barn south primary façade and west elevation. The circular outline in the foreground on the left from a demolished silo. Note the outline on the barn wall of the silage chopper house that is no longer extant.

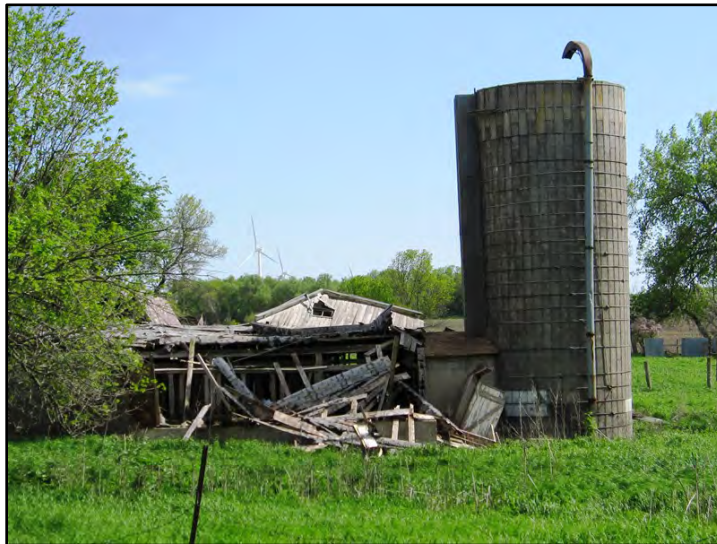
Building 4 is a severely deteriorated concrete stave silo and an associated Building 5 is a collapsed rural vernacular style barn building (Figure 3-77 and see site map).

Figure 3–77. View to southwest of Building 4 silo and collapsed Building 5.

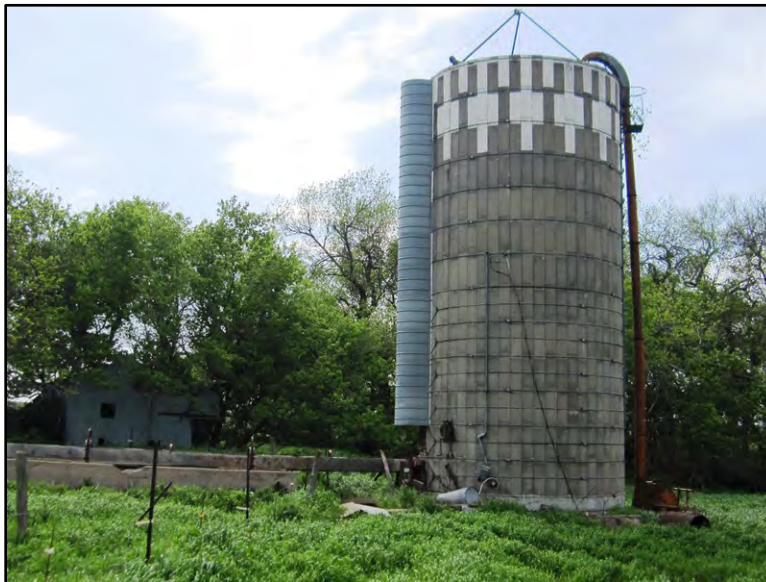
Figure 3–90. View to west of Building 5 concrete stave silo associated with demolished barn (note foundations on left). The red silage blower is located on the right. The collapsing Building 6 is in the left, rear.

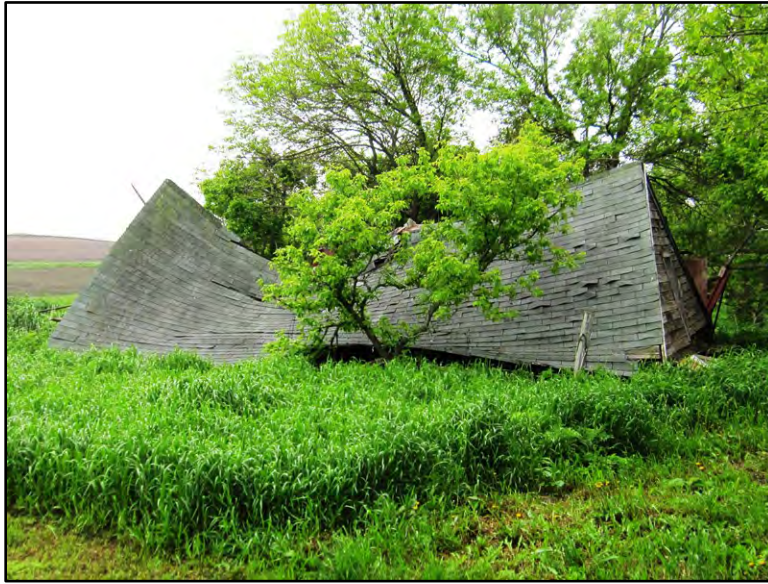
Figure 3–96. View to east of collapsed barn Building 3.
