Cracks in onshore wind turbine foundations

Author: [Miceli, Francesco](#)

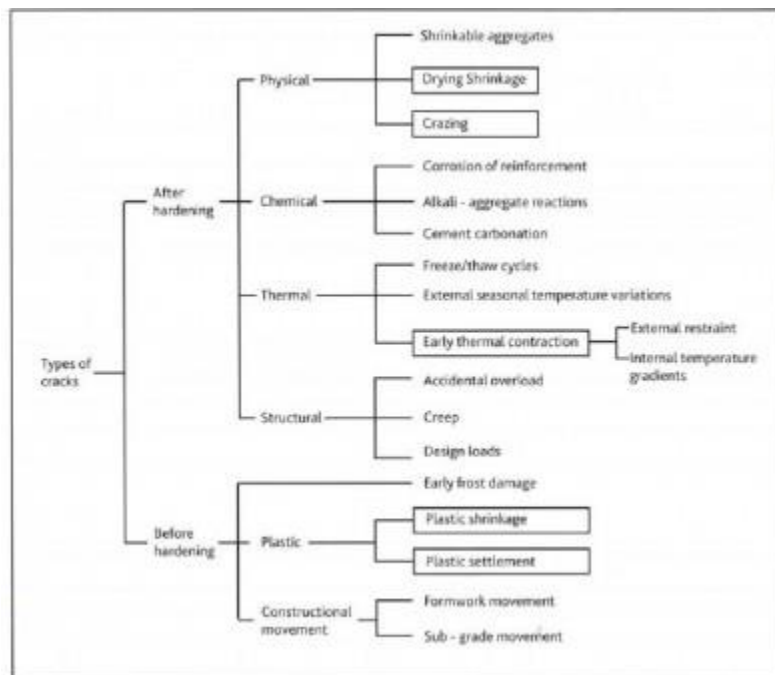
There is no consensus in the sector about the root cause of the cracks. You can find a comprehensive family tree of fracture types below:

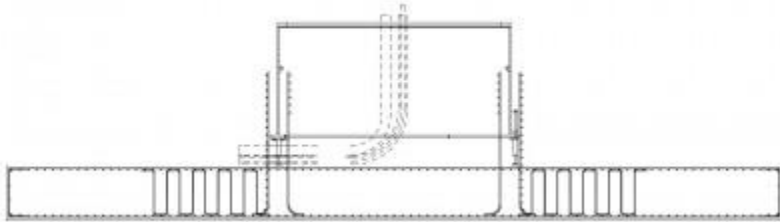
From my experience it seems that old foundations with embedded ring are more prone to fissures compared to the new foundations with anchor cage.

Among the foundations with embedded ring, high pedestal foundations like the one in the following picture are the most problematic:

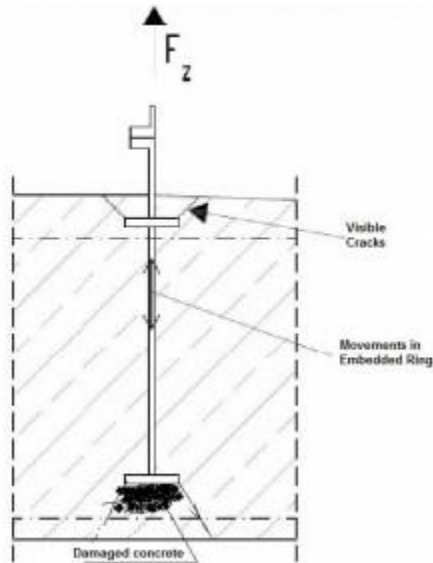
However it seems that the more dangerous fissures are the ones appearing below the lower flange. Apparently the load concentration below the steel plate, in combination with cyclic loads, can damage the concrete inducing small movements. This is an area where [it] is very complicated to pour correctly the concrete: the air can remain trapped, lowering the resistance of concrete.

After several cycles, these movements can pulverize the concrete below the flange and increase from few millimeters to a centimeter or even more.

At this point, the superficial sealing between the embedded ring and the concrete won't be able to withstand the displacement and will break. Subsequently, water will be able to enter the foundation: this will lead to a pumping effect, possibly even freezing and expanding in low temperature areas.

Several side effects will start, such as carbonation and possibly to reinforcement bars corrosion. Subsequently, it will be necessary to stop the wind turbine and undertake remedial works.

As solution, sufficient vertical reinforcement and anchorage length should be provided. Some designers also like to position the bottom flange as high as possible to increase the thickness of the concrete below.
