Stork Twin City Testing Corporation

PROJECT NUMBER: SOU263-01-15-91979

GRAIN STRUCTURE EXAMINATION

Cracked 2" diameter gas pipe section from PS07-002 Natural Gas Incident, Mitchell, South Dakota

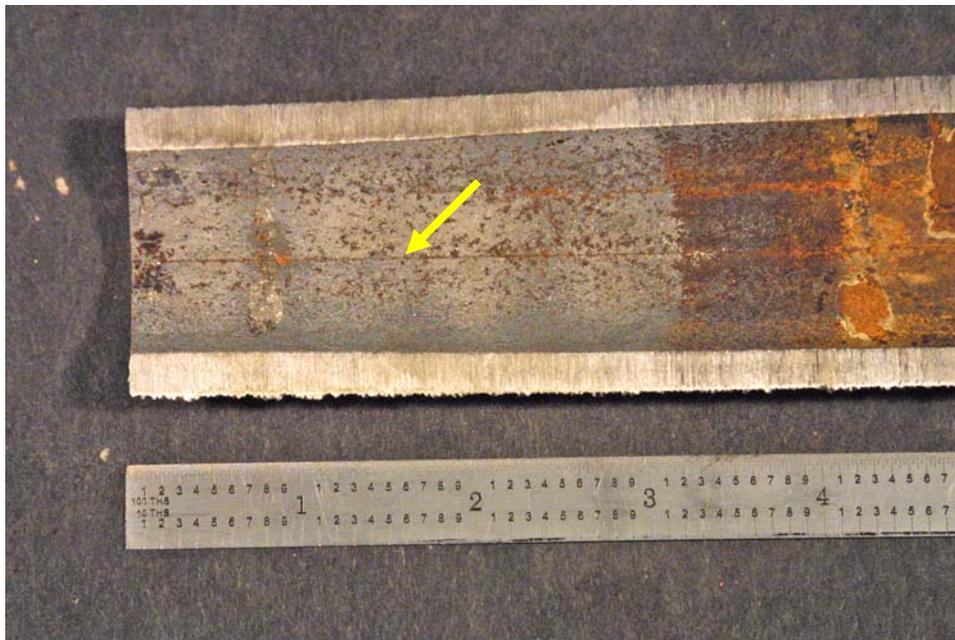
A transverse section was cut through a presumed longitudinal weld (Figure 1) in the 2" diameter gas pipe section. The transverse section was mounted in plastic, polished, etched in 10 % nital (10 % nitric acid in alcohol) and examined for grain structure. There was no grain deformation observed, but there was a significant variation in pearlitic grain structure (Figures 2-4).

Figure 1: Presumed longitudinal weld seam on inside surface of gas pipe section (arrow).

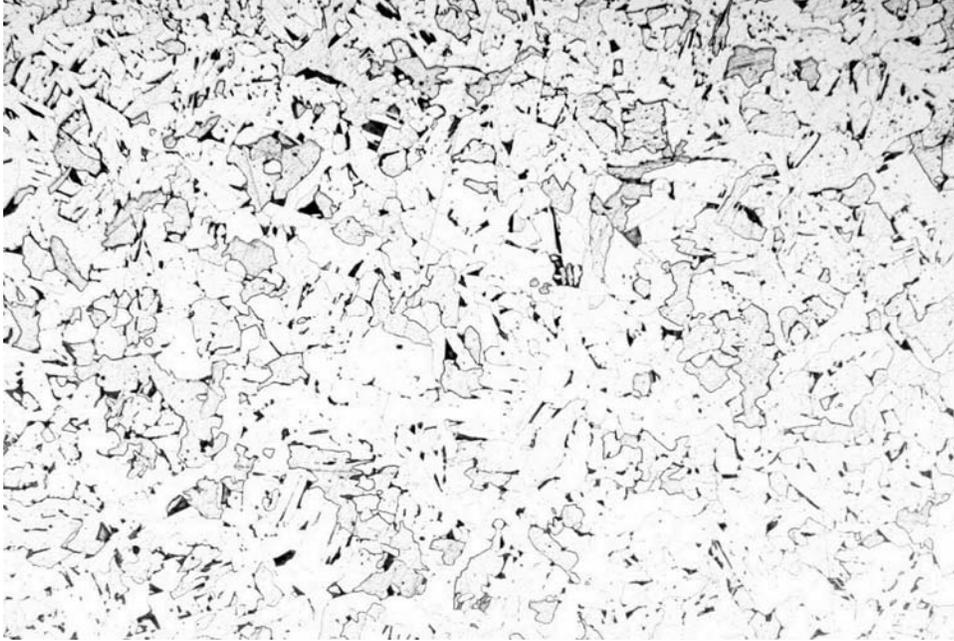
Figure 2: Grain structure left of presumed weld seam consisting of pearlite islands (dark) in a matrix of ferrite (light). Magnification 70X

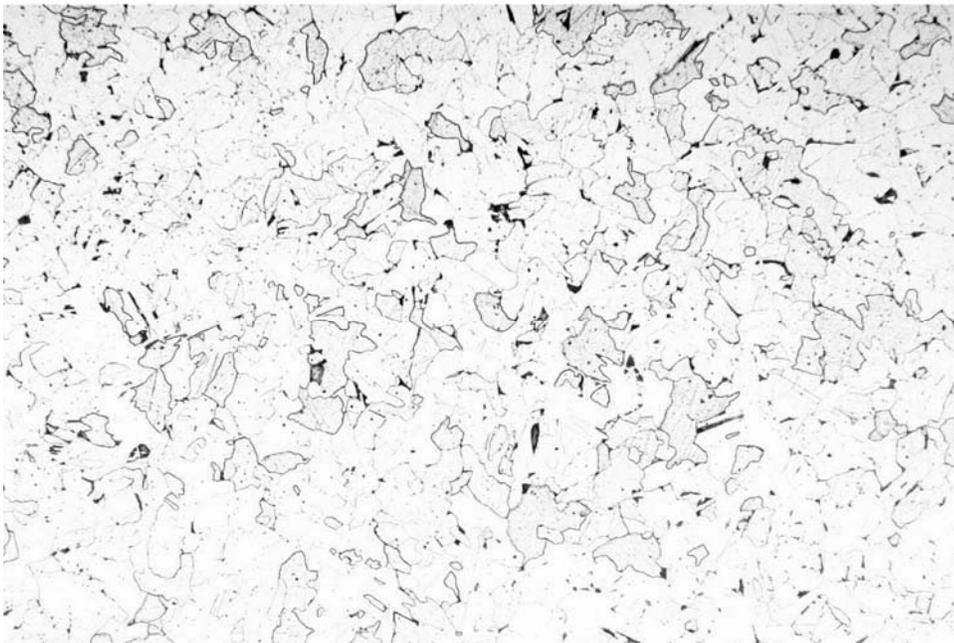
In light of the fact that the pipe was installed sometime in the mid-1950s, these characteristics suggest that the 2" diameter gas pipe section was furnace butt-welded pipe. For example, a typical furnace butt-welded pipe of this vintage might have been made as "Open Hearth Class II" material according to API Specification 5L dated March, 1955. A similar product, still produced currently, is continuous welded pipe, Grade A25, that is made in accord with API Specification 5L dated March 2004.

Figure 3: Grain structure at presumed weld seam consisting of pearlite islands (dark) in a matrix of ferrite (light). Note less pearlite present as compared to Figures 2 and 4. Magnification 70X

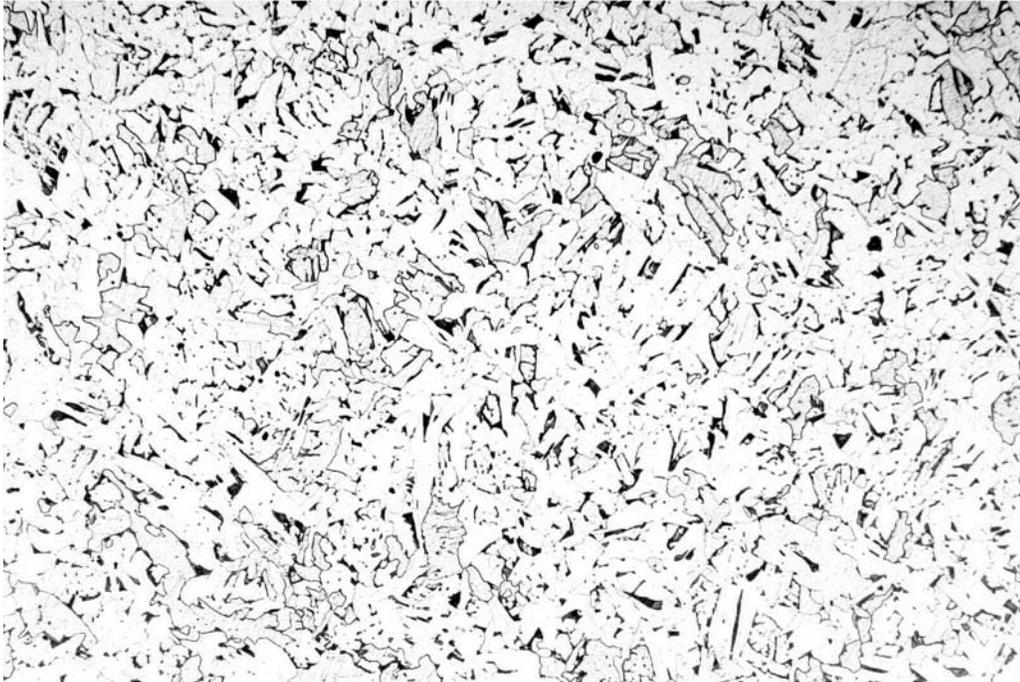
Figure 4: Grain structure right of presumed weld seam consisting of pearlite islands (dark) in a matrix of ferrite (light). Magnification 70X

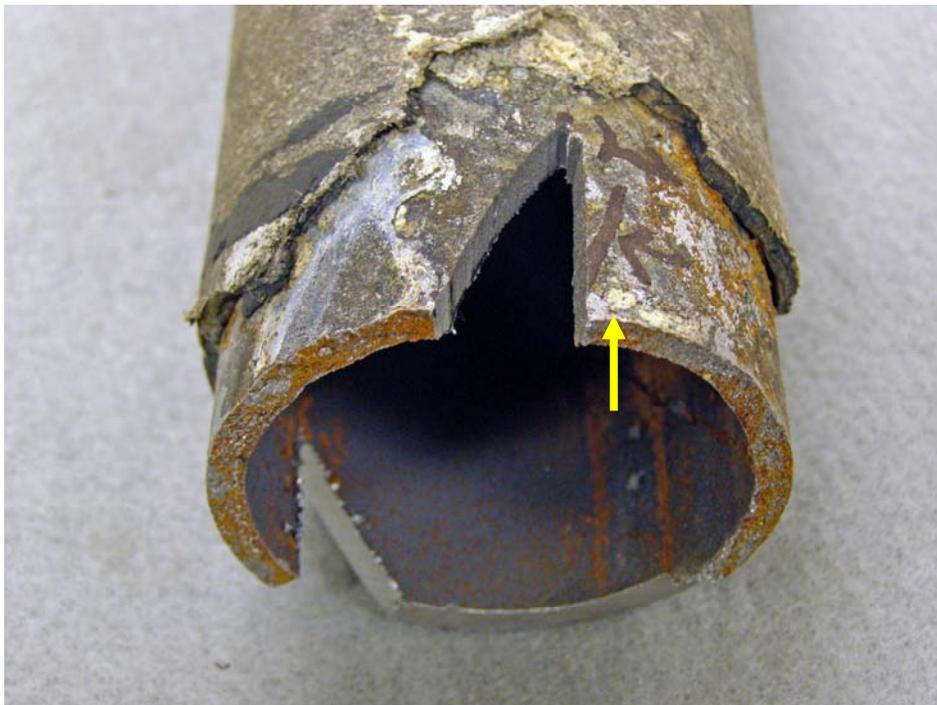
Two pie-shaped sections were cut through the exposed crack surface (Figure 5). The G section was located at the groove (Figure 6) approximately midway between the ends of the crack (at location where crack opening was greatest). The NG section was located approximately 135° around the pipe circumference from the G section (Figure 5). The NG section was at one end of the crack, and no groove was present on the adjacent pipe outside diameter. Both sections were mounted in plastic, polished and etched in 10 % nital (10 % nitric acid in alcohol) to view the grain structures adjacent to the groove and the no groove locations. The groove is readily apparent in the macrophoto of the pipe wall thickness at and adjacent to the crack location (Figure 7).

Figure 5: Failed end of the gas pipe section after separation of crack surfaces. Note the two pie-shaped sections cut and mounted for grain structure examination. Groove in pipe OD surface adjacent to crack is identified with arrow. Magnification 1.28X

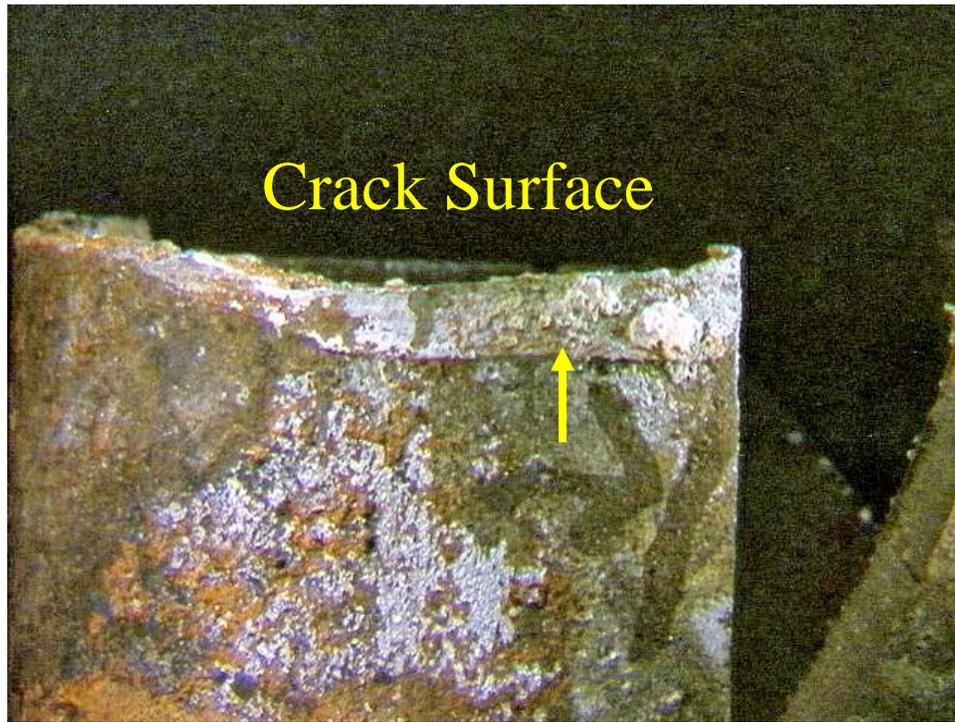
Figure 6: Close-up photo of the groove (arrow) adjacent to the crack surface at the point of maximum crack opening. Magnification 2.8X

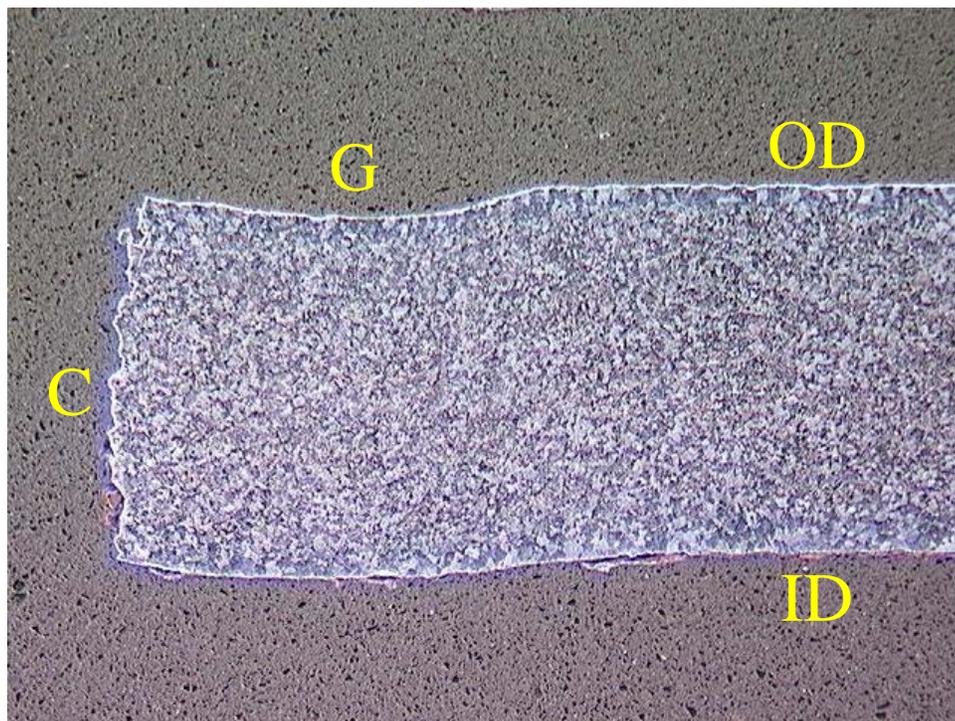
Figure 7: Cross section of pipe wall thickness through the groove (G) adjacent to the crack surface (C). The outside diameter (OD) and inside diameter (ID) of the pipe section are as shown. Mag. 11.8X

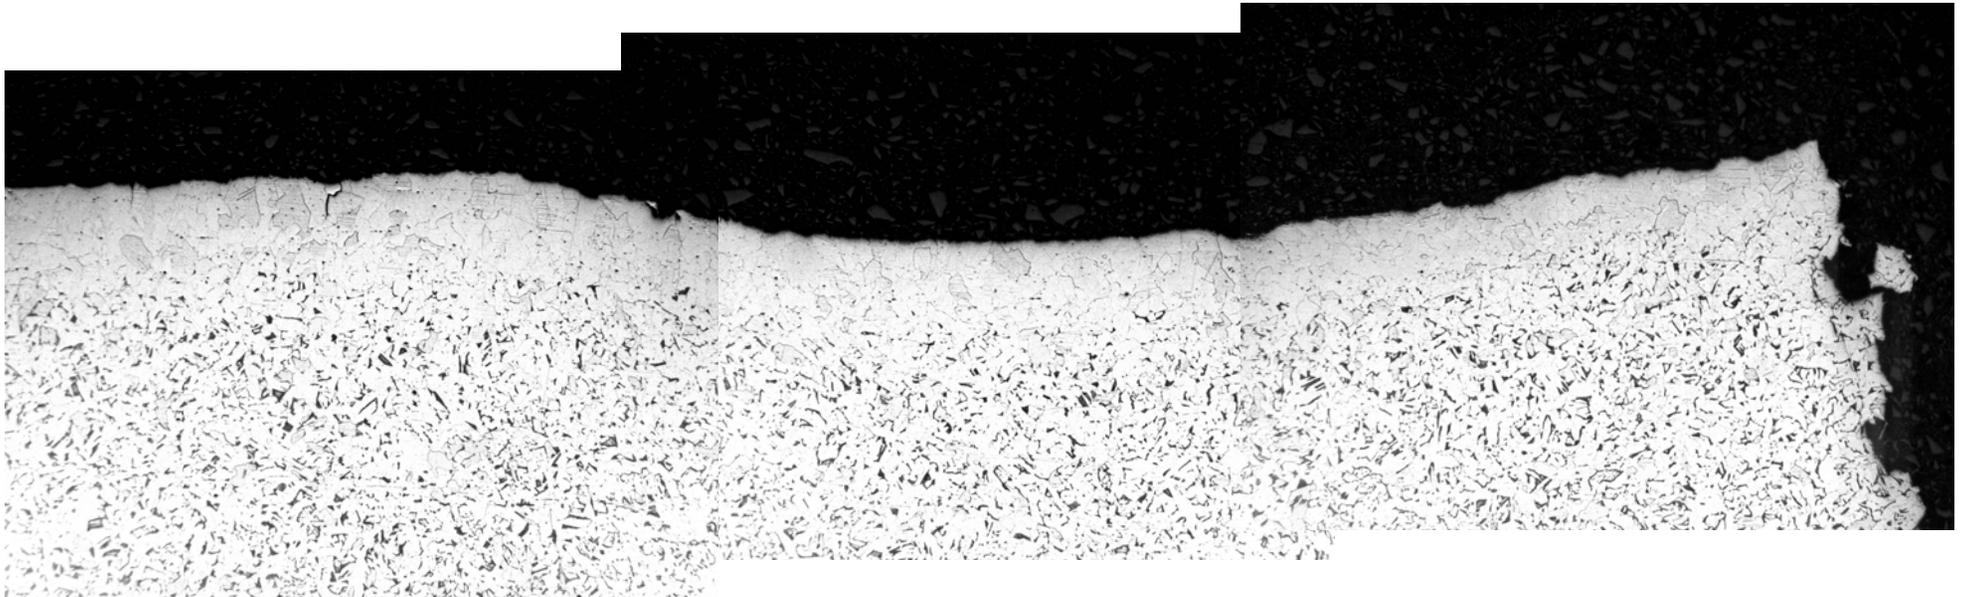
The grain structures are shown in the photo collage (Figure 8) and the comparison location (Figure 9). The grain structures consisted of pearlite islands (dark) in a matrix of ferrite (light). The grain structure examination was conducted on January 16 and 17, 2008 according to ASTM: E3-01.

Figure 8: Composite photo of OD surface grain structure extending across the groove adjacent to the crack surface at right. Groove is readily apparent at top of photo. Grain structure consists of pearlite islands (dark) in a matrix of ferrite (light). Magnification 39.3X

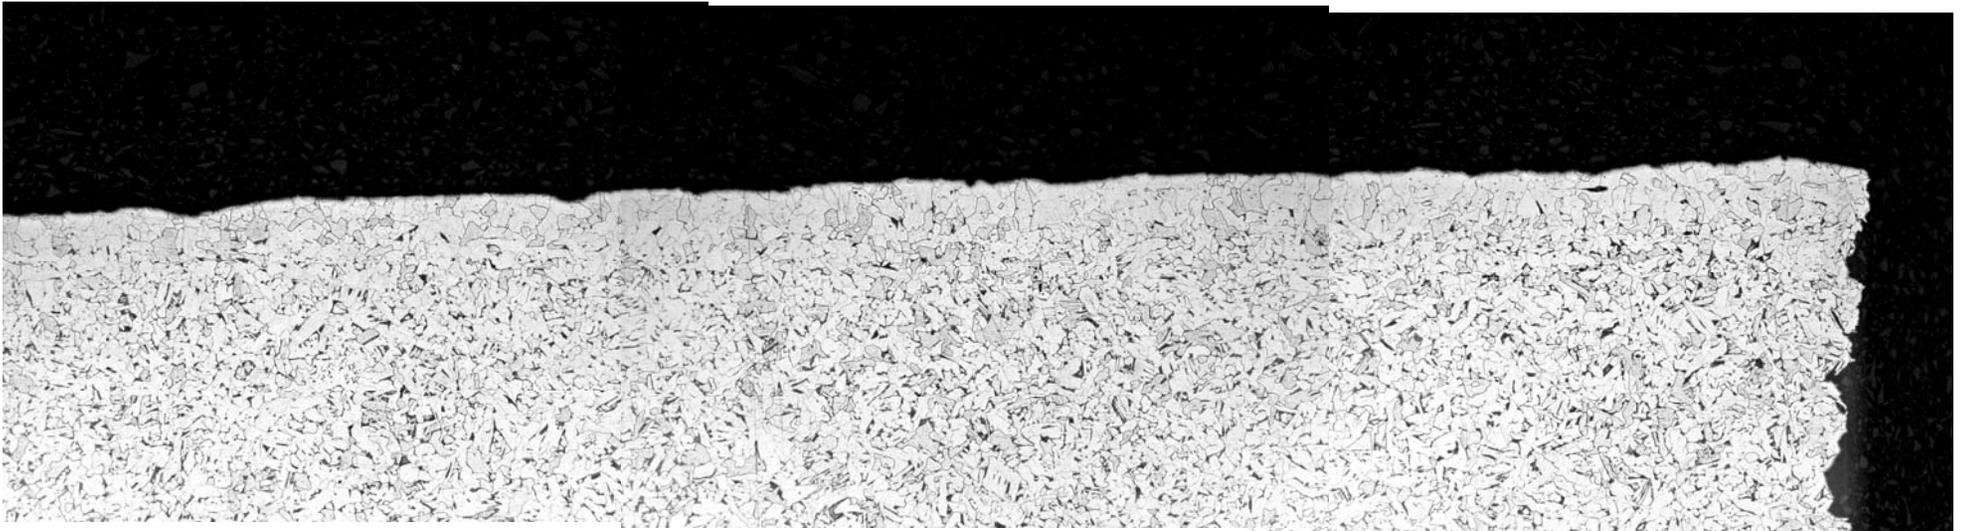
Figure 9: Composite photo of OD surface grain structure extending in from crack surface at right and at NG location (no groove). Grain structure consists of pearlite islands (dark) in a matrix of ferrite (light). Magnification 38.7X
