## **SOUTH DAKOTA PUBLIC UTILITIES COMMISSION**

RE: New Docket – SDIP Compliance Issues

On a recent site visit and inspection, I became aware of pipeline safety compliance issues on the South Dakota Interstate Pipeline (SDIP) system. Please open a pipeline safety docket to facilitate commission consideration and action regarding said items.

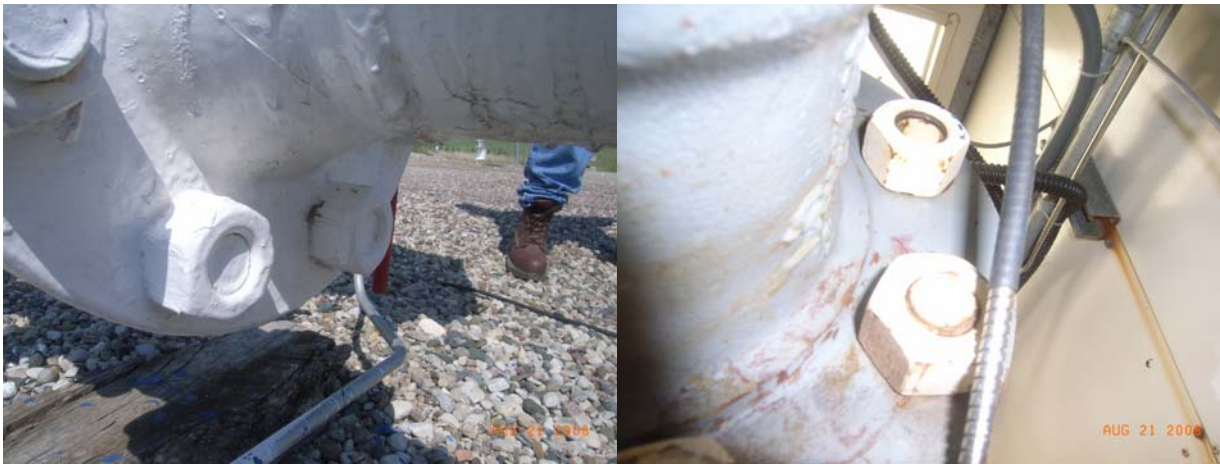
On August 21, 2008 at a regularly scheduled pipeline safety inspection at SDIP I noted several flange stud bolts at the regulator station less than flush with the nut. I noted the issue in my inspection report and recommended the flanges be fixed. October 31, 2008 was the stated corrective action due date. SDIP did not object either in writing or in person to my findings or the recommended corrective action. On April 2, 2009, in correspondence with SDIP, it was admitted the correction was not yet made and an extension was requested. The corrective action due date was extended to July 31, 2009. Again, SDIP did not object to my findings or recommended action. All referenced correspondence with SDIP is attached as Exhibit A.

On August 11, 2009, I inspected an SDIP regulator station in Mina, SD. I was on-site to observe the internal corrosion direct assessment (ICDA) process. While I was on site, it became apparent from observation and from conversation with Mr. Gordon Woods that the corrective action regarding short bolts was not done. He stated that the bolts had been purchased but he had not had time to install. At no time in previous reports or correspondence did Mr. Woods dispute my recommendation regarding the stud bolts but he now questions the validity of the recommendation.

An Office of Pipeline Safety training specialist taught me, in the course of my training, to check for short stud bolts when conducting inspections. Guidance materials from The American Gas Association's Gas Technical Committee for 49 CFR 192.147, Part 2, Flange Accessories, paragraph (g) states, "For all flange joints, the bolts or stud bolts used should extend completely through the nuts (see Exhibit C). SDIP's stud bolts do not extend completely through the nuts as can be seen in the following photographs.

Based both on SDIP's failure to reply to initial inspection reports and on the incorporated American Gas Association materials, I recommend the Commission assess a \$50.00 fine for SDIP's non-compliance when it failed to replace the short stud bolts. I also recommend the Commission order SDIP to replace said stud bolts.
