Pipeline Failure Investigation Report

Pipeline System: Distribution **Operator:** Montana-Dakota Utilities Co. (MDU)
Operator ID: 12684 **Unit Number:** _____ **Activity Number:** _____
Location: 920 11th Street Rapid City, SD **Date of Occurrence:** 11-29-2021
Material Released: Natural Gas **Quantity:** 46.28 MCF
11-29-2021 11:50 AM
PHMSA Arrival Time & Date: MT **Total Damages \$:** \$224,788
Investigation Responsibility: State PHMSA NTSB Other _____

On November 29, 2021 at 9:22 a.m. MST, an excavator notified Montana-Dakota Utilities Co. (MDU) that they damaged a 1" main near 920 11th Street, Rapid City, South Dakota. An MDU first responder arrived at 10:27 a.m. MST and after checking in with local fire department personnel on scene, began investigating. While the MDU emergency responders were working to secure the damage, the leaking natural gas caused by the excavation damage migrated and subsequently ignited causing an explosion and a fire at 920 11th Street. An MDU crew excavated and squeezed the 2" steel main upstream of the damaged 1" main. South Dakota PUC pipeline safety felt this incident could have been avoided if good emergency response steps were taken. Since the

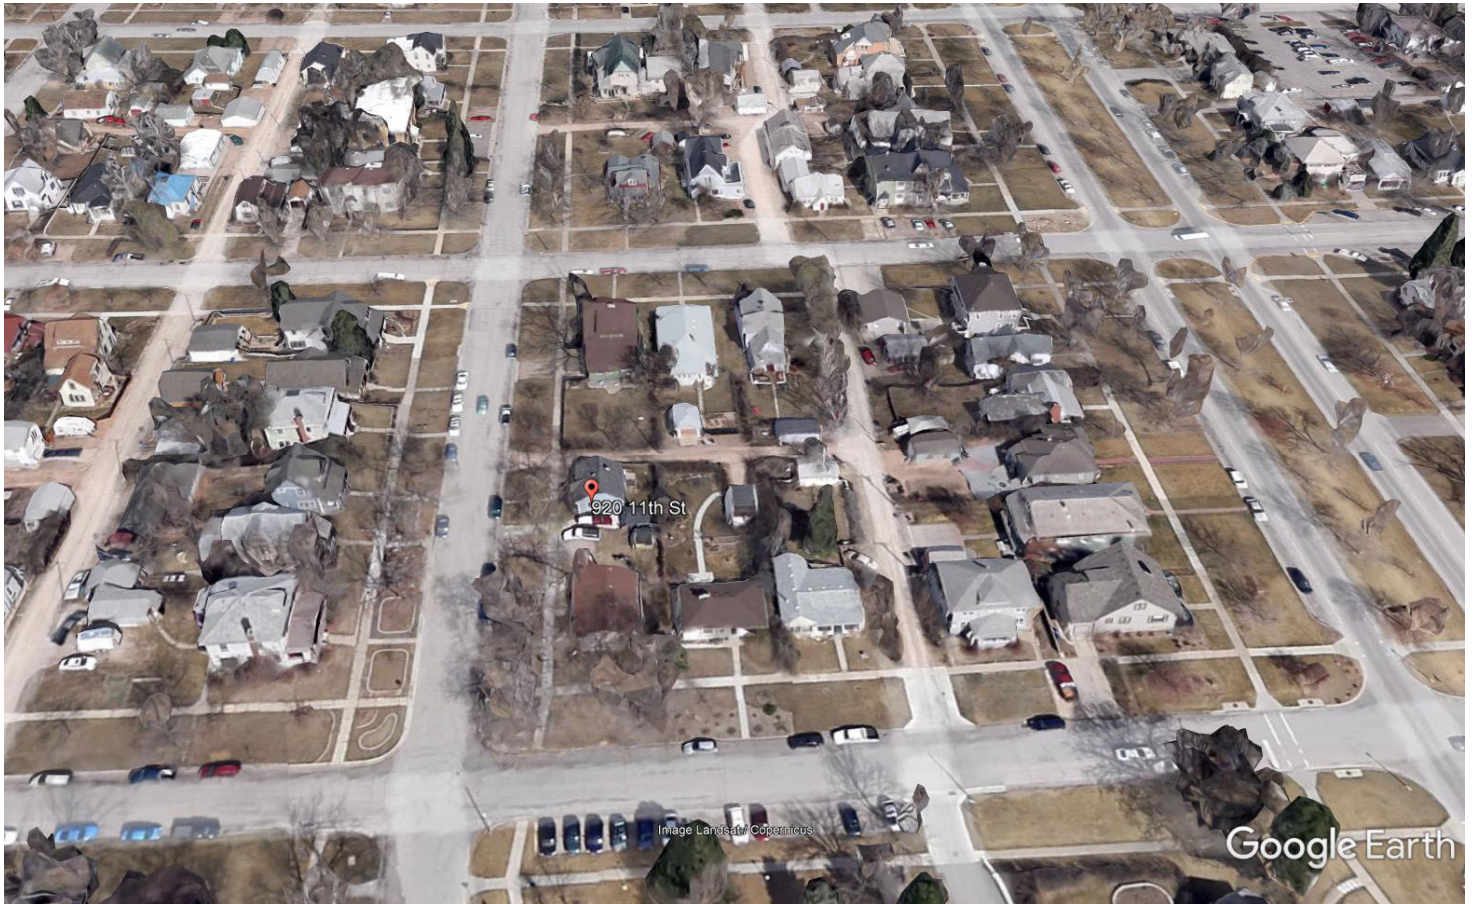
Site Description

Provide a sketch of the area including distances from roads, houses, stress inducing factors, pipe configurations, etc. Bar Hole Test Survey Plot should be outlined with concentrations at test points. Photos should be taken from all angles with each photo documented. Additional areas may be needed in any area of this guideline.
