Construction & Pipeline Coatings

Corrosion Found Less than One Year of Service

PHMSA New Construction Coating Issues

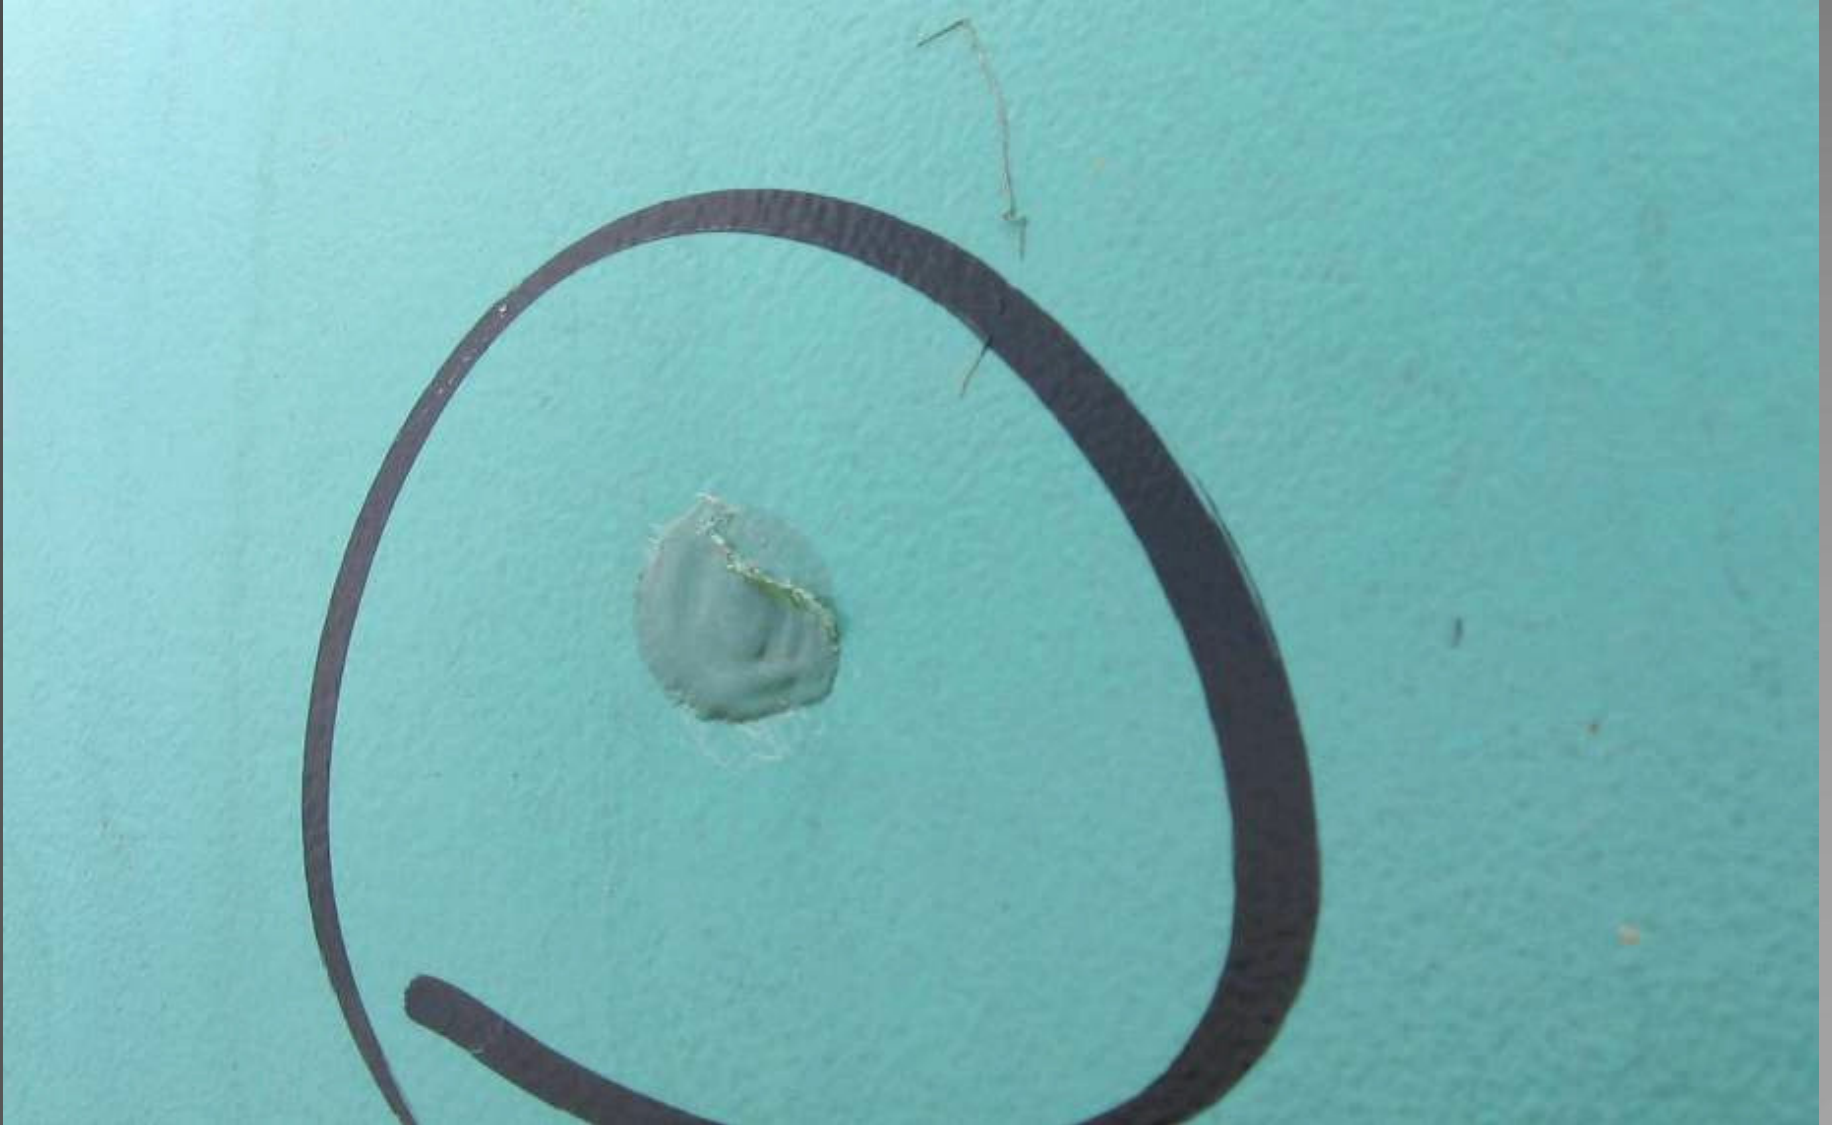
Poor Patch Stick Application Lack of Adhesion

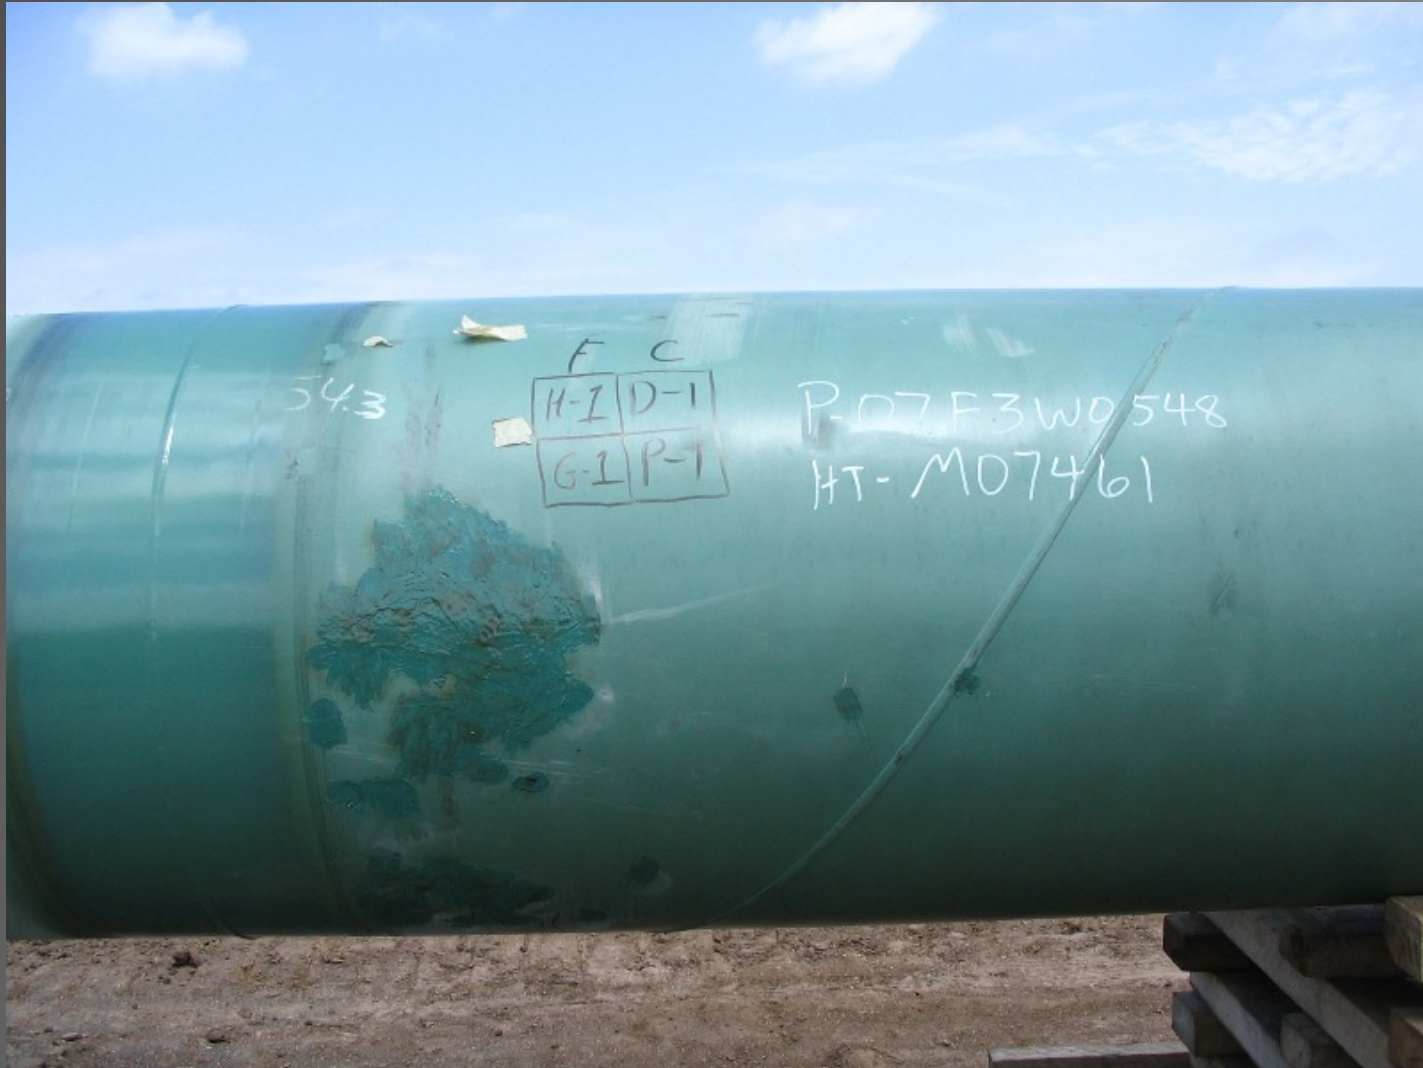
Excessively Large Patch Stick Application Use for Pinholes Only on 42" Pipe

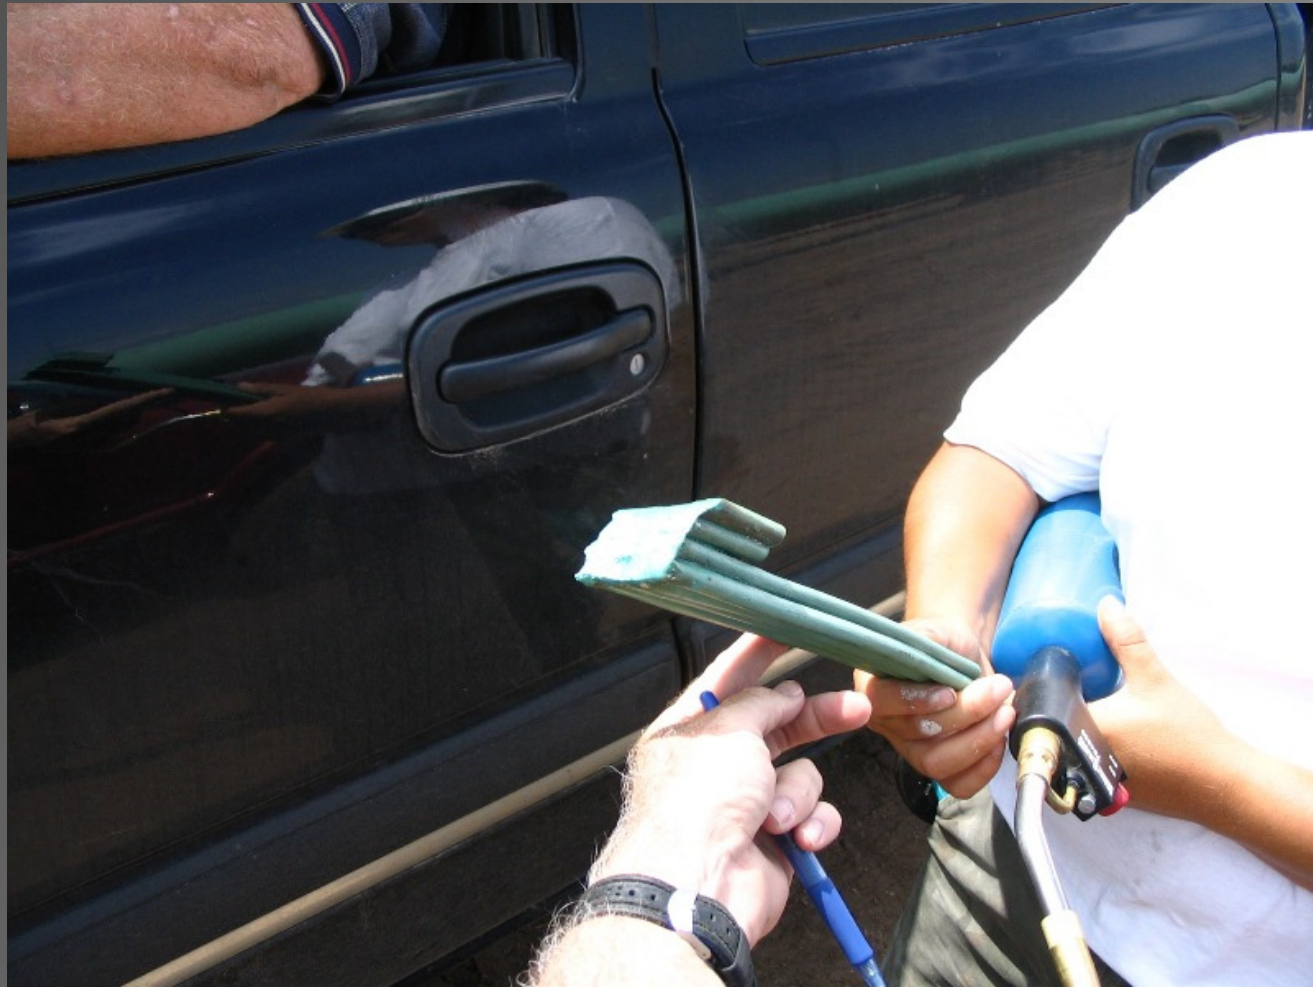
Inappropriate Bundling of Patch Sticks Use One Only-Small Areas

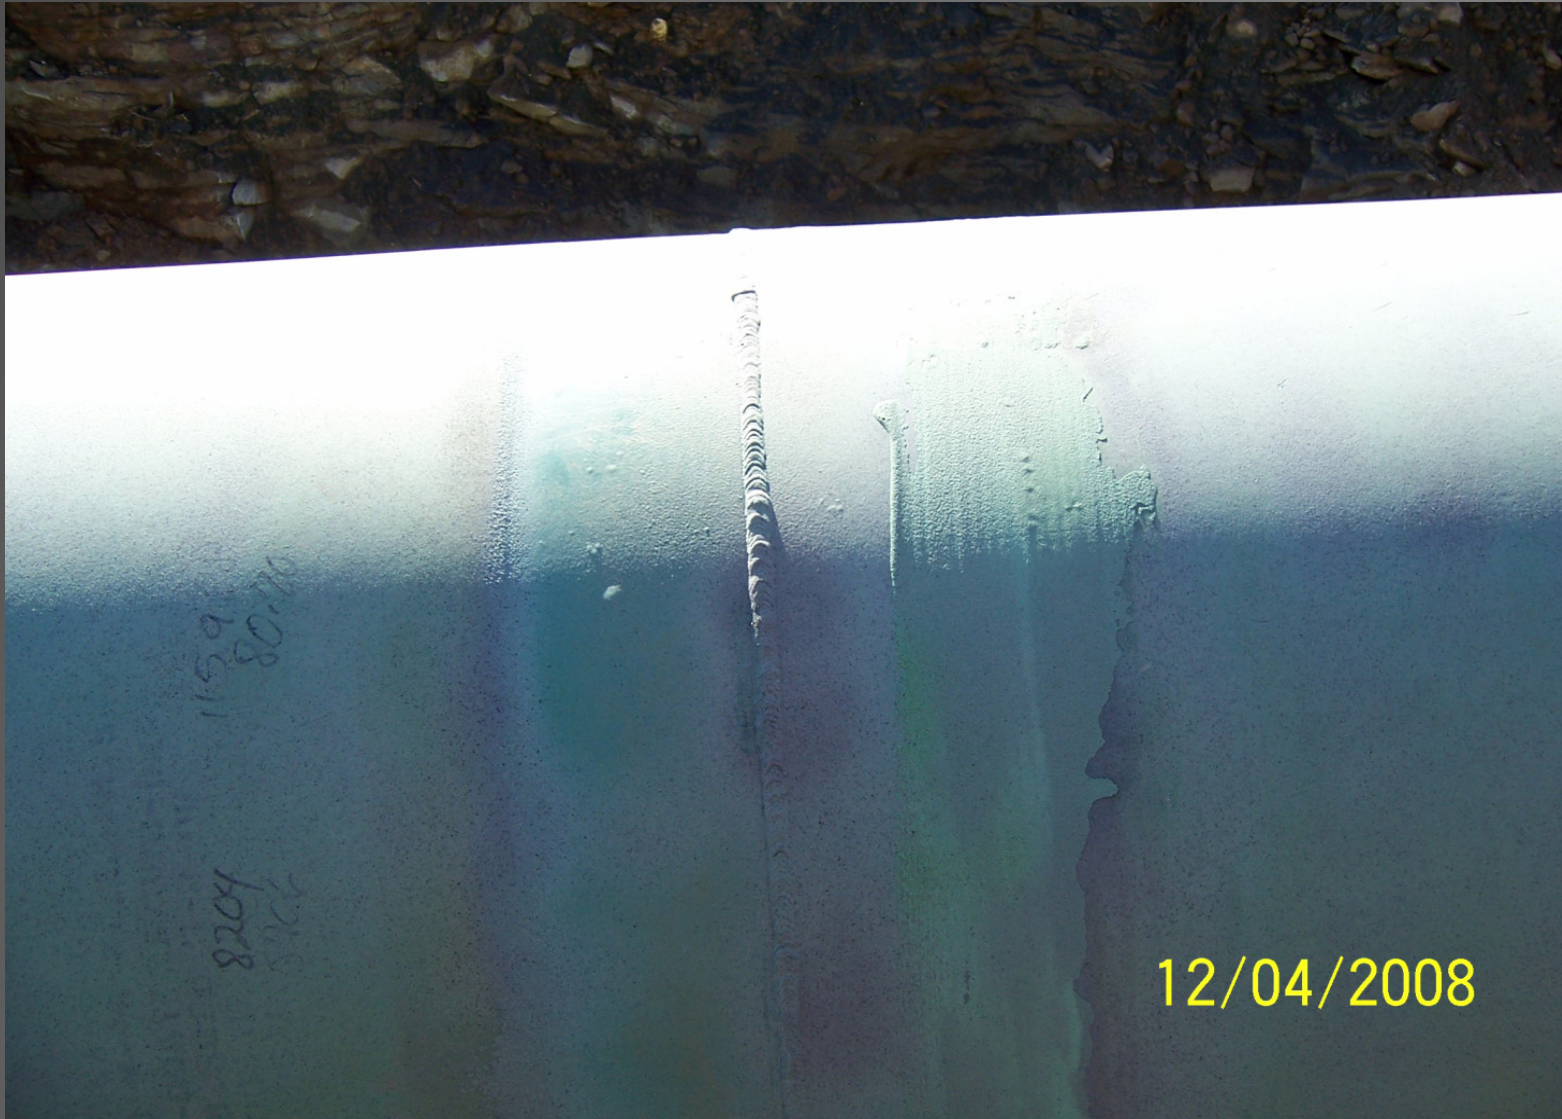
Thin Field Joint Coating

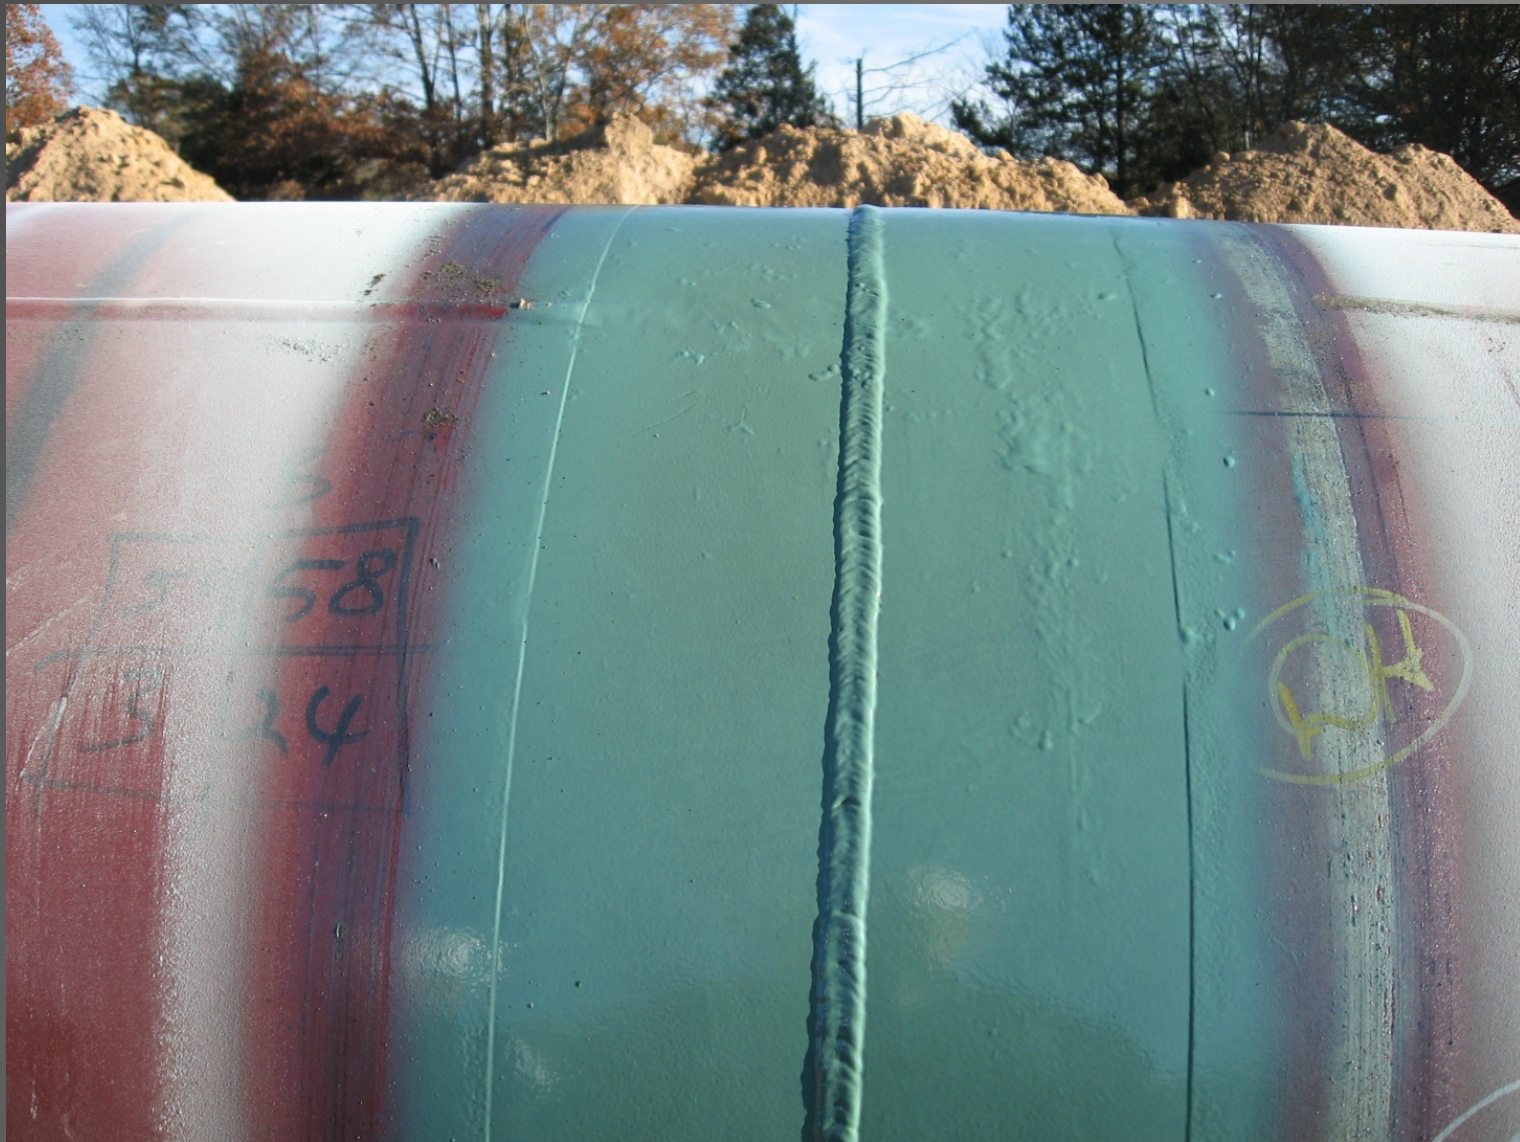
Joint Coating Applied over Dirt/Debris

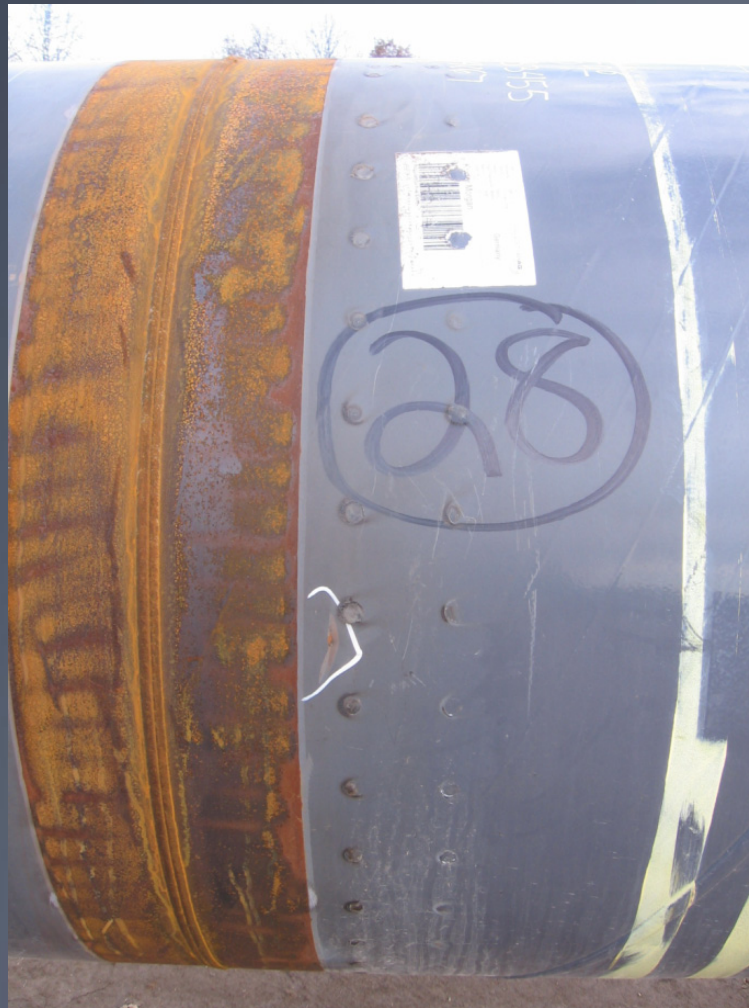
Coating Damage Cause by Welding Band (Jeep did not indicate holiday)

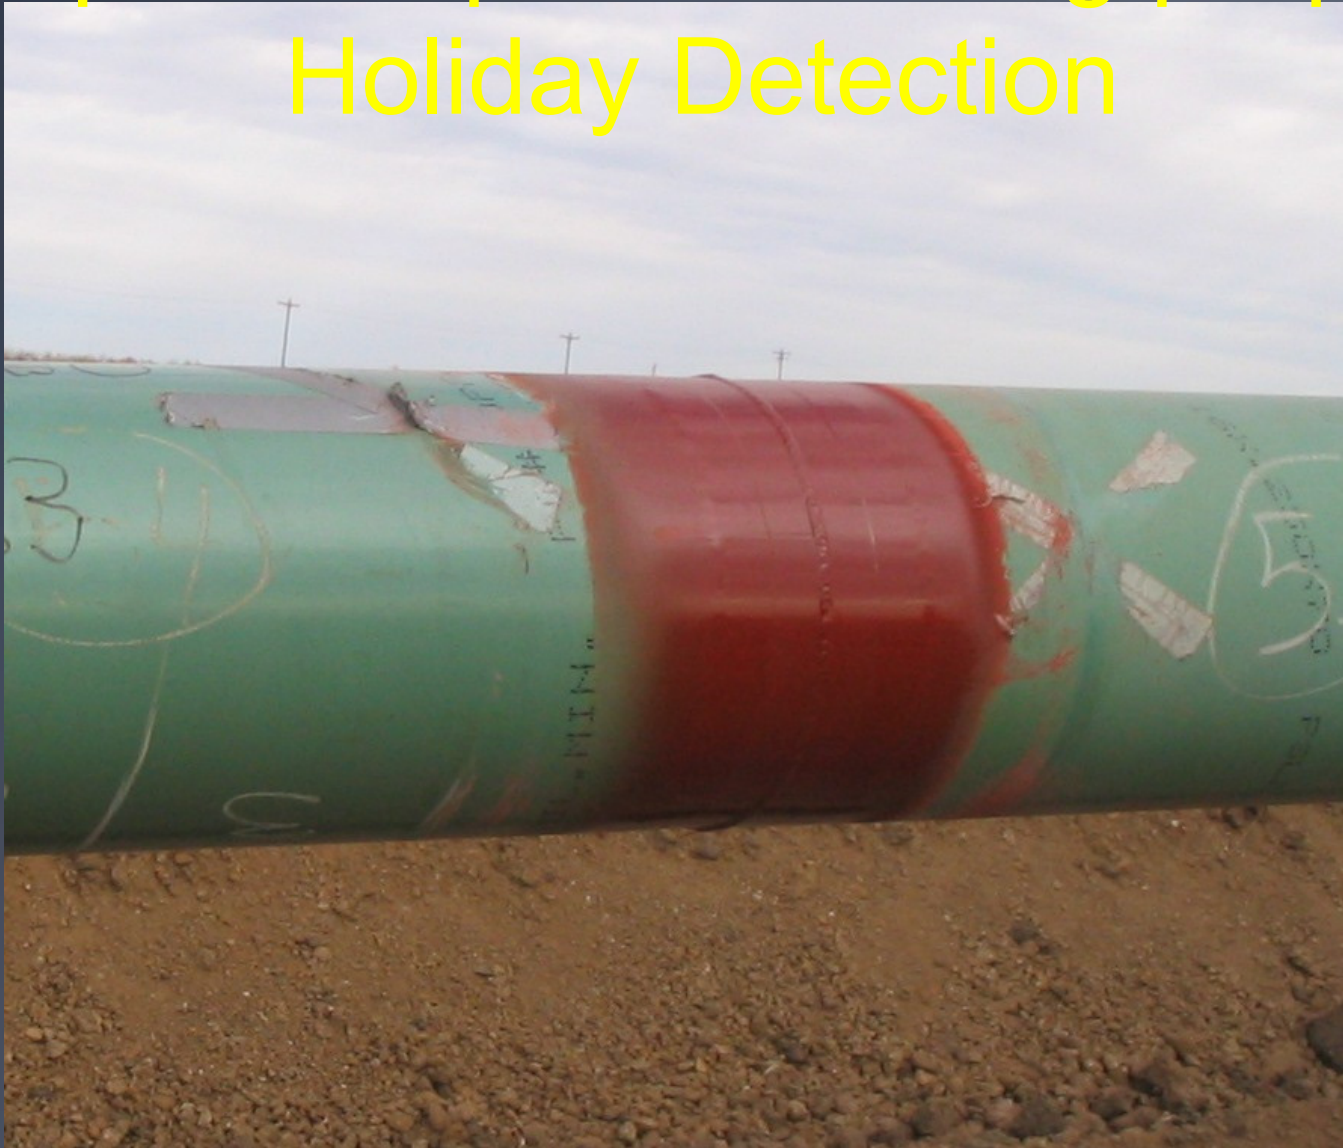
Tape on Pipe Preventing proper Holiday Detection

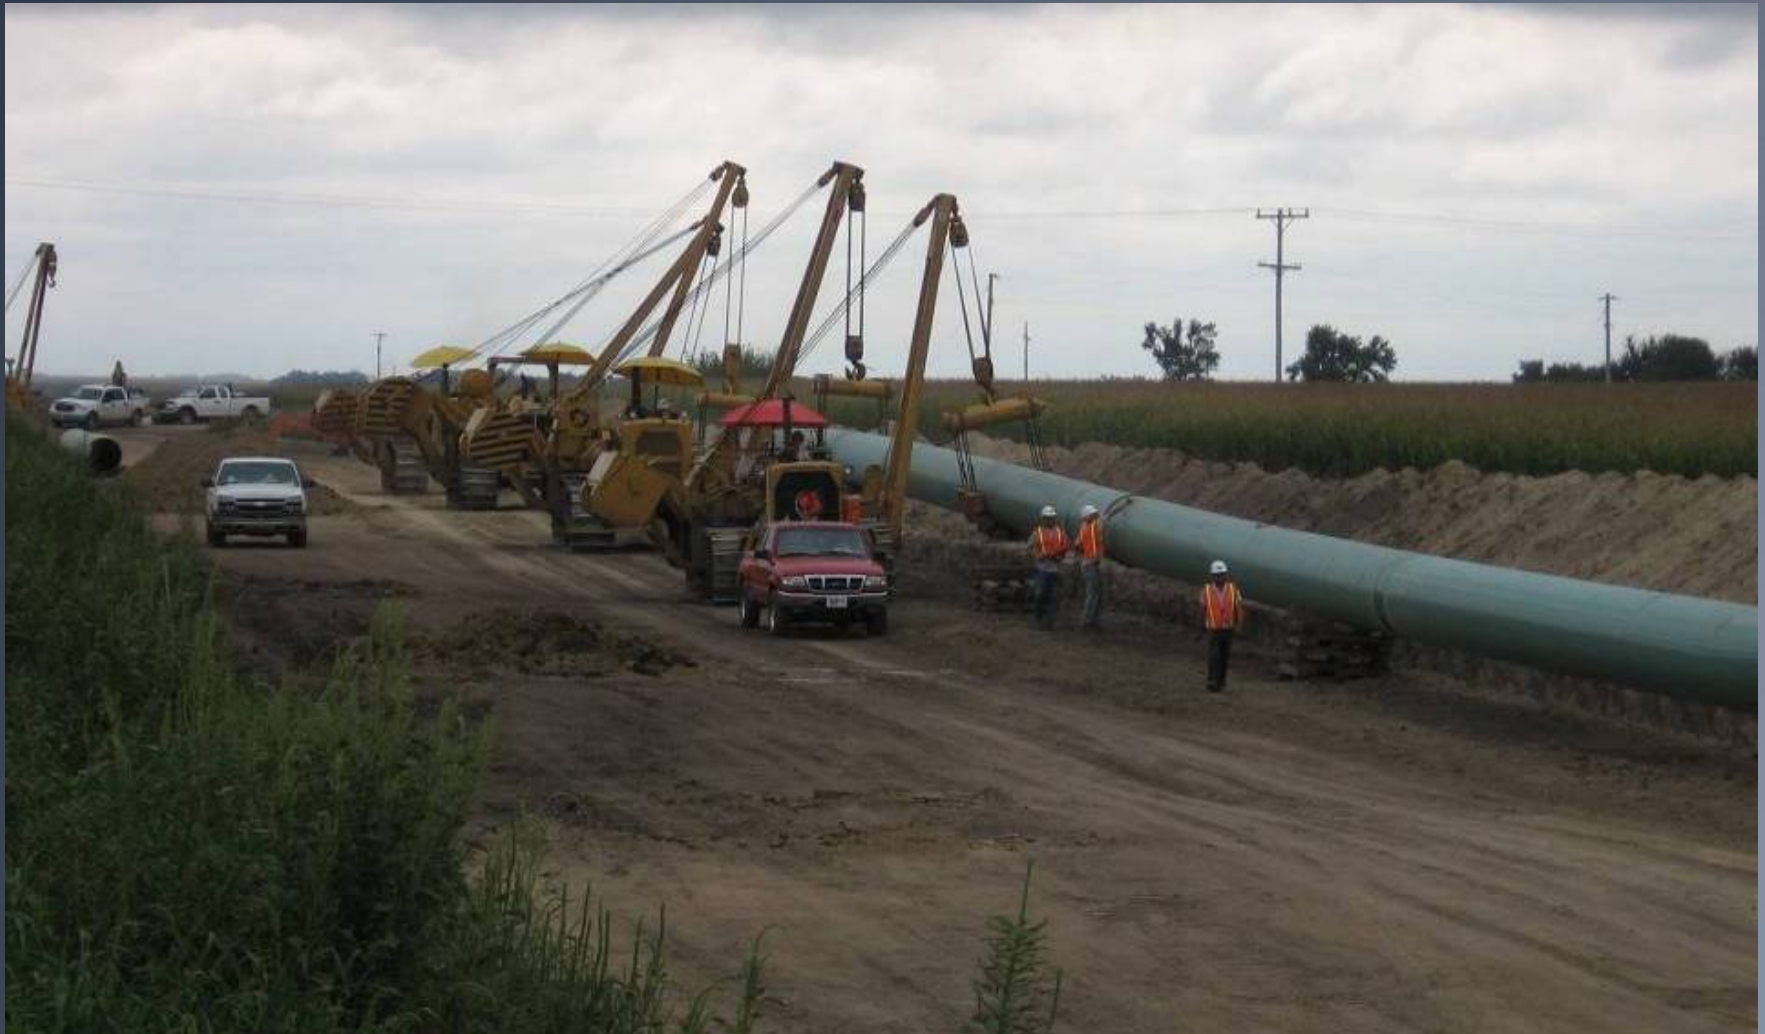
Sidebooms Spaced Per API 1104, Appendix A,
ECA Stress Analysis

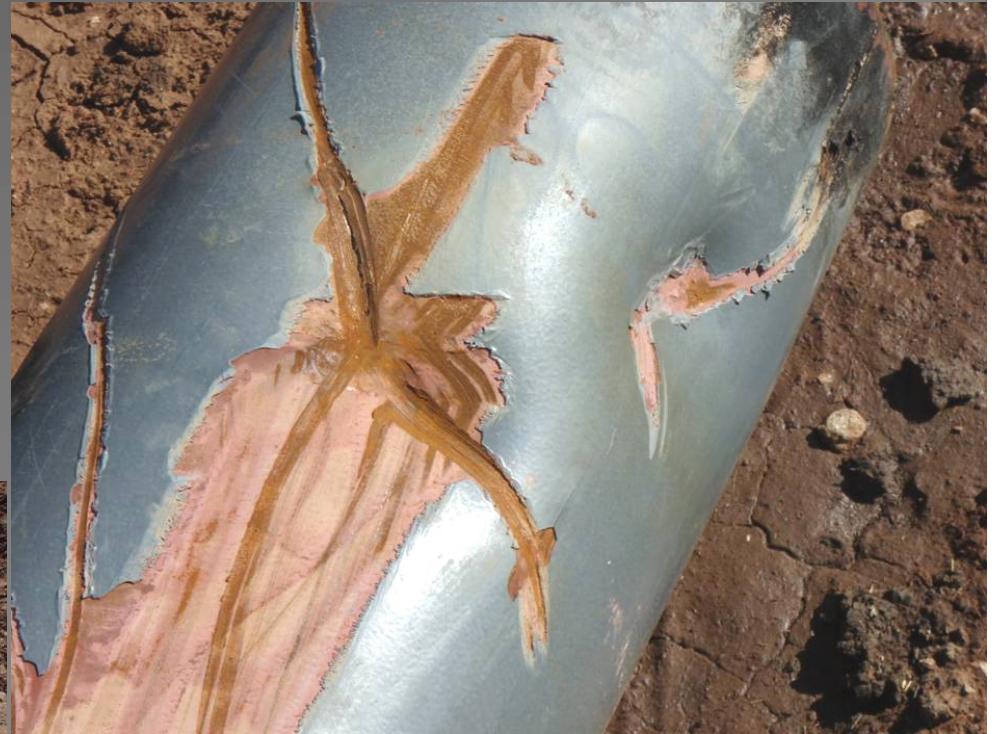
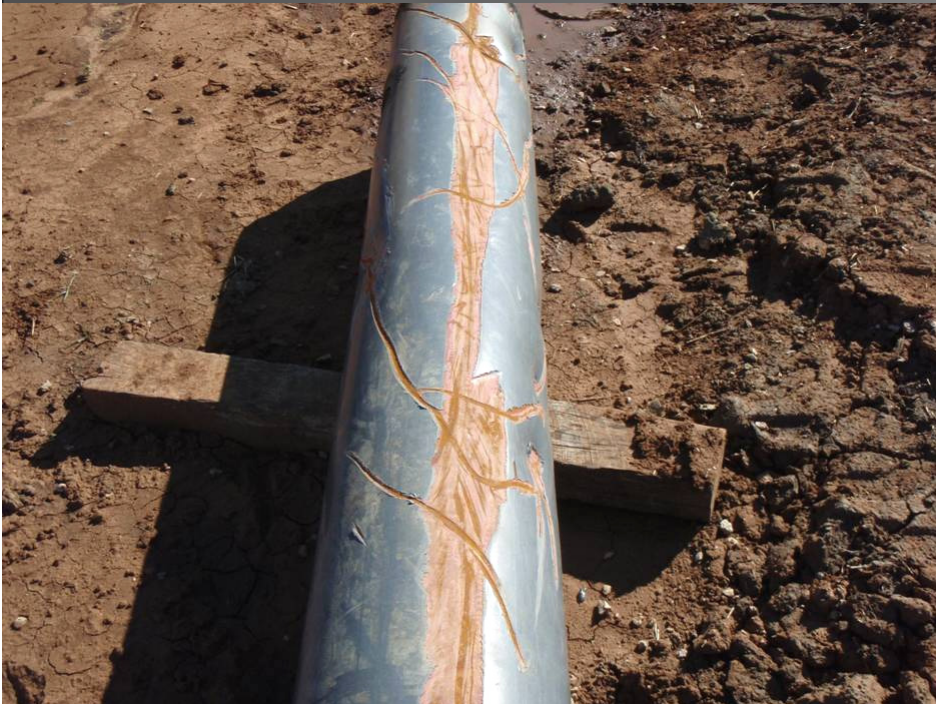
Bored Crossing – Failed Hydro Test

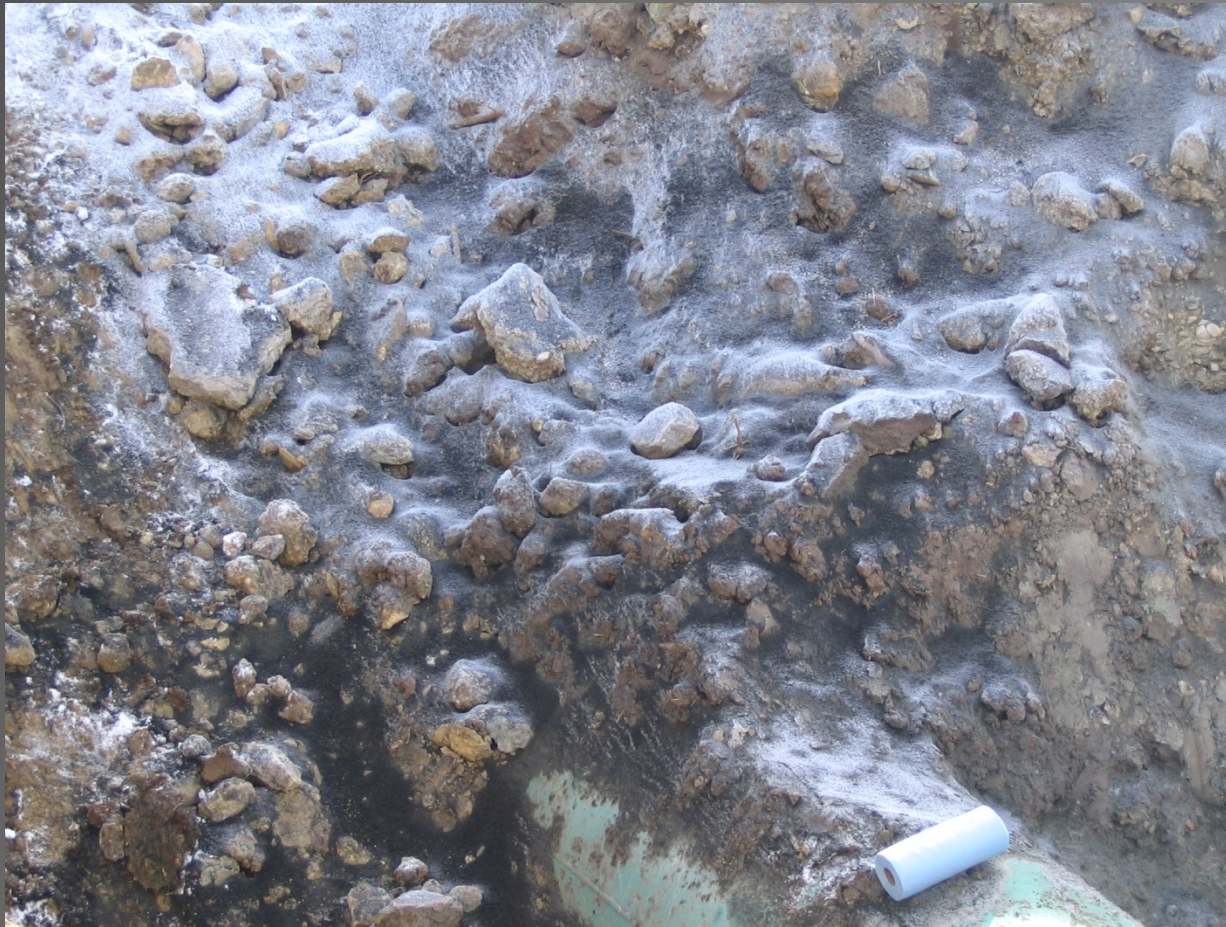
Rocks against pipe (No screening for over 1 mile)

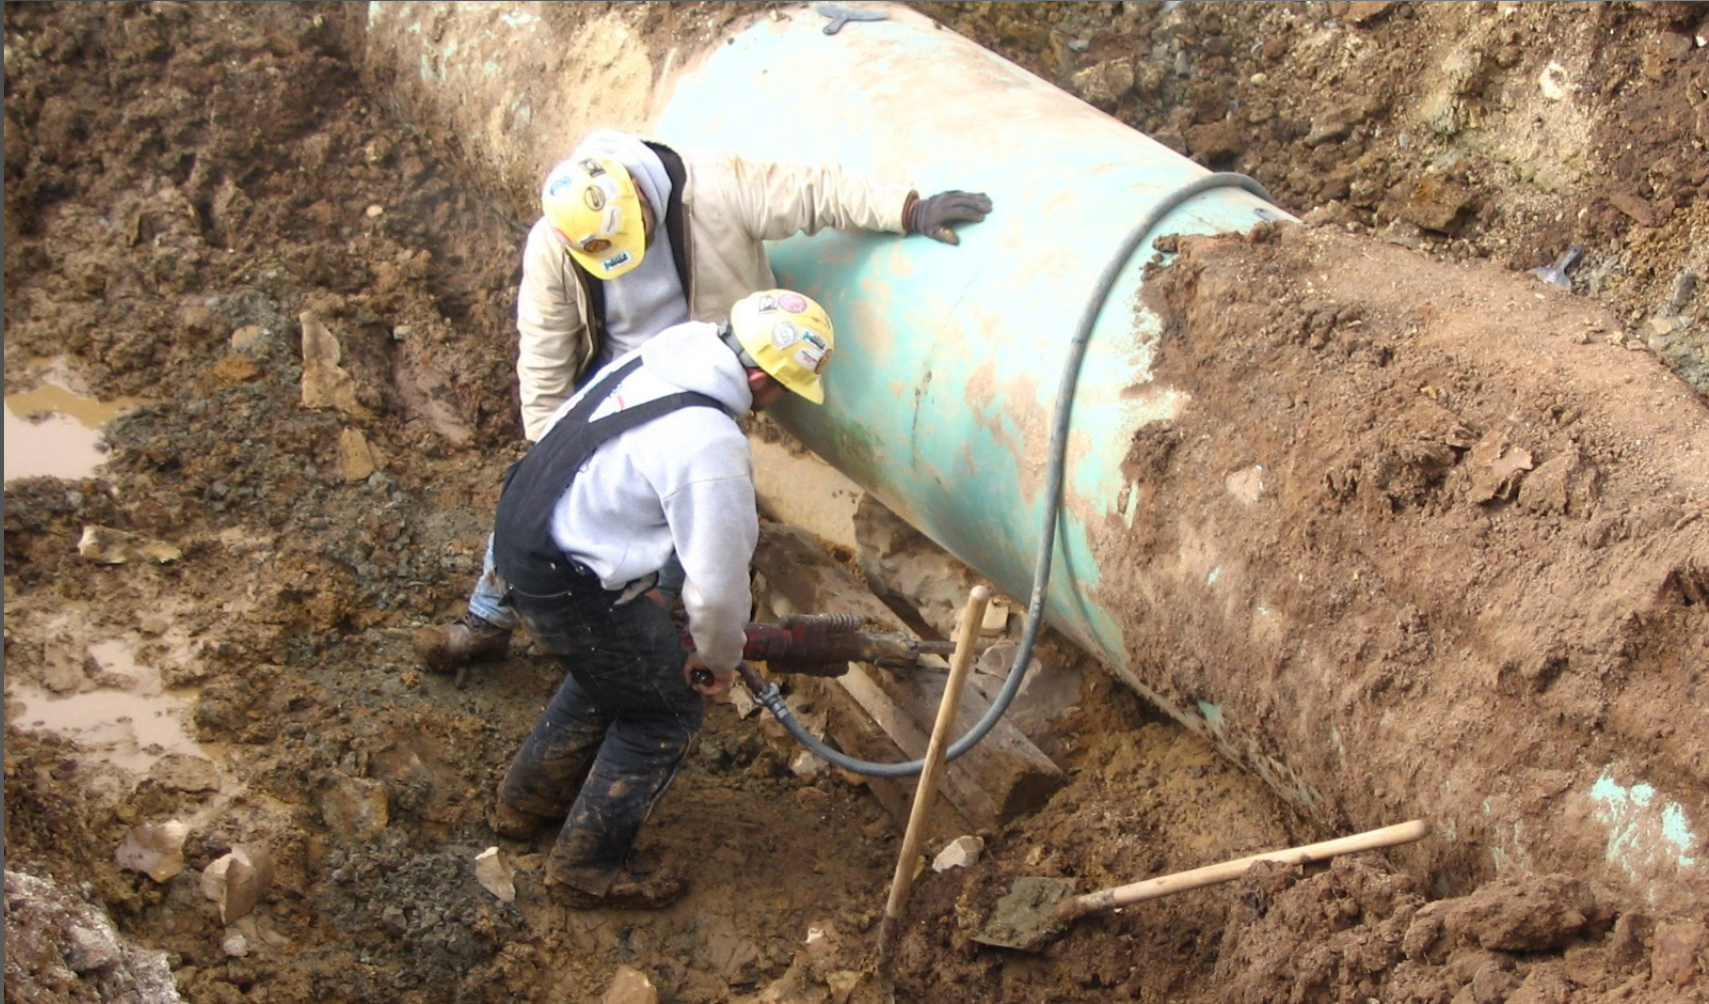
Pipe laid directly on solid rock

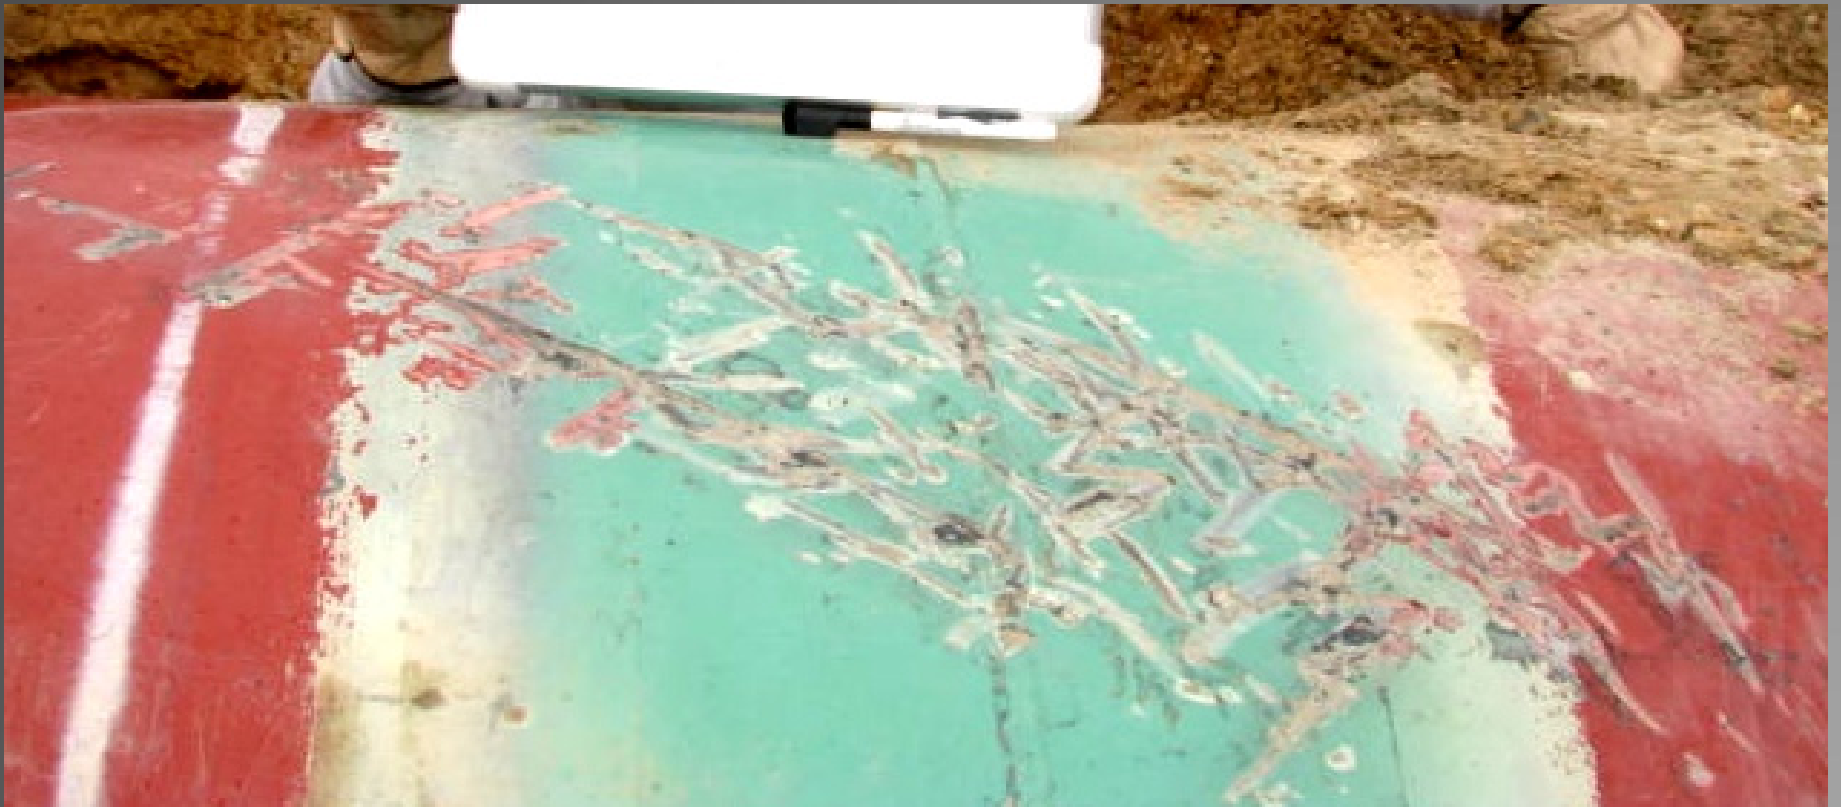
Section of Pipe was Replaced

(found by DCVG Survey-Line was in Service)

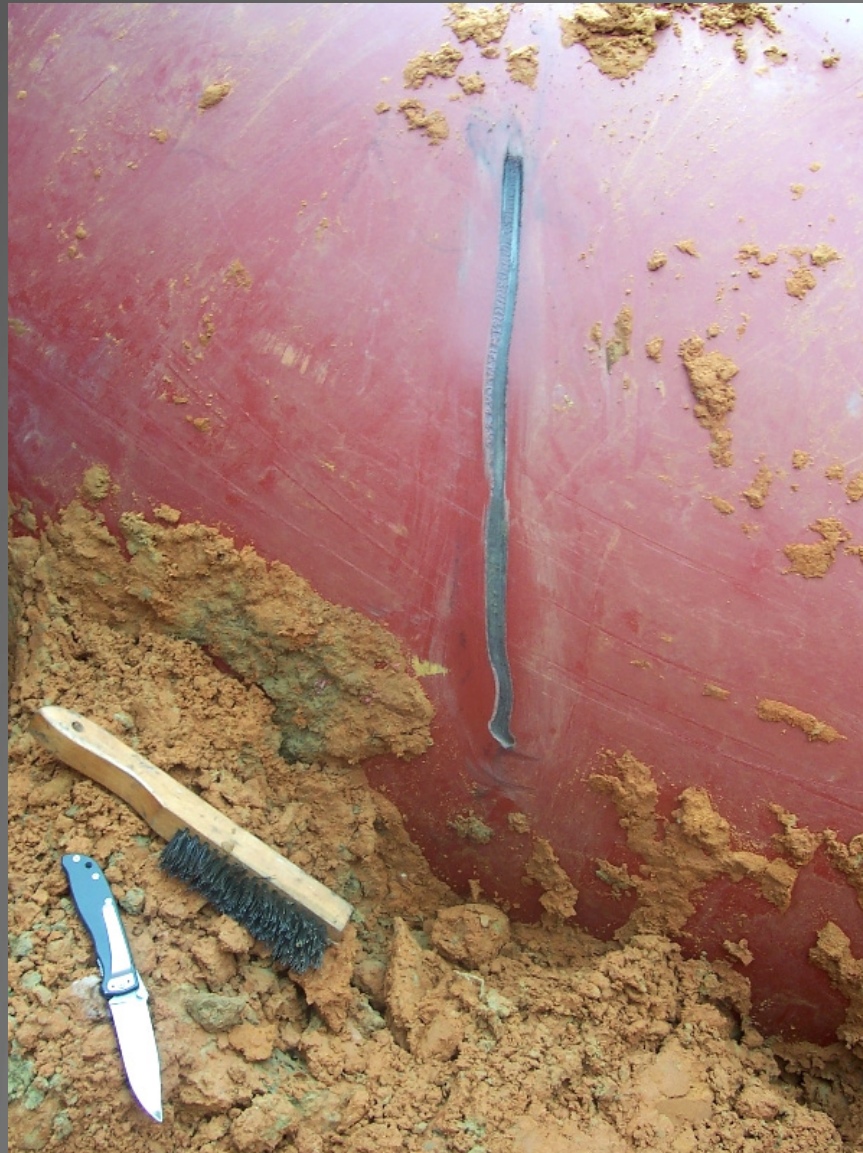
Gouge in Pipe

(found by DCVG Survey-Line was in Service)

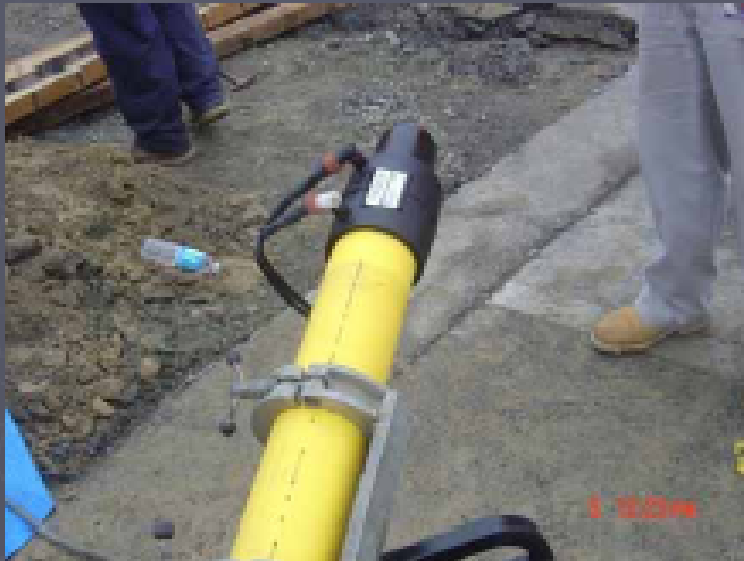
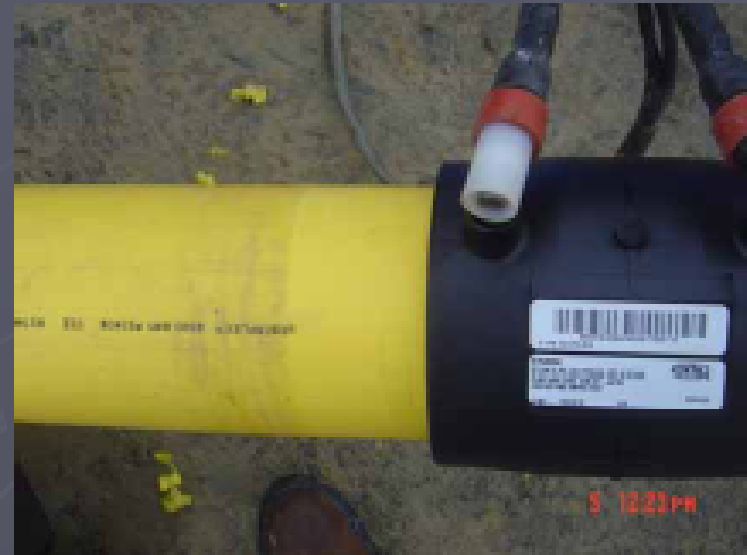
The Operator did not mark the proper stab depth before performing an electrofusion.

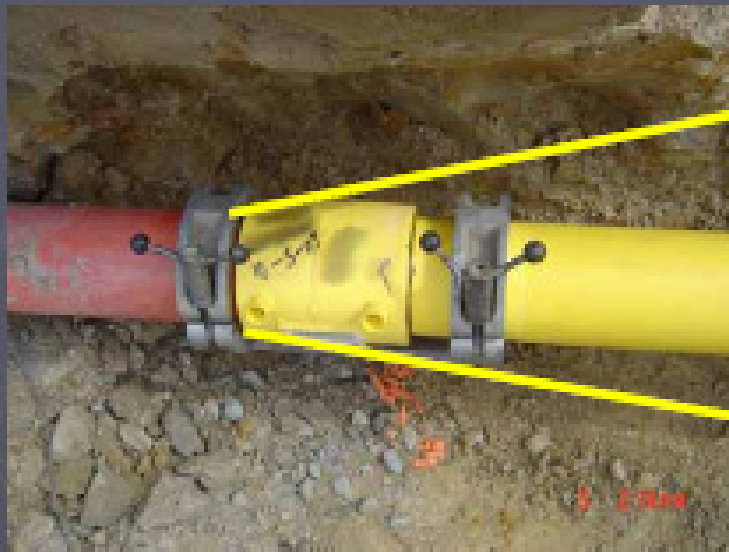
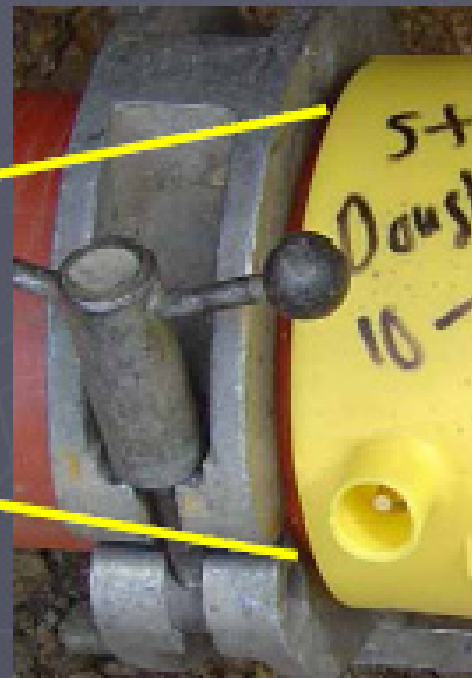
Another example of not marking the proper stab depth before performing an electrofusion.

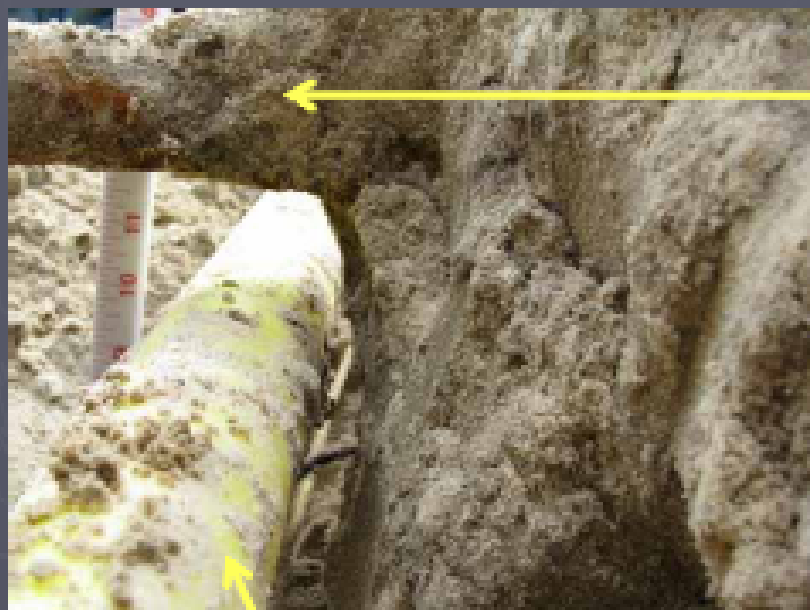
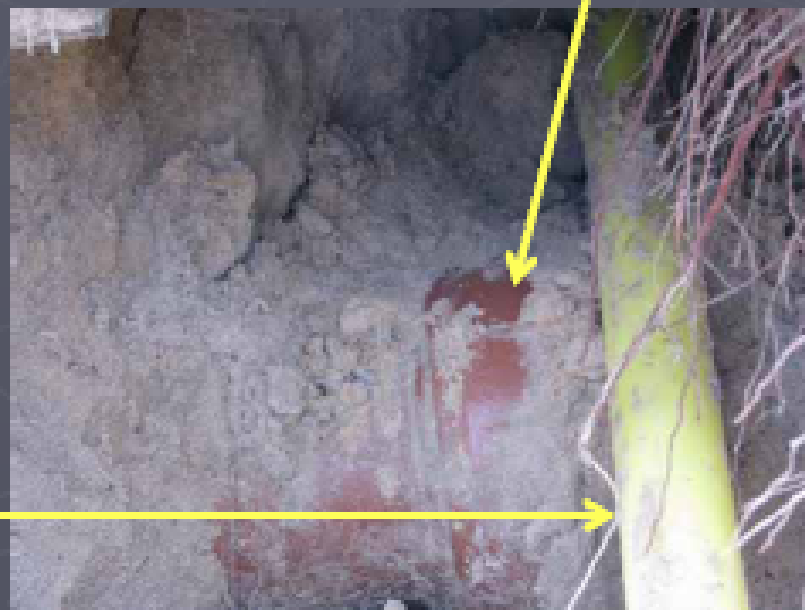
§192.325(b) - Failure to install a main with enough clearance from any other underground structure to allow for proper maintenance
