SD/ND Conference March 2025

Accident Investigation
Division (AID)

Darren Lemmerman

Case Study
Atmos Energy
Dallas, Texas
Gas Migration
One Fatality and
Three Injuries
February 23, 2018

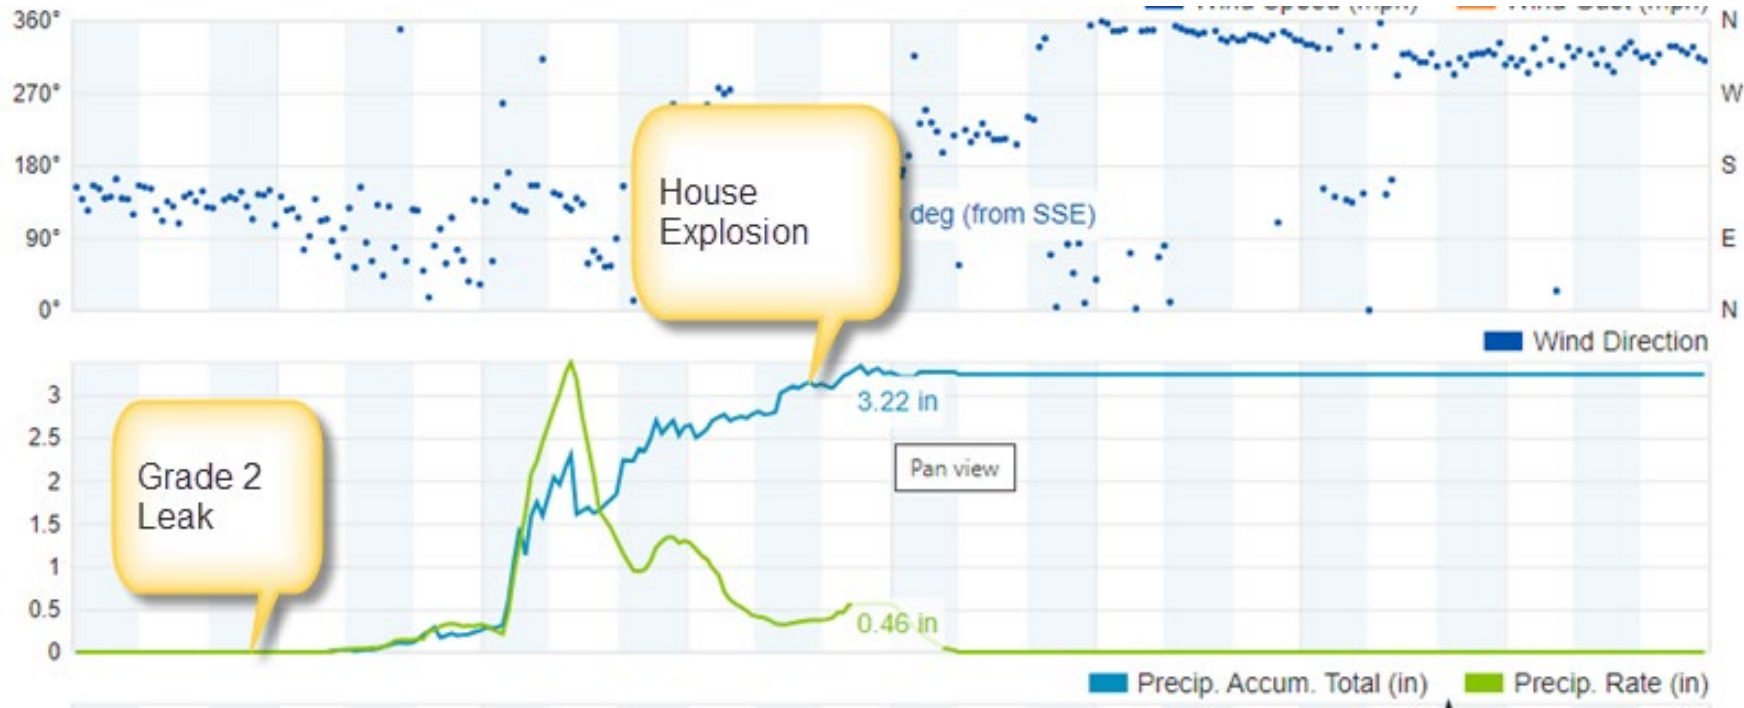
* Each bar represents 1-hour. 5 hours of heavy rain capped the gas plume. Leak was graded 3 months prior to explosion.

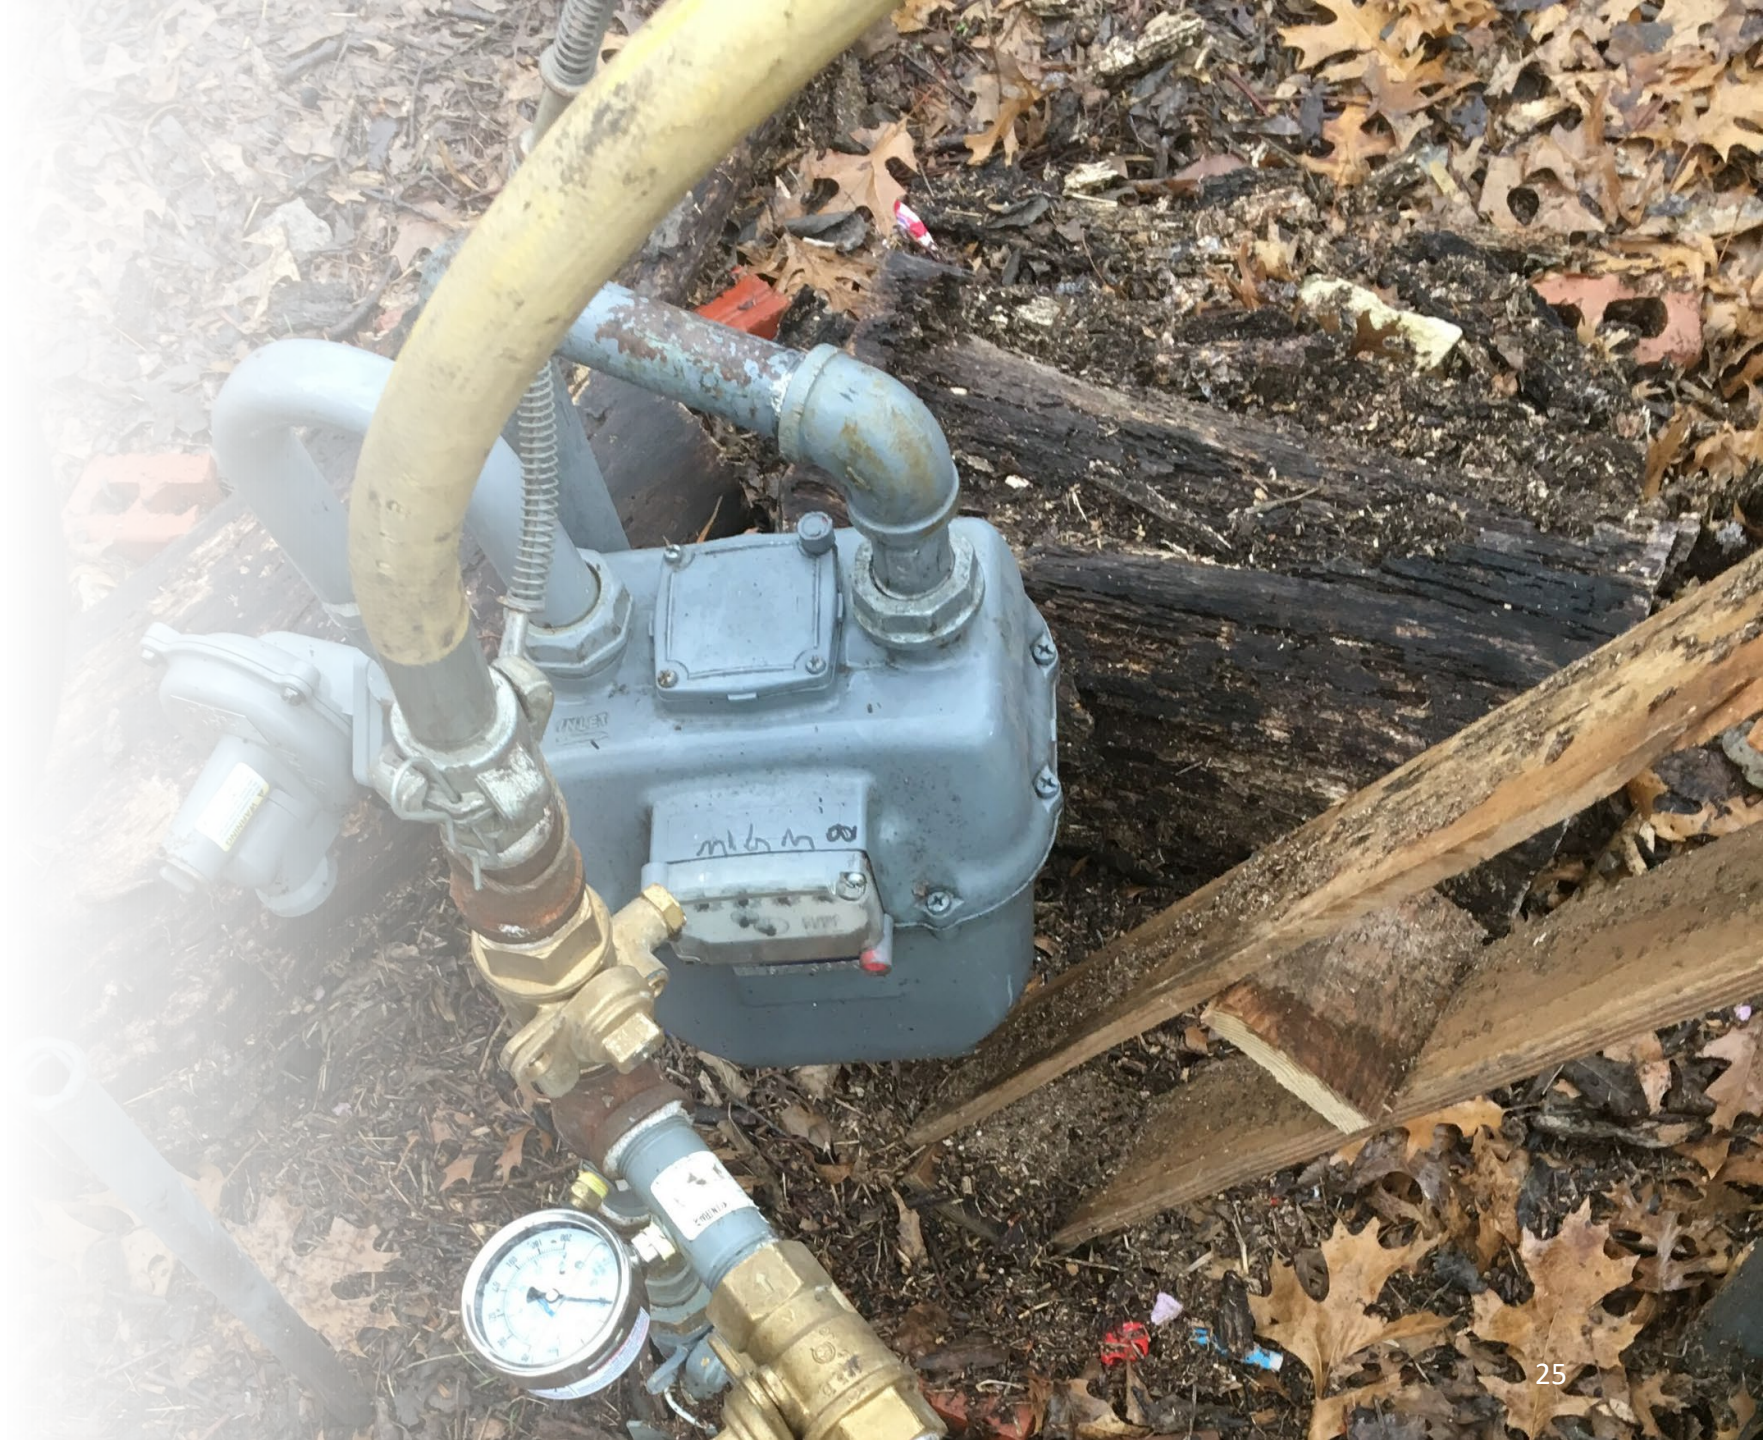
Mains and services capped and ready for pressure testing.

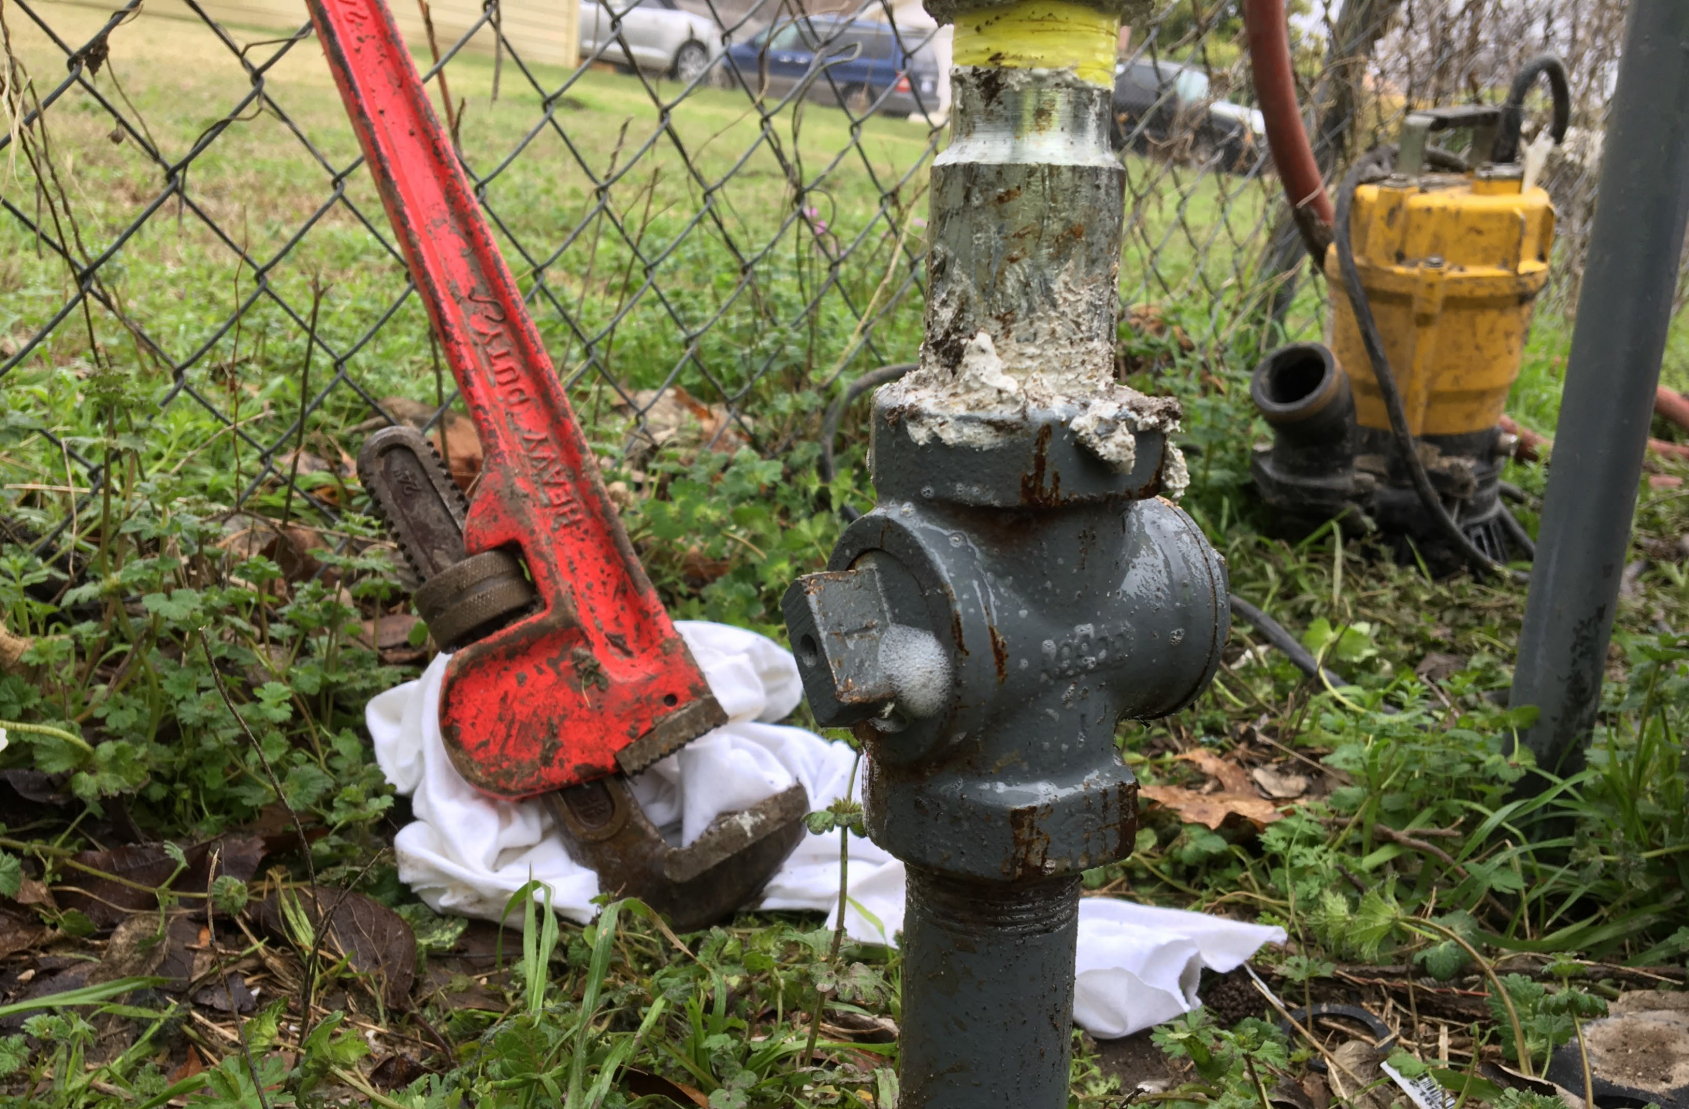
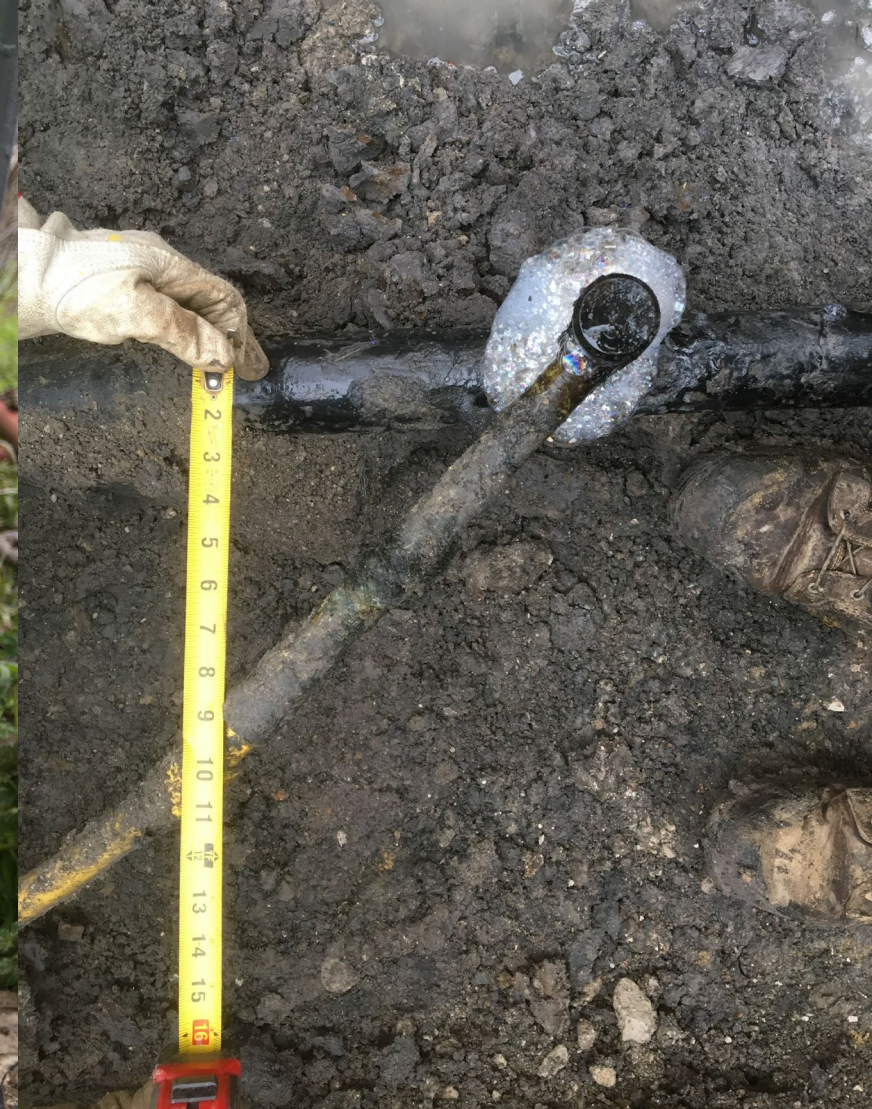
Leaks at service tee and stopcock. Some leaks will cause test pressure failures but are not hazardous. The flow rate will be inadequate to migrate any distance. Flow rate testing pipelines that fail pressure tests should be performed prior to exposing buried leaks.

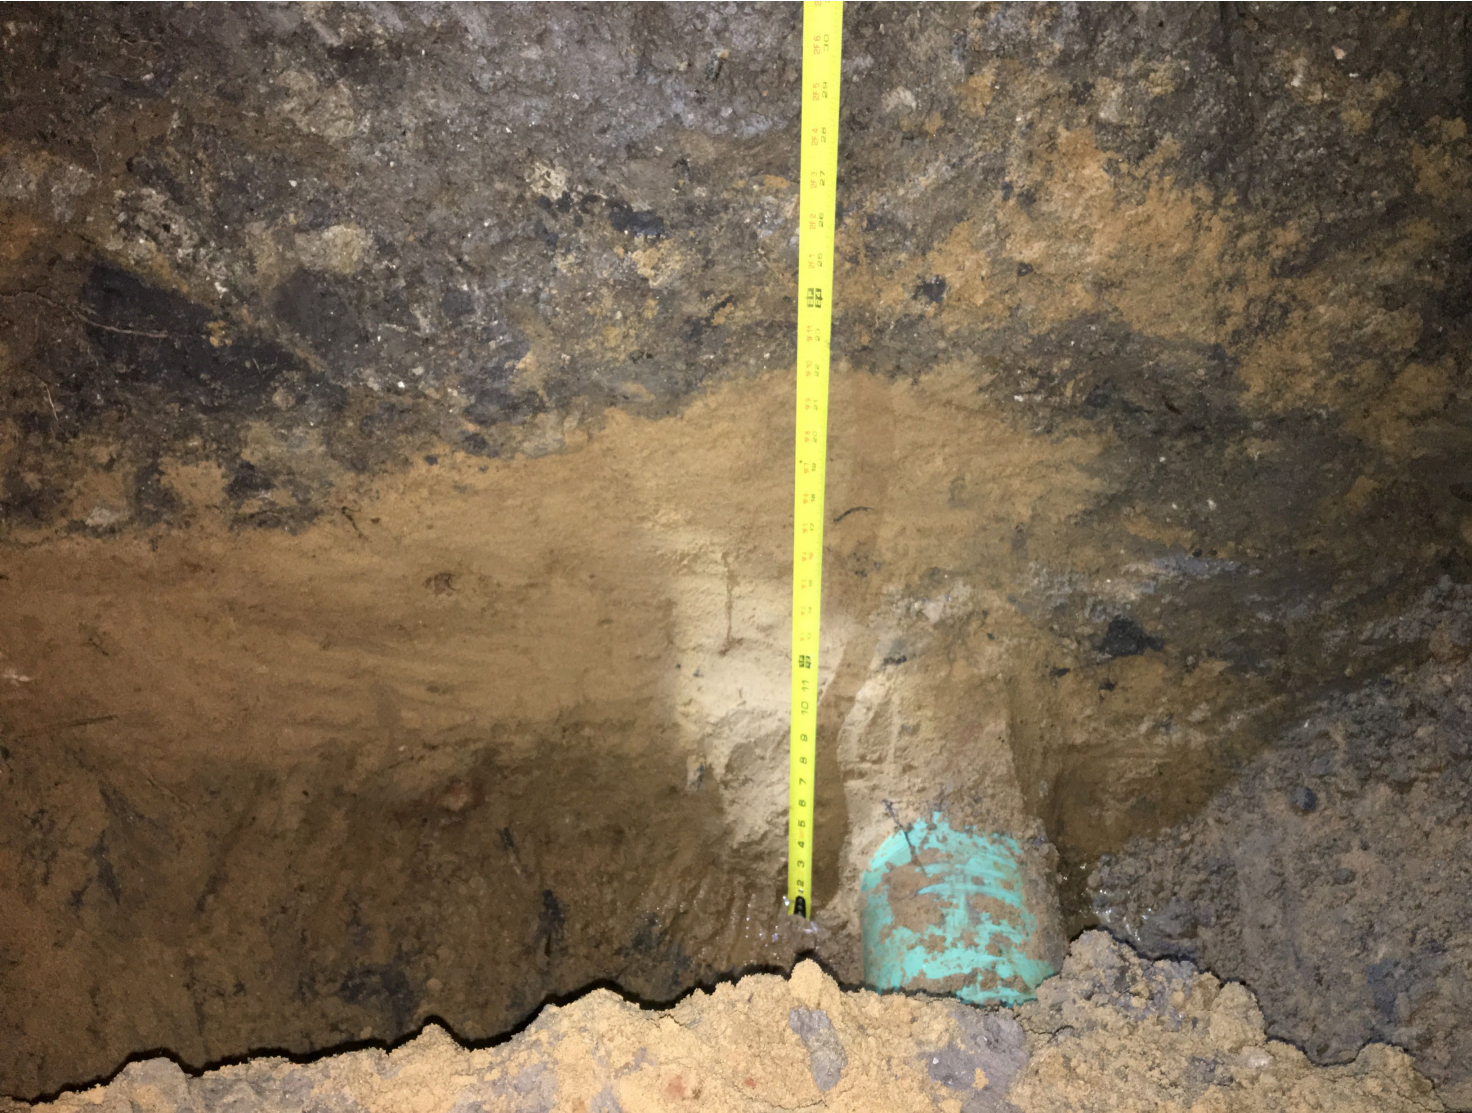
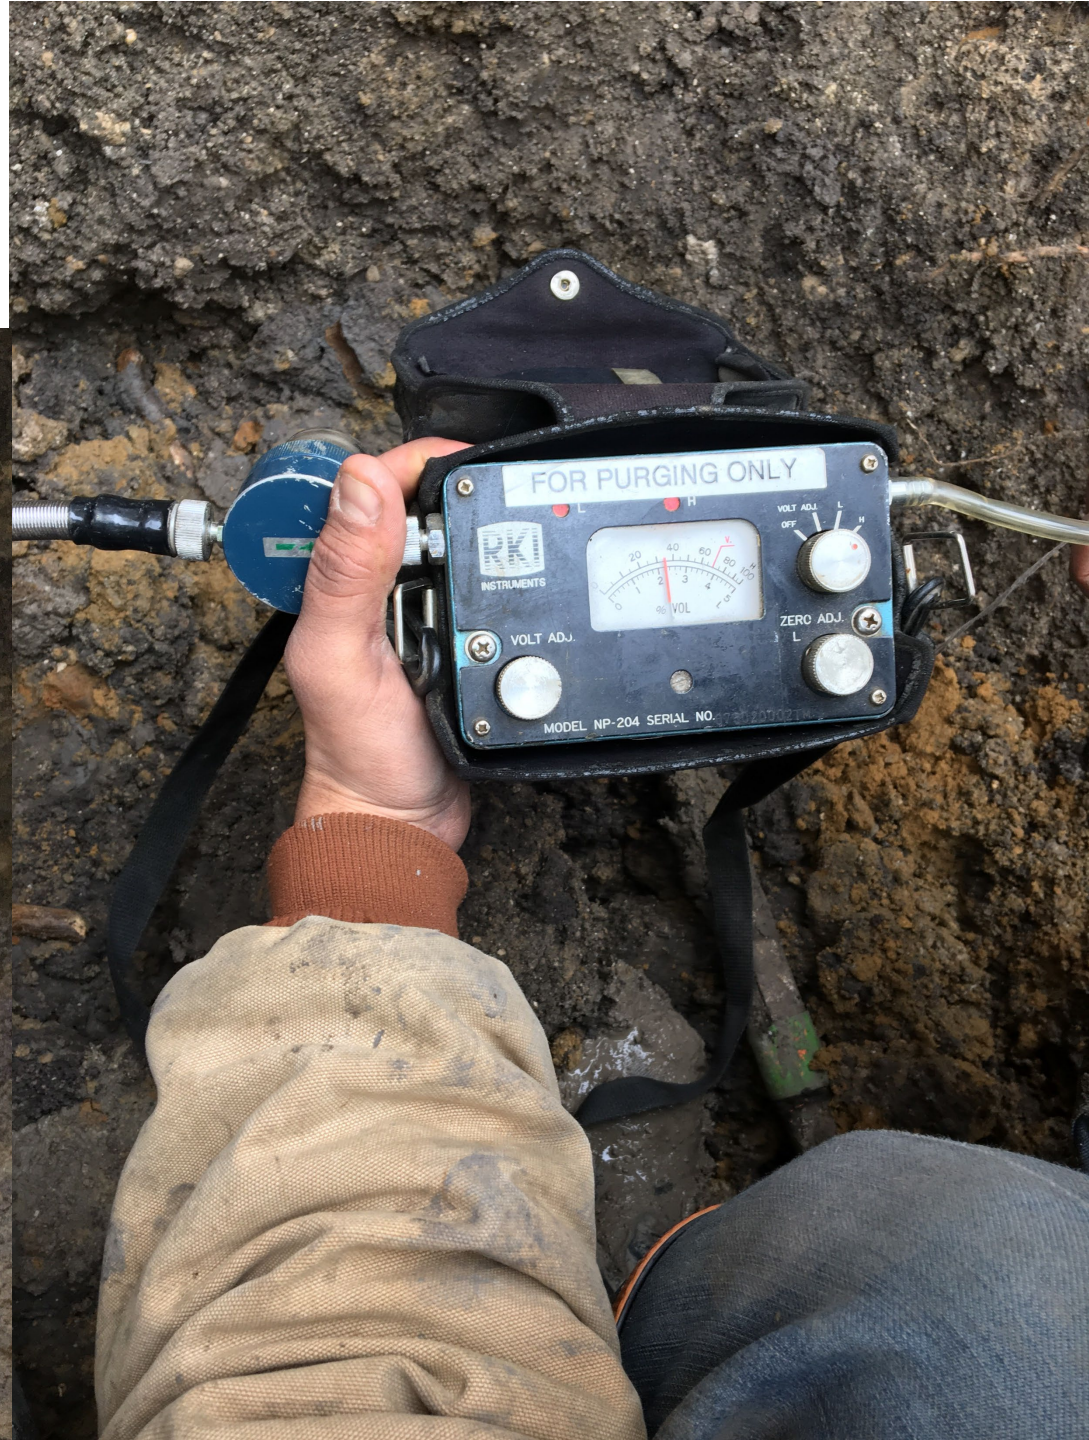
During excavation pay close attention to what is being dug up. Evidence can be anywhere. Sand bedding for sewer line was conduit for gas migration. Test and document to confirm theory. CGI shows 35% LEL, 9 days after the gas was shut-off.

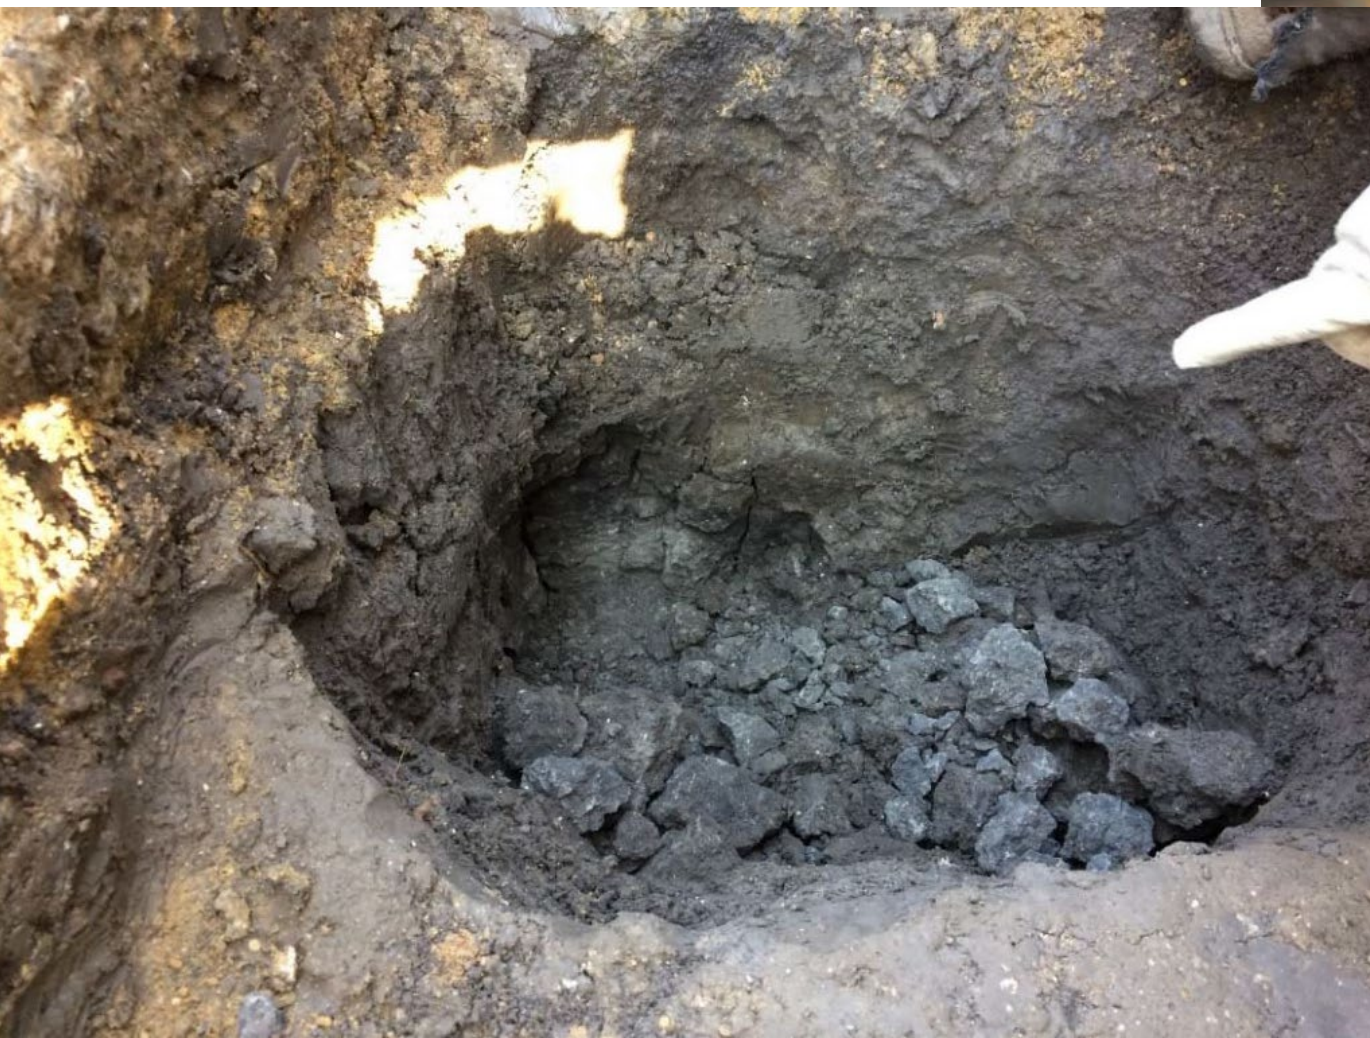
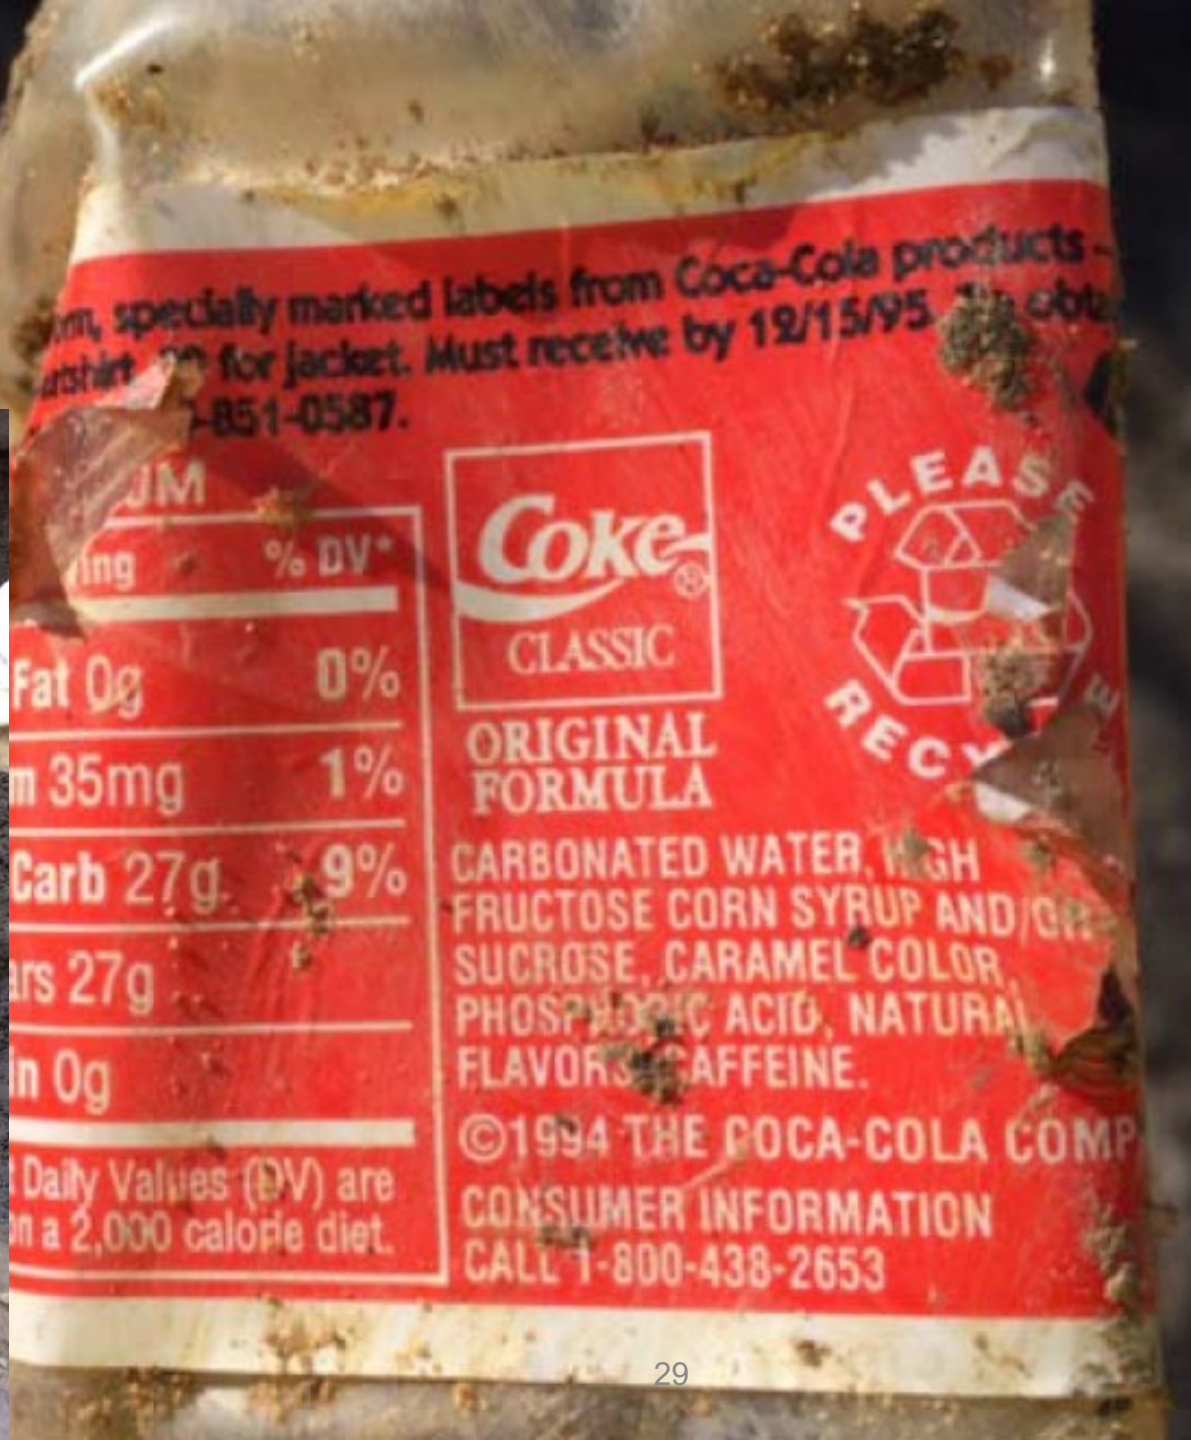
Evidence can be anywhere. Soil will discolor from the release of natural gas, dry out and scrub odorant. A dated coke bottle found next to main failure. Date corresponds to sewer installation.

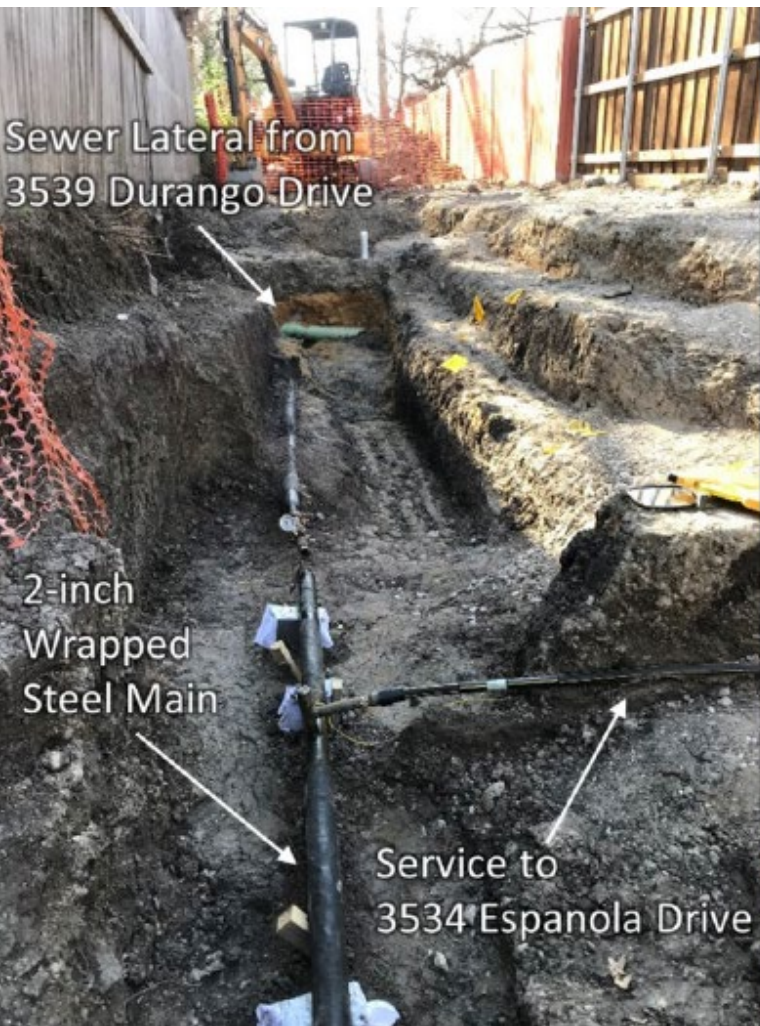
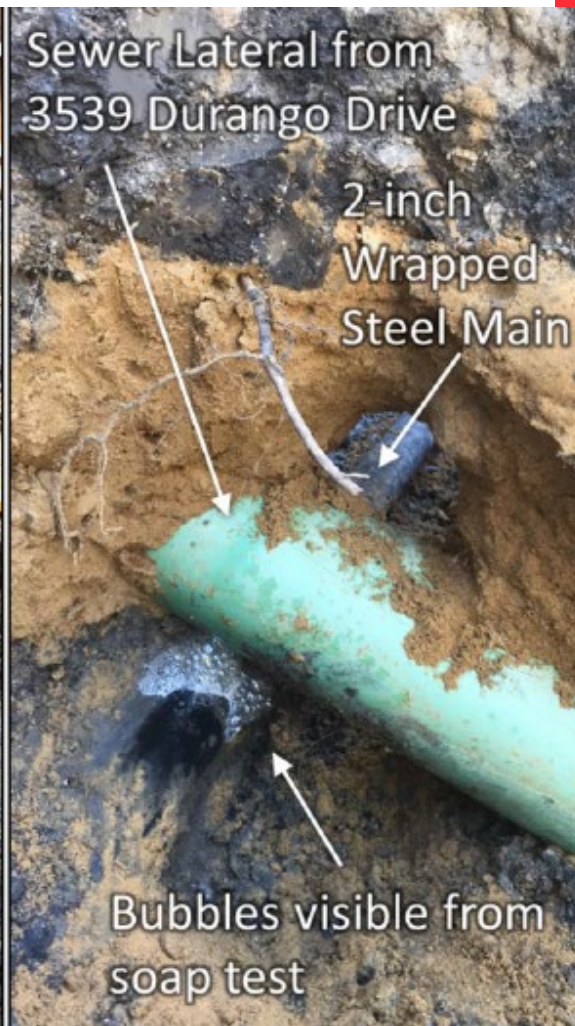
Source of the gas was identified at a location where a sewer main was installed in 1995, with only 2-inches of clearance. The line was dented and gouged with excavation equipment and failed 23 years later as a circumferential crack.

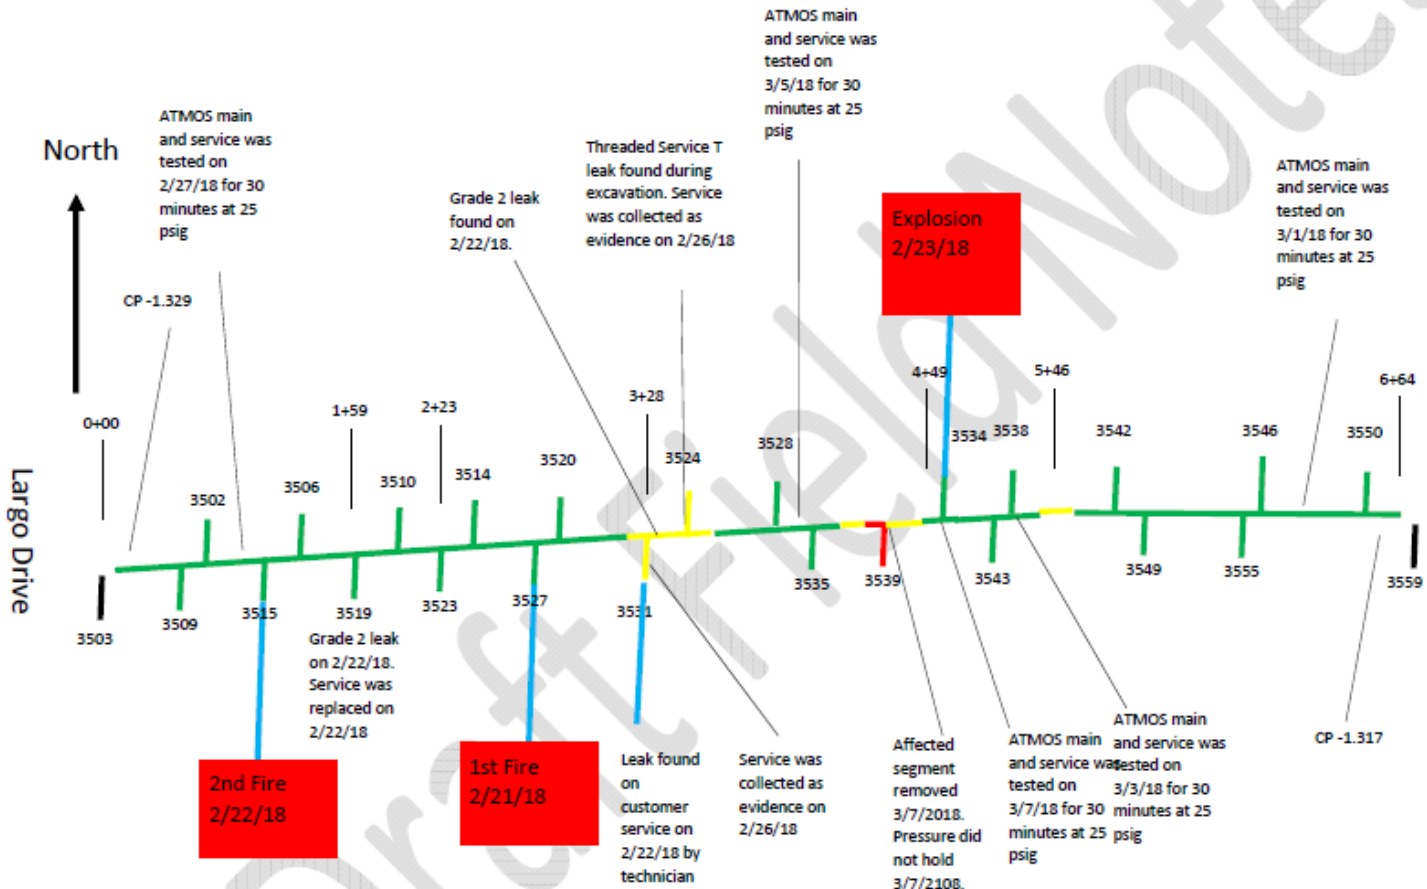
Overview of gas main and service in alley between Espanola and Durango Updated March 7, 2018

Document the details as it paints a picture. 664 feet of pipe tested with multiple leaks identified. Only one was large enough to result in the migration.

- Green main segments passed pressure test
- Red main segment has not held pressure.
- Blue - Customer Owned services
- Yellow—not pressure tested and cut out

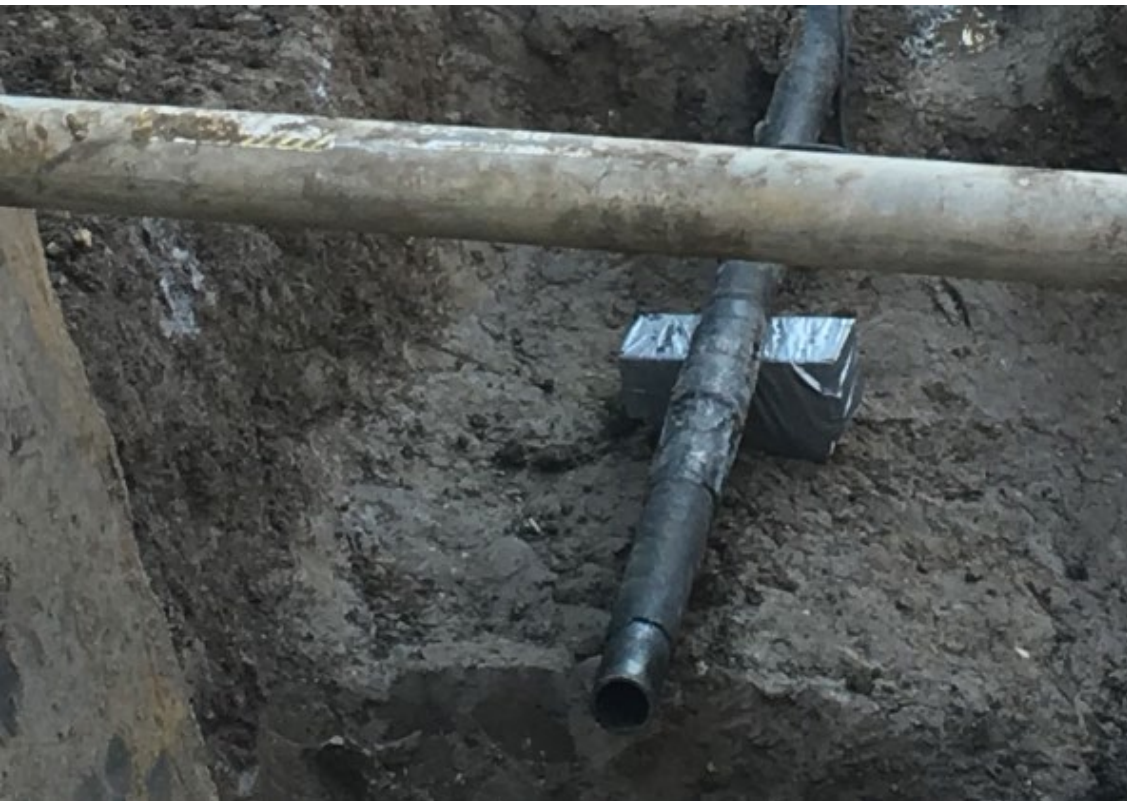
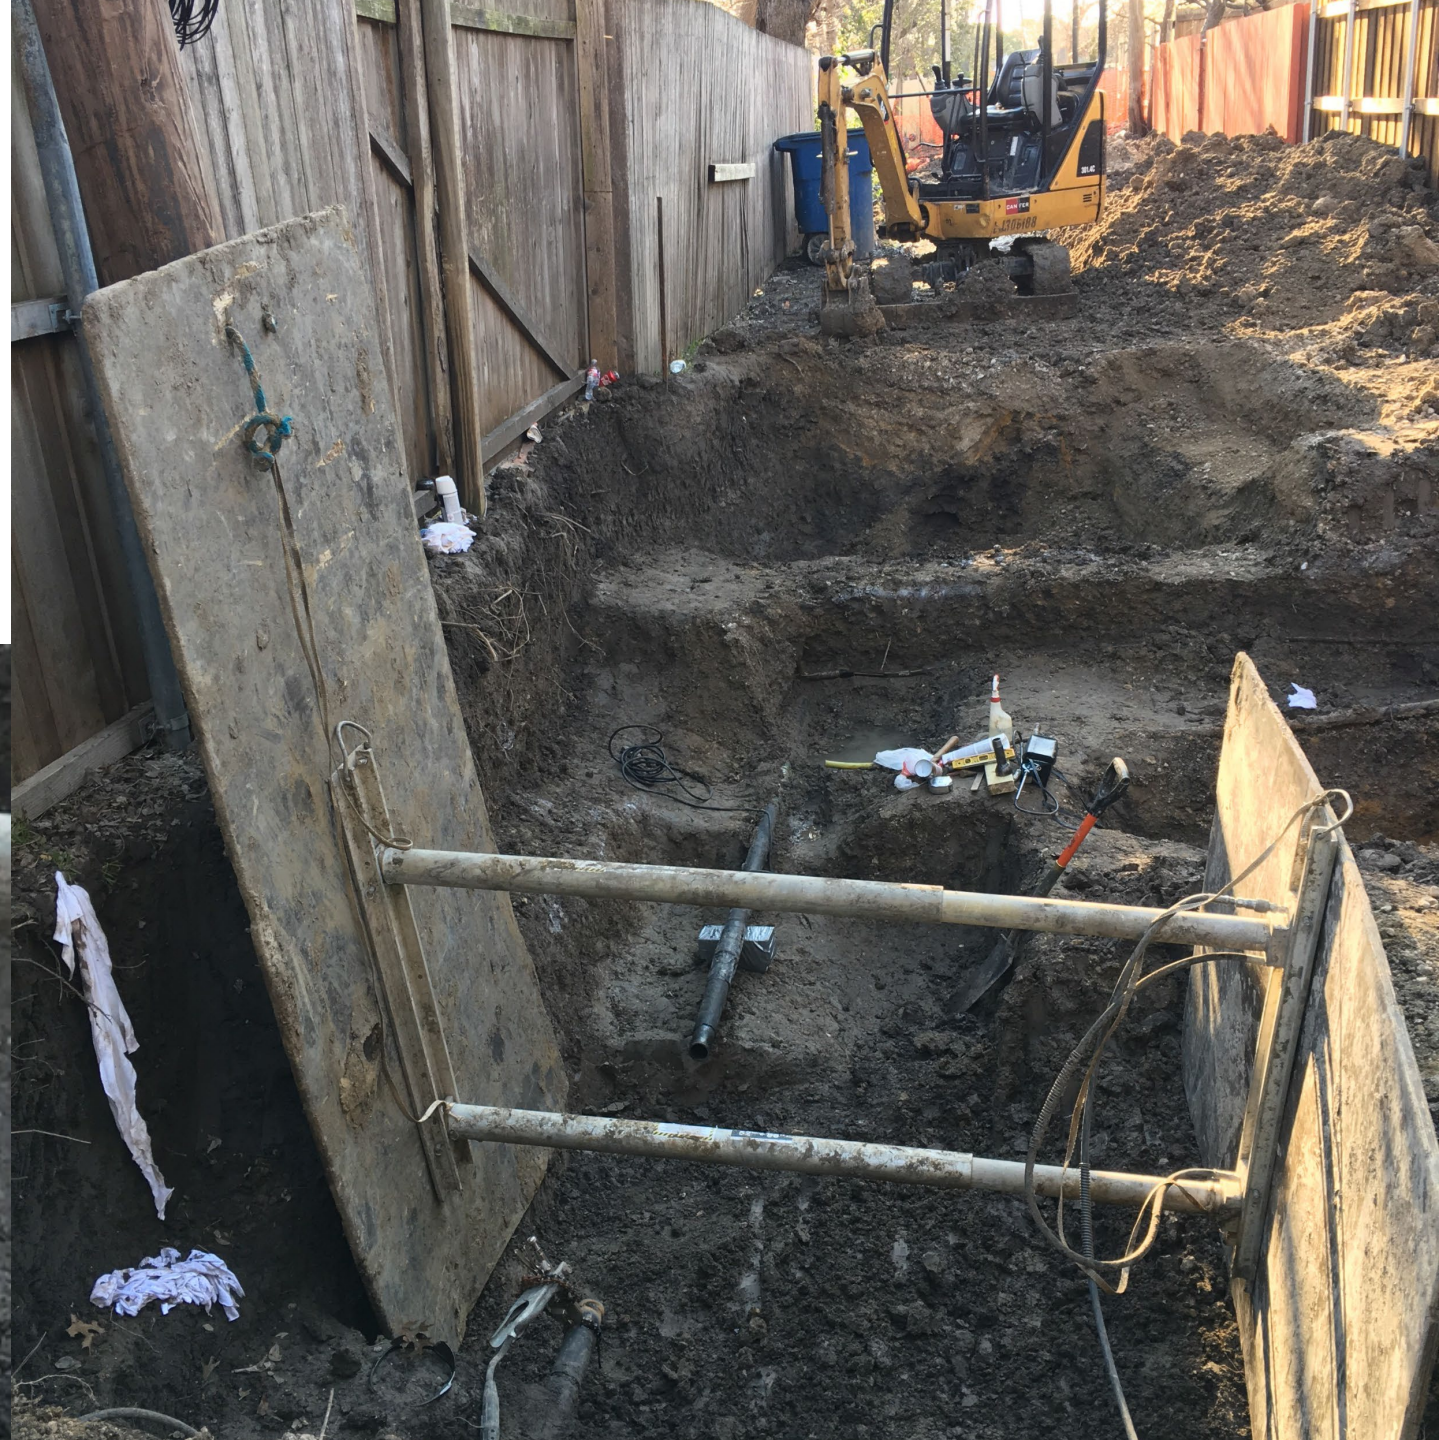
Be safe while working, What is wrong with this picture. A pressure test cap will be welded on for pressure testing in a few minutes. A compression coupling can be seen by support block.
