Hard Spots

Advisory Bulletin (ADB-2024-01)
Identification and Evaluation of Potential
Hard Spots

U.S. Department of Transportation
Pipeline and Hazardous Materials
Safety Administration

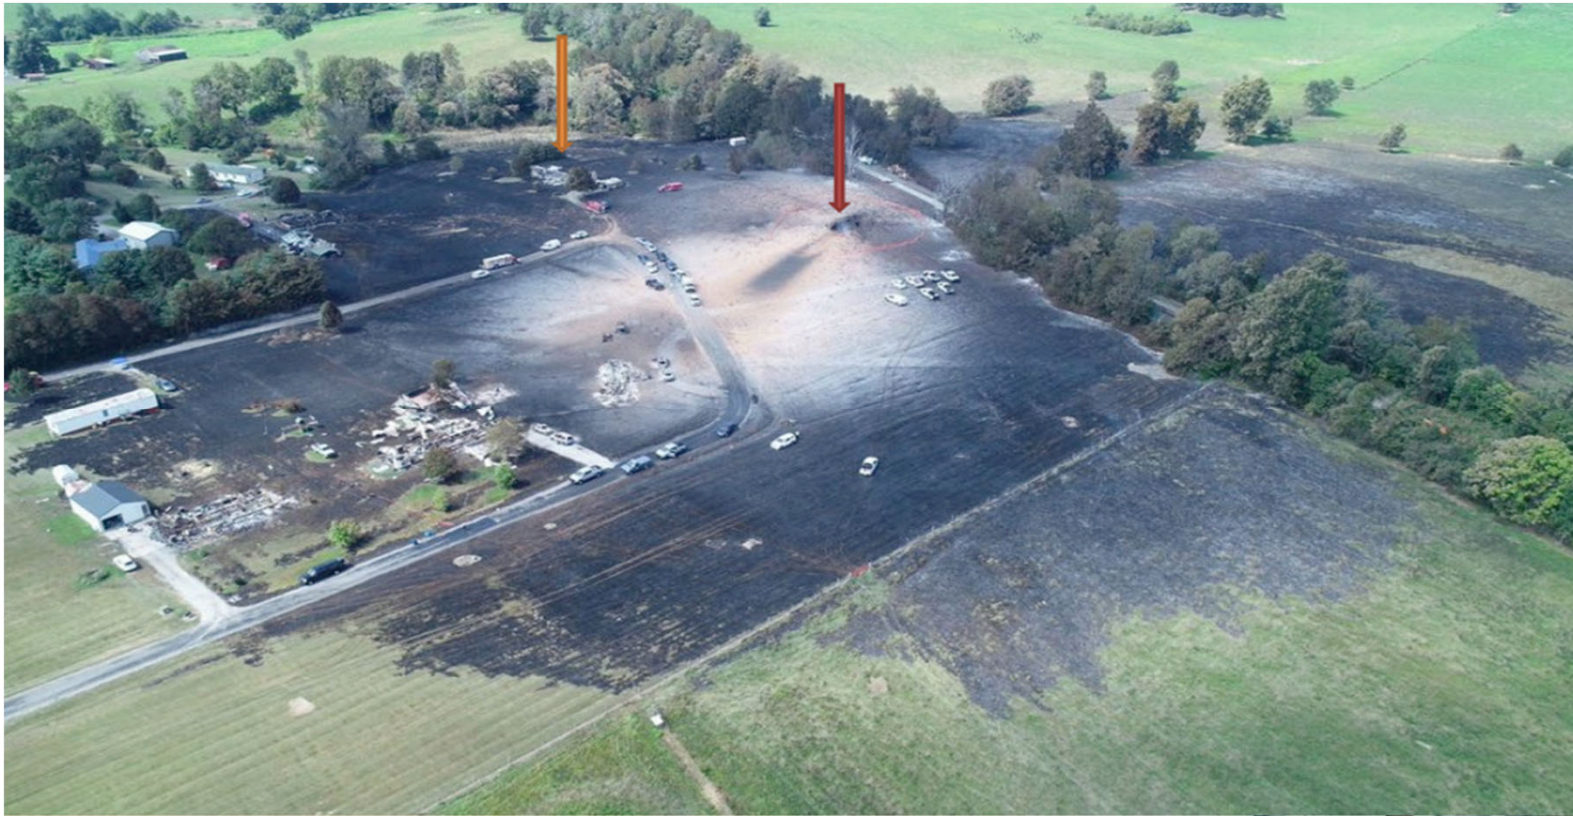
Danville Incident Investigation

- August 1, 2019
- 30-inch natural gas
- Danville, Kentucky
- 1957 - A.O. Smith
- Hydrogen-induced cracking in a hard spot – 5.85” x 3”
- Brinell hardness 362 – 381 extended through the pipe wall
- Operator ran ILI tools in 2004, 2005, and 2011
- Pipeline was cathodically protected with a coal tar coating
- Pipeline had a flow reversal in 2014

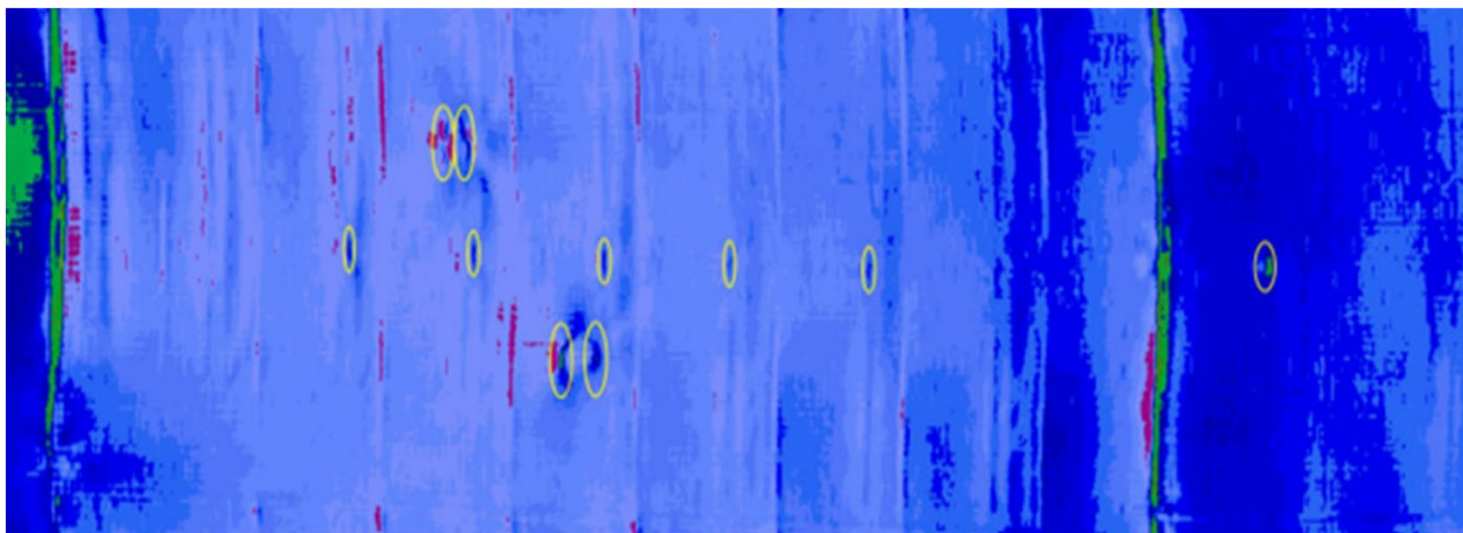
Danville Incident Investigation

- Hardness testing by NTSB identified the origin hard spot
- 5.85 inches by 3 inches and had hardness values between 362 and 381 Brinell
- Hardness readings extended through the wall

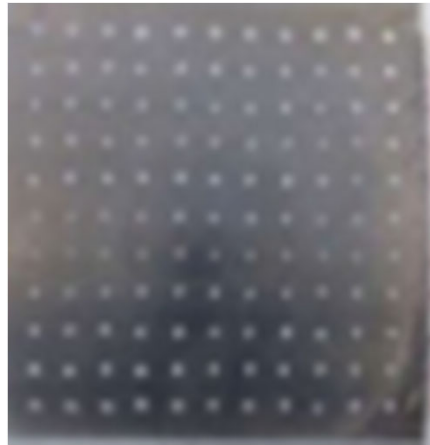
Hard Spot Integrity Program

179	183	189	200	212	198	192	182	195	187	184
199	192	203	249	261	257	229	196	195	187	178
194	198	221	260	266	267	270	242	201	180	176
194	237	256	265	268	266	262	250	210	203	194
199	238	258	274	267	265	259	264	246	201	190
203	240	251	256	268	263	278	262	266	230	252
205	246	247	245	267	270	271	258	271	226	206
186	213	246	256	261	264	265	265	263	200	185
176	190	196	235	243	241	242	227	261	203	182
174	182	188	186	198	200	199	191	220	203	184

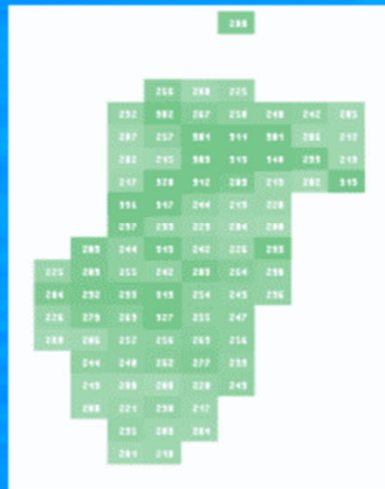
Hard Spot Integrity Program

Field: 312 BHN

ILI: 329 BHN
