# Black Hills Power

CIS Testing Importance to  
your TIMP Programs

Black Hills Power's  
Lessons Learned

# BHPs Transmission Pipelines

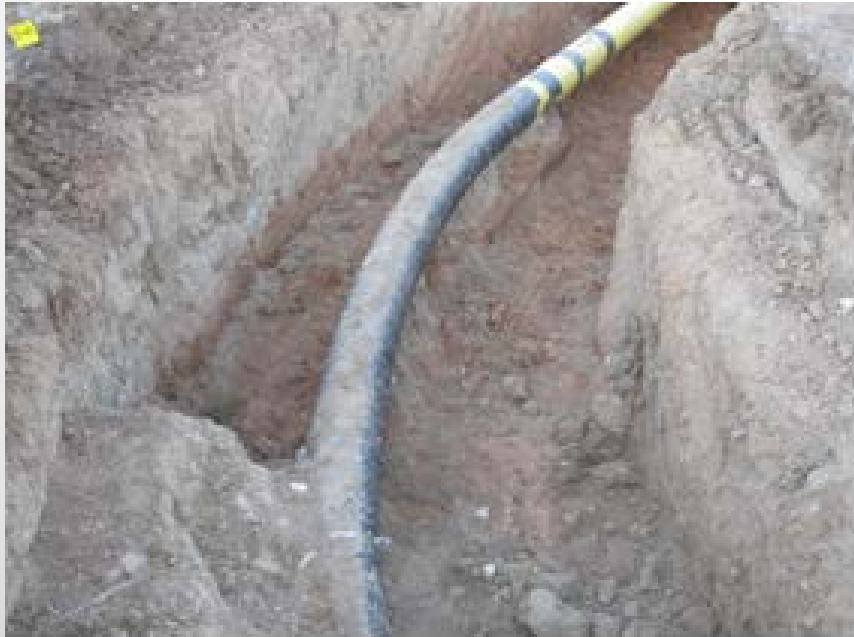
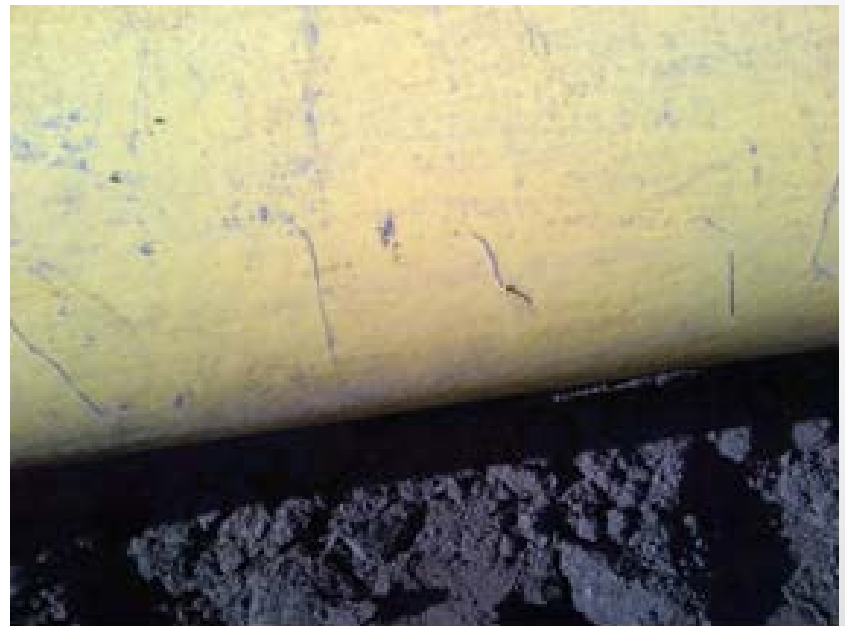
**ADDITIONAL CONCERN:**  
Field bending of the yellow-jacketed coated pipe caused cracking of the outer coating

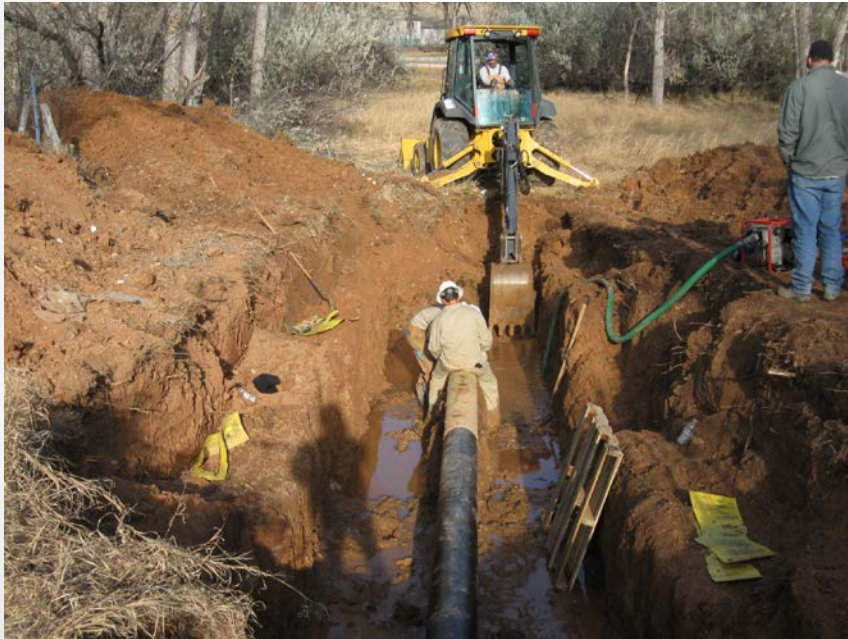
# Pipeline built under a dry creek bed - - Not so in 2011

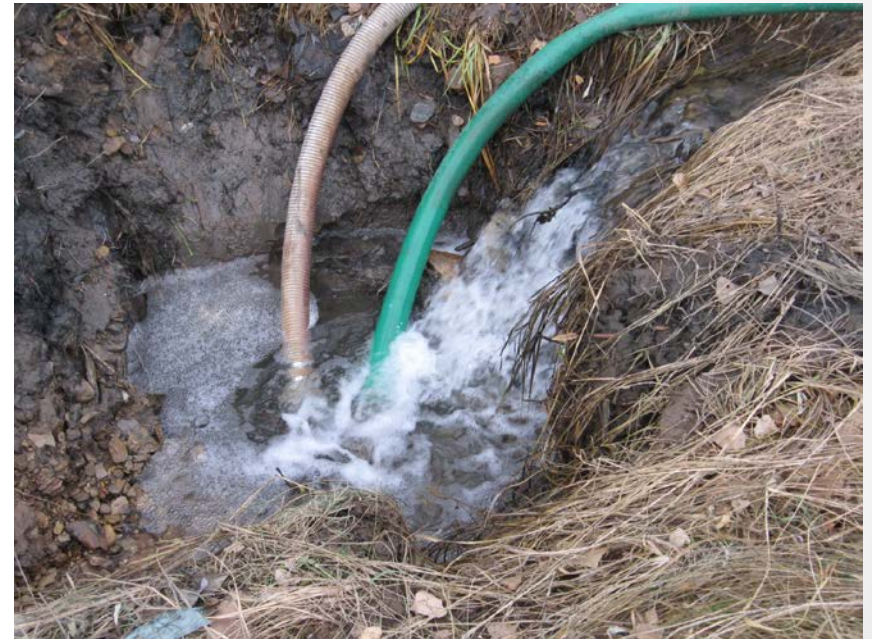
**Ground Water & Wetlands**

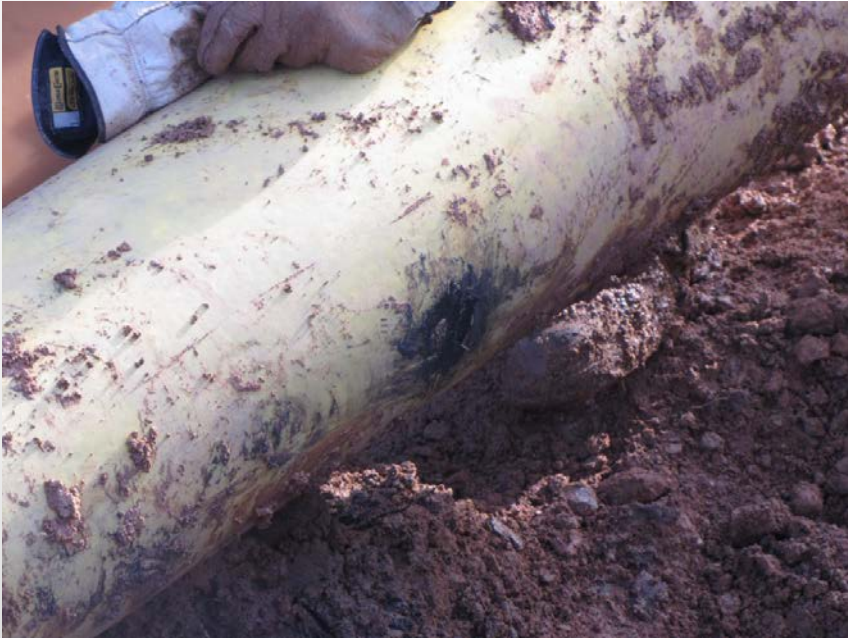
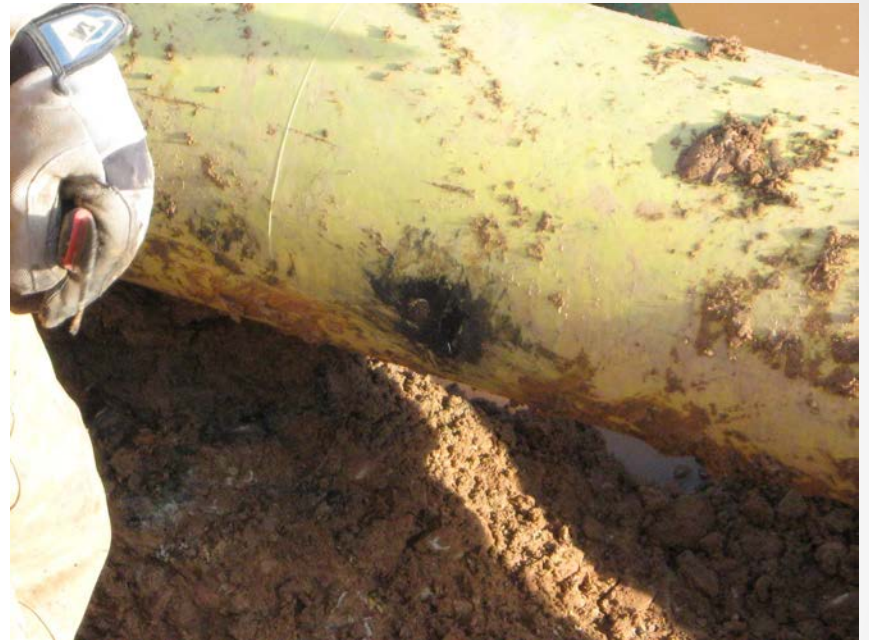
# Holiday in Coating

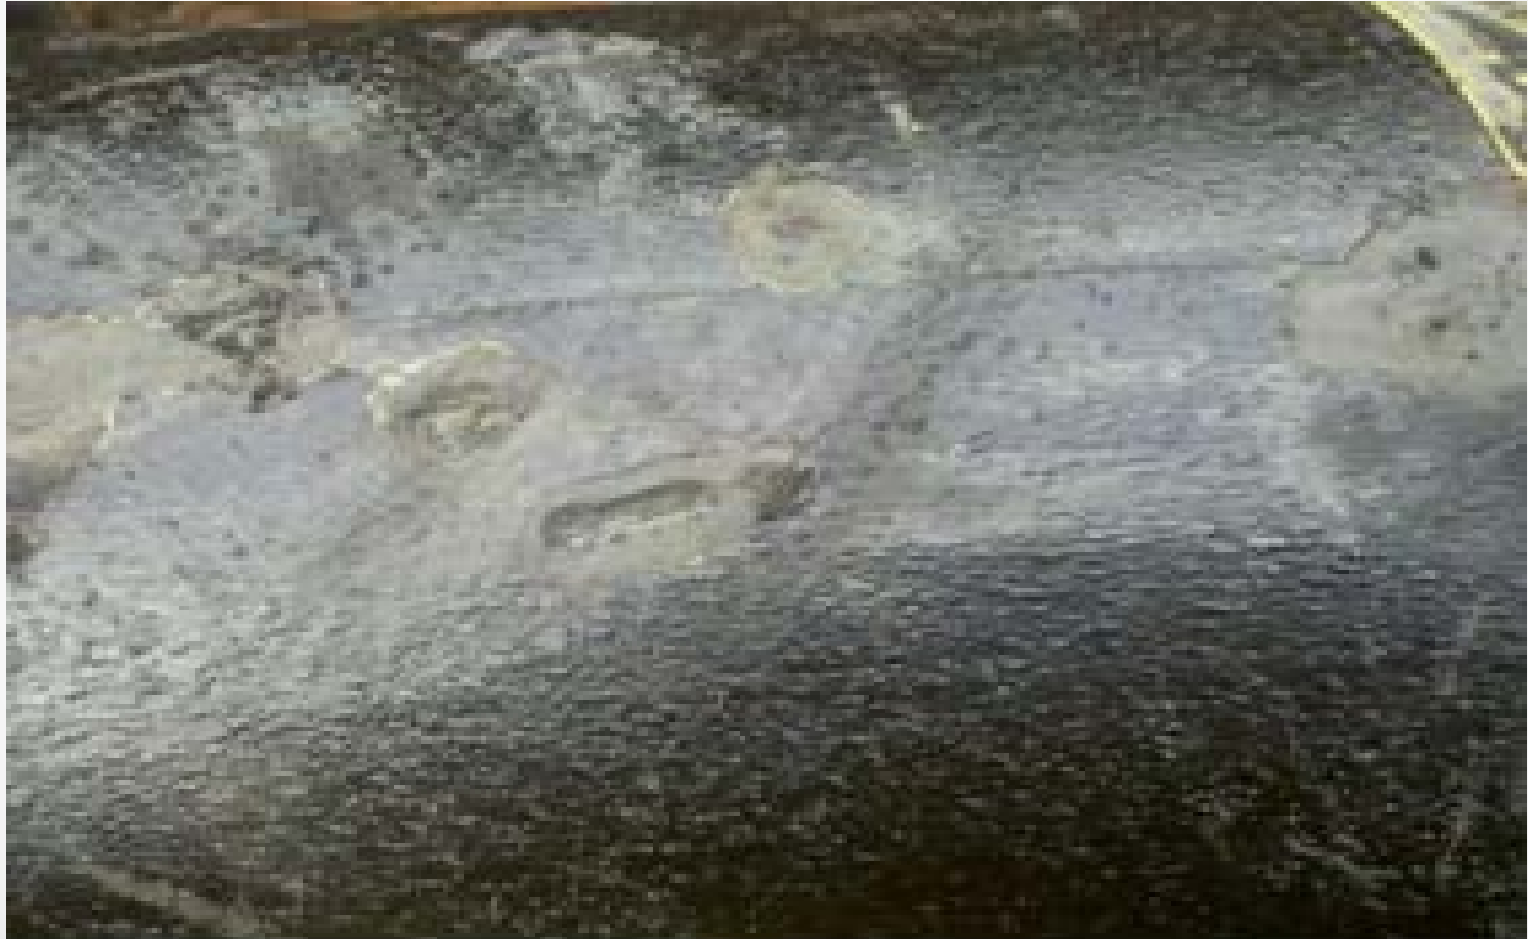
## Microbiological Influenced Corrosion (MIC)
