## Waterbody Data Form

Centerline ID: **5308ME001**
Project Designated Name: **KXL**

Date: **7-24-12**
Client/Project Name:
Milepost Enter/Exit: **~404.60 / CAR-167 (MP 3.5)**

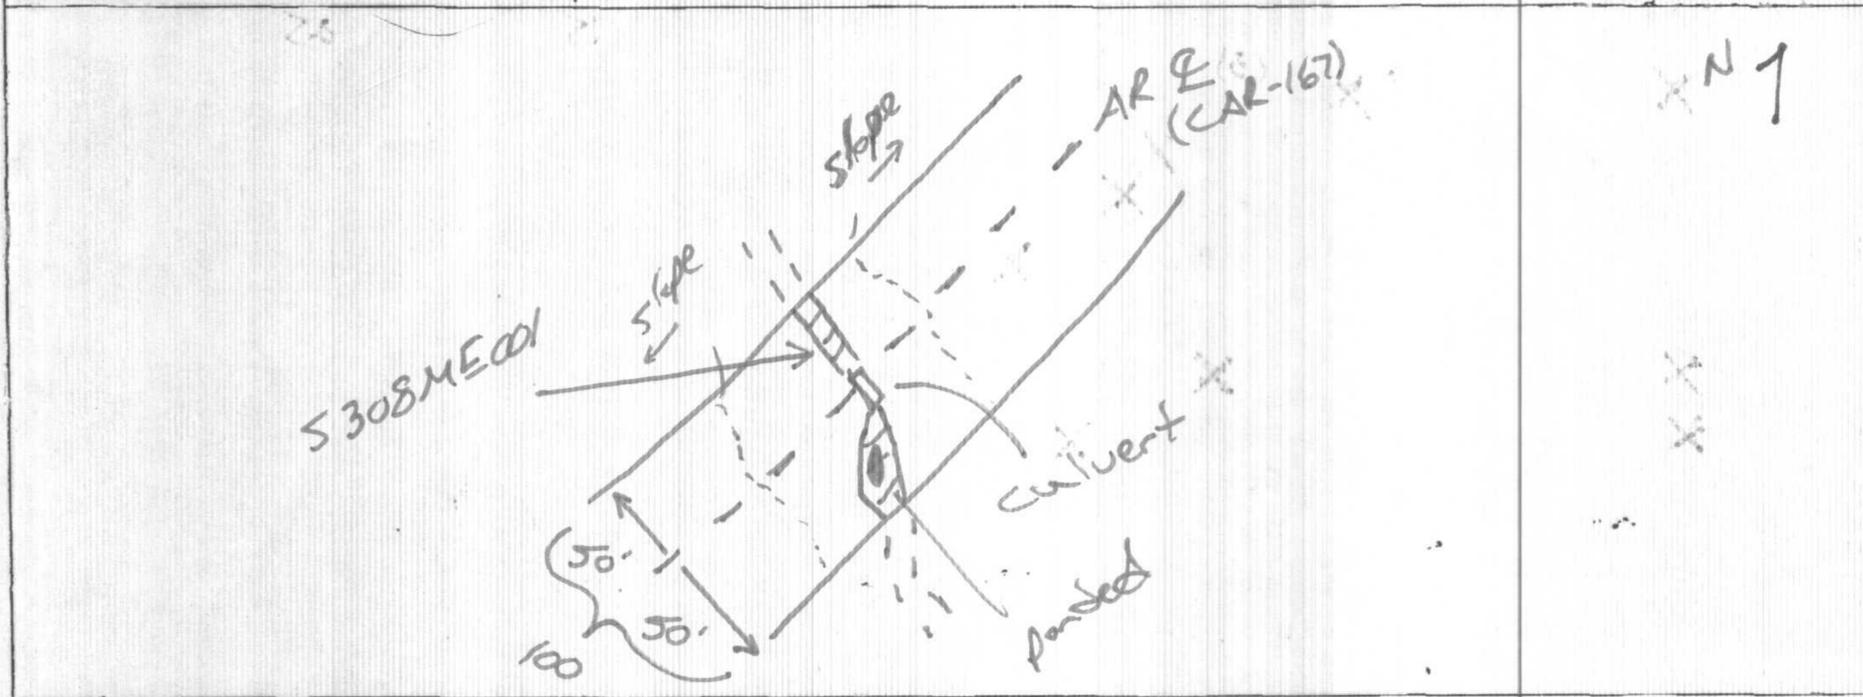
Drawing (Please provide orientation arrow, all features identified, location to centerline, etc.)

<b>Comments:</b> <i>Tributary is a low quality tributary of Sulphur Creek. An existing structure crosses over the tributary through a single culvert which has caused ponding on the upstream side. The downstream side exhibits a narrow channel which loses stream beyond the survey corridor.</i>
---
