Ferebee Service Hill City South Dakota

Customer Service Description

Grounding Study

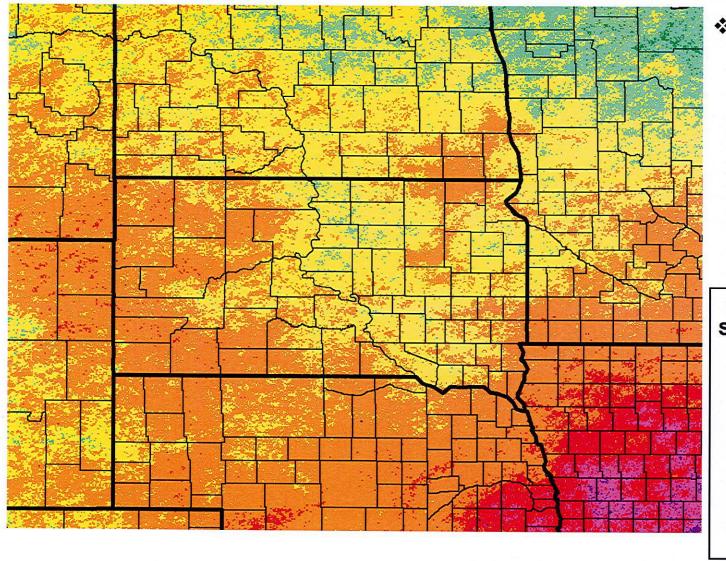
2005 – 2014 Lightning Strike / Stroke Map Enlarged

According to NOAA: Black Hills storms produce twice the amount of ground strikes per year compared to the surrounding region (besides Colorado).

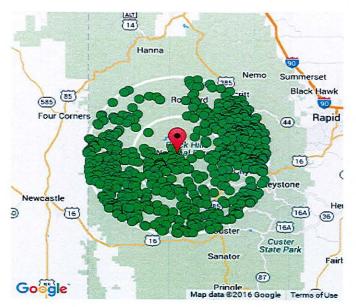
LIAS Stroke Map

690 cloud-to-ground events were detected by the USPLN
