The Ferebees and Wilsons live in a remote area with a unique geological structure and weather conditions that have hampered the quality of their service. CenturyLink serves them with a digital carrier system which is 77,980 feet or 14.76 miles from the Hill City Central Office. This map shows the route CenturyLink's facilities follow to serve them:

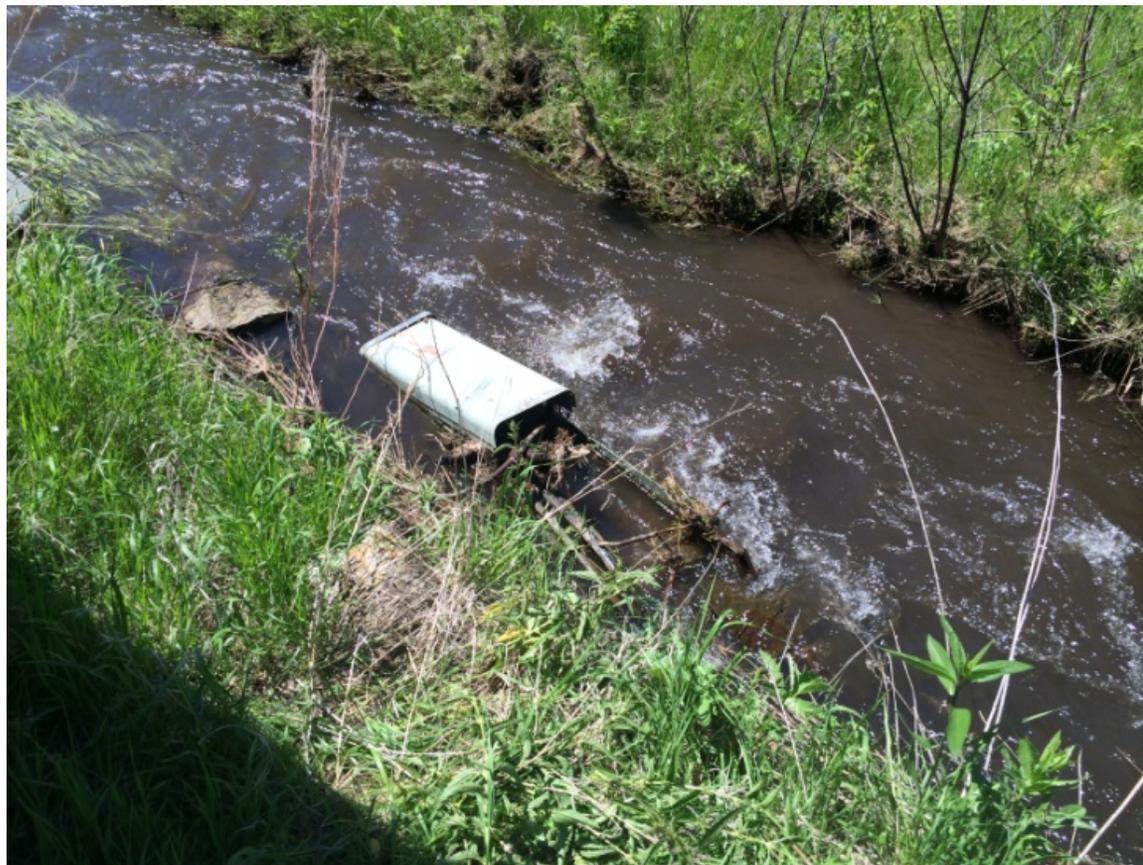
The ground around these customers' homes contains a large quantity of metal, making it especially vulnerable to lightning strikes. The plant between Hill City and their home is very remote, difficult to reach and subject to severe weather, which can result in outages due to significant storms, such as washouts from floods.
