The Ferebees and Wilsons live in a remote area with a unique geological structure and weather conditions that have hampered the quality of their service. CenturyLink serves them with a digital carrier system which is 77,980 feet or 14.76 miles from the Hill City Central Office. This map shows the route CenturyLink's facilities follow to serve them:

CenturyLink has made extensive efforts to address those issues. Those efforts are outlined on the charts that follow for each customer:

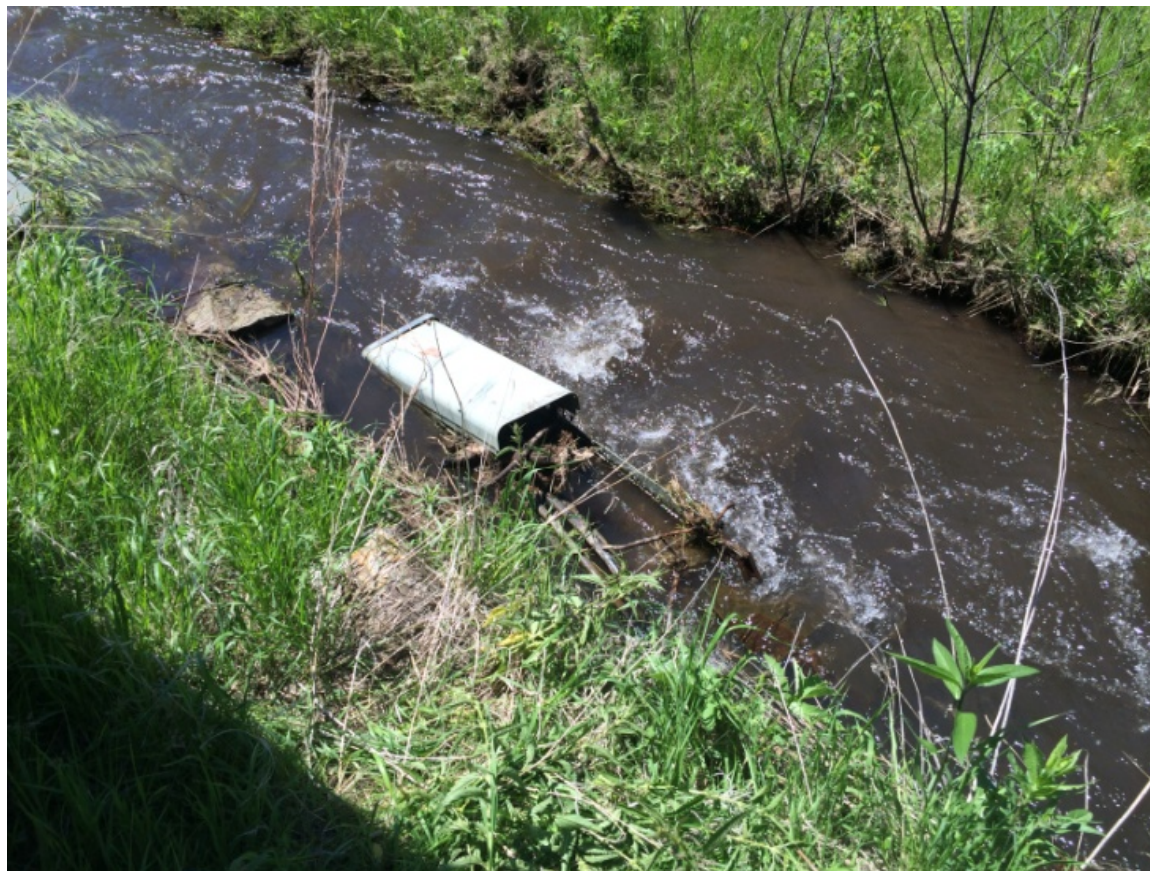
The ground around these customers' homes contains a large quantity of metal, making it especially vulnerable to lightning strikes. The plant between Hill City and their home is very remote, difficult to reach and subject to severe weather, which can result in outages due to significant storms, such as washouts from floods.
