National Transportation Safety Board

Safety Recommendation

In reply refer to: A-13-18 and -19

**Exhibit
G28**

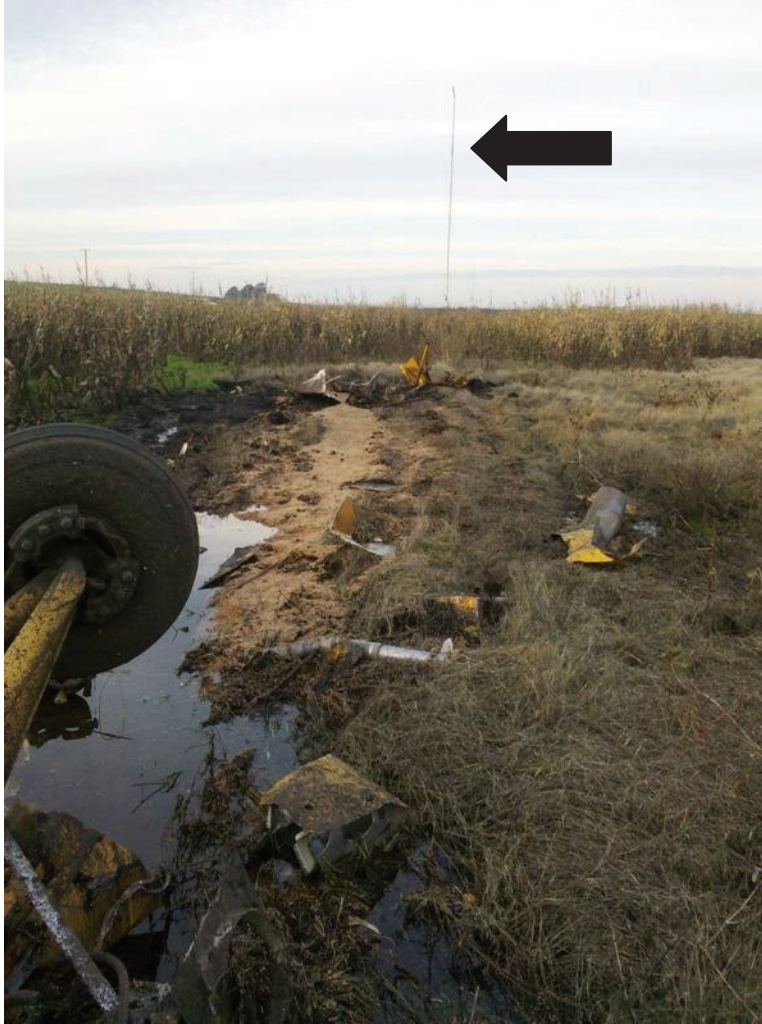
On January 10, 2011, about 1057 Pacific standard time, the left wing of a Rockwell International S-2R, N4977X, impacted an unmarked and unlighted MET during an aerial seed application flight on Webb Tract Island, Oakley, California.¹ Witnesses reported that they did not see the airplane perform any evasive maneuvers before the impact, indicating that the pilot did not see the obstruction. The pilot was fatally injured, and the airplane sustained substantial damage. Visual meteorological conditions prevailed and no flight plan was filed for the 14 *Code of Federal Regulations* (CFR) Part 137 flight. The NTSB's investigation found that the county

permit² for the MET had expired more than a year before the accident, but the MET had not been removed as stipulated by the permit's conditions of approval.

METs can be erected quickly and, depending on their location, without notice to the local aviation community. In March 2011, the NTSB issued a safety alert⁶ about METs, noting that the speed with which they can be erected is an important aspect of this safety issue—in just a matter of hours, the navigable airspace for low-flying operations can change without notice. Because their height is typically just under the 200-feet-above-ground-level (AGL) threshold that requires Federal Aviation Administration (FAA) notification,⁷ including a marking and lighting plan, METs are often erected without markings or lighting. Because of these factors, pilots have reported difficulty seeing METs from the air (the following figure shows an example MET), which has led to accidents.

Figure. A photograph showing a MET (indicated by the black arrow), as seen from an accident site (NTSB case number WPR11LA094).

Revise the *Wind Energy Siting Handbook* to clearly indicate the hazards that meteorological evaluation towers (MET) pose to low-altitude aviation operations and encourage voluntarily marking them to increase their visibility by reference to Advisory Circular 70/7460-1, "Obstruction Marking and Lighting." (A-13-18)

Inform your members about the circumstances of the airplane accidents that have occurred in connection with the presence of meteorological evaluation towers (MET) and emphasize the importance of understanding the aviation safety hazards associated with METs when erecting them. (A-13-19)
