Final Evaluation of Designated Roads (Transmission Line Phase)

Prepared for:
Codington County Highway Department
Codington County, SD

FEBRUARY 2021

BAI No. 22913.00 - Phase 05

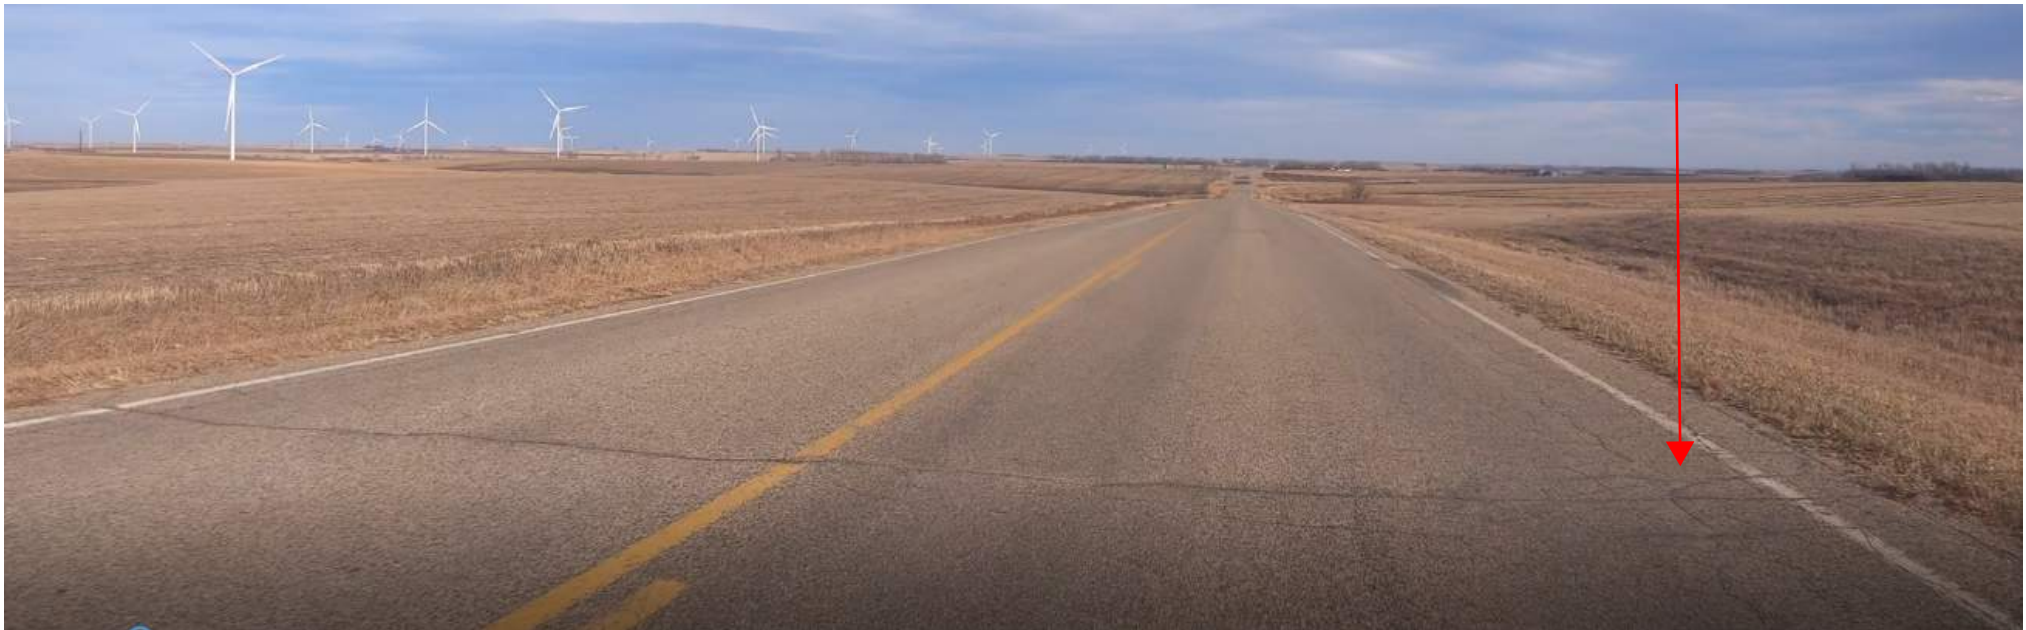
Post CCR 4 from 464th Ave. to 465th Ave. 0:22 video time

- Moderate amount of longitudinal and transverse cracks of medium severity throughout, with many longitudinal cracks in wheel paths
- Moderate severity block and alligator cracking present along outside ¼ of lanes for approximately 35% of the segment length
- Asphalt settlement was noted in a couple locations, particularly above culvert crossings
- Moderate severity of aggregates worn away in the wheel paths coupled with oil migrating to the surface, creating a slick traveling surface.
- Seven new patches were noted along this segment of roadway replacing areas of pavement that were compromised during construction.
- Rutting measured between 1/16th and 3/8th of an inch.

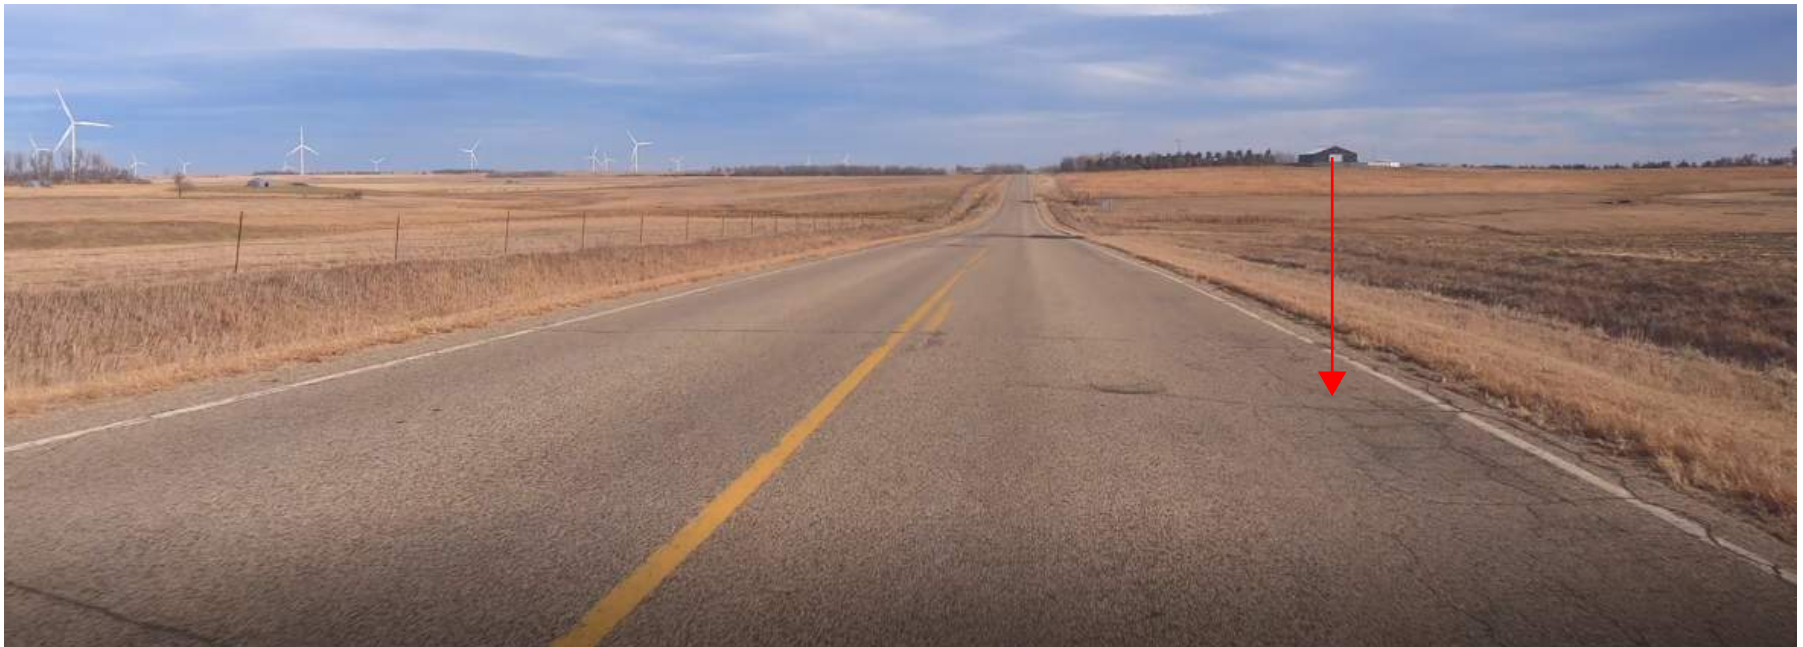
Post CCR 4 from 465th Ave. to 466th Ave. 1:30 video time

- Moderate severity of aggregates worn away in the wheel paths coupled with oil migrating to the surface, creating a slick traveling surface.
- Rutting measured between 1/16th and 5/16th of an inch.
- Three new patches were noted along this segment of roadway replacing areas of pavement that were compromised during construction.

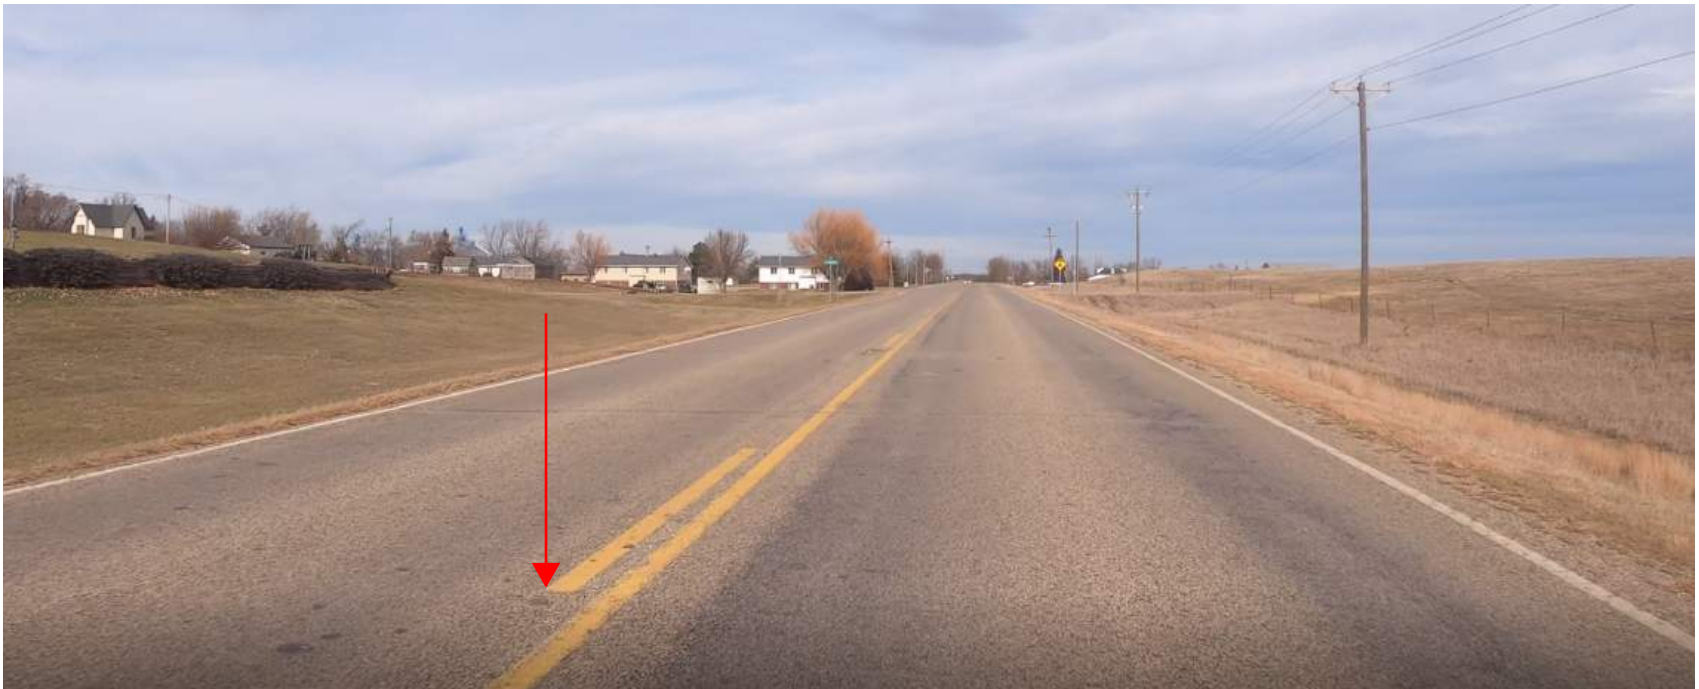
Pre CCR 3 from 157th St. to 158th St. 0:28 video time

- Moderate amount of longitudinal and transverse cracks throughout, with longitudinal cracks mostly prevalent in wheel paths and along centerline. Transverse cracks at a fairly consistent frequency of approximately 25' intervals.
- Moderate severity of block and alligator cracking present along outside ¼ of lanes for approximately 35% of the segment length
- High severity of aggregates worn away in the wheel paths coupled with oil migrating to the surface, creating a slick traveling surface.
- No new patches observed
- Rutting measured between 1/16th and 7/16th of an inch.

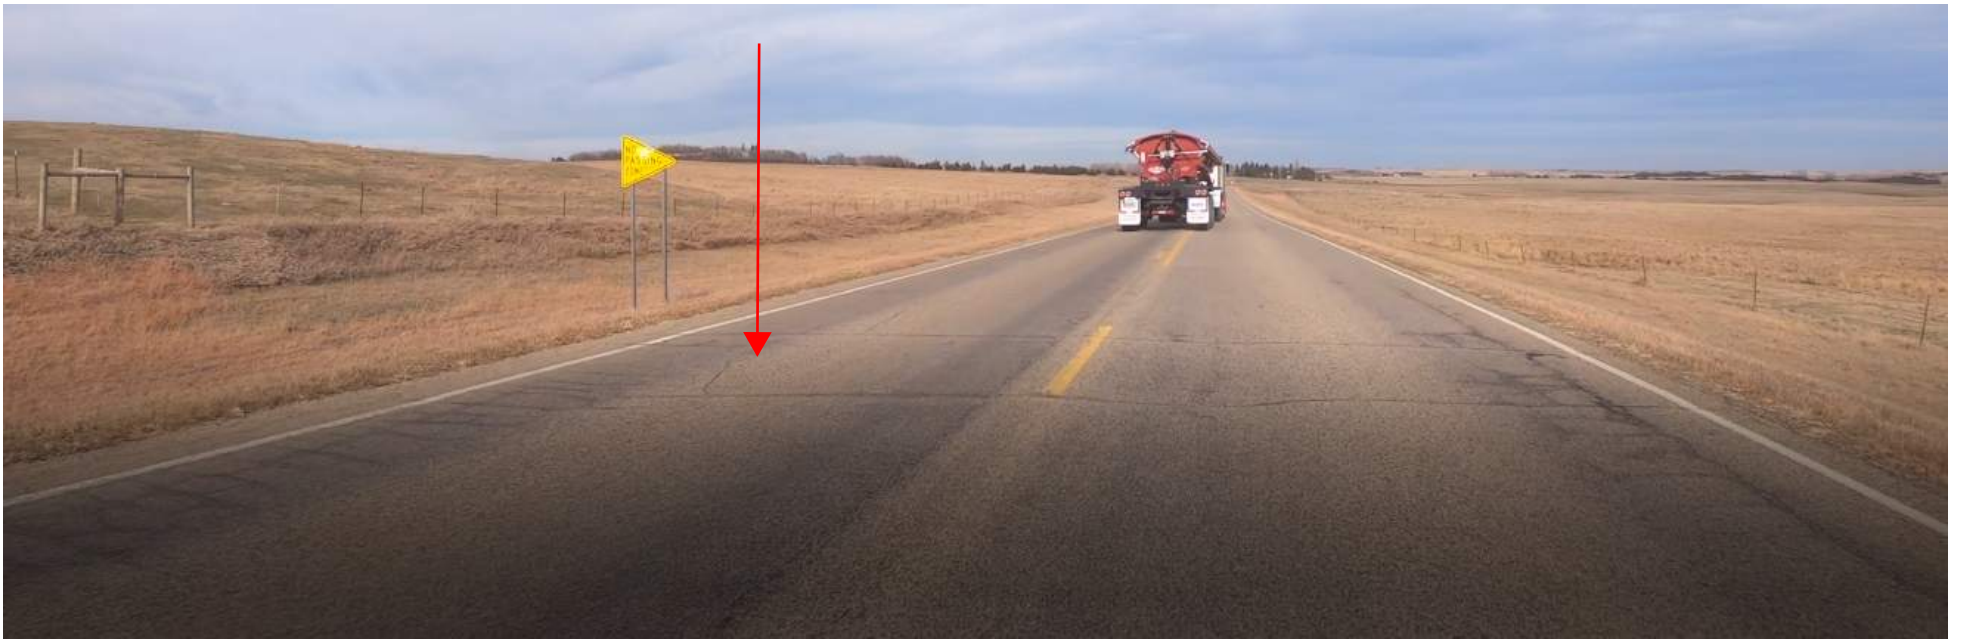
Post CCR 3 from 158th St. to 159th St. 6:55 video time

- Moderate amount of longitudinal and transverse cracks throughout, with longitudinal mostly prevalent in wheel paths and along centerline. Transverse cracks at a fairly consistent frequency of approximately 25' intervals, tightening to 15' intervals near south end of segment.
- High severity of block and alligator cracking present along outside 1/3 of lanes for approximately 70% of the segment length, and especially prevalent in southbound lane
- Asphalt settlement and movement noted in some areas, particularly near the ½ mile line
- Moderate severity of aggregates worn away in the wheel paths coupled with oil migrating to the surface, creating a slick traveling surface.
- One new patch was noted along this segment of roadway replacing an area of pavement that was compromised during construction.
- Rutting measured between 1/16th and 3/8th of an inch.

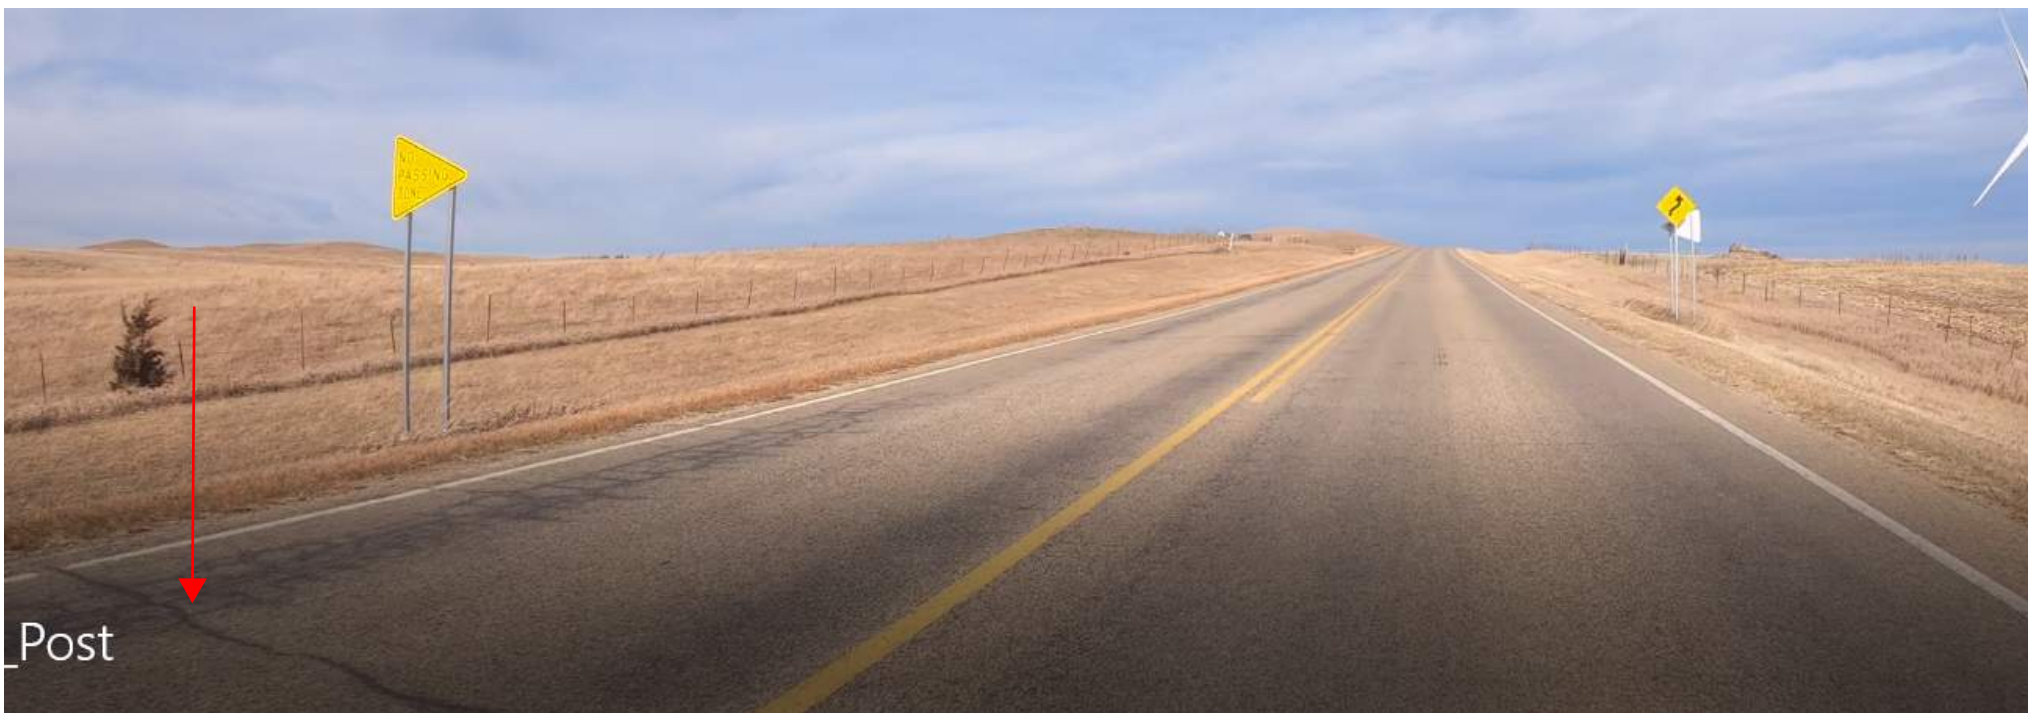
Post CCR 3 from 159th St. to 160th St. 4:13 video time

- Moderate amount of longitudinal and transverse cracks throughout, with longitudinal cracks mostly prevalent in wheel paths
- High severity of block and alligator cracking present along outside 1/3 of lanes for approximately 35% of the segment length
- Asphalt settlement was noted in a couple locations, particularly above culvert crossings
- High severity of aggregates worn away in the wheel paths coupled with oil migrating to the surface, creating a slick traveling surface.
- No new patches observed
- Rutting measured between 1/16th and 3/16th of an inch.

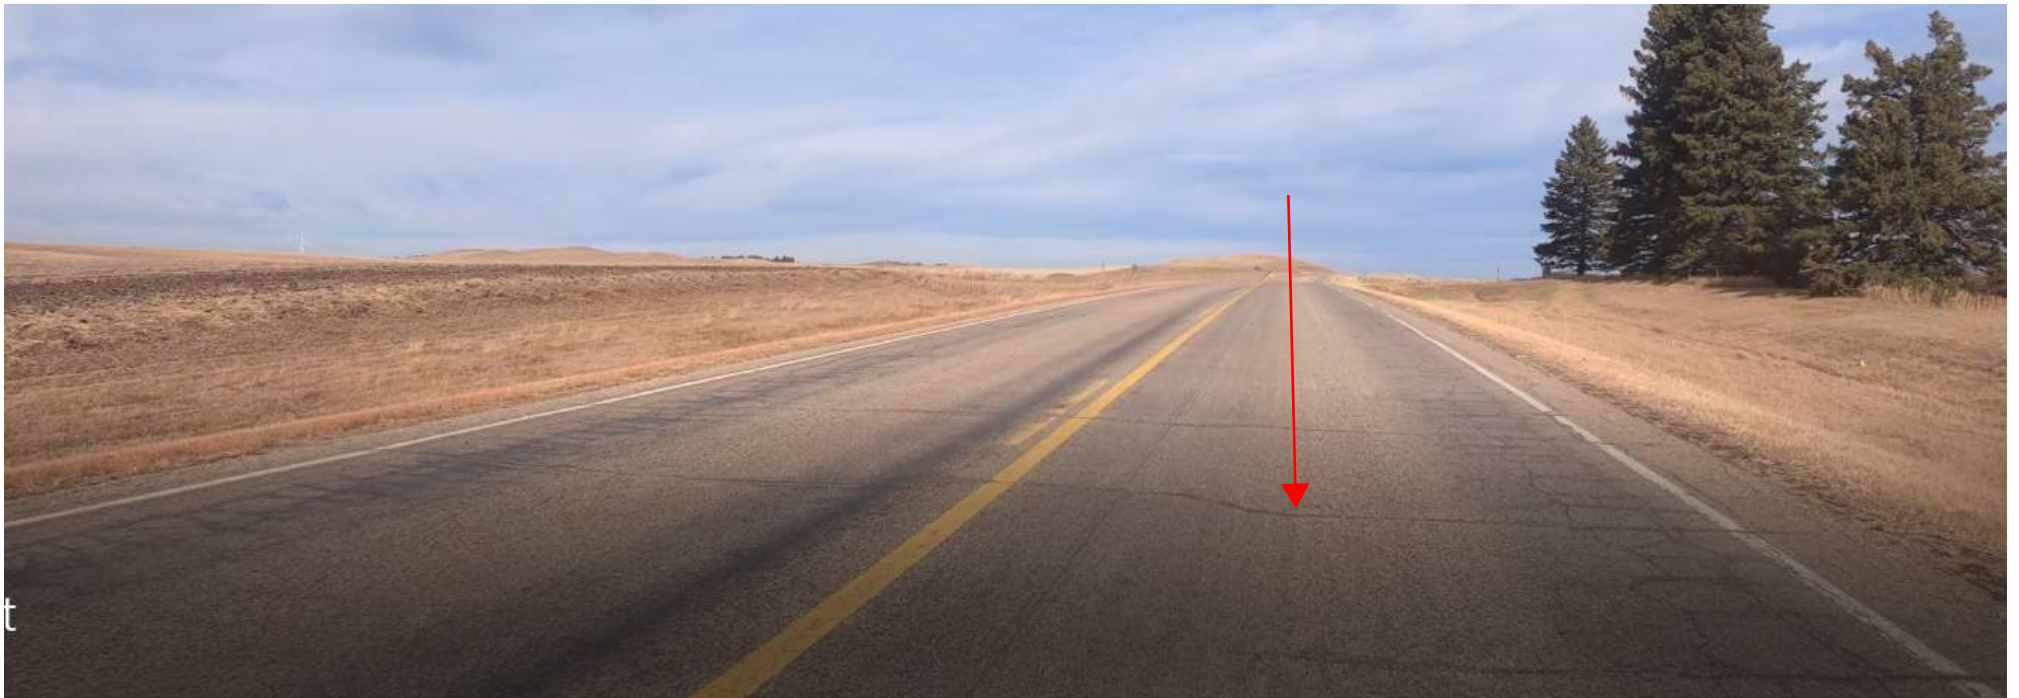
Post CCR 3 from 160th St. to 161st St. 3:47 video time

- Moderate amount of longitudinal and transverse cracks throughout, with longitudinal cracks of medium severity mostly prevalent in wheel paths
- High severity of block and alligator cracking present along outside 1/2 of lanes for approximately 95% of the segment length
- Asphalt settlement was noted in a couple locations, particularly above culvert crossings
- High severity of aggregates worn away in the wheel paths coupled with oil migrating to the surface, creating a slick traveling surface.
- One new patch was noted along this segment of roadway replacing an area of pavement that was compromised during construction.
- Rutting measured between 1/16th and 3/8th of an inch.

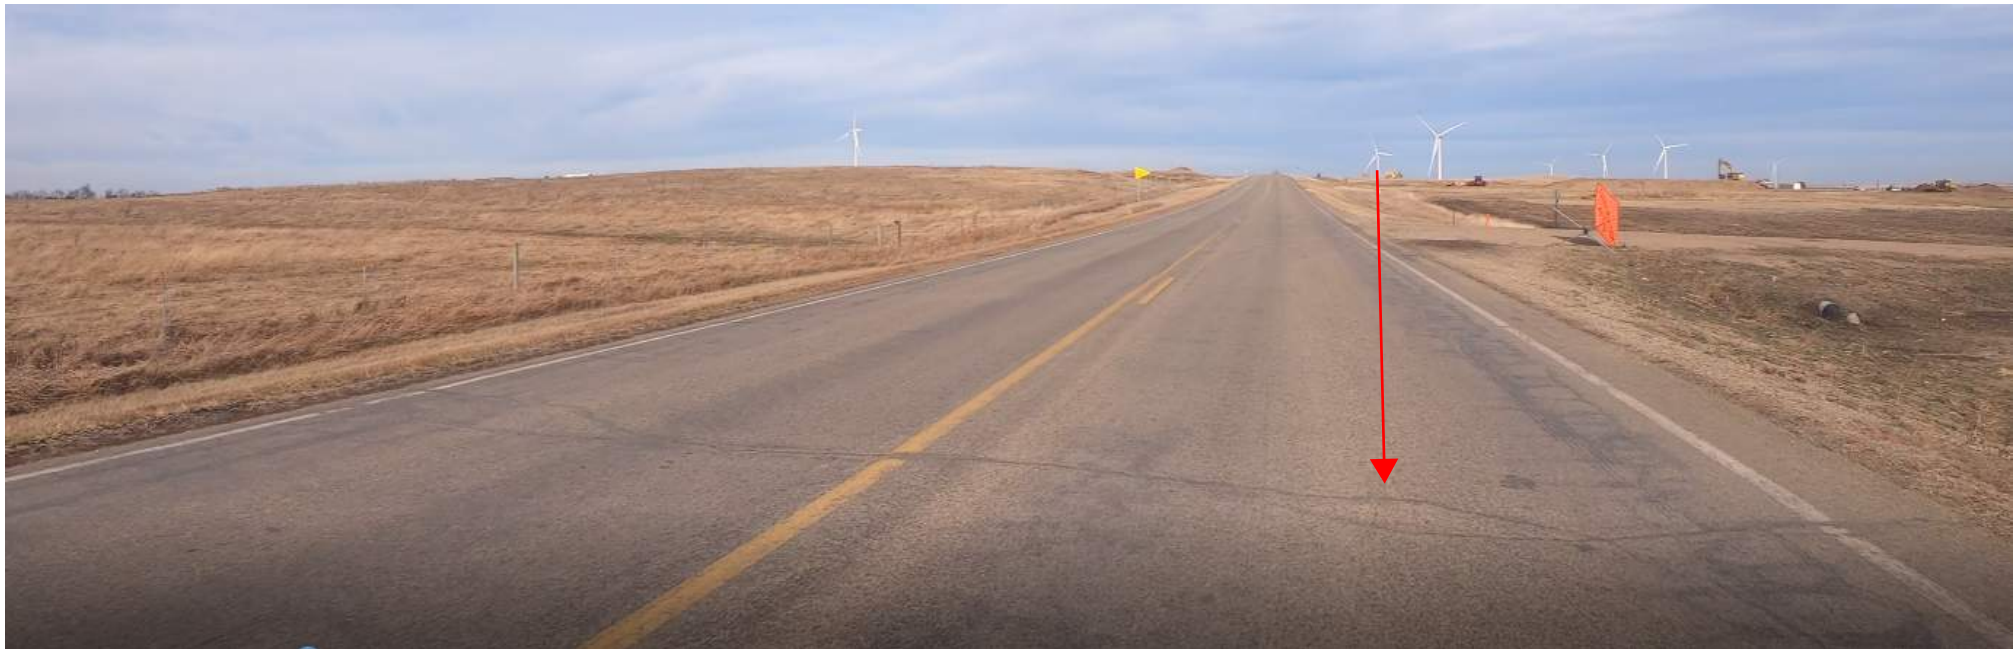
Post CCR 3 from 161st St. to 162nd St. 1:33 video time

- Moderate amount of longitudinal and transverse cracks throughout, with longitudinal cracks of medium severity mostly prevalent in wheel paths
- Moderate severity of block and alligator cracking present along outside ¼ of lanes for approximately 35% of the segment length
- Asphalt settlement was noted in a couple locations, particularly above culvert crossings
- High severity of aggregates worn away in the wheel paths coupled with oil migrating to the surface, creating a slick traveling surface.
- One new patch was noted along this segment of roadway replacing an area of pavement that was compromised during construction.
- Rutting measured between 1/16th and 5/16th of an inch.

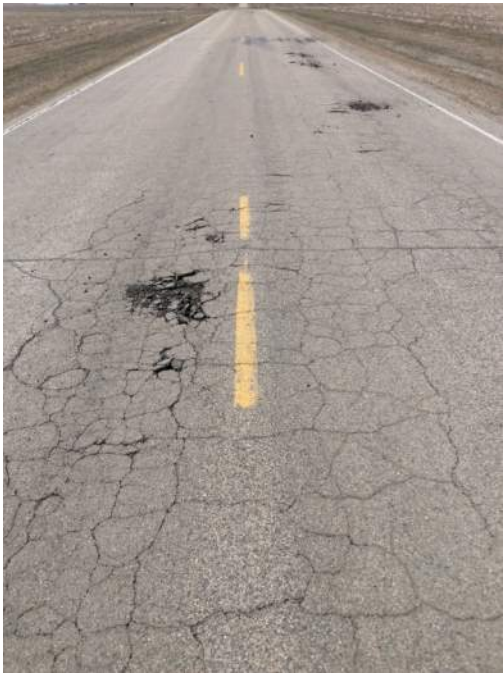
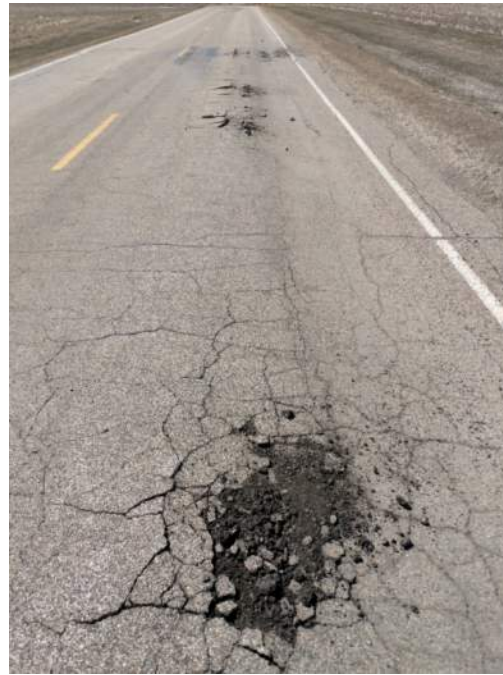
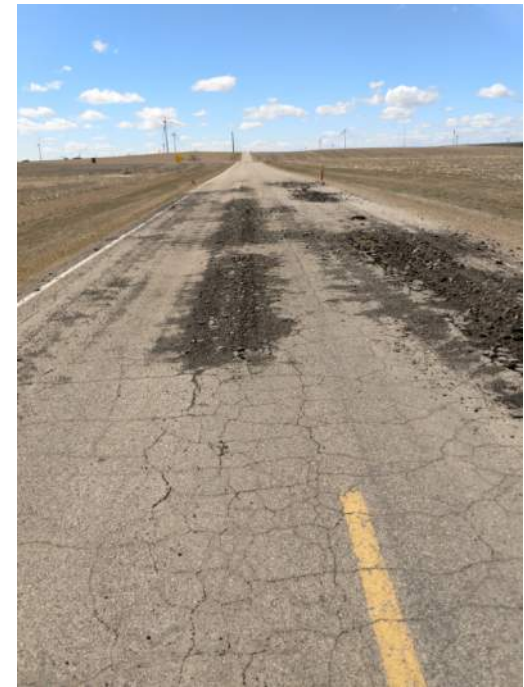
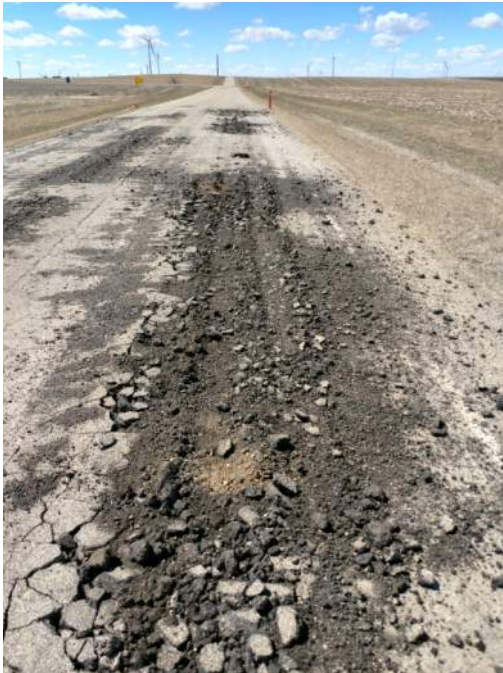
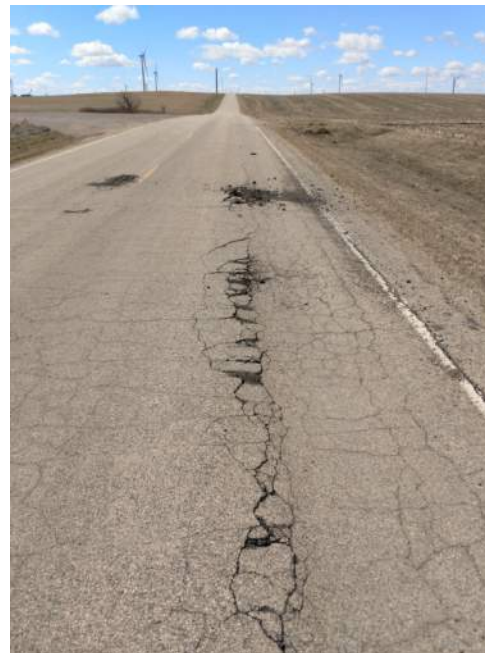
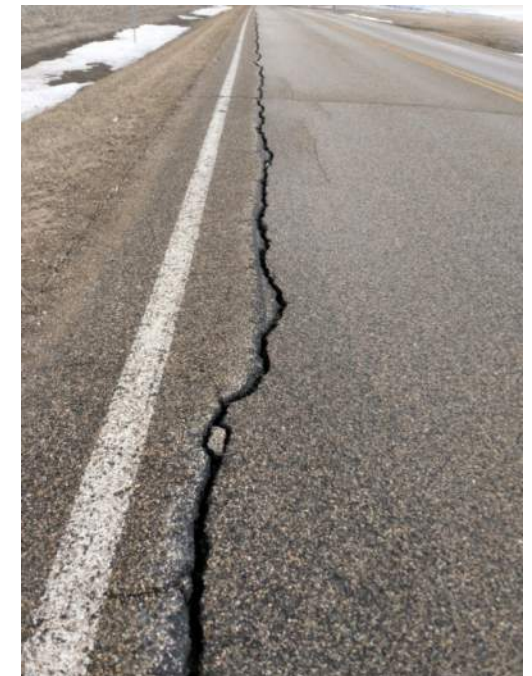
CROWNED RIDGE WIND I TRANSMISSION LINE PHASE MID-CONSTRUCTION PHOTOS

APPENDIX G contains pre- and post-construction frozen frames from video of the haul routes collected by Banner. Each sheet shows a side-by-side comparison of the same location from each evaluation period. The damages shown are intended to depict the typical damage experienced by that segment of roadway. Please note that some haul routes were driven in opposite direction pre- and post-construction, so a red arrow is used to point out an identifier in each photo to verify it is the same location in both frozen frames. Banner has also included a sheet of photos taken during construction of areas of roadway that were completely compromised.
