Final Evaluation of Designated Roads (Crowned Ridge Wind I Phase)

**Codington County Highway Department
Codington County, SD**

FEBRUARY 2021

BAI No. 22913.00 - Phase 05

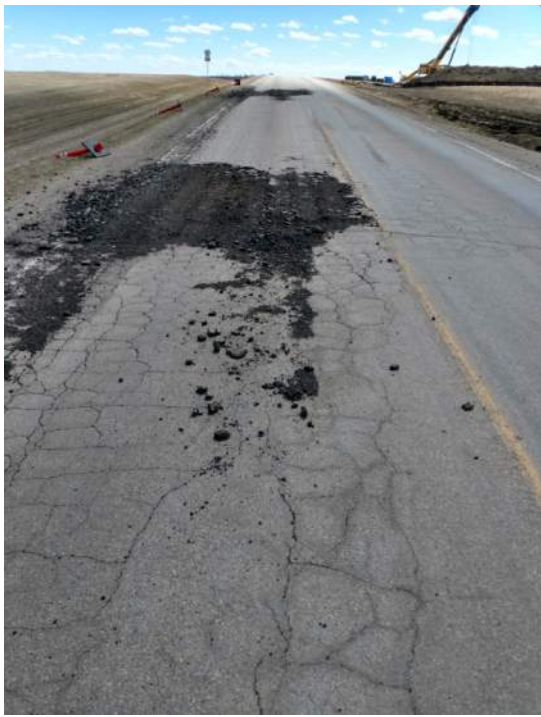
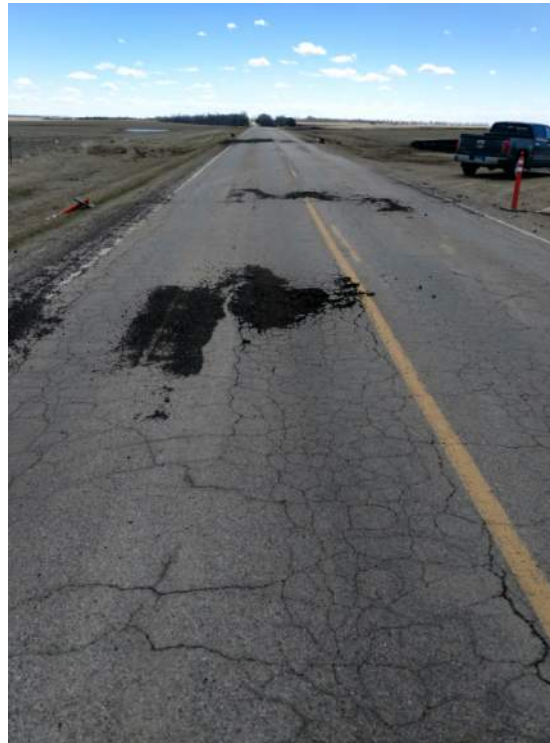
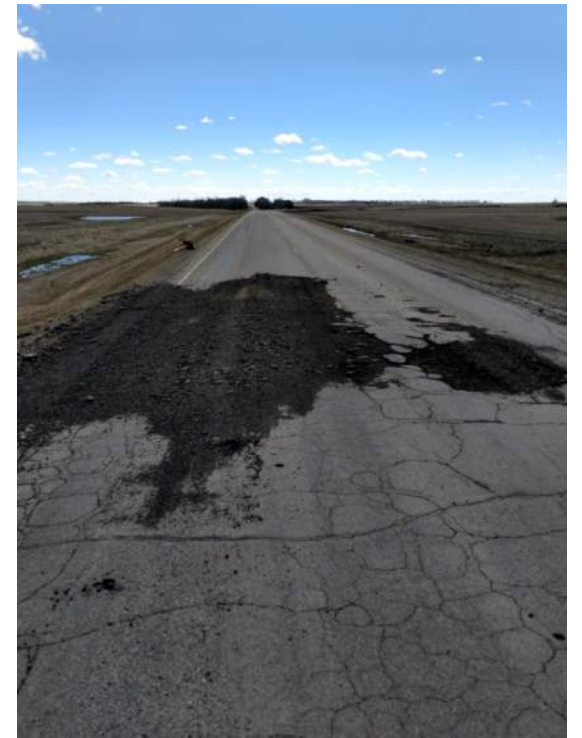
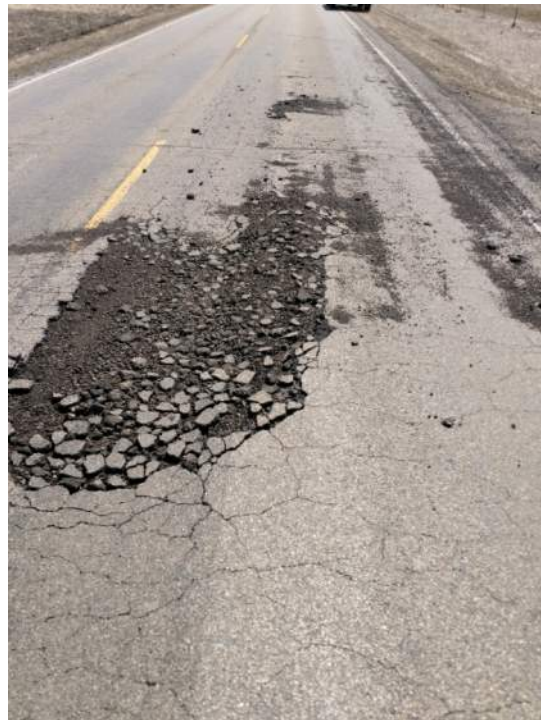
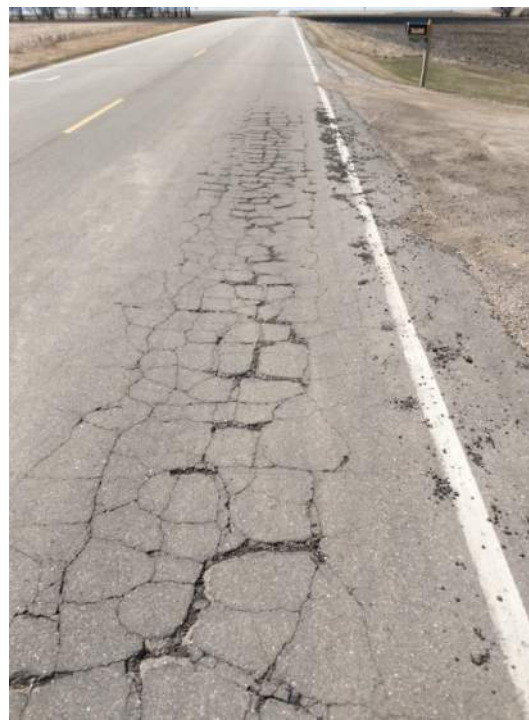
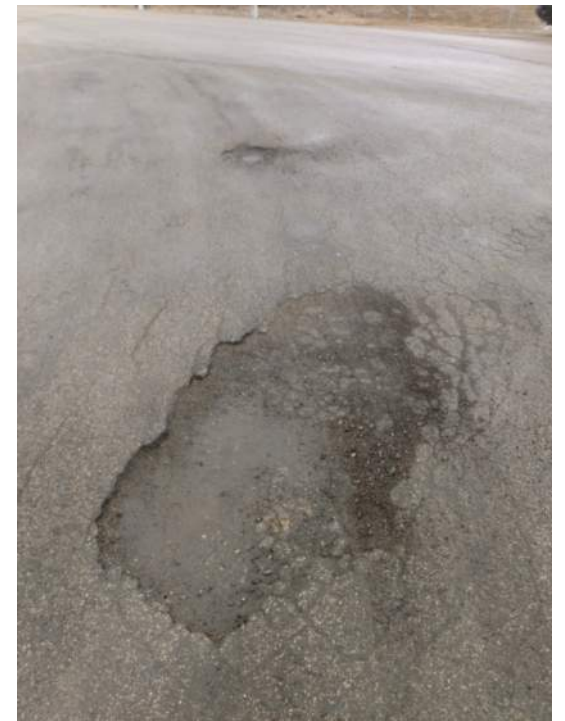
CROWNED RIDGE WIND I PHASE MID-CONSTRUCTION PHOTOS

APPENDIX G contains pre- and post-construction frozen frames from video of the haul routes collected by Banner. Each sheet shows a side-by-side comparison of the same location from each evaluation period. The damages shown are intended to depict the typical damage experienced by that segment of roadway. Please note that some haul routes were driven in opposite direction pre- and post-construction, so a red arrow is used to point out an identifier in each photo to verify it is the same location in both frozen frames. Banner has also included a sheet of photos taken during construction of areas of roadway that were completely compromised.
