Final Evaluation of Designated Roads (Crowned Ridge Wind II Transmission Line Phase)

Prepared for:
Codington County Highway Department
Codington County, SD

FEBRUARY 2021

BAI No. 22913.00 - Phase 05

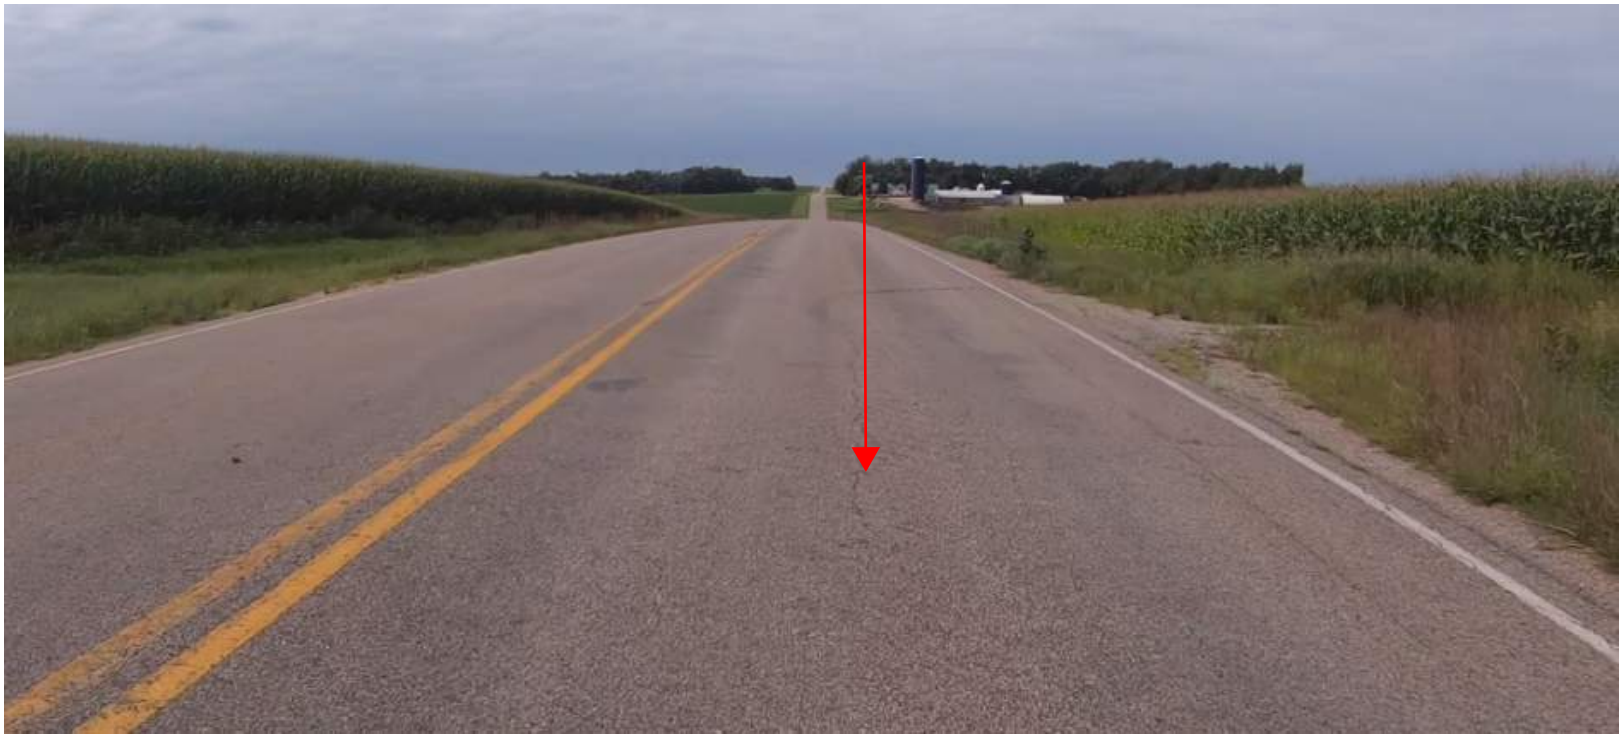
Pre CCR 6 from 462nd to 463rd 0:12 video time

This segment of roadway covers one (1) mile of asphalt roadway, totaling five (5) manual roadway measurement locations. Of the five locations, two (2) showed an increase in rut depth for at least one measurement at that location. The severity of the increased rut depths ranged from 1/8th of an inch to 3/16th of an inch. Banner also completed a visual inspection and assigned a PASER roadway rating to this one-mile stretch of designated haul route. The post-construction visual inspection showed an increase in both frequency and severity of the common asphalt pavement distresses. Cracking was more prevalent on the post construction inspection, particularly additional longitudinal cracks or existing cracks that now are at a higher severity. Flushing and polishing also increased, with it being very evident that heavy loadings has caused oil to migrate to the surface of the asphalt in the wheel paths. This also couples with the aggregate in the wheel paths being worn to a point where there is no angularity left on the aggregates at the surface, creating a very slick and friction-free surface. The post-construction PASER rating assigned to this segment is six (6), which is a decline from the pre-construction PASER rating of seven (7).

Banner has determined that the roadway segment has experienced damages to the extent that the structural integrity of the roadway section has been compromised, including additional and expanded cracking of both longitudinal and transverse types, as well as general roadway wear. Banner is recommending that this segment of roadway be assessed for any specific locations where damages require a full dig out and patching effort, followed by milling 1.5" of the wearing course of asphalt and relaying a 2" wearing course. Any restoration effort short of milling and overlaying would leave Codington County with a roadway that is less structurally sound than what was existing prior to construction.
