**BEFORE THE PUBLIC UTILITIES COMMISSION
OF THE STATE OF SOUTH DAKOTA**

**IN THE MATTER OF THE)
APPLICATION OF CROWNED)
RIDGE WIND, LLC FOR A) EL-19-003
PERMIT OF A WIND ENERGY)
FACILITY IN GRANT)
AND CODINGTON COUNTIES)**

WEEKLY REPORT ON AIRCRAFT DETECTION LIGHT SYSTEM

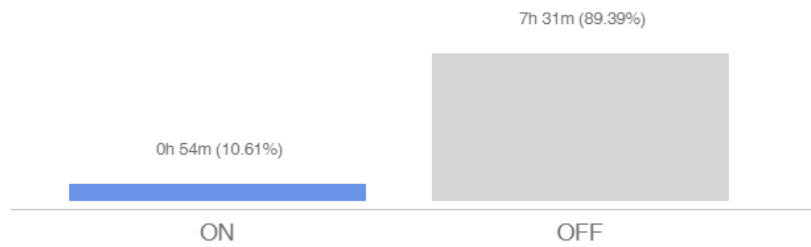
Harrier ADLS Summary

- Lights were OFF for 7h and 31min during the night.
- 46 aircraft detections events were fired during the day (11h and 29min) and 8 during the night (54min).
- 233 aircraft lost events were fired during the day and 13 during the night.
- There were no weather events.
- There were no radar processing failures.
- No Adls failsafe events.
- There were no Database failures.
- No Lights comms tests were performed.
- No comms failures with Adls Manager.

Additionally, redundant automatic reporting has been implemented to provide daily summaries to DeTect staff and to the Crowned Ridge operations site manager. Below is a generic example of the daily summary email generated by the system so that DeTect and Crowned Ridge are provided the current status of the ADLS and how it is performing.
