Fatigue Cracking in Enbridge Pipe Manufactured by U.S. Steel

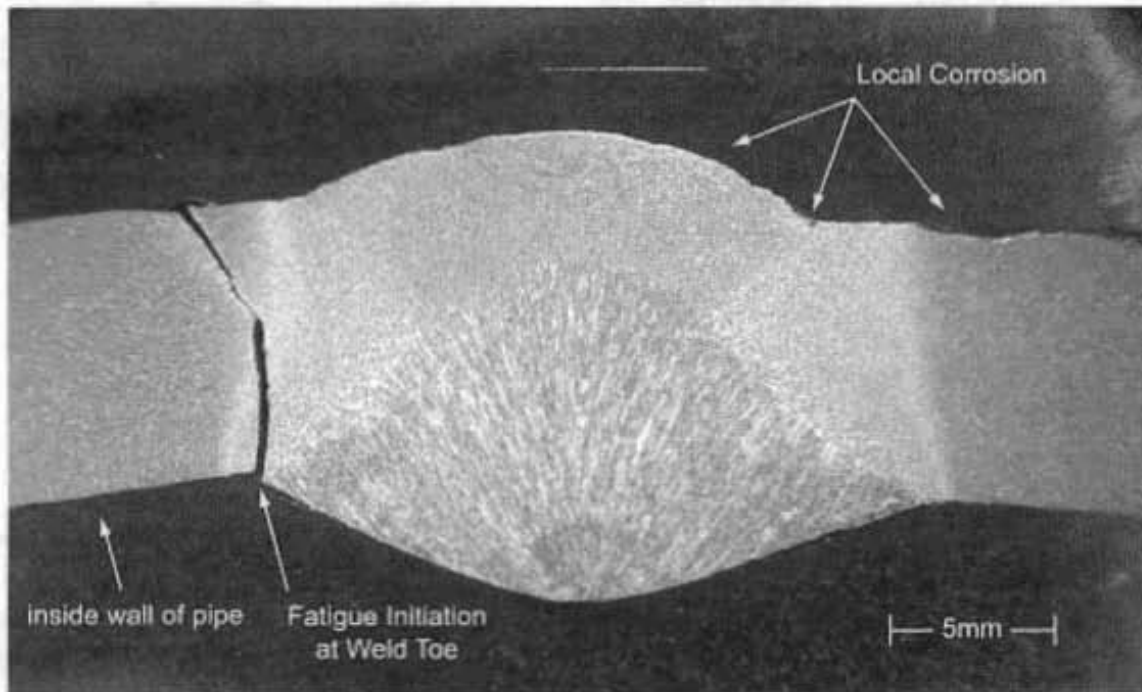
Figure 8. Fatigue initiating at toe of weld on interior surface of pipe.

Enbridge's 34-inch U.S. Steel DSAW pipe had a documented history of longitudinal seam weld failures due to fatigue cracks. Metallurgical analysis reports of longitudinal seam weld failures in Enbridge's U.S. Steel pipe in 1974, 1979, 1982, 1986, 1989, and 1991 identified the causes as fatigue cracking at the toe of the weld. Enbridge's 34-inch pipeline system also used A.O. Smith flash-welded pipe, Canadian Phoenix electric resistance welded pipe, and Kaiser Steel submerged arc welded (SAW) pipe. All of the longitudinal seam weld failures caused by fatigue cracks in this pipeline have occurred in pipe manufactured by U.S. Steel.
