Stork Twin City Testing Corporation

PROJECT NUMBER: SOU263-01-15-91979

VISUAL EXAMINATION

Cracked 2" diameter gas pipe section from PS07-002 Natural Gas Incident, Mitchell, South Dakota

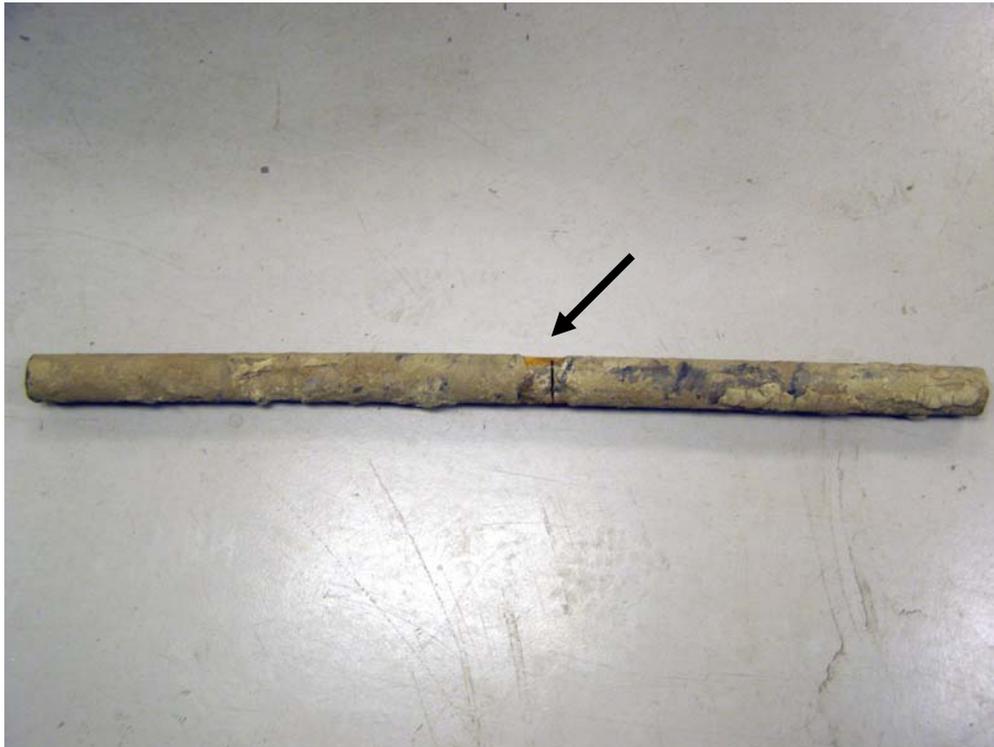
Overall pipe section length-	51" (Figures 1-3)
End identification-	End A adjacent most coating damage End B adjacent least coating damage
Crack location-	28" from End A (Figure 4)
Coating damage location D1-	7" from End A (Figures 5-6)
Coating damage location D2-	13+" from End A (Figures 7-8)
Coating damage location D3-	21" from End A (Figure 9)
Coating condition End B side-	42" from End A (Figure 10)
Pipe surface condition End B side-	No corrosion damage to external pipe surface of 14" section cut for tensile specimen removal. Removal of coating revealed the OD pipe surface was in pristine condition (Figure 11).
Pipe dimensions-	2.278" OD x 0.162" wall (obtained from tensile test coupon). Coating thickness measured 0.150" thick (based on overall outside diameter with sound coating (2.578") minus the measured pipe OD (2.278") divided by 2 wall thicknesses of coating.
Crack measurements-	Crack was reportedly centered on the 6:00 position of the gas line as embedded in the ground. The crack extended three quarters around the pipe circumference leaving a remaining un-cracked ligament of 1-1/2" at the 12:00 position. Maximum measured crack opening was 0.12"-0.13" at the ~6:00 position (Figure 12). Complete crack photos are provided separately under "Visual Examination Photos".

Figure 1: Overall photo of the 51" long pipe section with the crack exposed (arrow).

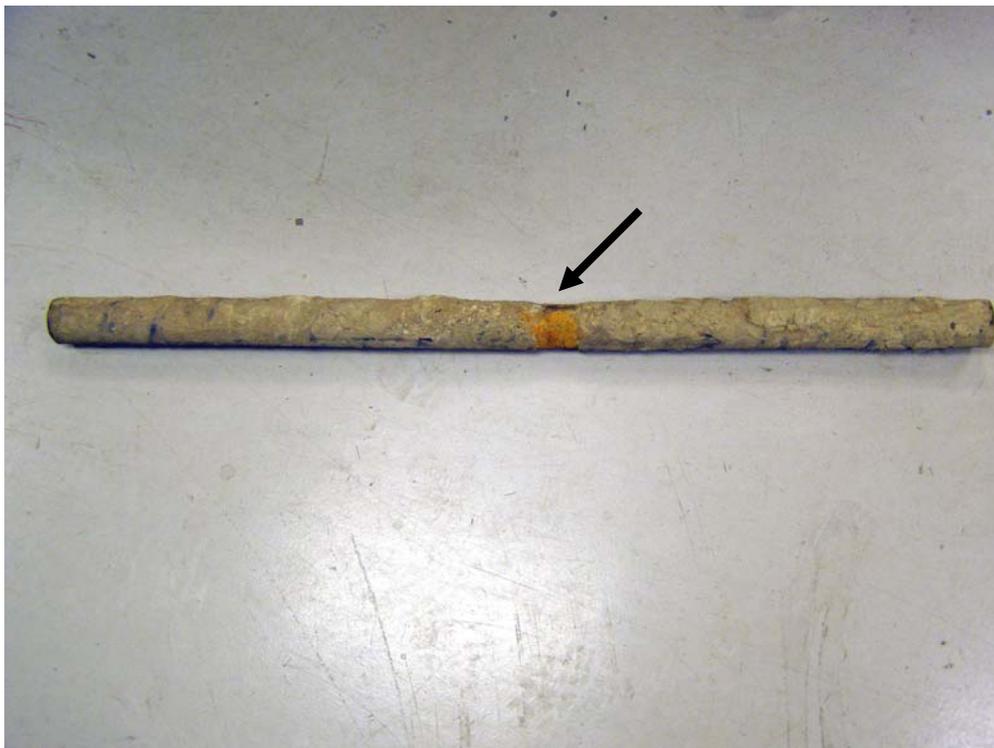
Figure 2: Overall photo of the 51" long pipe section with the crack location rotated (arrow).

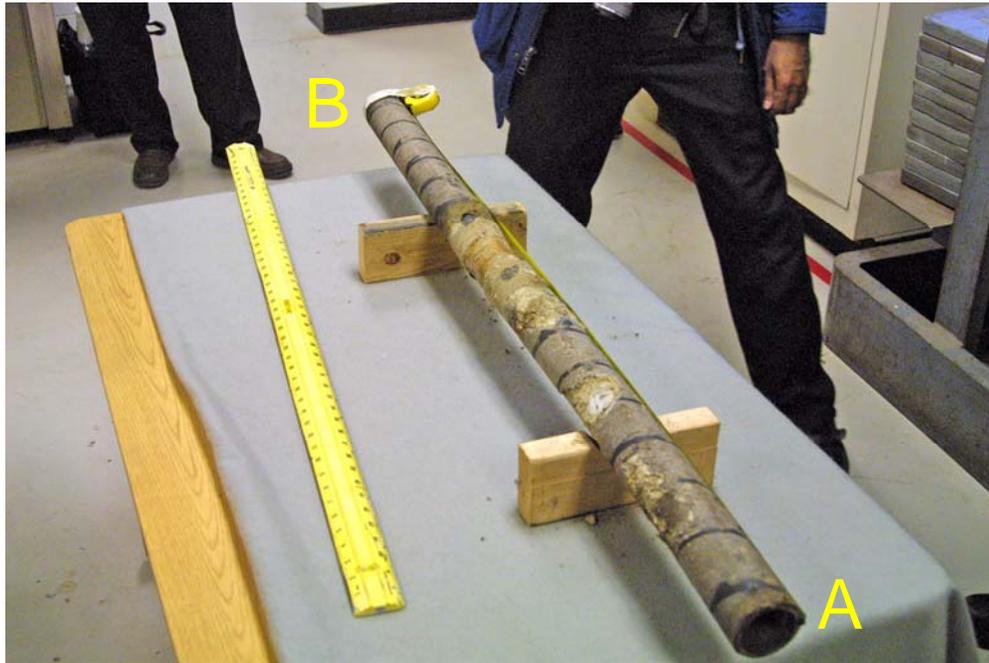
Figure 3: Table set-up for examining the pipe section. The ends are identified as A and B as shown.

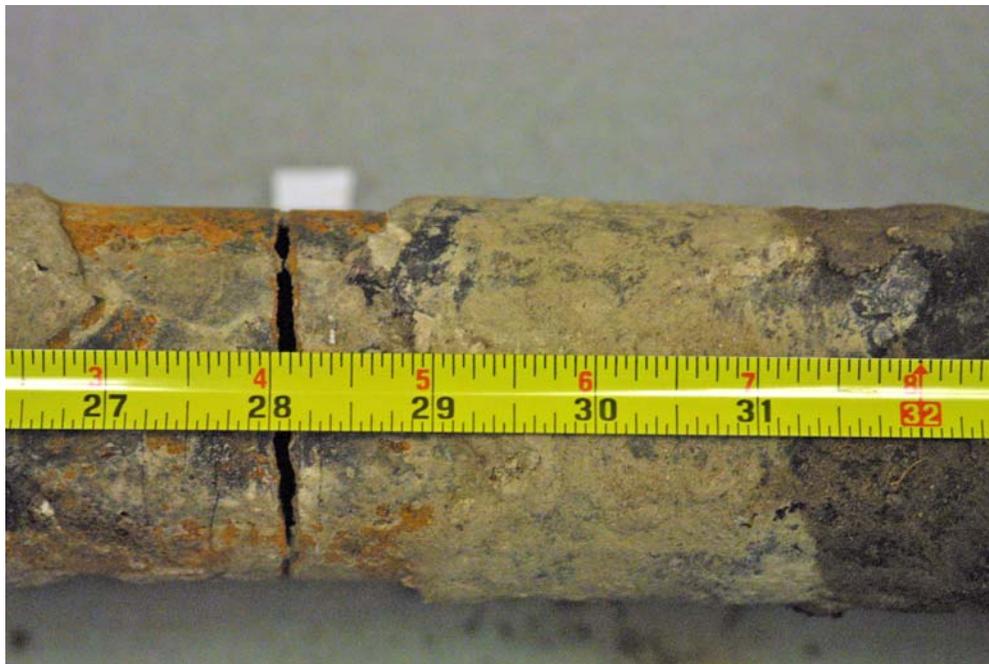
Figure 4: Location of crack 28" from End A.

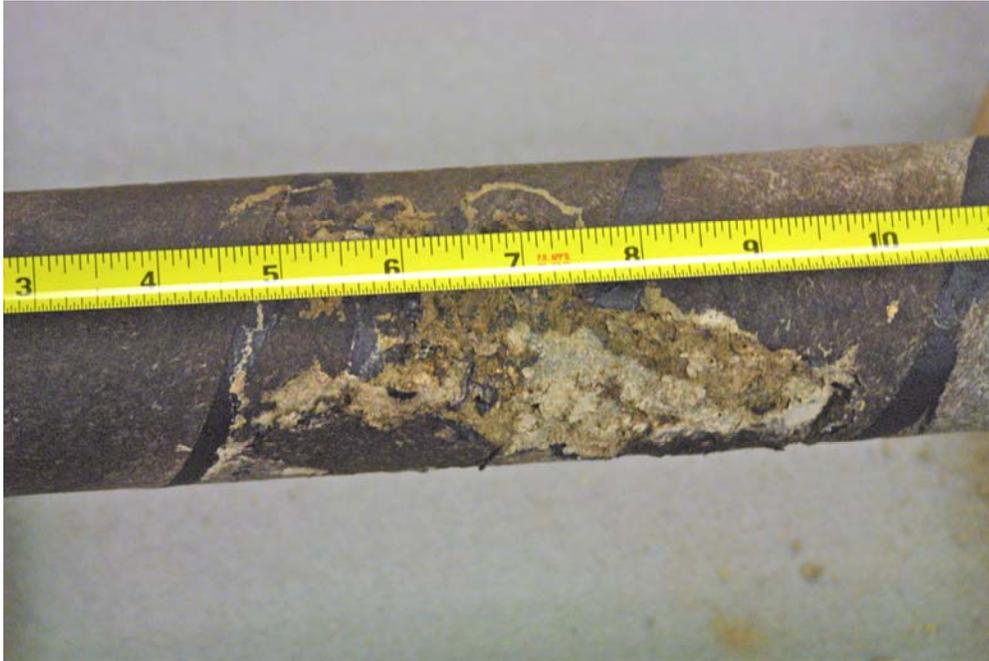
Figure 5: Coating damage 7" from End A (Location D1).

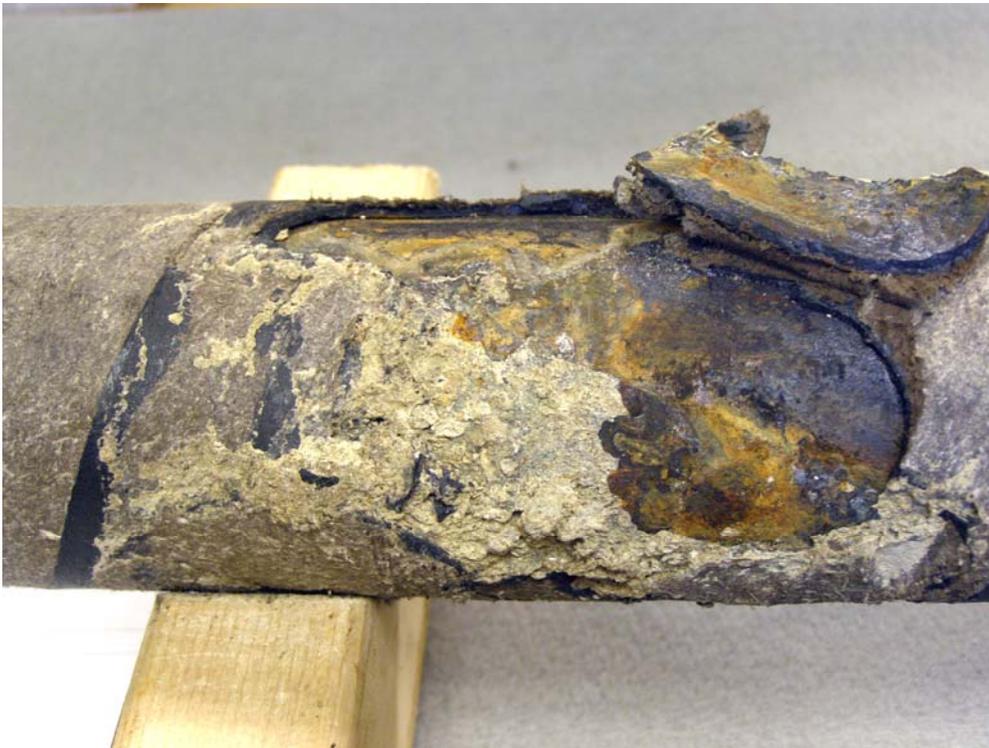
No corrosion apparent on the OD pipe surface where the coating was not damaged (Figure 11). Some rusting but no significant pitting corrosion on the OD pipe surface where the coating was damaged (Figures 6,8 &12). Some rusting but no significant pitting corrosion on the ID pipe surface (Figure 15).

Figure 6: Coating damage and underlying pipe surface 7" from End A (Location D1) after removal of some coating for visual examination.

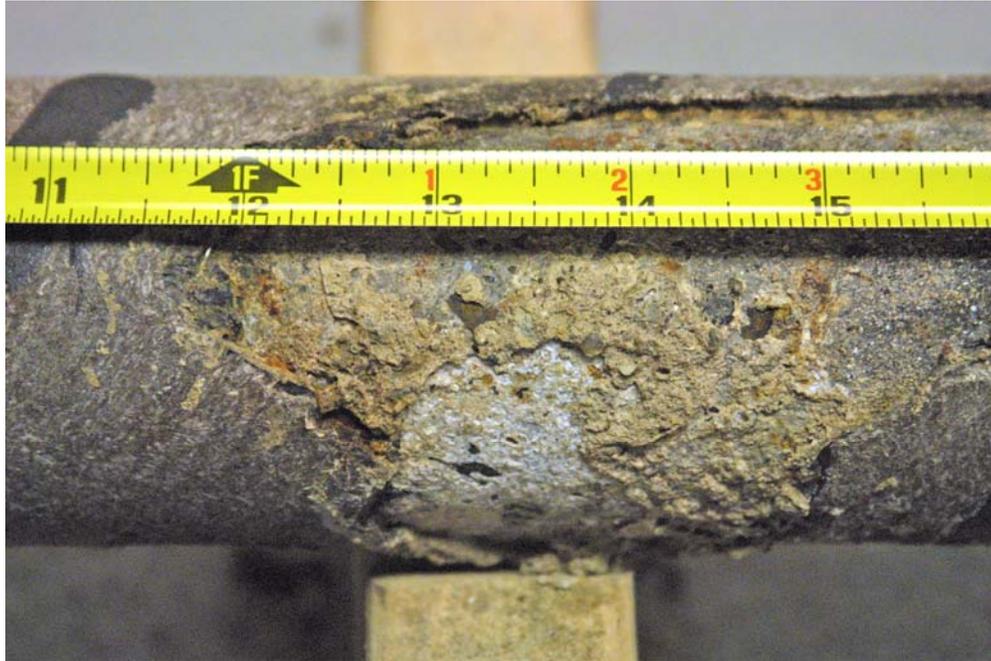
Figure 7: Coating damage 13+" from End A (Location D2).

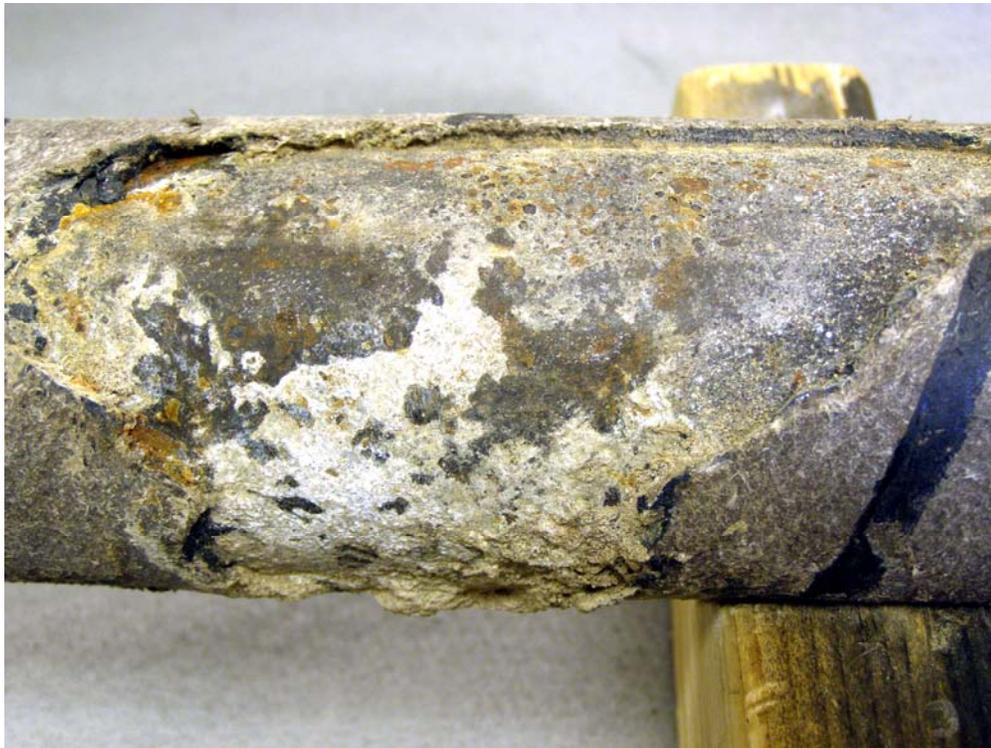
Figure 8: Coating damage and underlying pipe surface 13+" from End A (Location D2) after removal of some coating for visual examination.

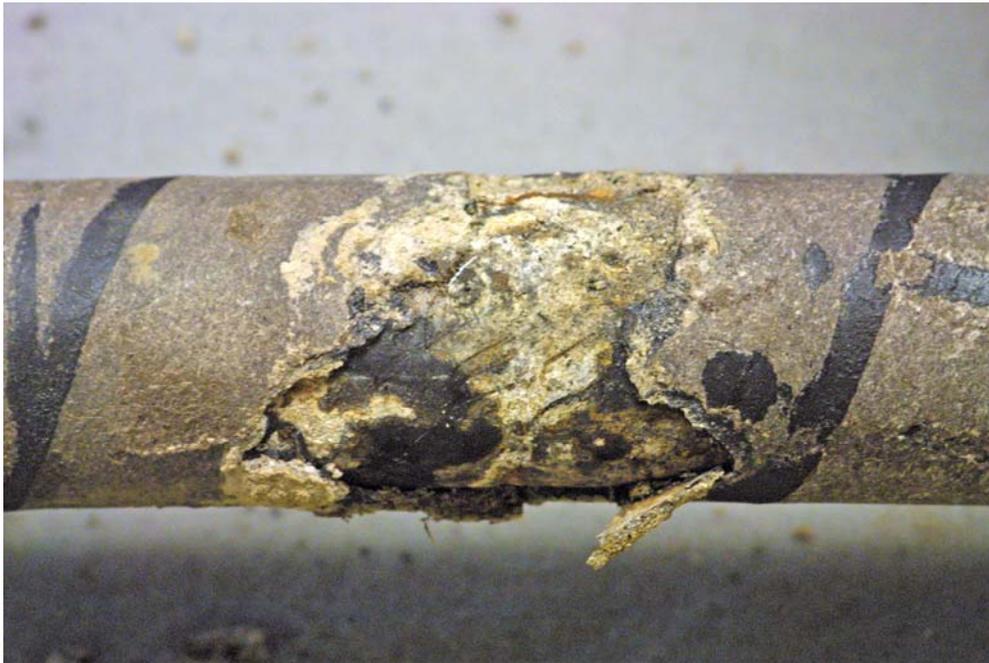
Figure 9: Coating damage 21" from End A (Location D3). Photo reversed for continuity.

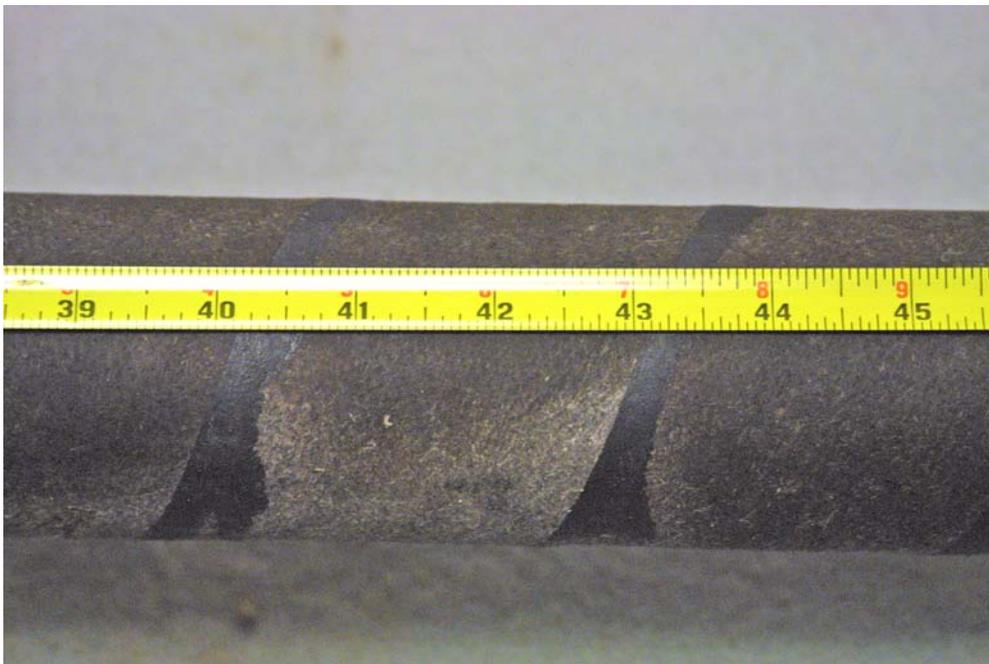
Figure 10: Coating condition 42" from End A showing no apparent damage this point and beyond.

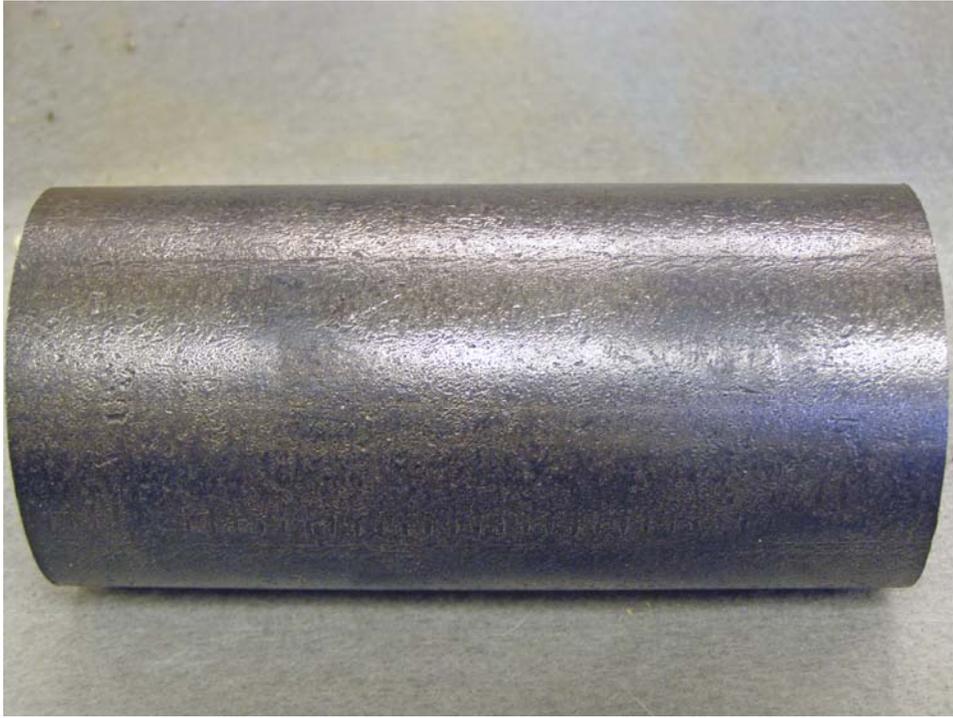
Figure 11: Section of pipe adjacent End B after removal of the coating. Note the pipe OD surface is in pristine condition with no observable corrosion.

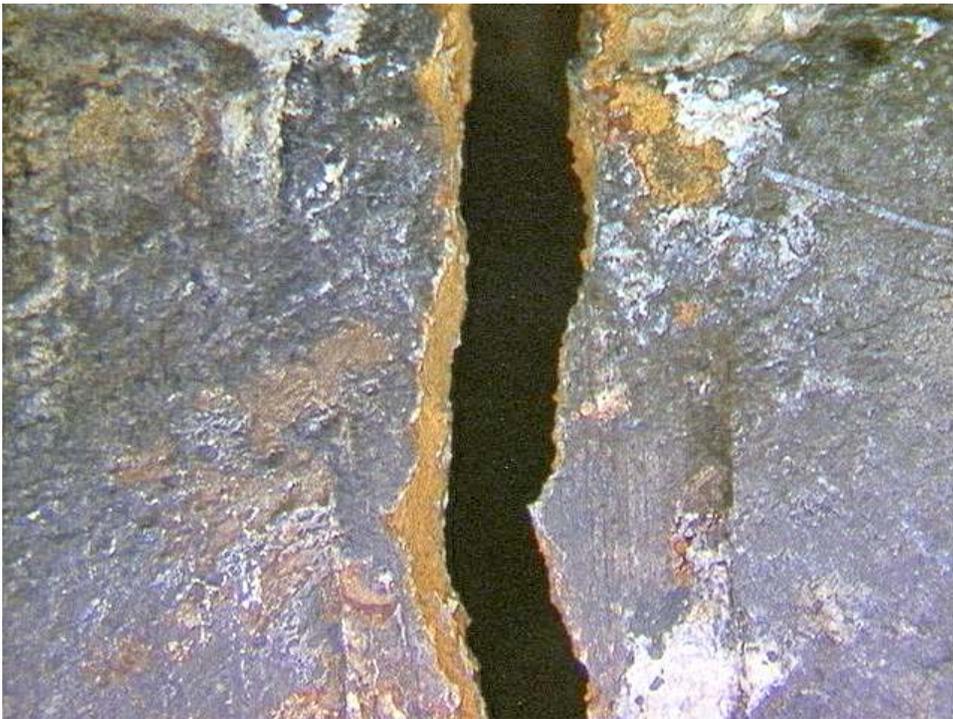
Figure 12: Point of maximum crack opening (6:00 position). Measurements can be made by referring to crack calibration photo provided separately under “Visual Examination Photos”.

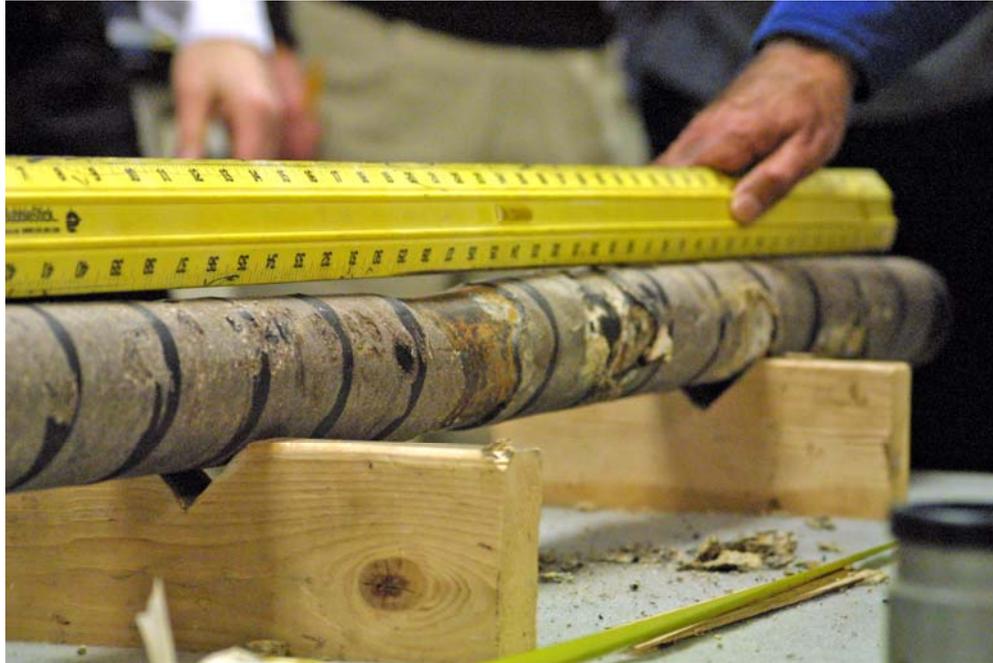
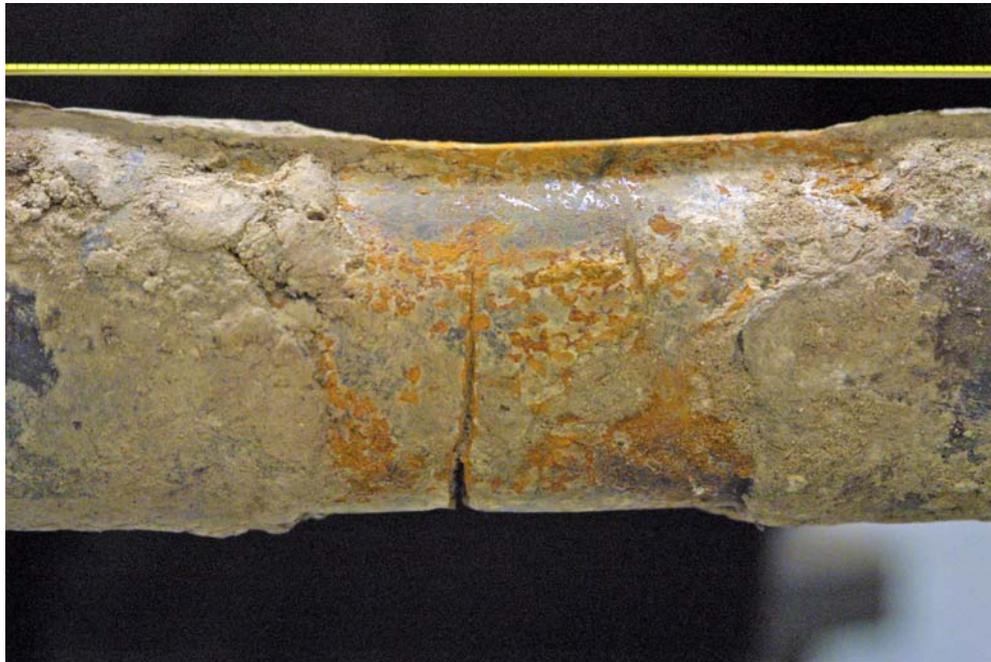
Deflection measurements-	Using a measuring tape as a straight edge, the maximum deflection measures 0.44" from the measuring tape to the bare pipe surface at the crack location (Figures 13-14). Since the straight edge was bearing on sound coating at both support points, the thickness of the coating (0.150") must be subtracted from the maximum deflection measurement of 0.44" to obtain the actual pipe deflection relative to the straight-edge support points. The actual pipe deflection therefore is 0.29".

Figure 13: Isometric view of the pipe deflection with the crack down (6:00 position).

Figure 14: Close-up view of the pipe deflection with the crack down (6:00 position). The maximum deflection measures 0.44" from the measuring tape to the bare pipe surface at the crack location.

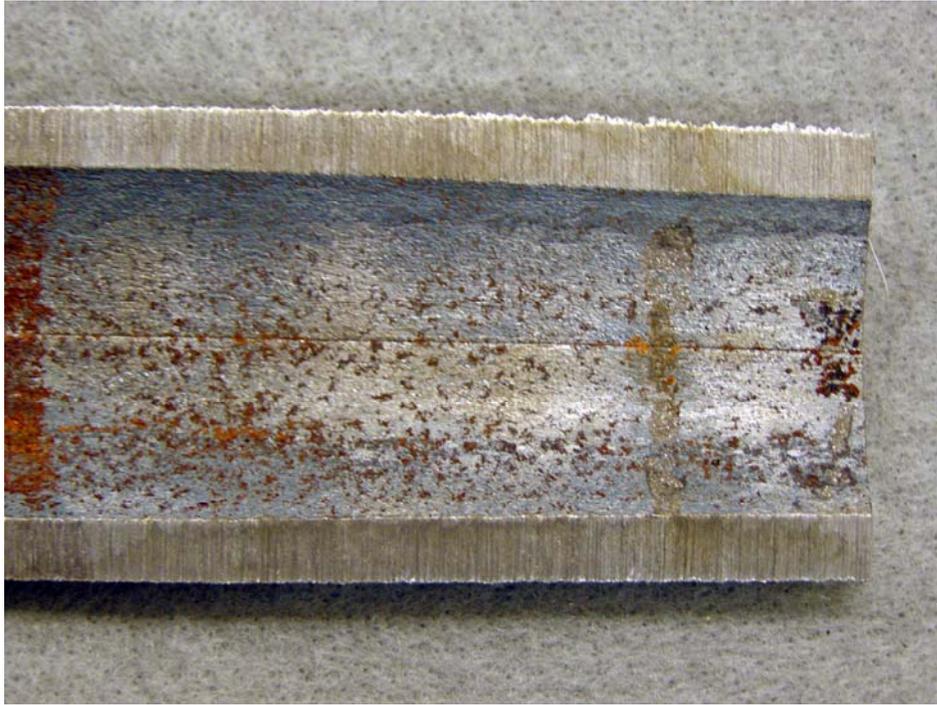
Figure 15: Typical ID surface of pipe after removal of some of the rust. Note the lack of any significant pitting corrosion.

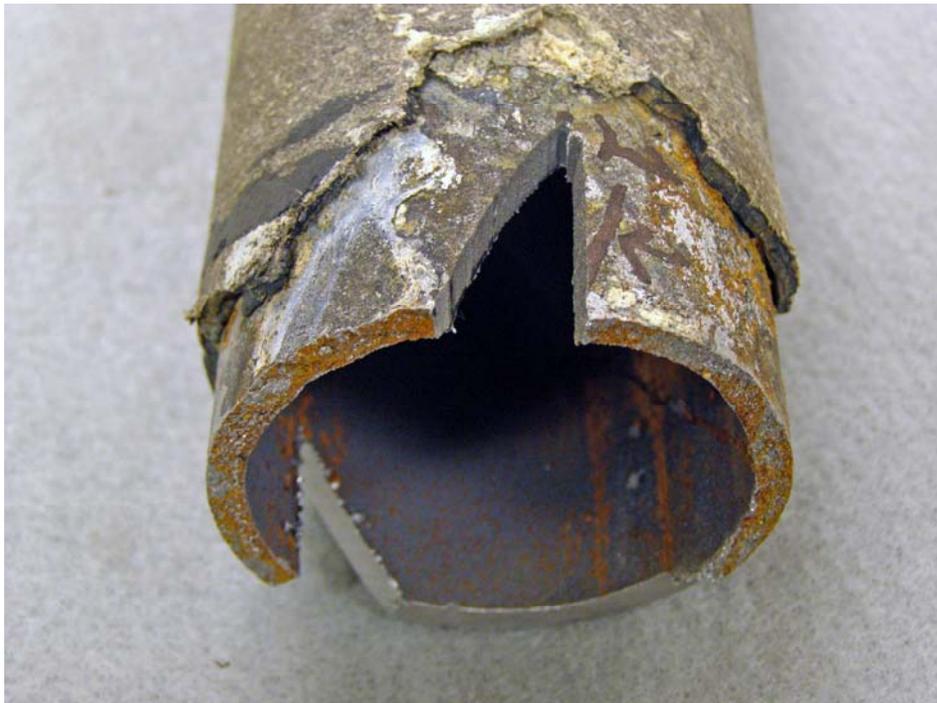
No significant corrosion associated with the fracture (Figure 16). No necking down or stretching at the fracture edge (Figure 17). The fracture surface was cleaned with ammonium citrate solution combined with ultrasonic cleaning, but the rust could not be completely removed. The fracture surfaces will be preserved pending future SEM examination. A groove was observed adjacent to the fracture at the point of maximum crack opening. This groove is shown in Figures 17-18, and is described more completely in the **GRAIN STRUCTURE EXAMINATION**.

Figure 16: Failed end of the gas pipe section after separation of crack surfaces. Note the two pie-shaped sections cut and mounted for grain structure examination. Also note the lack of any significant pitting corrosion associated with the fracture.

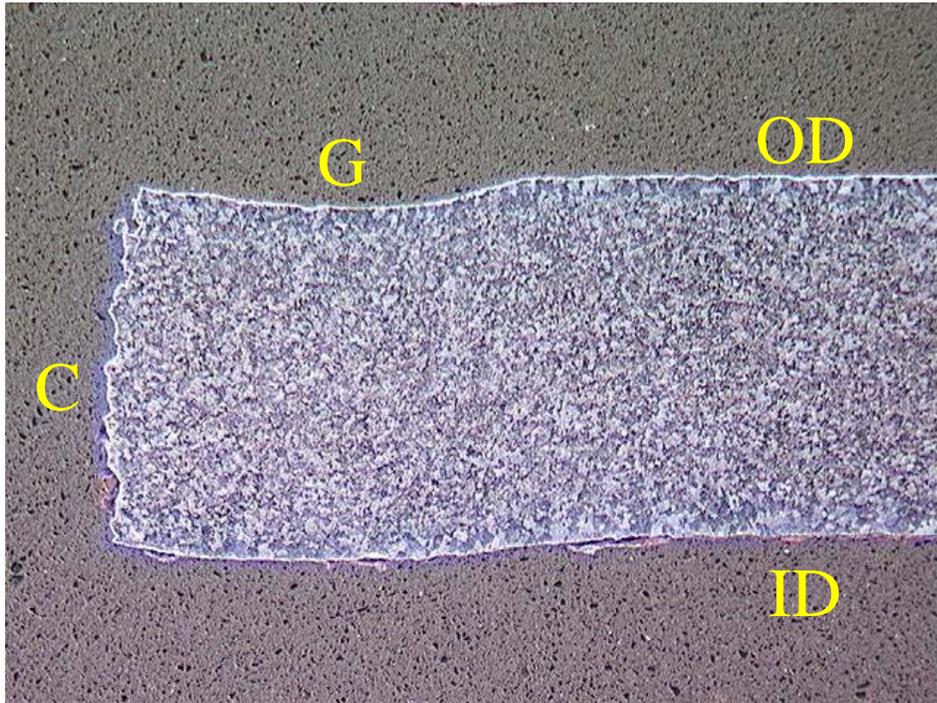
Figure 17: Cross section of pipe wall thickness through the groove (G) adjacent to the crack surface (C). The outside diameter (OD) and inside diameter (ID) of the pipe section are as shown. Mag. 11.8X

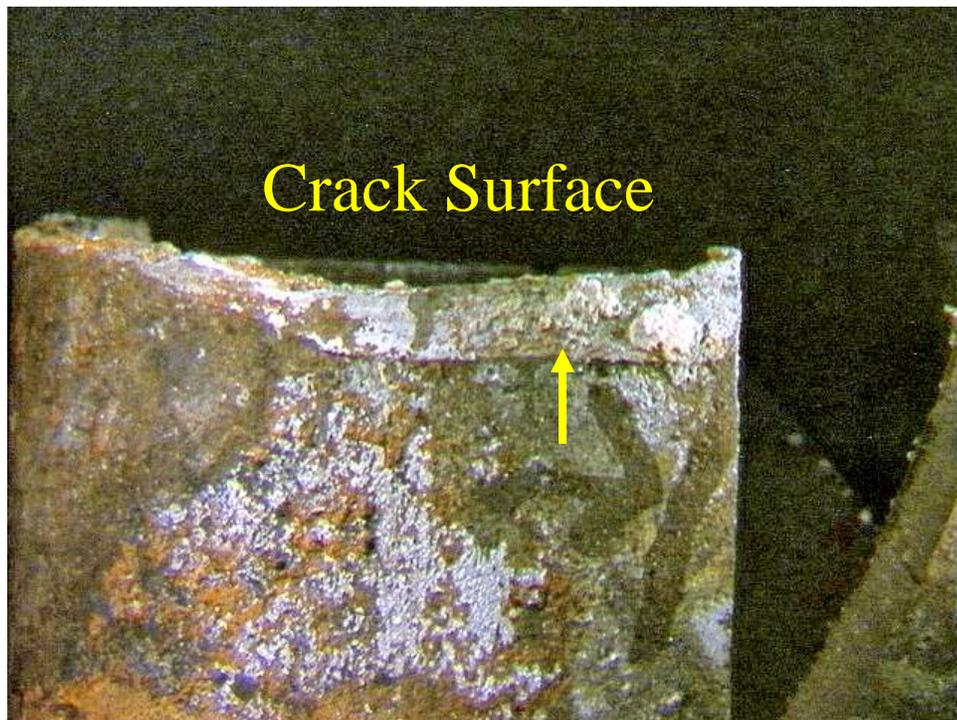
Figure 18: Close-up photo of the groove (arrow) adjacent to the crack surface at the point of maximum crack opening. Magnification 2.8X
