Re: PS07-002

## Investigation of the Natural Gas Pipeline Incident of March 8, 2007, in Mitchell South Dakota

John F. Kiefner, Ph. D., PE.

February 22, 2008

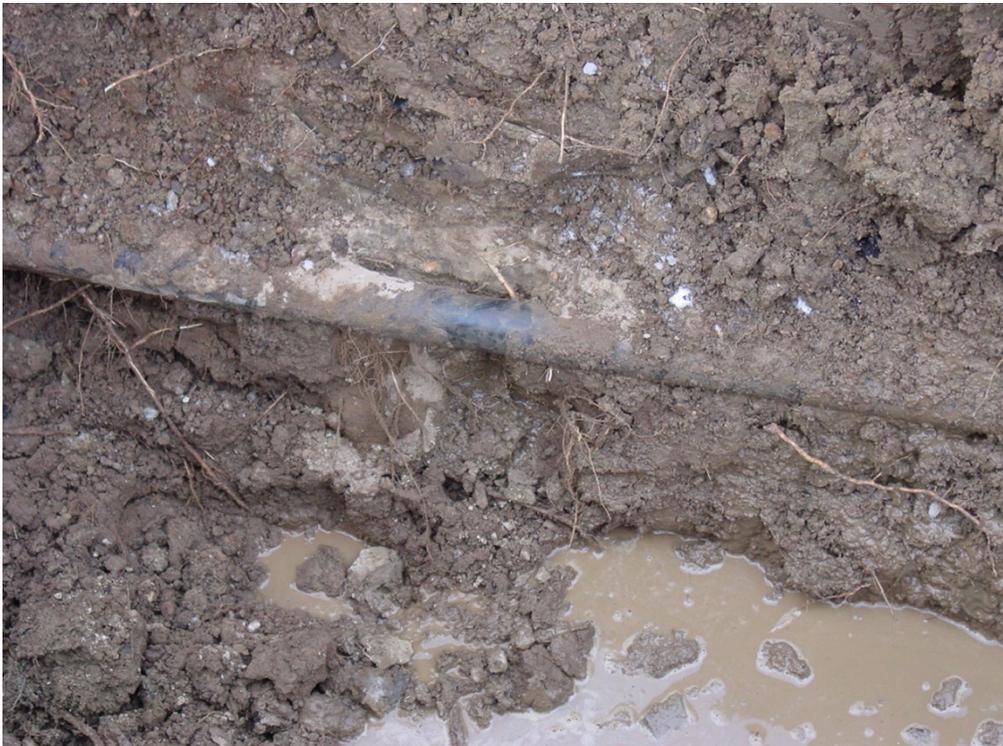
**Figure 1. Pipe as initially exposed after the incident**

The dark-colored area in the center corresponds to the location of the leak. Upon removal of the piece containing the leak, it was found that the pipe contained a circumferentially oriented crack as shown in Figure 2. The crack is not visible in Figure 1 because it was located on the bottom portion of the pipe.

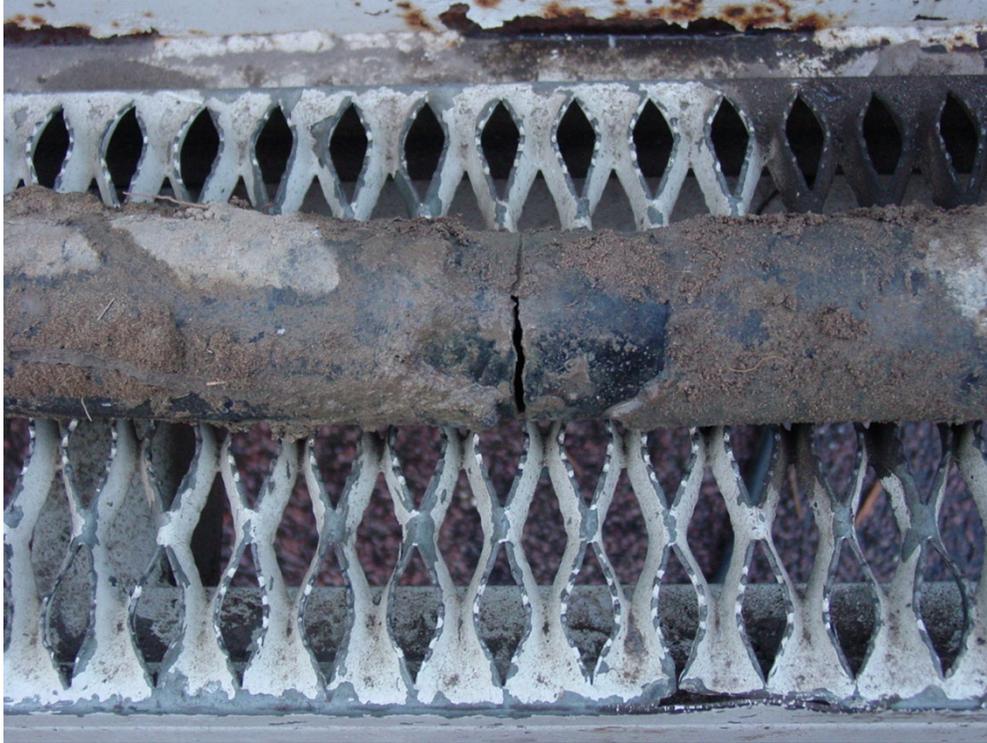
**Figure 2. Circumferentially oriented crack in the pipe**

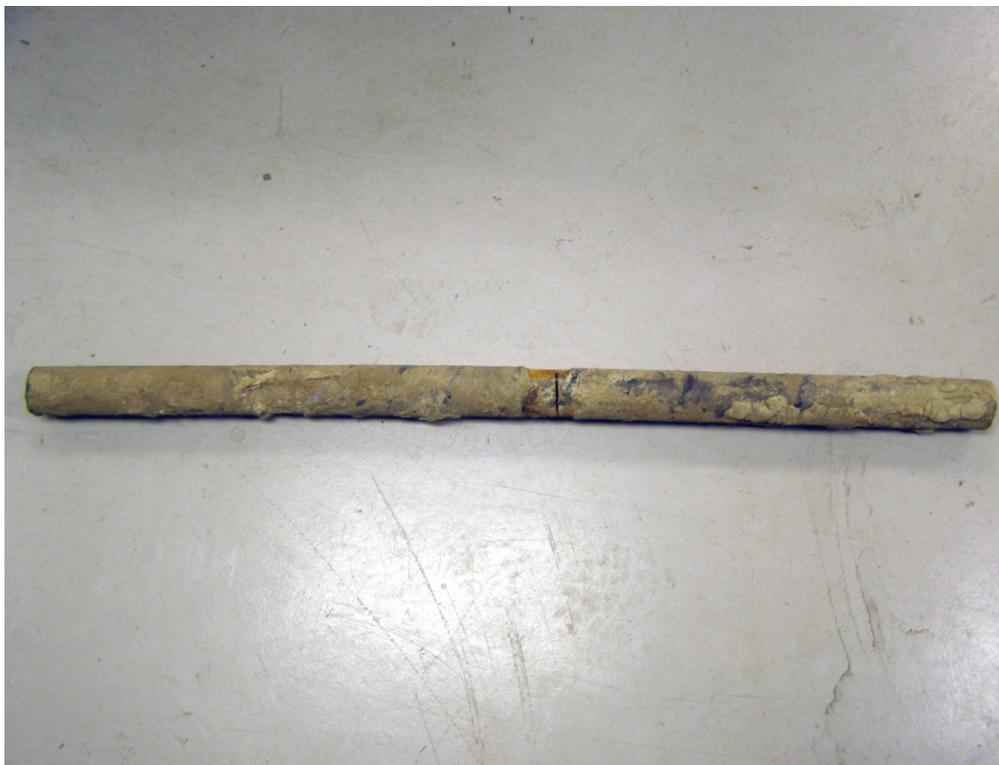
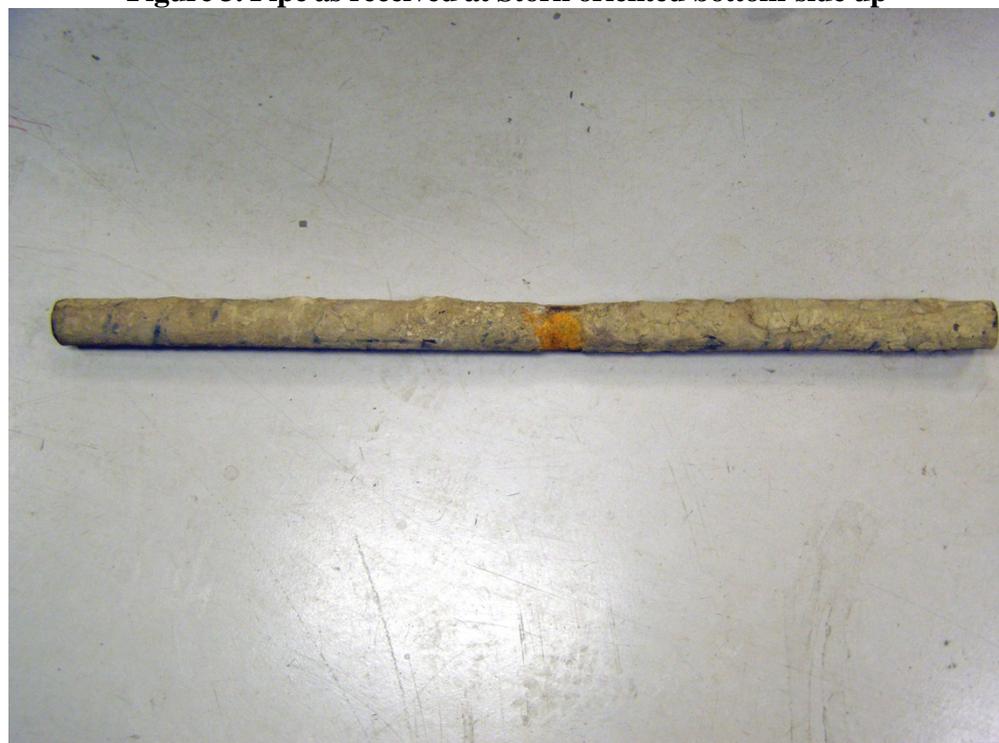
**Figure 3. Pipe as received at Stork oriented bottom-side up**

**Figure 4. Pipe as received at Stork oriented top-side up**

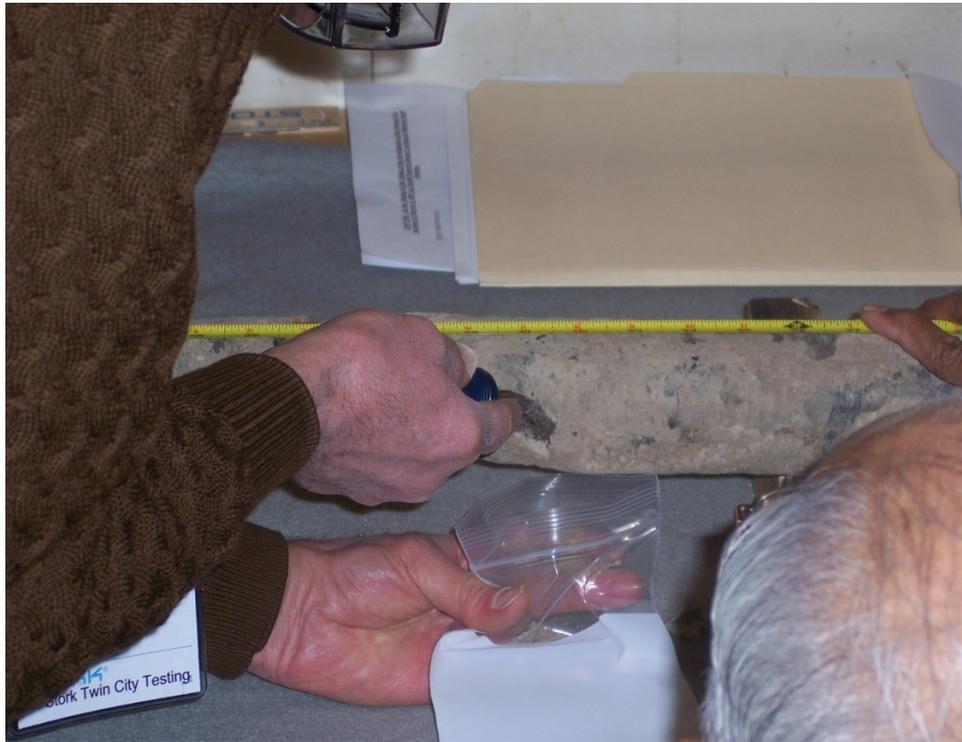
**Figure 5. Illustration of sampling of coating and deposits that was done at eight locations along the pipe**

The samples were removed from the side of the pipe in most cases as shown in Figure 5, and the samples and locations are as shown below. Qualitative analyses of these samples were carried out with energy dispersive spectrometry (EDS) in conjunction with a scanning electron microscope (SEM). The results of the EDS analyses are presented in Appendix C.

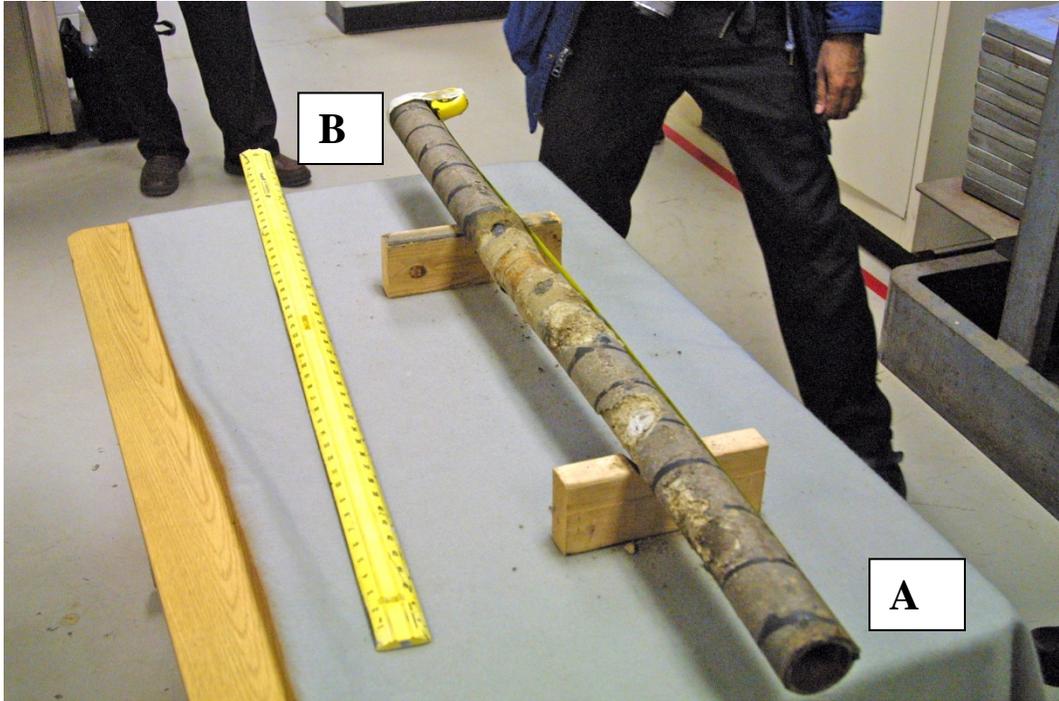
After the samples had been collected, most of the soil was removed from the pipe by means of water and a soft brush. The pipe at this stage is shown in Figure 6 and the crack is shown in Figure 7. The maximum crack opening was determined to be about 0.12 inch (at the 6 o'clock position). The total circumferential extent of the crack was found to be 5-3/4 inches leaving an uncracked ligament of 1-3/4 inch. Assuming that the opening would be diamond-shaped if the pipe were to be laid out flat, one calculates a total crack-opening area of 0.345 square inches.

**Figure 6. Piece of pipe after removal of most of the soil. Note that ends are labeled A and B and that the measuring tape is aligned with the top (12 o'clock position) of the pipe in service.**

As seen in Figure 6 the coating was applied in a helical pattern highlighted by the black strip of coal tar enamel. The gray-colored portion of the coating is a fiber-wrap material that was impregnated with coal tar enamel. The coating was found to be in good condition except in the immediate area of the crack where the coating was missing and except for three other areas where disbonding of the coating had occurred. These three areas were located at roughly the 7 o'clock to 9 o'clock position when the pipe was in service looking from End A, and they were spaced roughly at distances of 7, 13, and 21 inches from End A. These three areas are shown in Figures 8 through 10.

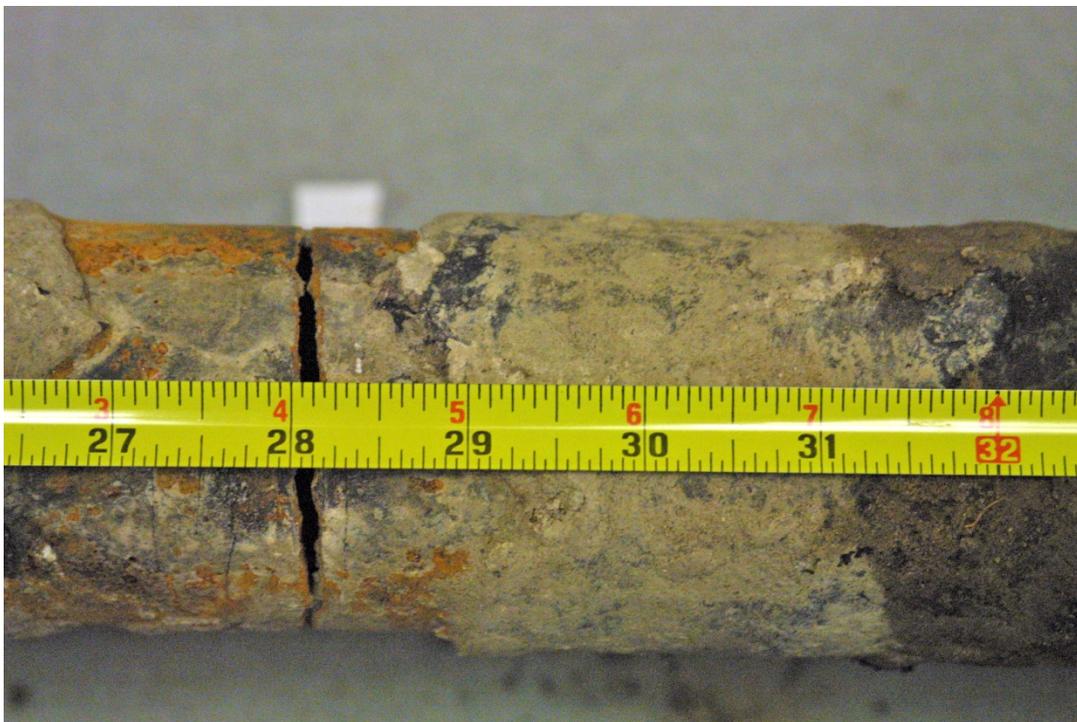
**Figure 7. Circumferentially oriented crack located 28 inches from End A. The measuring tape in this photo is aligned with the bottom (6 o'clock position) of the pipe in service.**

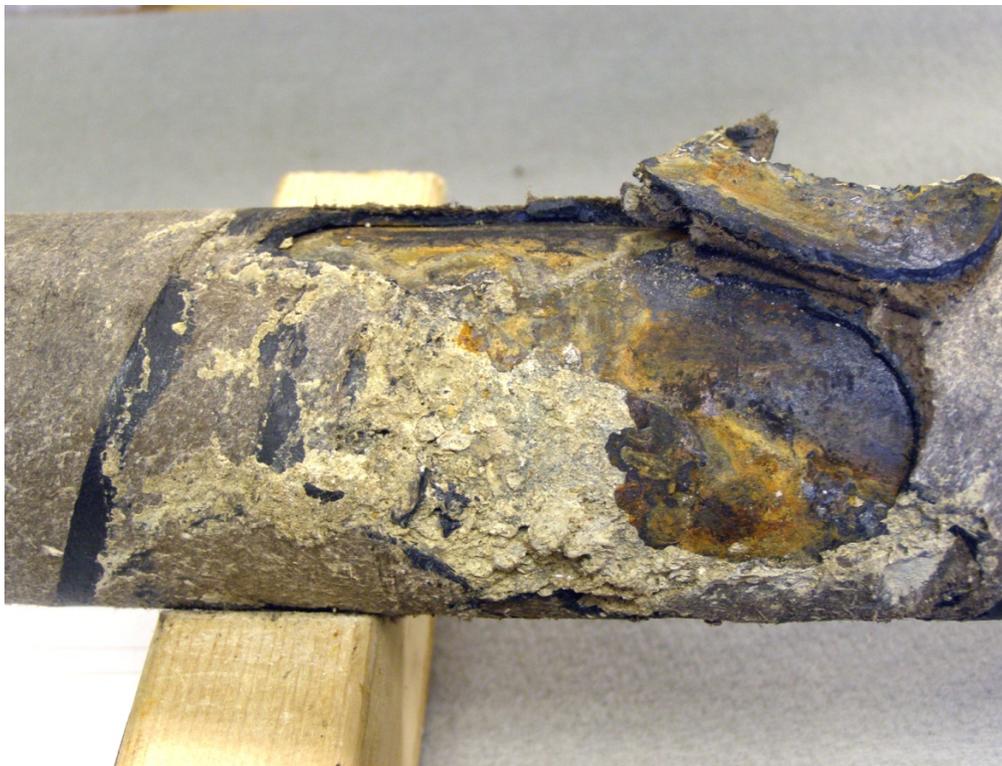
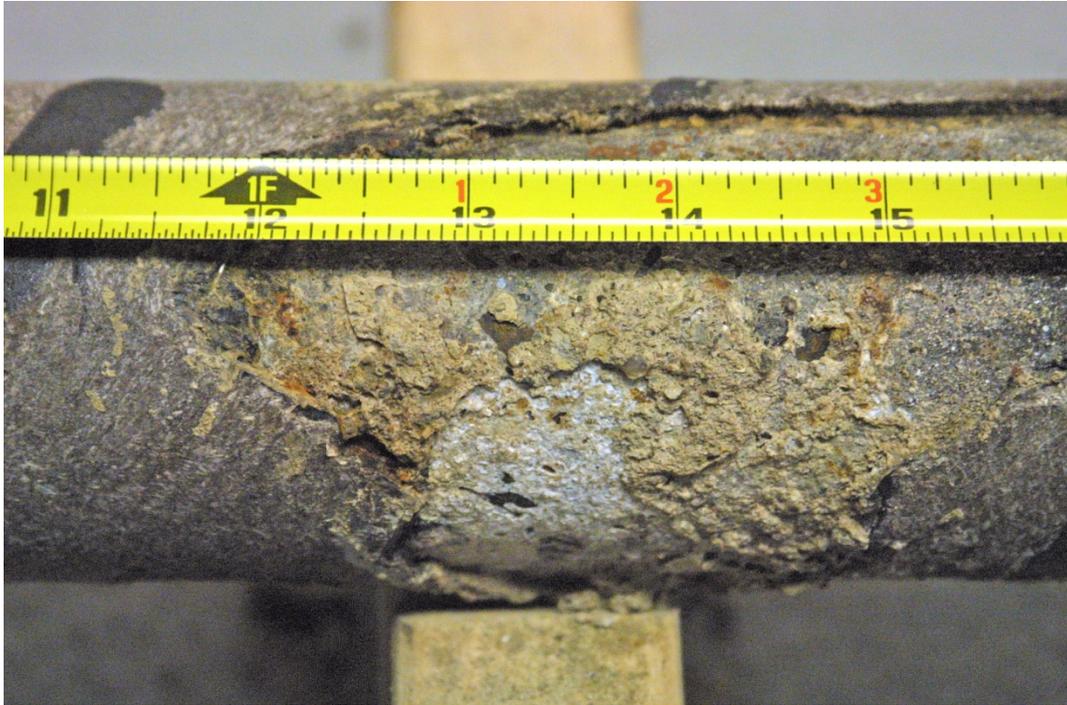
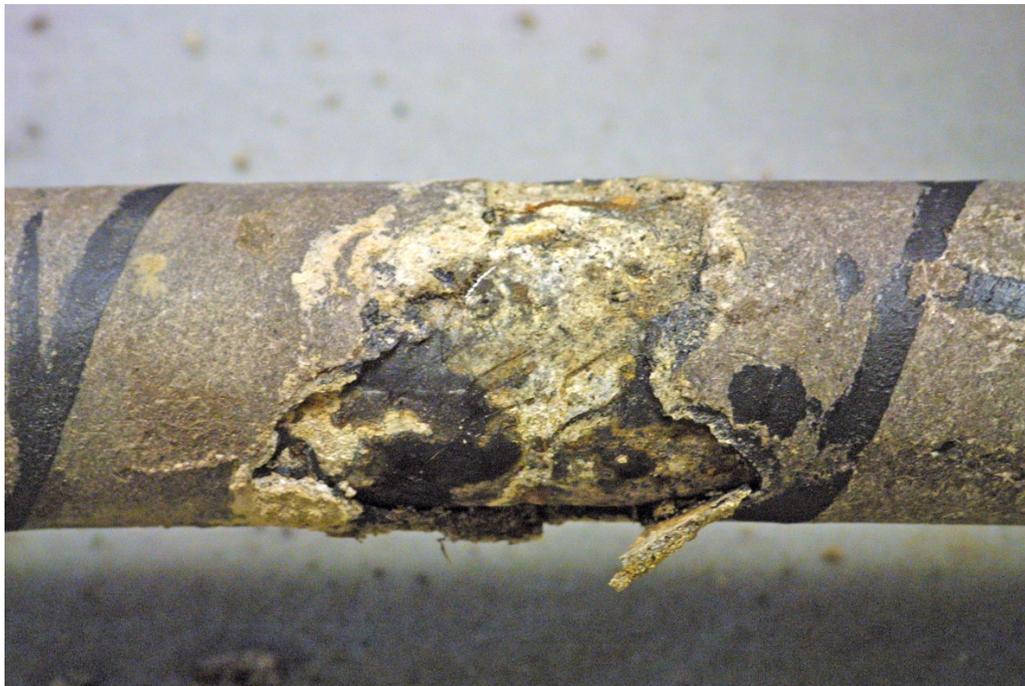
**Figure 8. Disbonded area, side of pipe, located about 7 inches from End A**

**Figure 9. Disbonded area, side of pipe, located about 13 inches from End A**

**Figure 10. Disbonded area, side to bottom of pipe, located about 21 inches from End A**

As seen in the photographs these areas were mostly covered with a hard white deposit the removal of which required scraping with a screwdriver blade. As shown in Figure 11, additional coating disbondment had occurred in the vicinity of the crack, although the some of the coating was still intact. The boundary of the intact but disbonded coating is characterized by a hard white deposit as well.

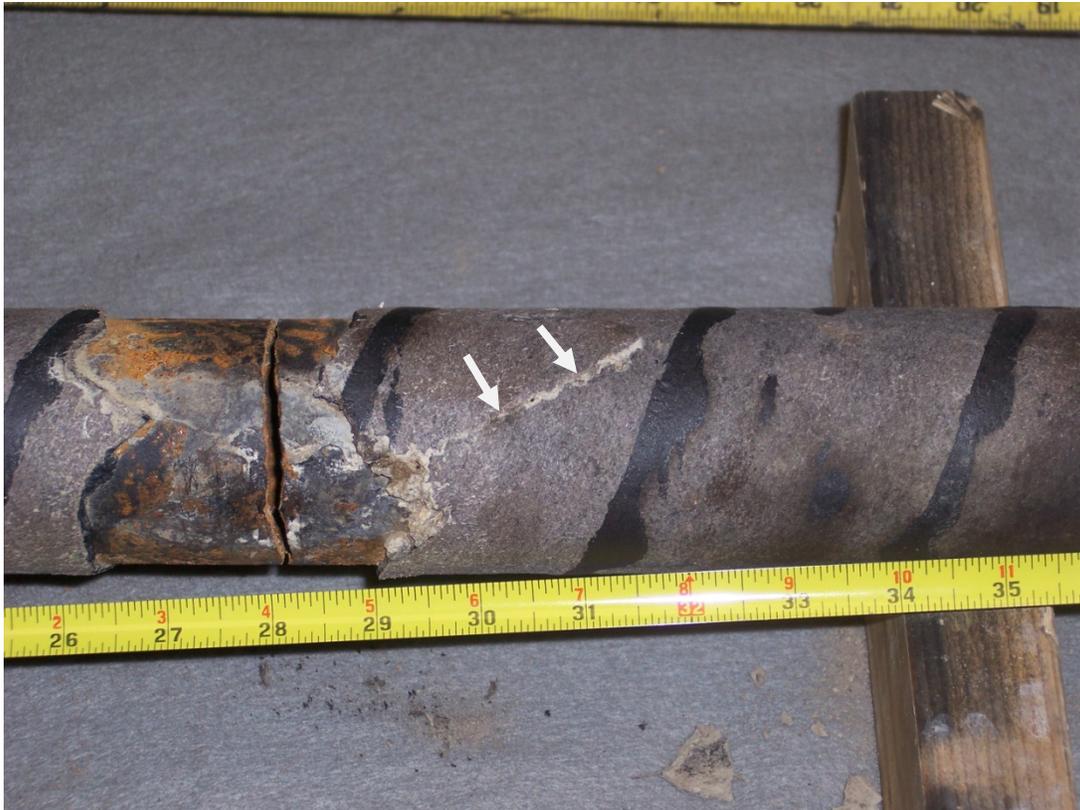
**Figure 11. Disbonded area near crack where coating remained intact. The boundary of the disbonded area is characterized by a white deposit (denoted by arrows).**

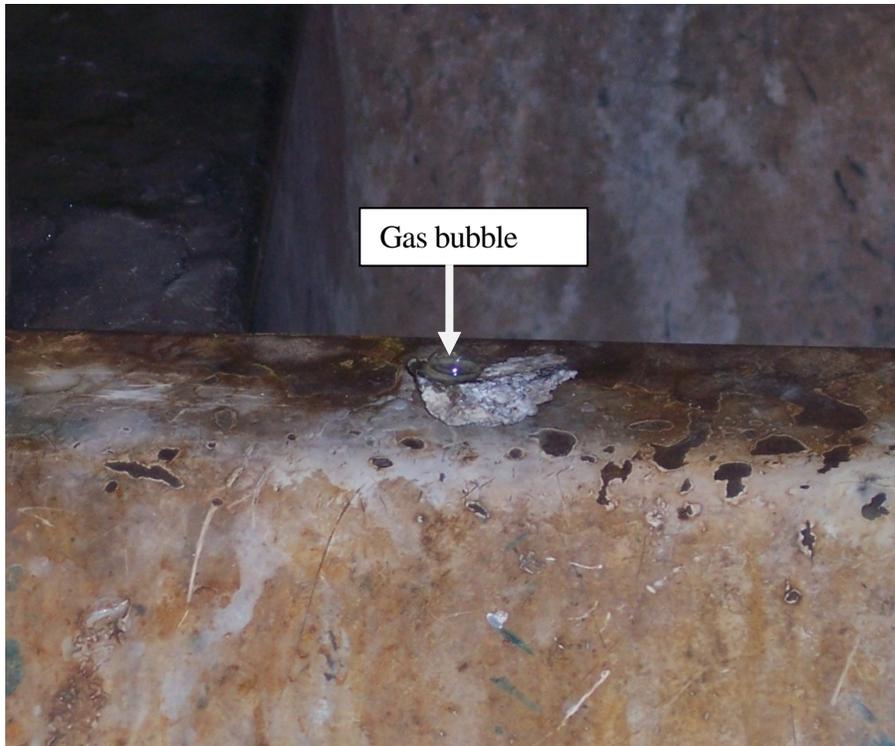
A sample of the white deposit was moistened with dilute hydrochloric acid. As shown in Figure 12, the acid caused effervescence indicating the probable release of carbon dioxide from the deposit.

**Figure 12. Effervescence of white deposit when treated with dilute HCl.**

Samples 2 and 7 were taken primarily from the hard, white-colored deposits associated with areas of coating disbondment. Along with the characteristic peaks of the previously discussed samples, these two samples show strong peaks for calcium which would be consistent with the calcareous deposits (mostly calcium carbonate,  $\text{CaCO}_3$ ) often associated with cathodically protected metal surfaces exposed to soil-ground water environments. These deposits characteristically effervesce  $\text{CO}_2$  when treated with dilute hydrochloric acid. Such effervescence was demonstrated as shown previously in Figure 12.

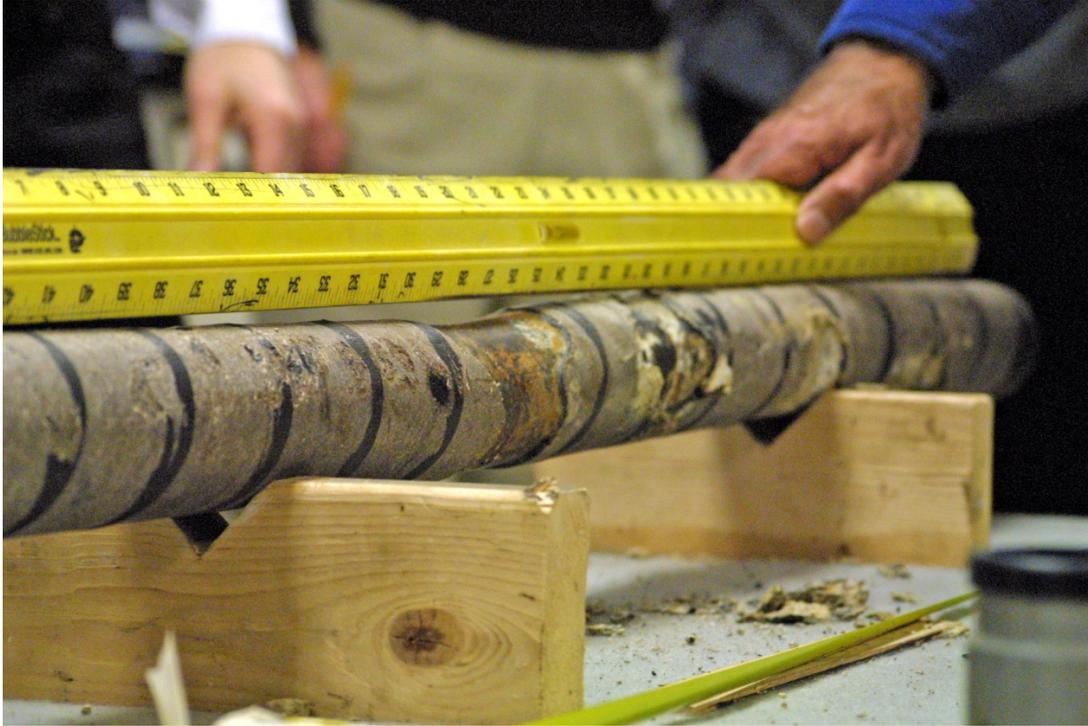
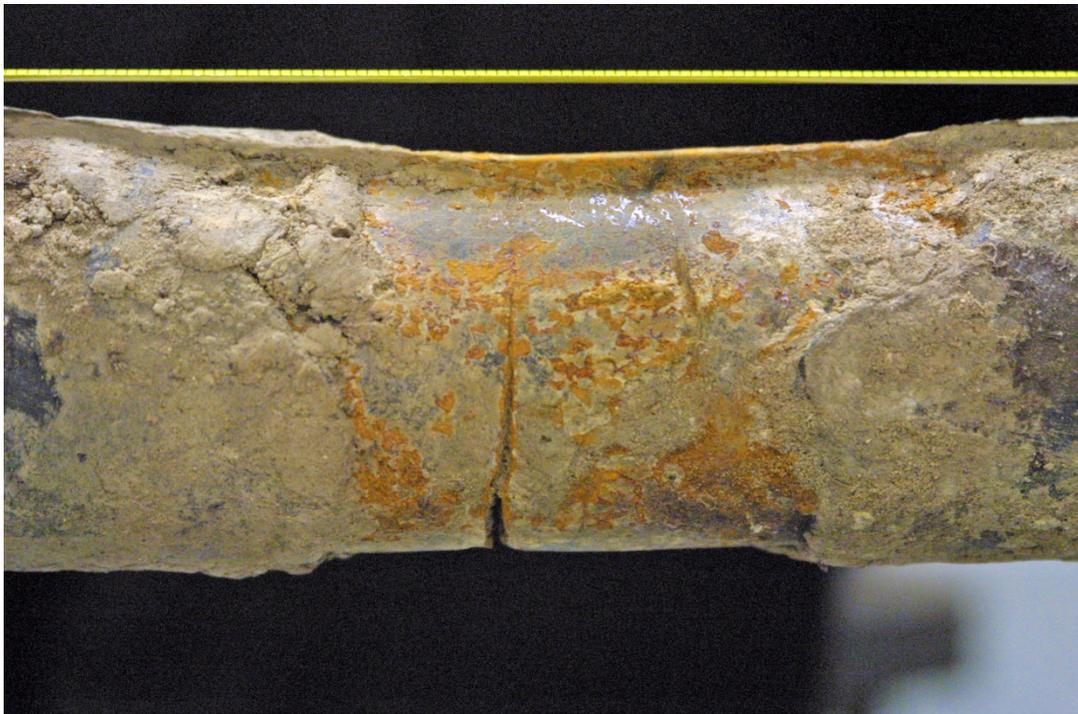
The fifty-one inch piece of pipe was clearly not straight. The deviation from straightness is somewhat evident in Figures 3 and 4, but it became obvious when the pipe was compared to a straight-edge as illustrated in Figures 13 and 14.

**Figure 13. Deviation from straightness looking toward End A**

**Figure 14. Maximum deviation from straight-edge bearing on coated portions of the pipe**

As these photographs indicate, the pipe appears to have the greatest deflection at the region of the crack. It is deflected downward relative to a straight-line position in service. Subtracting the thickness of the coating (0.15 inch) from the measured maximum deflection of 0.44 inch one finds that the deflection from straight is 0.29 inch. Note that the pipe appears to be straight between the region of the crack and End B though deflected downward from End B. In contrast, the pipe appears to be rather abruptly curved just beyond the cracked region looking toward End A in Figure 13.

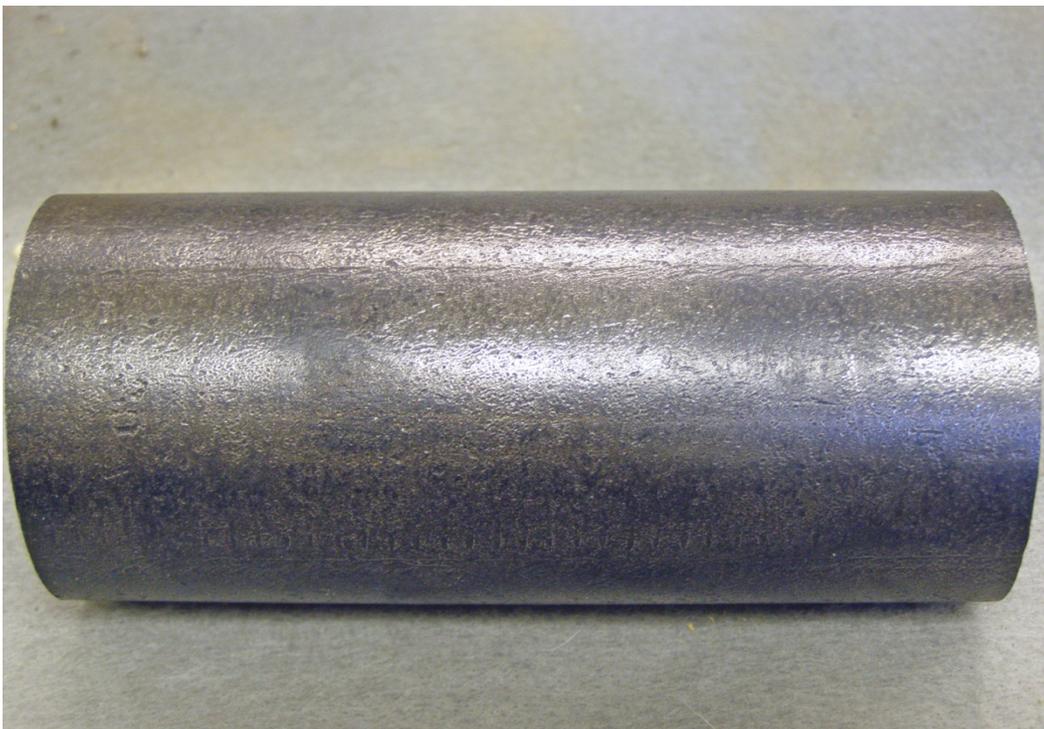
Upon removal of intact coating the pipe metal was observed to be in like-new condition as seen in Figure 15.

**Figure 15. Representative appearance of pipe in areas where coating was intact before being removed.**

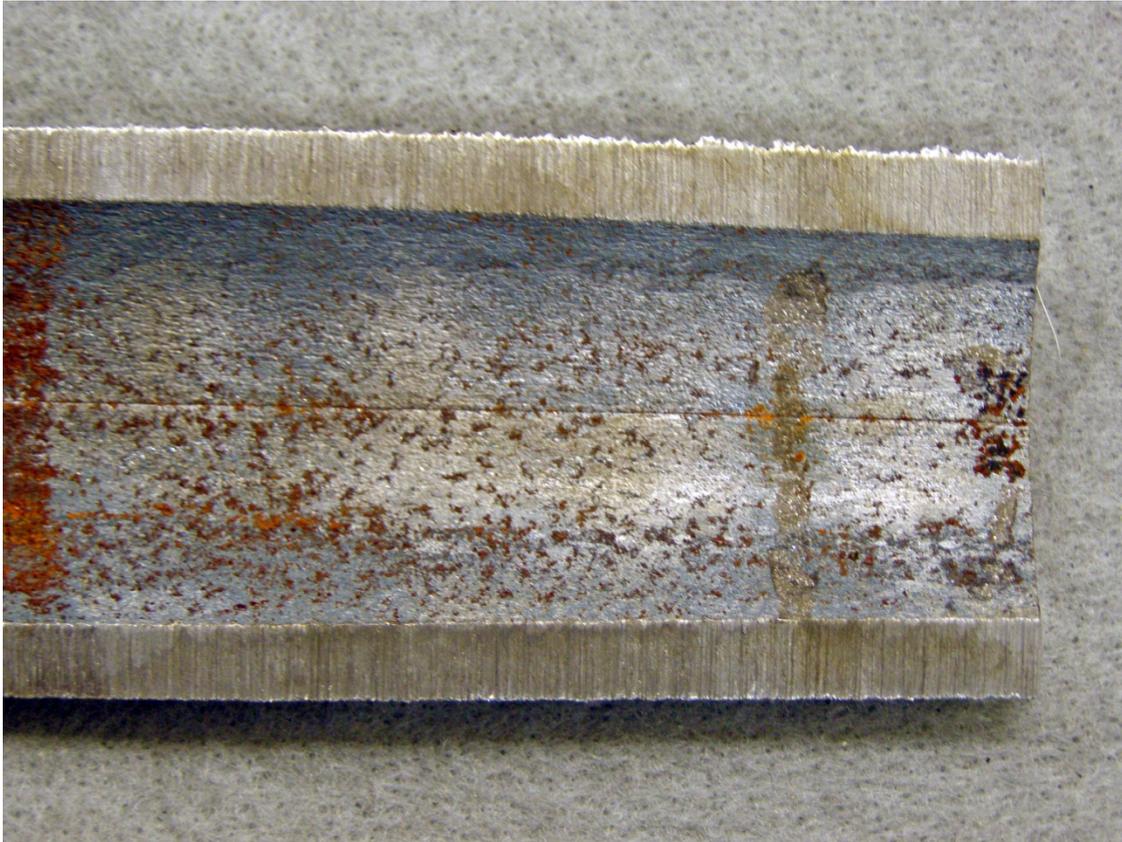
**Figure 16. Score mark visible at ID surface that corresponded to butt-welded seam**

It was thought that this score mark might correspond to the location of a seam weld. Indeed that turned out to be the case. At that location in the ring, a distinct difference in microstructure characterized by reduced pearlite relative to the parent metal was evident. The appearance of the microstructure suggests that the pipe is furnace butt-weld pipe. Furnace butt-welded pipe, a now obsolete product, was made by heating a 20-foot-long flat strip of pipe “skelp” to welding temperature and pulling the skelp through a circular die called a “welding bell”. The weld is formed by mechanical pressure between the forced-together edges of the skelp. No filler metal was required. A similar product called continuous welded pipe is still made today though the

process has been modernized to allow the use of coil stock rather than flat individual pieces. It should be noted that the butt weld in the subject pipe was of excellent quality and contained no defects.

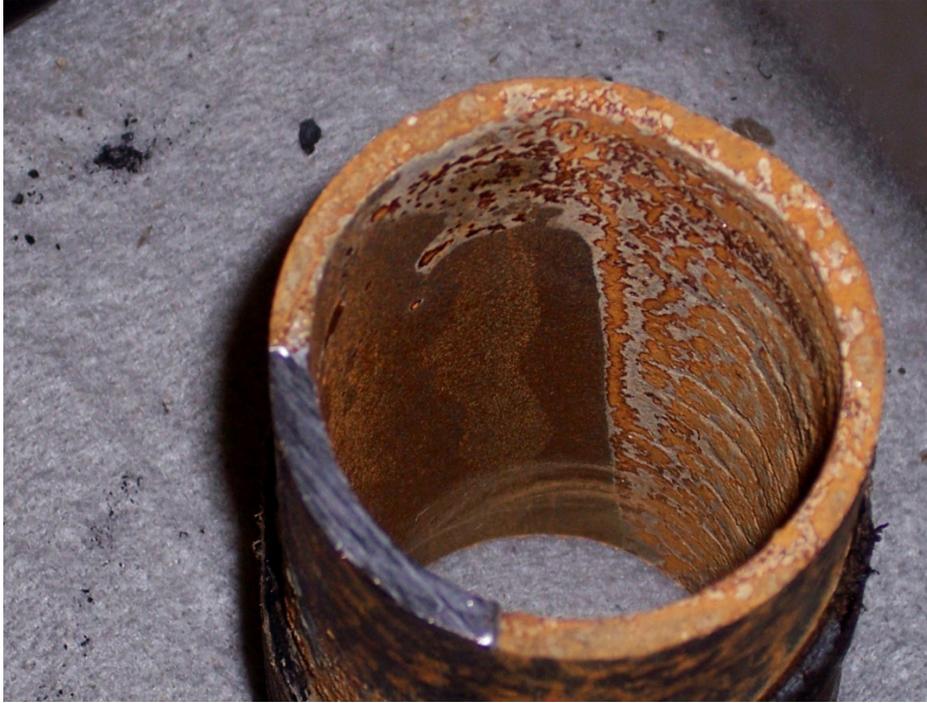
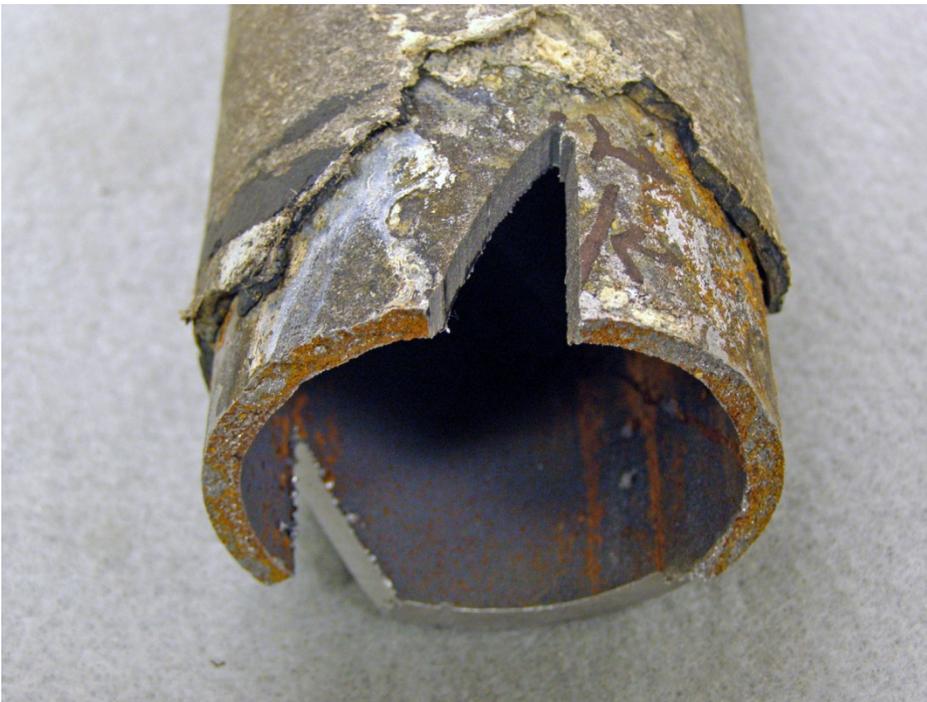
**Figure 17. Fracture surface (one side)**

**Figure 18. Fracture surface showing locations of metallographic samples**

Examination of the fracture surface revealed a brittle fracture, the origin of which was not absolutely clear. The nature of the partial circumferential fracture and the fact that the pipe appears in Figures 13 and 14 to have been flexed downward indicate that the fracture was created by bending stress. Because the crack was symmetrical about a vertical axis, one can reasonably believe that the bending stress would have been at its maximum tensile value at the bottom of the pipe. Moreover, the crack opening was maximum at the bottom of the pipe, and the location coincided with a gouge as can be seen in Figure 19.

The presence of the gouge made this region an area of primary interest as the likely origin of the crack. Accordingly, a longitudinally oriented metallographic section was taken at the location shown in Figure 19. For comparison a second metallographic section was taken across the fracture near one end of the crack as shown in Figure 18.

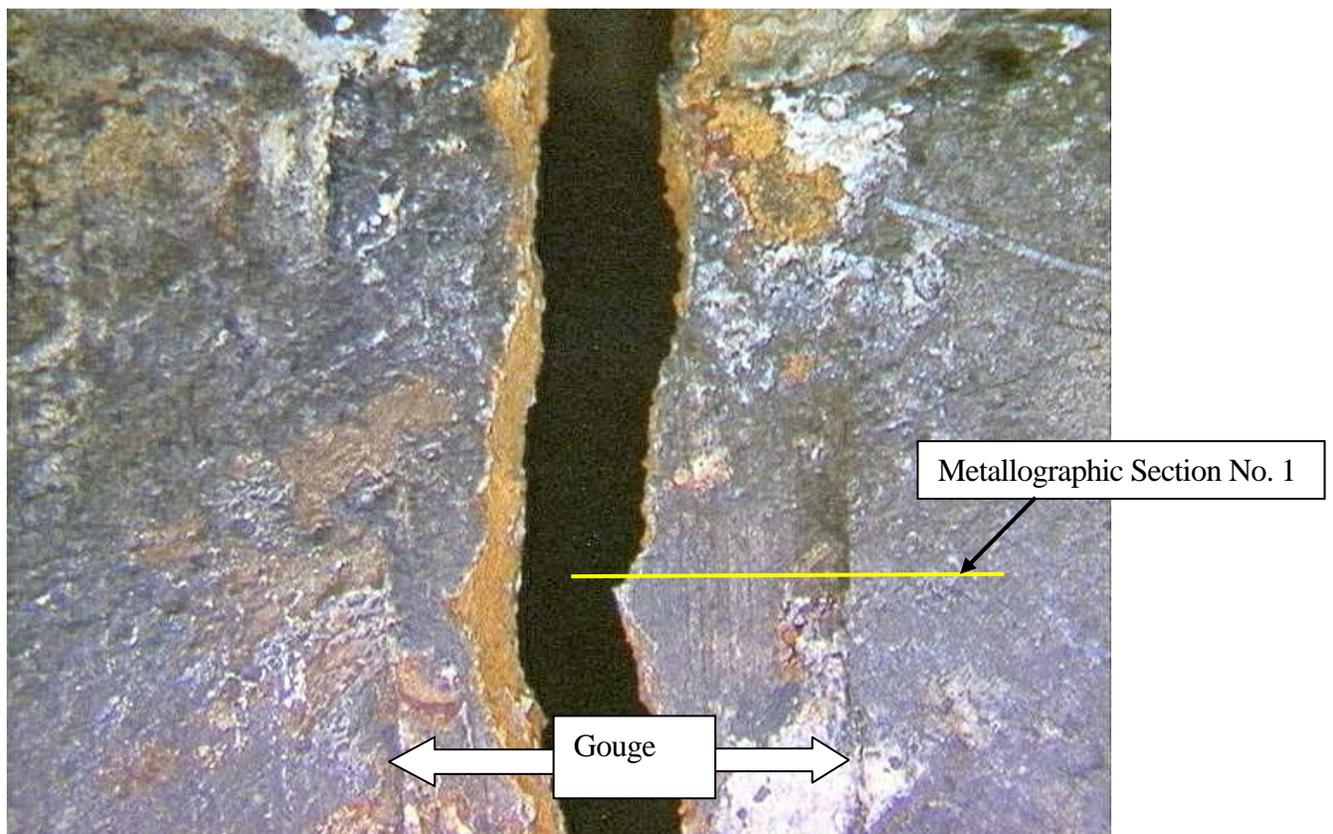
**Figure 19. Gouge that coincided with the crack at the bottom of the pipe**

The crack was caused by mechanical damage to the pipe. The apparent origin of the crack coincides with a mechanically-created gouge that was inflicted on the bottom of the pipe. One would expect that an upward deformation of the pipe would have been created at the same time. On the contrary, the pipe has been permanently deformed downward. Moreover, within two feet of the location of the crack, three other areas of damage were found that appear to have been caused by mechanical equipment impacts. These three areas are located at clock positions ranging from 7 to 9 o'clock. In the area located 20 to 22 inches from End A, the gouge can be seen in Figure 25.

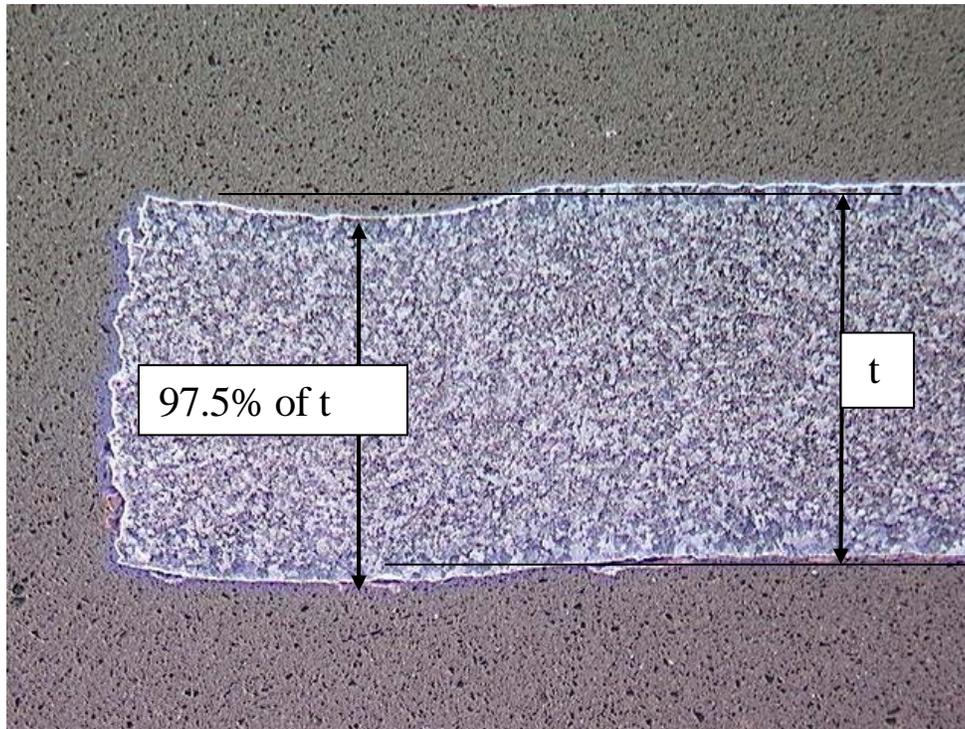
**Figure 20. Metallographic Section No. 1, cross section of gouge at 12X**

This photograph shows that whatever hit the pipe, bent the pipe wall thickness as well as gouged it. The groove visible at the outside surface of the pipe was found to be about 0.012 inch deep relative to the original surface of the pipe. However, the pipe is about 2.5 % thinner at the gouge than it is away from the gouge. Two and one-half percent of the average wall thickness (0.164 inch) is 0.004 inch. The bulge at the inside surface is two-thirds as high as the apparent depth of the groove. The reduction in thickness of 0.004 inch is the result either of compression of the material at the contact surface or the physical removal of material or a combination of the two. The microstructure at the base of the gouge is shown in Figures 21 through 23, and a comparative picture of the microstructure at the non-gouged section is shown in Figure 24.

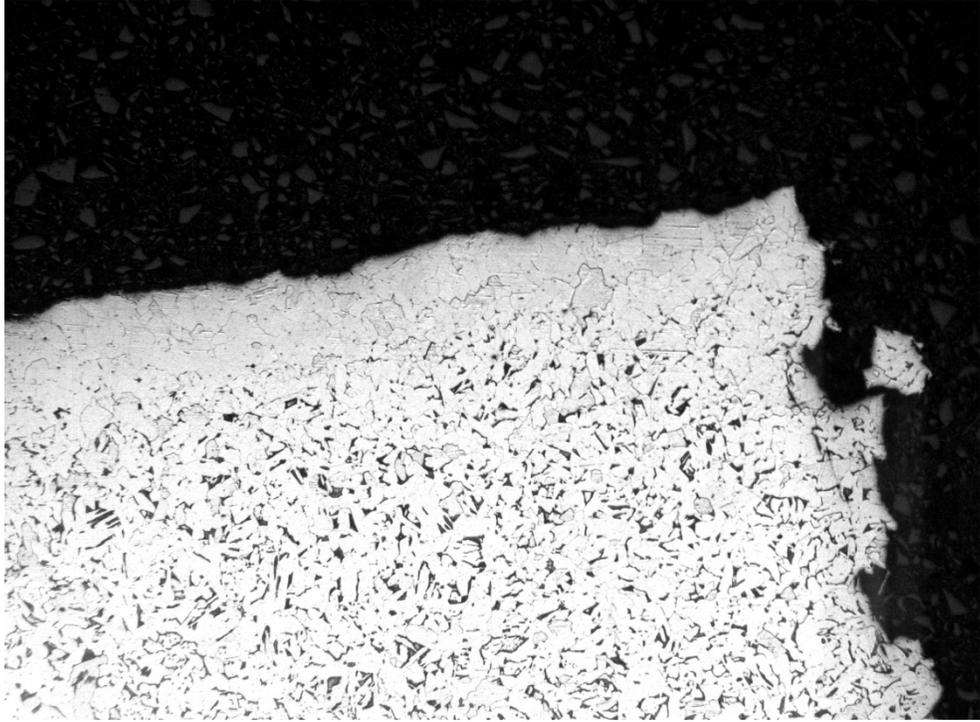
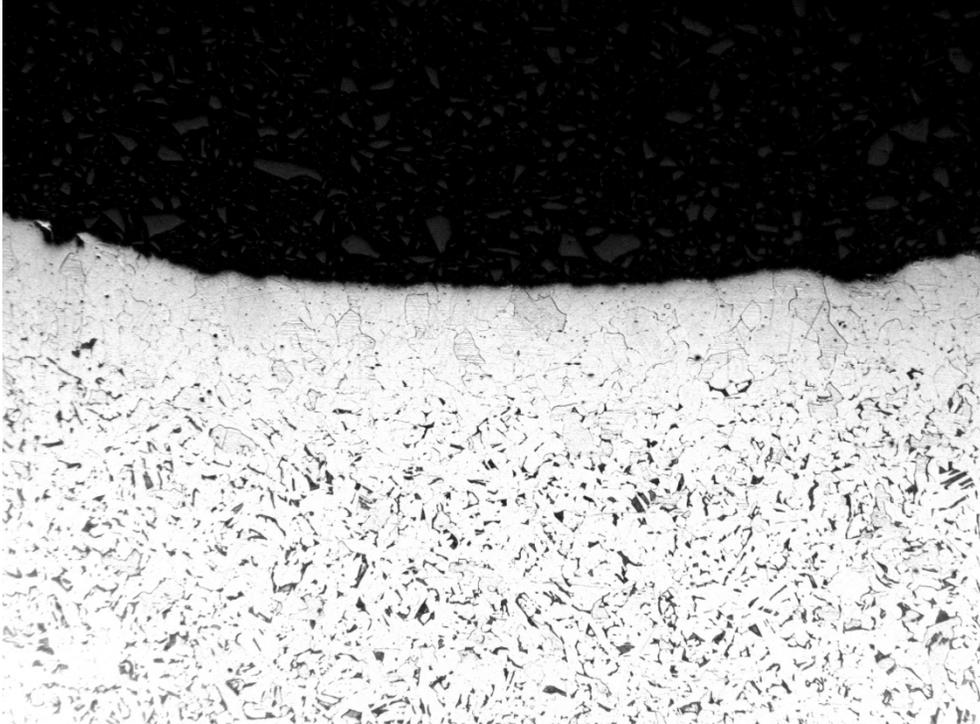
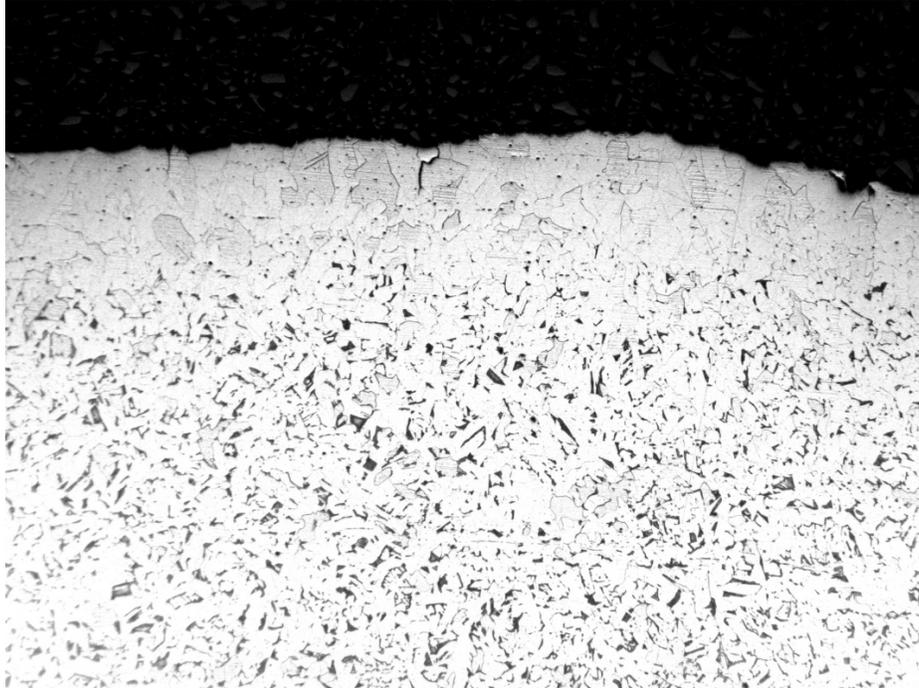
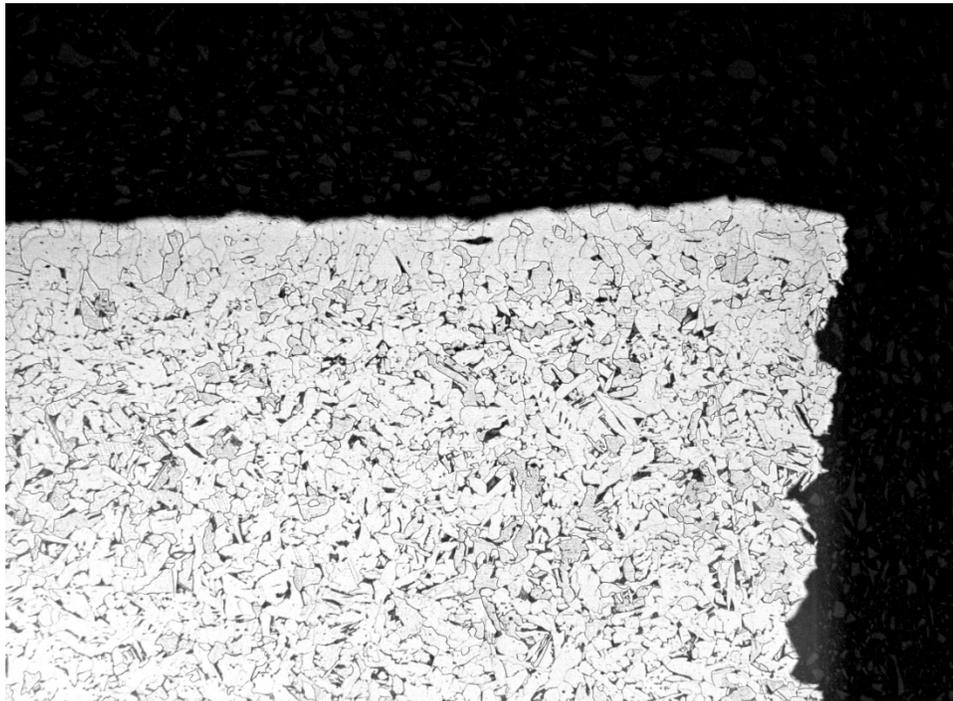
**Figure 21. Gouged surface adjacent to crack at 50X**

**Figure 22. Gouged surface in center of groove at 50X**

**Figure 23. Gouged surface at edge opposite crack at 50X**

**Figure 24. Non-gouged surface at crack at 50X**

The micro photos of the gouged surface reveal a layer at the OD surface that is lighter in color than the material in the underlying substrate. The lighter-colored layer extends beyond the edge of the gouge as shown in Figure 23, so it is not possible to attribute its appearance to the gouging action. The non-gouged section shown in Figure 24 exhibits no similar layer.

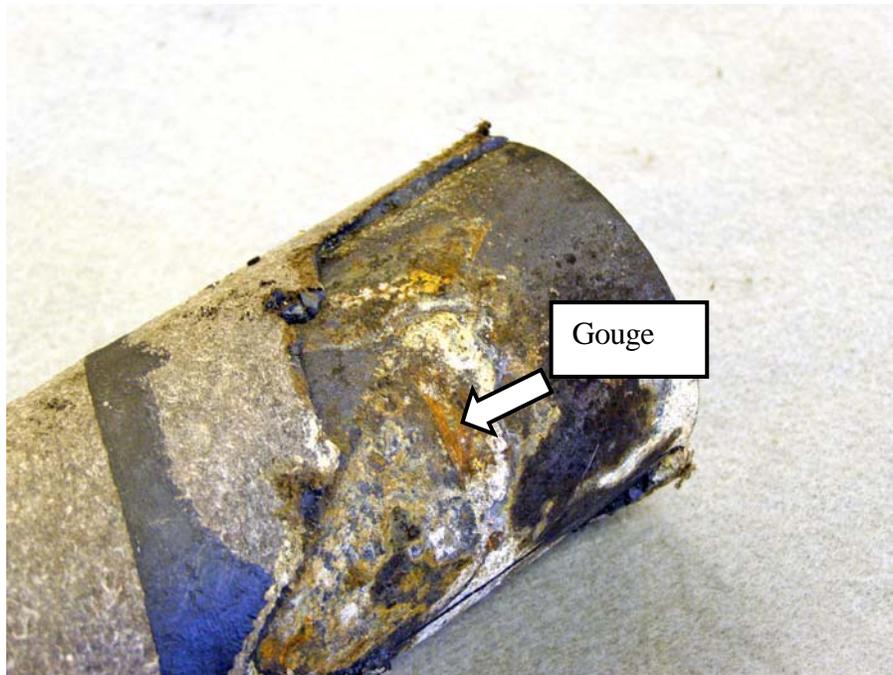
**Figure 25. Gouge within the disbonded area located 20”-22” from End A**

Thus, while the gouge that coincided with the crack was inflicted by an impact to the bottom of the pipe, the gouge shown in Figure 25 was inflicted on the side of the pipe. It does not seem likely that both of these gouges could have been inflicted by a single motion of a piece of mechanical excavating equipment. Moreover, it is hard to visualize how the downward deformation of the pipe could have resulted from the same motion that created either of the two gouges. It appears likely that multiple contacts with the pipe occurred. Whether or not the multiple contacts occurred as the result of a single excavation activity or more than one excavation activity could not be determined. The calcareous deposits on the gouged surface adjacent to the crack and at other areas where the coating was damaged indicate that none of the damage is new, but the evidence does not suggest when the damage was inflicted. Why the failure occurred after a delay rather than when the damage was inflicted is not known. A change in the status of the stress acting on the pipe and/or a change in the status of the gouge could explain the delay. The status of the gouge appears to have remained constant as there was no evidence of any time-dependent enlargement of the gouge. With regard to a possible change in stress, this investigation did not reveal whether any such change may have occurred.
