Waterbody Data Form

Centerline ID: S312ME014		Project Designated Name: tributary	
Date: 10-6-12	Client/Project Name: Keystone XL	Milepost Enter/Exit: 429.2	
Team: 312	State/County: SD / ME	Quad Name:	
Logbook No.: 1	Logbook Page No.:	Tract No.: ML-SD-ME-01240.000 ; AR-SD-ME-01250.000

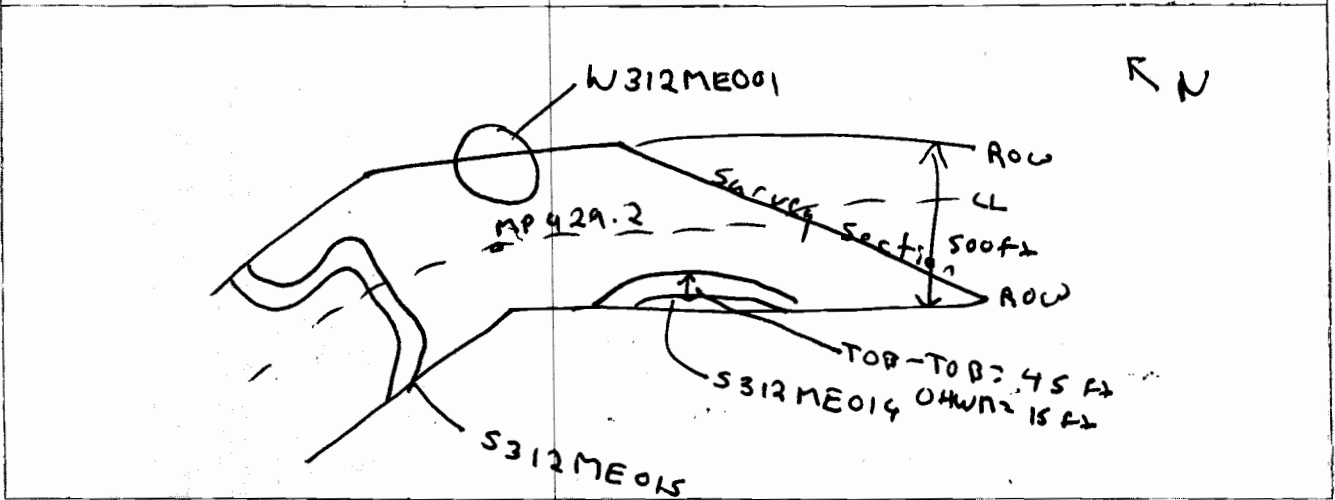
Drawing (Please provide orientation arrow, all features identified, location to centerline, etc.)

- severe downcutting

- cattle access ; severe downcutting
