Waterbody Data Form

Centerline ID: S312PN003		Project Designated Name: tributary to Ash Creek	
Date: 10-9-12	Client/Project Name: Keystone XL	Milepost Enter/Exit: spur at 430.1	
Team: 312	State/County: SD/PN	Quad Name:	
Logbook No.: 1	Logbook Page No.:	Tract No.: ML-SD-PN-10040.000

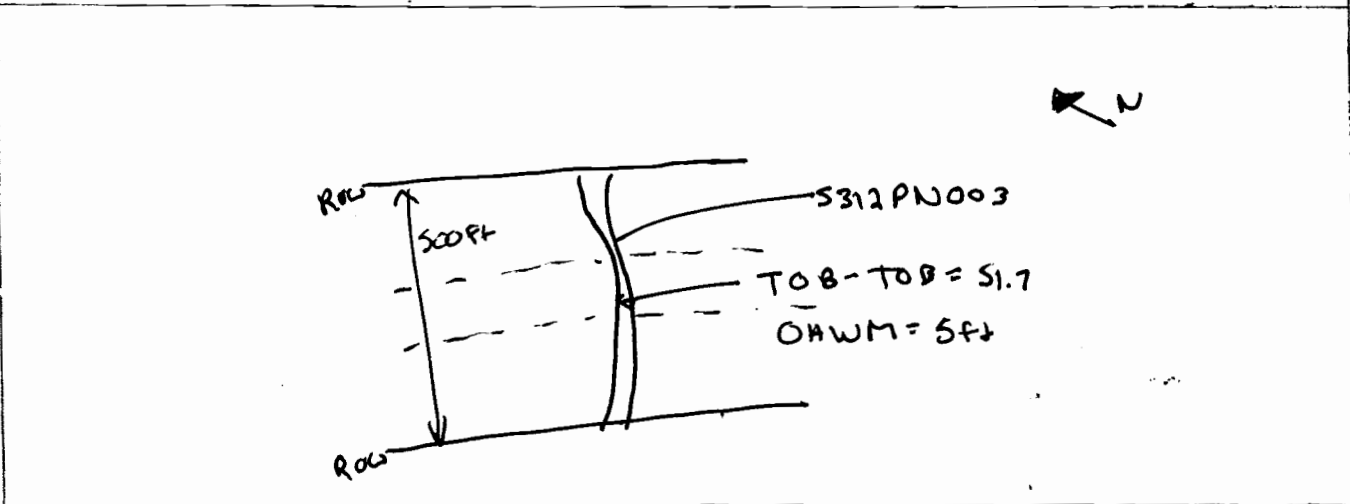
Drawing (Please provide orientation arrow, all features identified, location to centerline, etc.)

- steep banks but well vegetated

- cattle access
