# WATERBODY DATA FORM

**Feature ID #: S8AHK003**

Stream/Waterbody Name (if known): BRIDGER CR.

<b>Date:</b> 6/28/08	<b>Project Name &amp; No.:</b> Keystone XL-10623-007-803A	<b>Milepost:</b> 429.0
<b>Investigators:</b> 8A	<b>State/County:</b> SD/HK	<b>Quad Name:</b> HILLAND NW
<b>Logbook No.:</b> 2	<b>Logbook Page No.:</b> 47	<b>Tract No.:</b> ML-SD-HK-00110.000
		<b>Picture No.:</b> S8AHK003_N,W,S

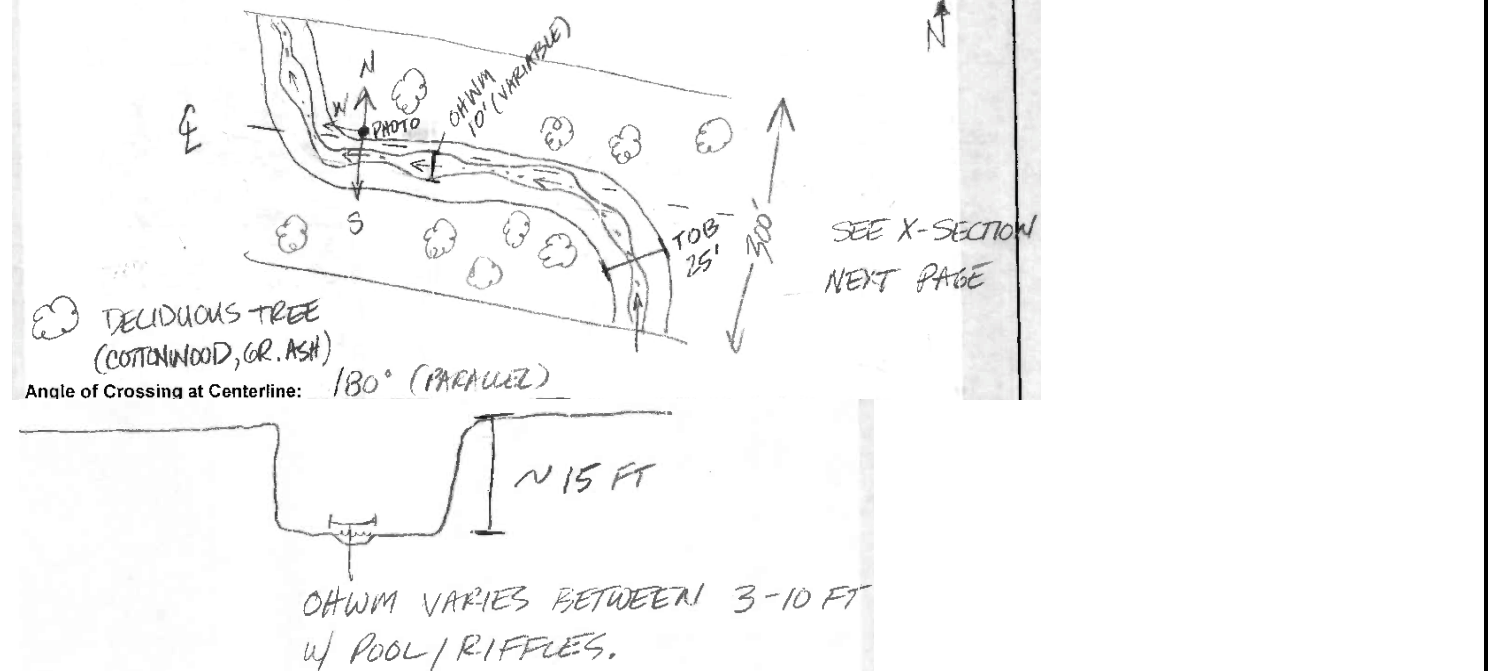
**Waterbody Sketch Plan**

Describe Habitat Characteristics, Aquatic & Terrestrial Diversity:	Habitat ID No.:
SEVERLY DOWNCUT CHANNEL-(ABOUT 15FT DEEP); ACTIVE BANK FAILURE IS CAUSING TREES TO FALL; STREAM HAS SMALL RIFFLES & POOLS, WIDENS & NARROWS. VEG. COMMUNITY: MIXED GRASSLAND & DECIDUOUS FOREST (BROJAP, PASSMI, COTTONWOOD, GREEN ASH & HACKBERRY OR ELM SP?)

Comments (e.g. pipeline crossing angle, construction constraints, erosion potential, existing disturbances, and meanders)
VERY STEEP (VERTICAL) BANKS, HIGHLY ERODIBLE SOILS? ABOUT 400' OF CREEK RUNS RIGHT DOWN CL.
<b>STREAM QUALITY</b> High <input type="checkbox"/> Moderate <input checked="" type="checkbox"/> Low <input type="checkbox"/>
