Waterbody Data Form

Centerline ID: 5312ME001		Project Designated Name: Narcelle Creek	
Date: 10-5-12	Client/Project Name: Keystone XC		Milepost Enter/Exit: 425.7
Team: 312	State/County: SD/ME		Quad Name:
Logbook No.: 1	Logbook Page No.:	Tract No.: ML-SD-ME-01190.000; -01187.000

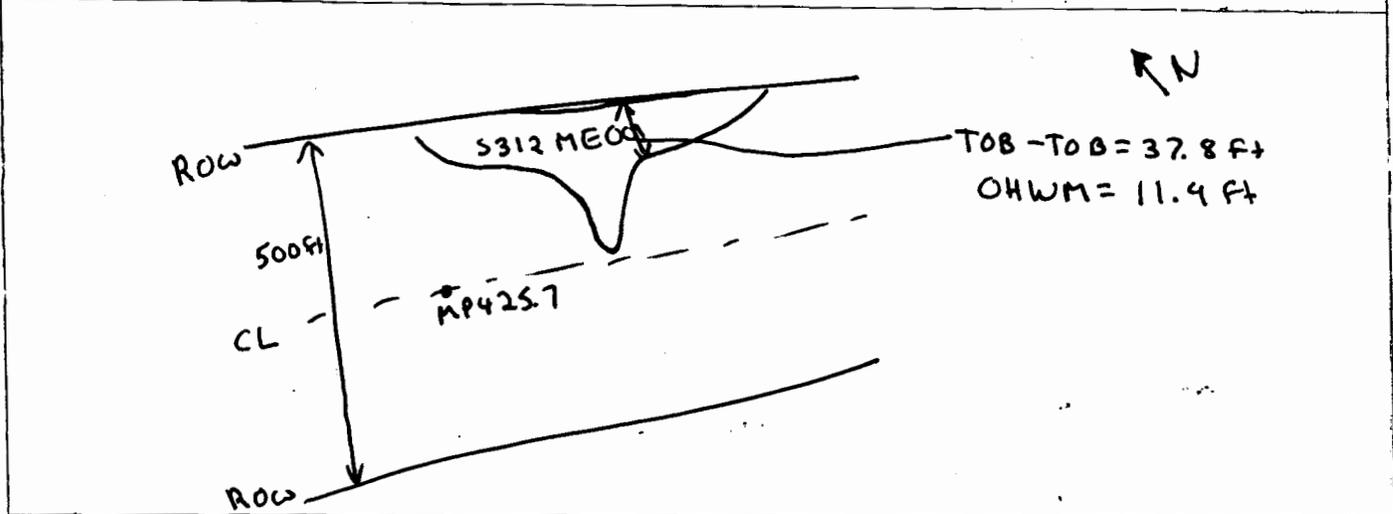
Drawing (Please provide orientation arrow, all features identified, location to centerline, etc.)

Comments:
- erosion of banks + headcutting on southwestern bank

Stream Quality: <input type="checkbox"/> High <input type="checkbox"/> Moderate <input checked="" type="checkbox"/> Low
livestock access to channel ; erosion
