Waterbody Data Form

Centerline ID: 5103J0001		Project Designated Name:	
Date: 5-18-10	Client/Project Name: Transcanada-Trow/KXL Phase IV	Milepost Enter/Exit: 497.42	
Team: 103	State/County: SD/Jones	Quad Name: —	
Logbook No.: 1	Logbook Page No.:	Tract No.: MC-SD-Jo-10340.000

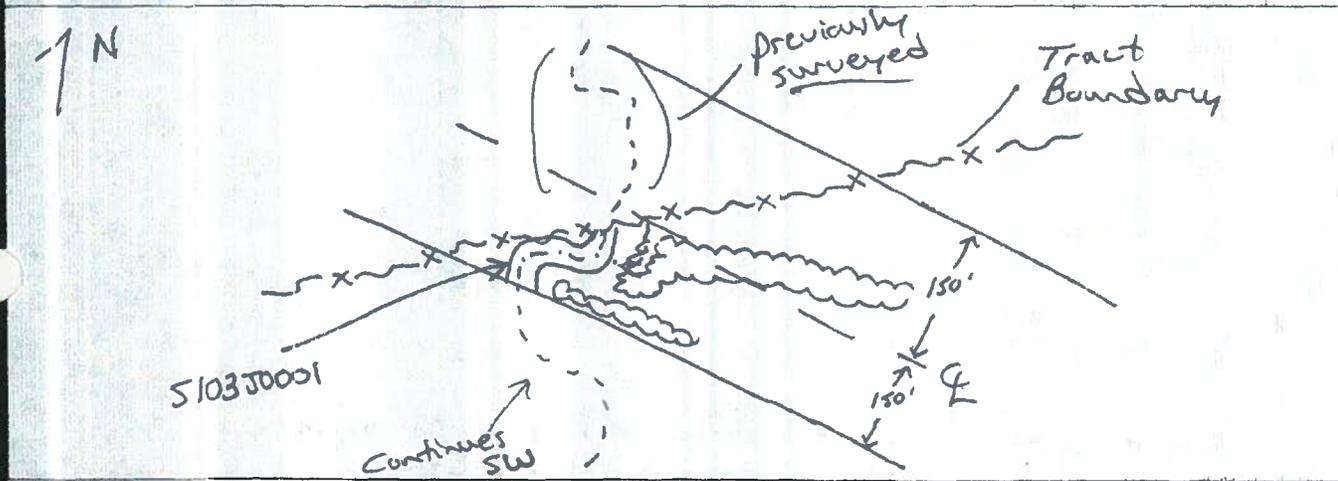
Drawing (Please provide orientation arrow, all features identified, location to centerline, etc.)

Habitat ID Number: Stream appears to provide adequate habitat for aquatic species. Stream contains a significant amount of woody debris.

The tributary continues onto an adjacent property which appears to have been previously bio surveyed. Tributary situated in a deep valley.
