WATERBODY DATA FORM

Feature ID #: S6ALY002

Stream/Waterbody Name (if known): SEDLANO CREEK

Date: 7/7/08	Project Name & No.: Keystone XL-10623-007-803A	Milepost: 528.8
Investigators: 6A	State/County: SD/ LYMAN	Quad Name: VIVIAN SE
Logbook No.: 2	Logbook Page No.:	Tract No.: ML-SD-LY-10170.000
		Picture No.: S6ALY002_SW,W,NE

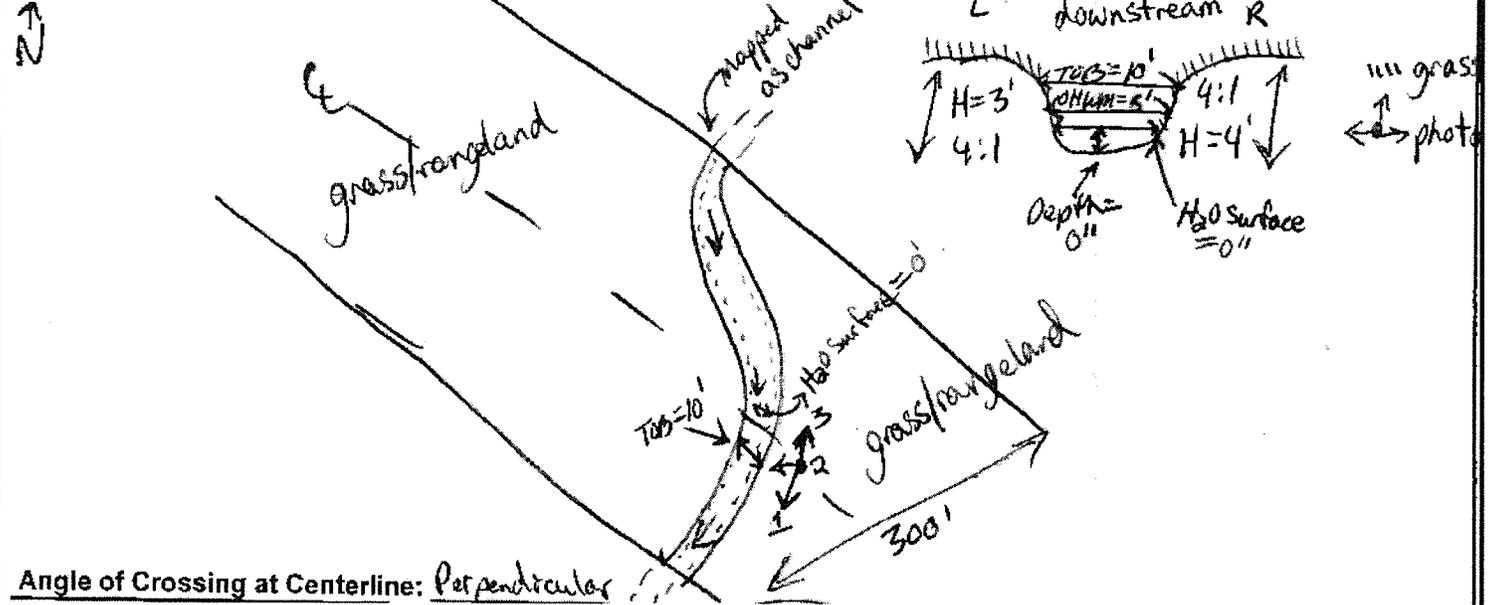
Waterbody Sketch Plan

Angle of Crossing at Centerline: Perpendicular

Comments (e.g. pipeline crossing angle, construction constraints, erosion potential, existing disturbances, and meanders)
CATTLE ACCESS AND TRACKS THROUGHOUT STREAM CHANNEL. CROSSES CL.
