Re: In the Matter of the Complaint filed by Larry Fliss, Hendricks, Minnesota, against Otter Tail Power Company Regarding Voltage Fluctuations, Docket No. CE05-001.

### **RE: Hendricks Golf Course Update**

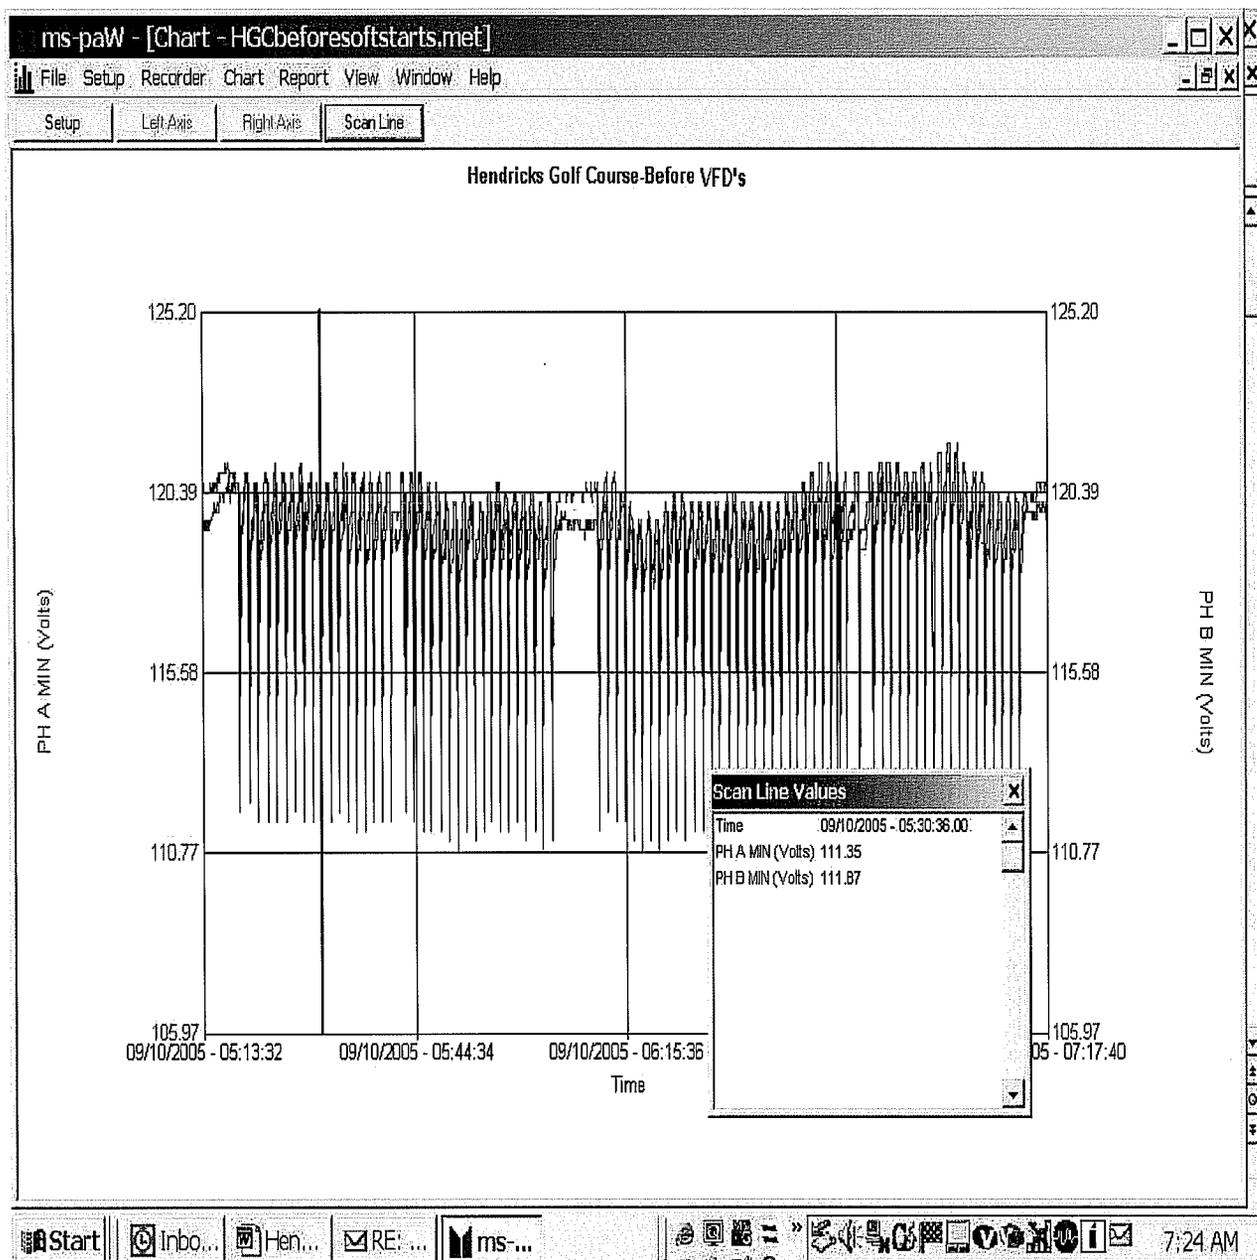
### Voltage Plot A

(Hendricks Golf Course before the VFD's were added)  
(Note: Frequent 7% dips)

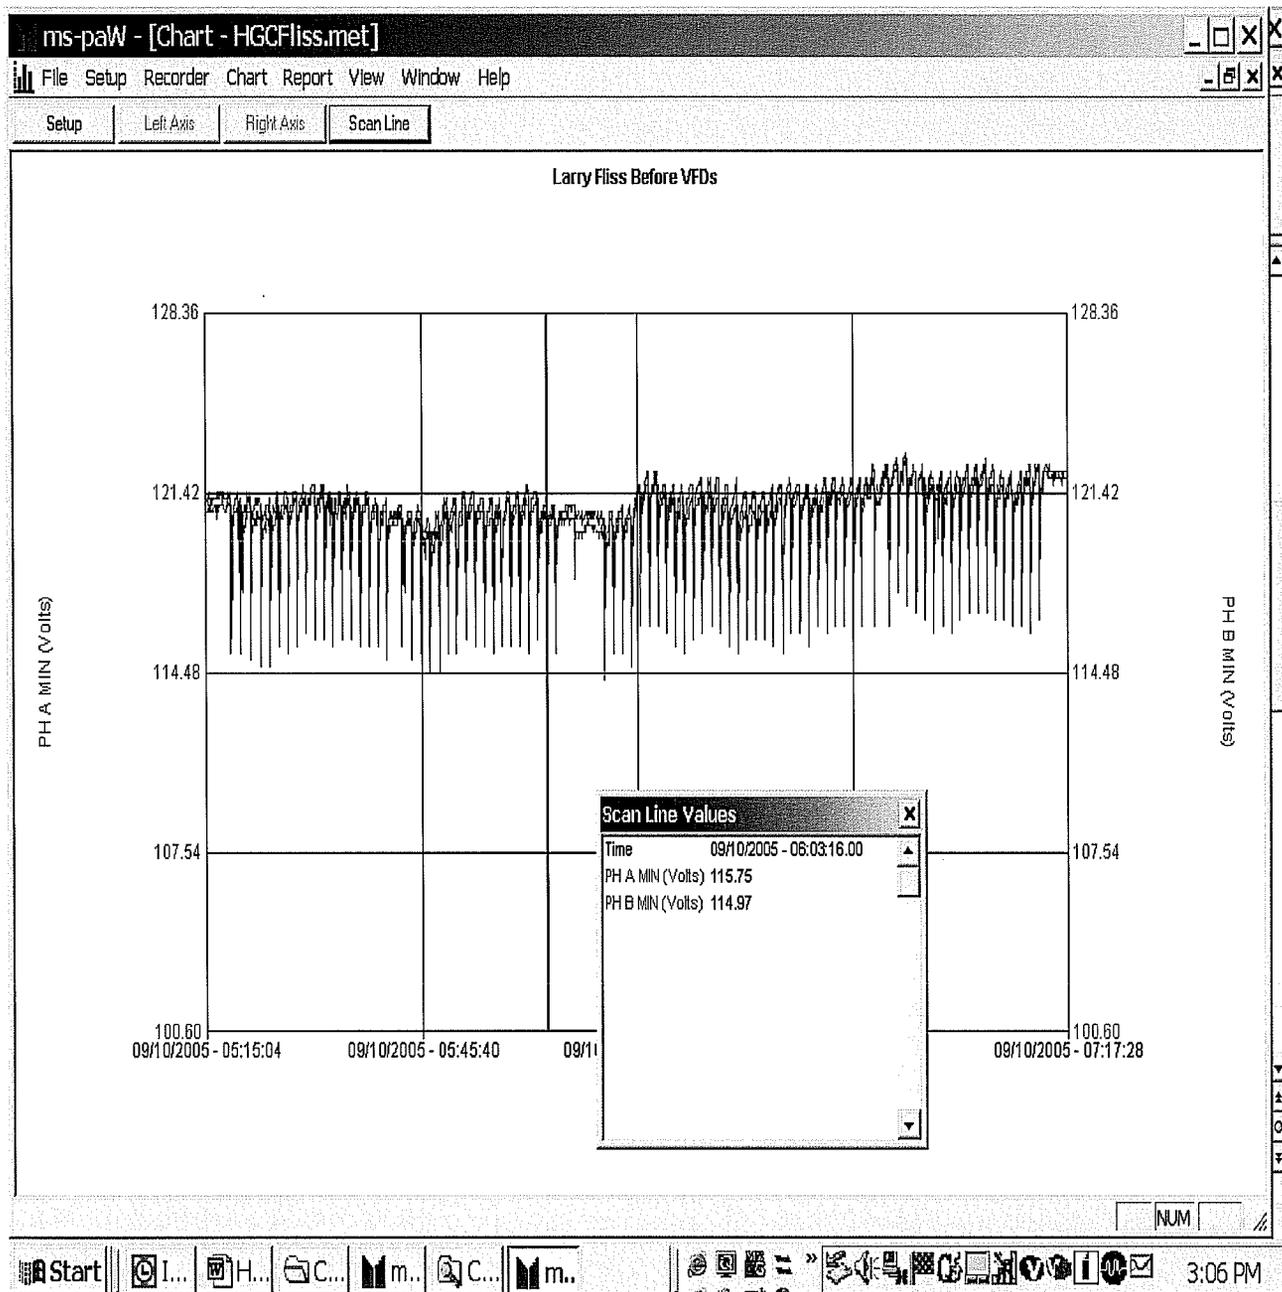
### Voltage Plot B

(Larry Fliss before the VFDs were added)  
(Note: Frequent 4% dips)

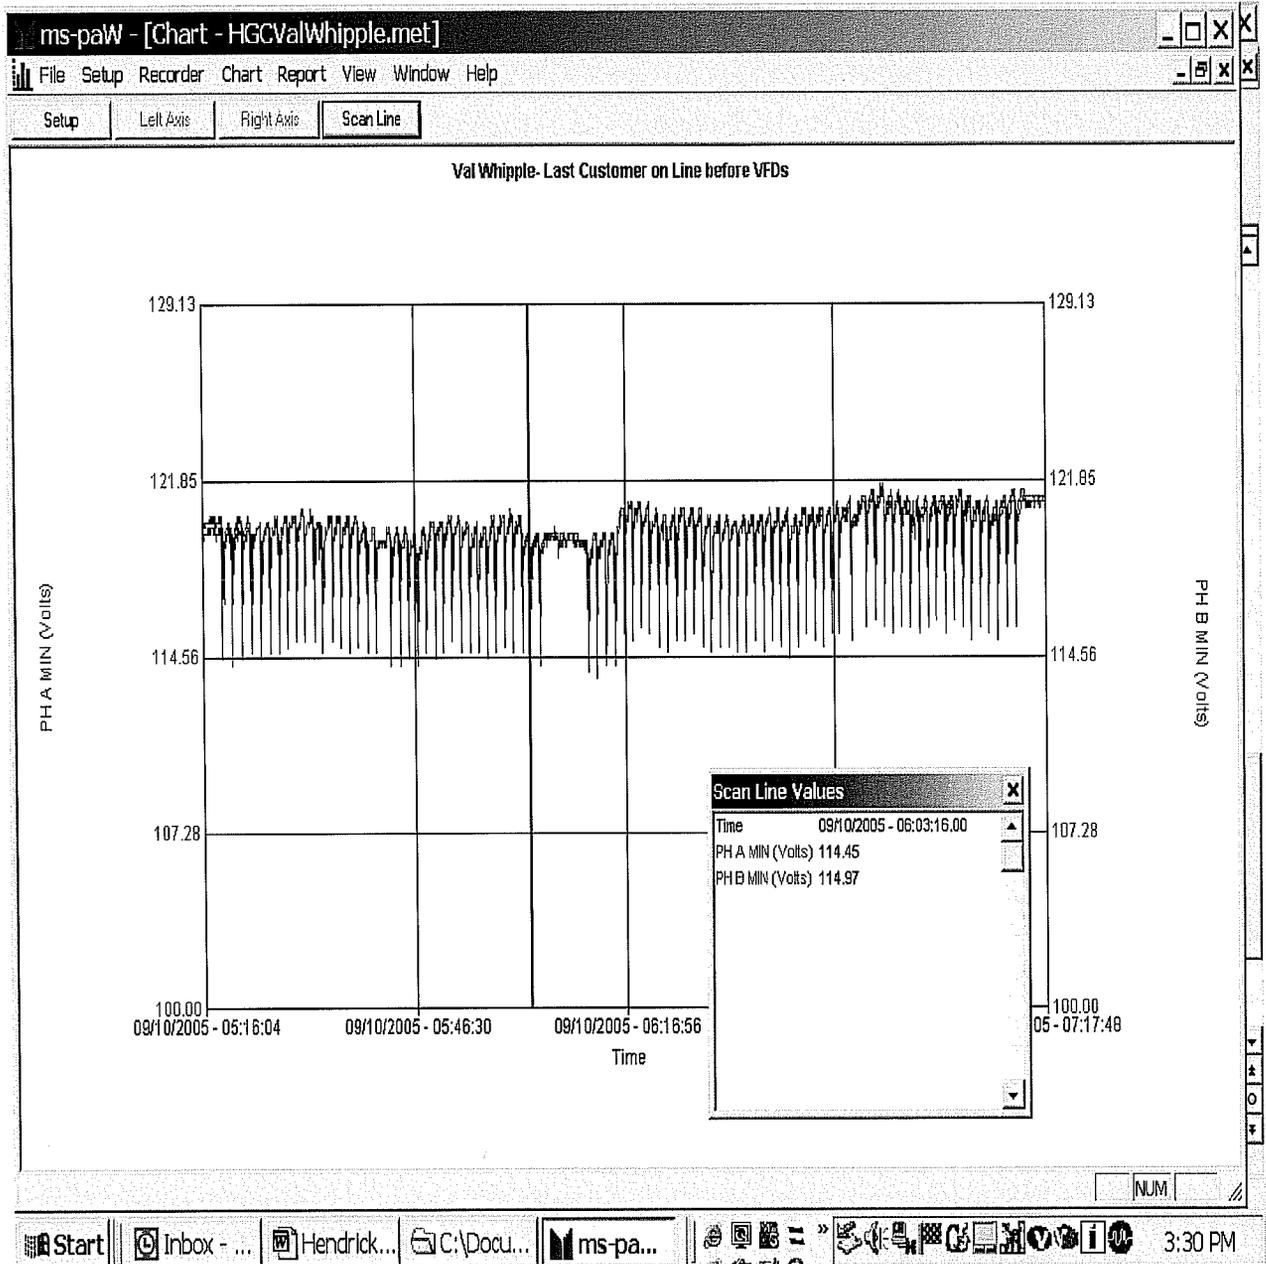
### Voltage Plot C

(Val Whipple before the VFDs were added)  
(Note: Frequent 4% dips)

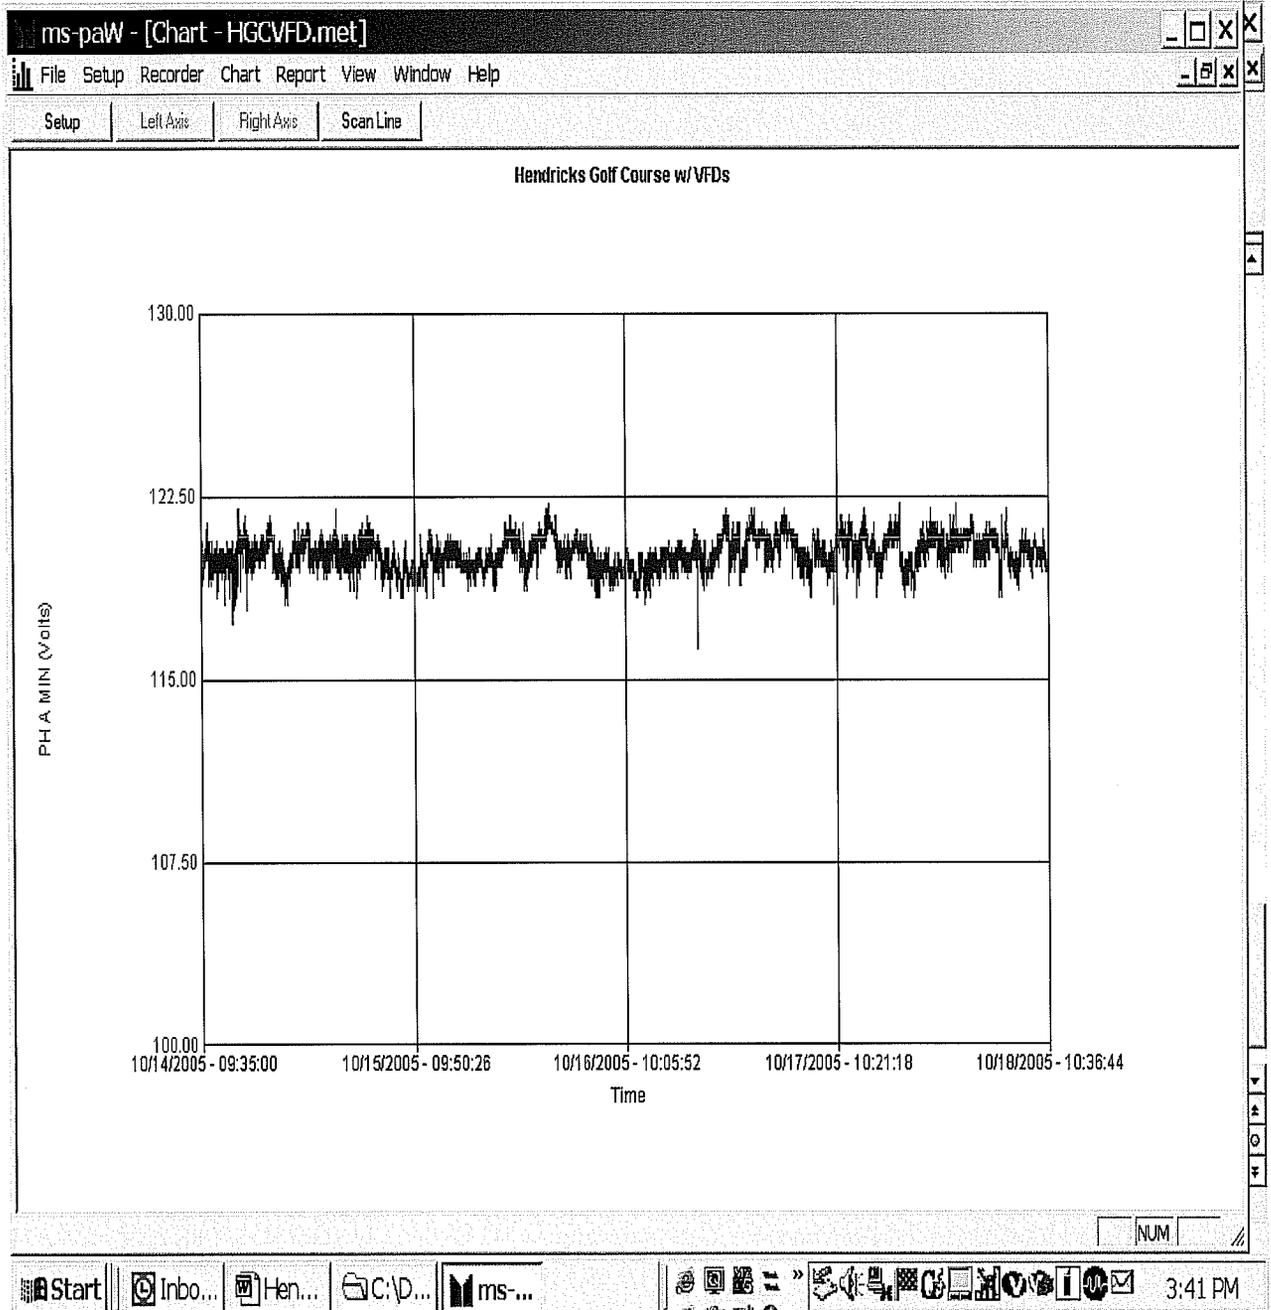
### Voltage Plot D

(Hendricks Golf Course plot after the VFDs were added)  
(Note: No flicker)

When examining the recorded before and after coincidental data after the VFDs were added, it was concluded that the VFDs prevented any significant motor starting inrush current so **no flicker voltage** was recorded at any of the three locations.

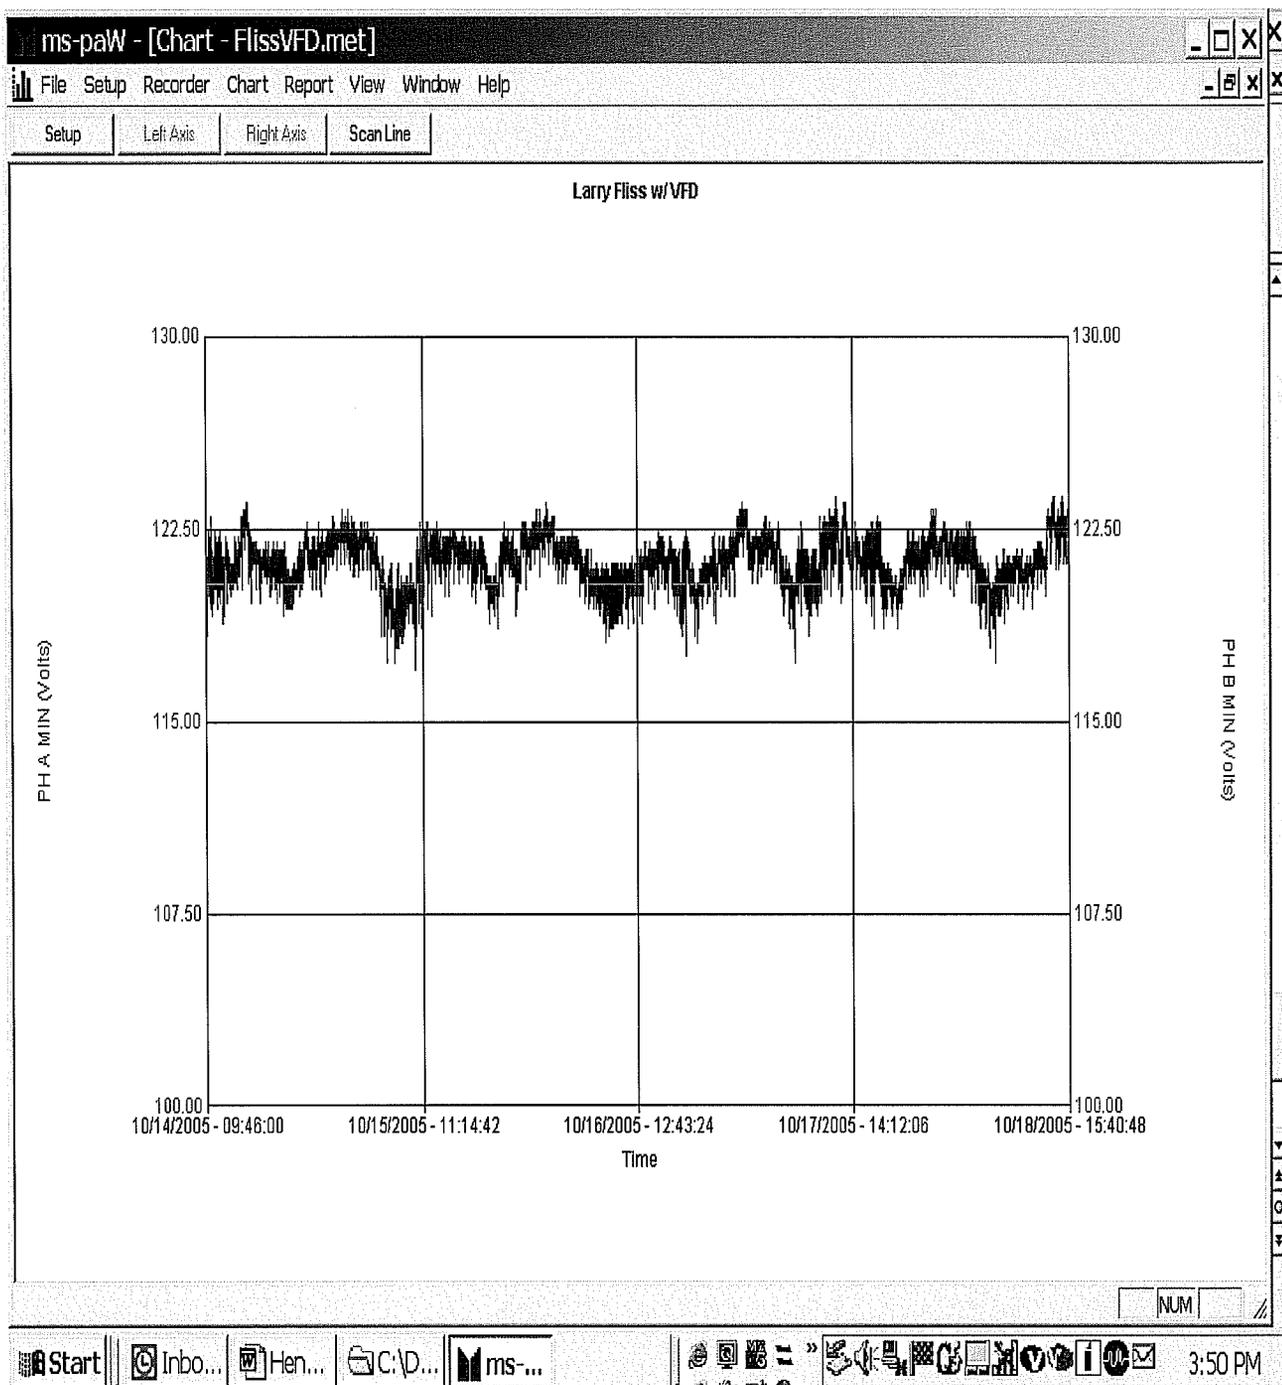
### Voltage Plot E

(Larry Fliss plot after the VFDs were added)  
(Note: No flicker)

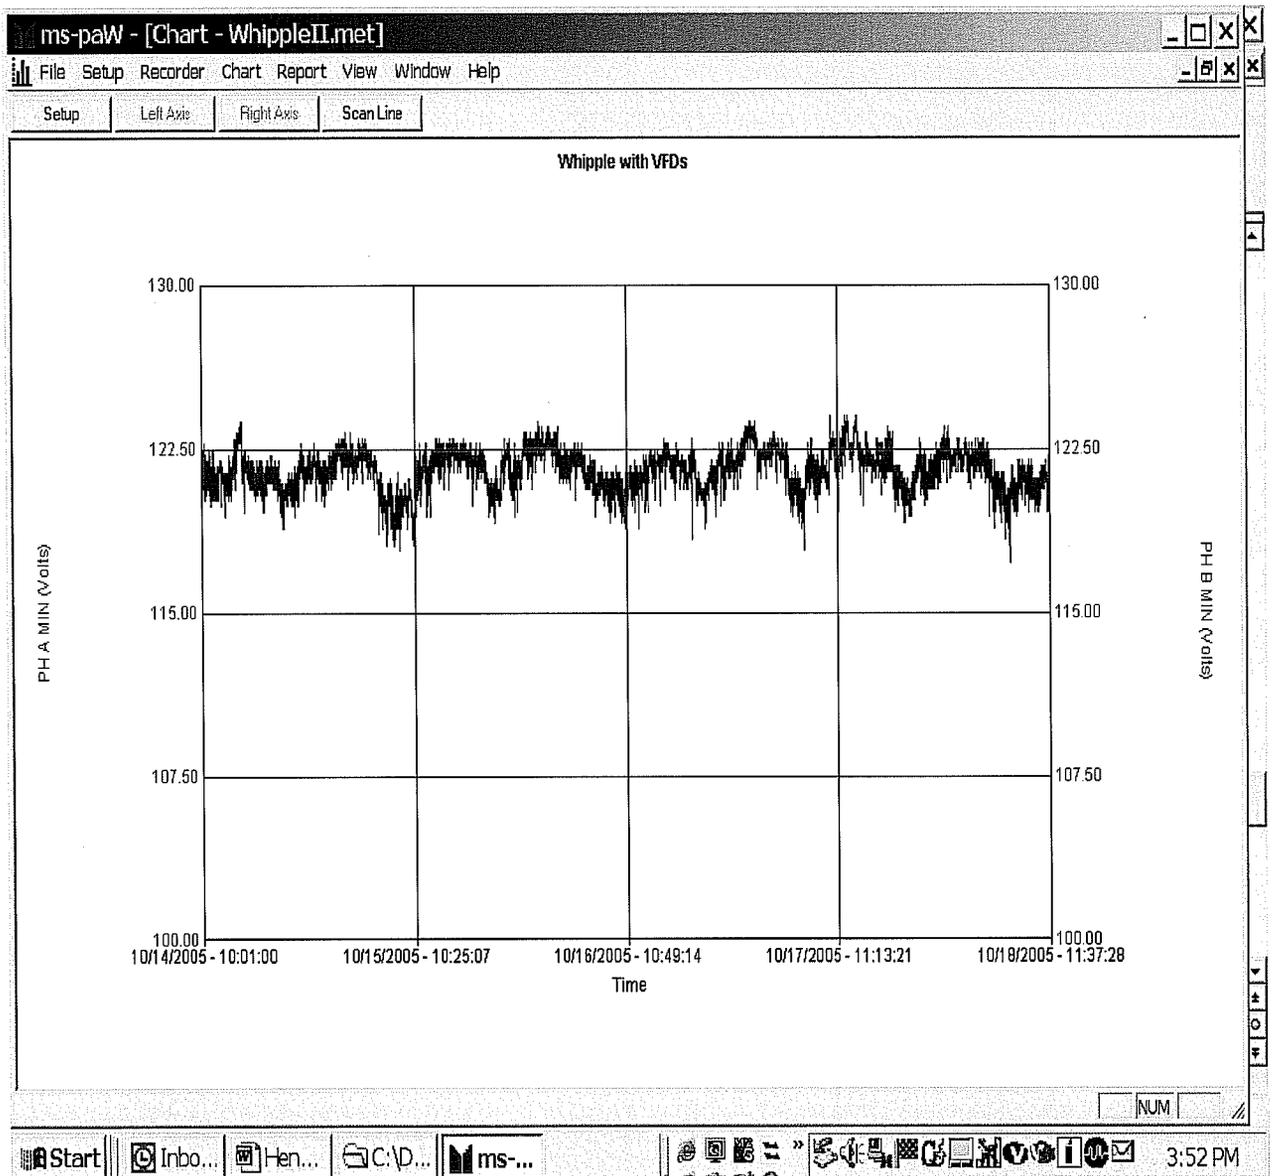
### Voltage Plot F

(Val Whipple after VFDs added)  
(Note: No Flicker)

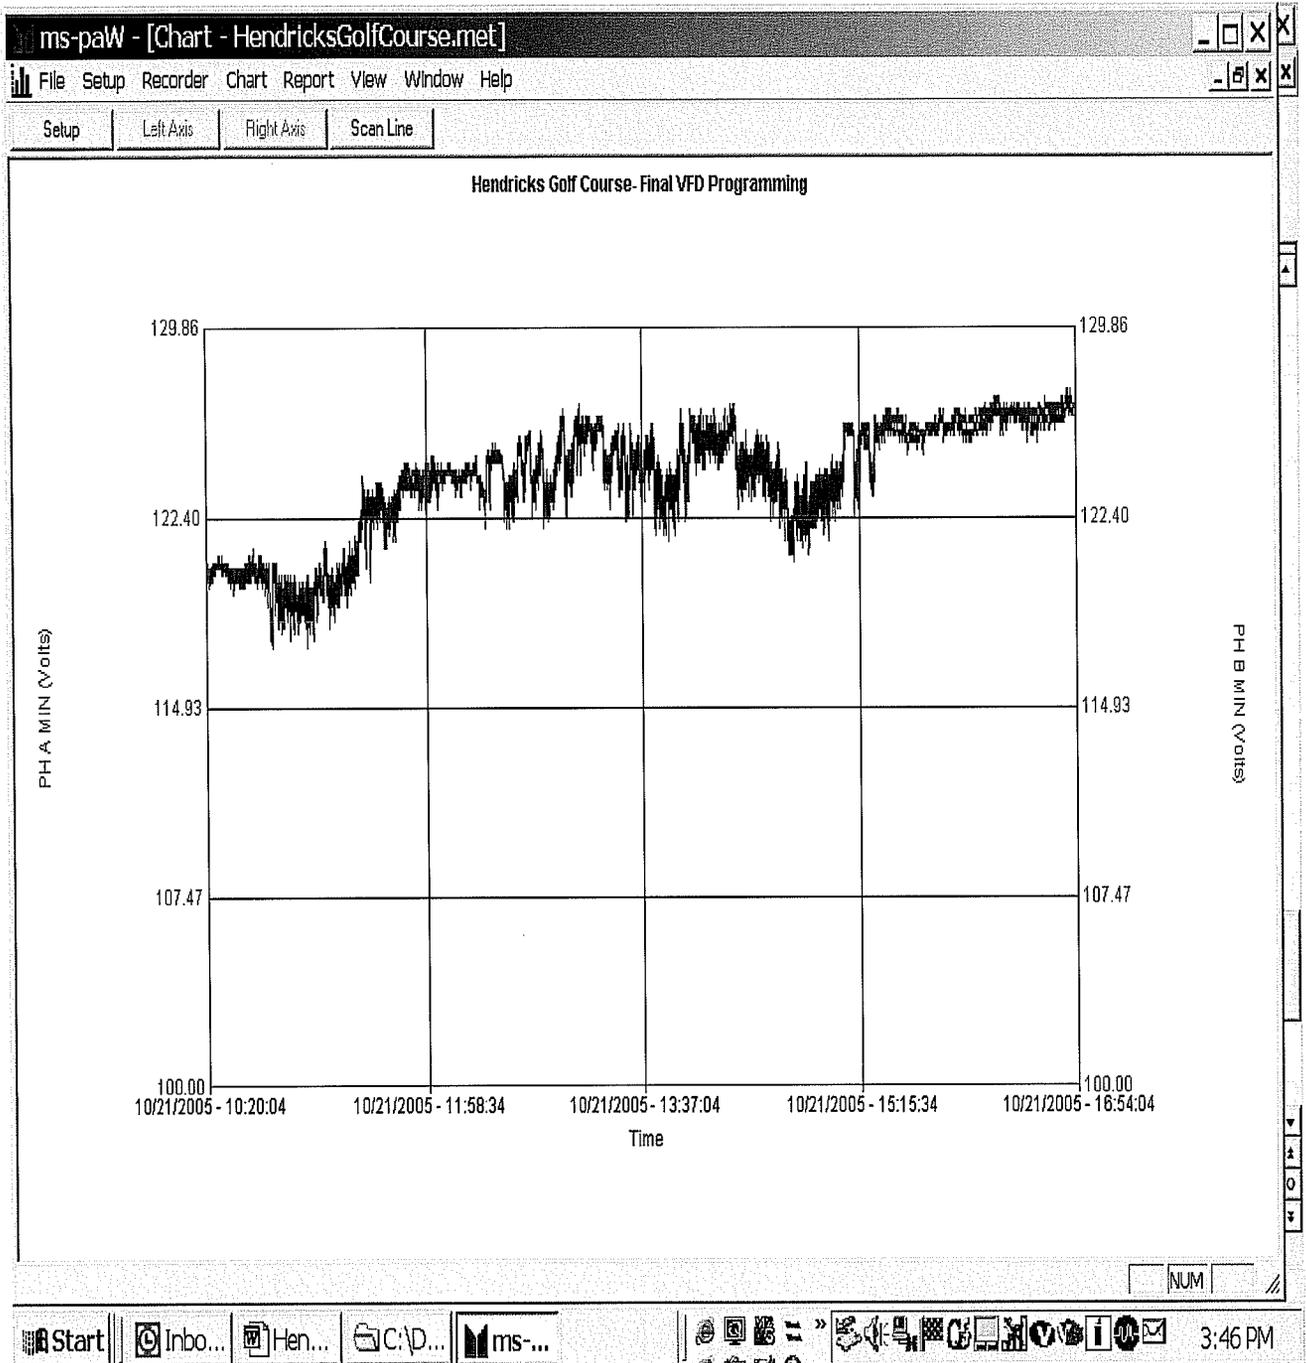
### Voltage Plot G

(Oct. 21<sup>st</sup> Hendricks Golf Course plot after the VFDs were reconfigured)  
(Note: No flicker)

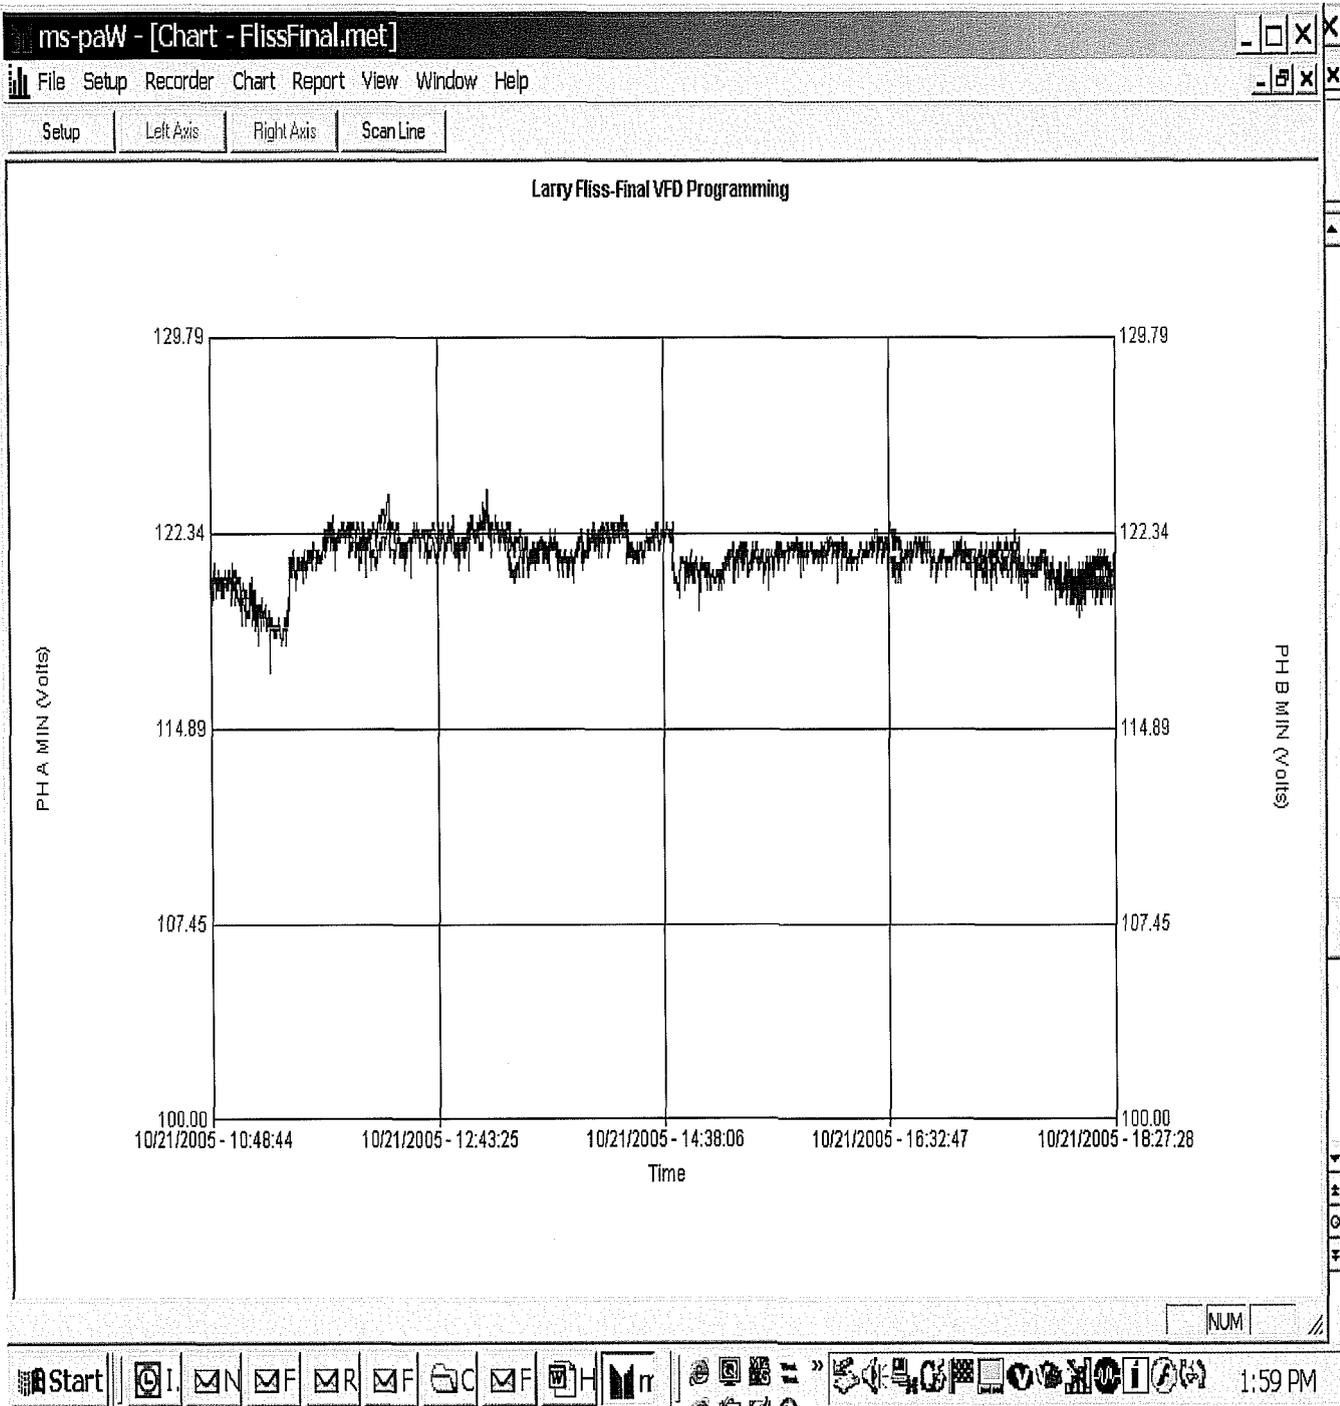
### Voltage Plot H

(Oct. 21<sup>st</sup> Larry Fliss plot after the VFDs were reconfigured)  
(Note: No flicker)
