# Foodland

## Anatomy of an Incident

- Excavation damage incident.
- Excavator strikes previously abandoned pipeline?
- Operator responds with service personnel, supervisors.
- Occupants report smelling gas.
- Building explodes approximately 2-1/2 hours after gas serviceman arrives.

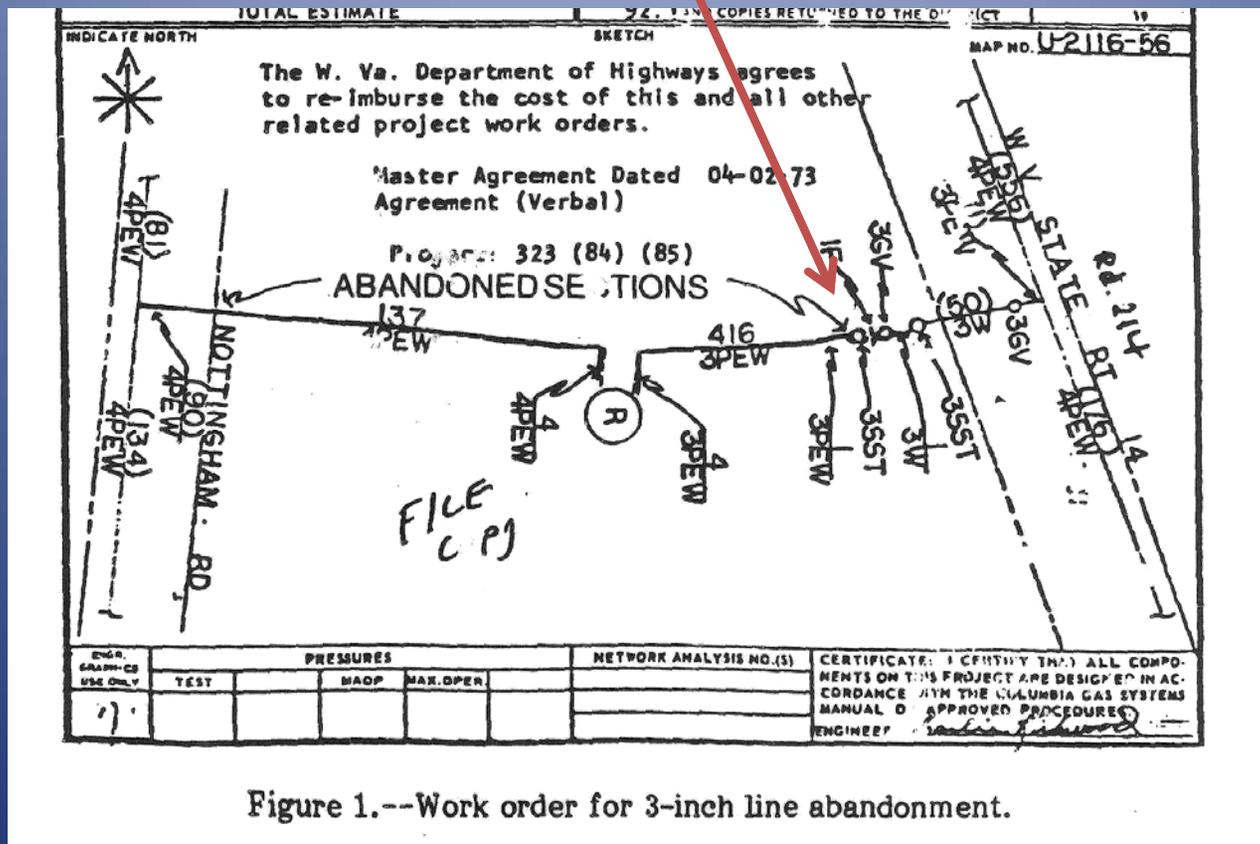
- Line abandoned at short stop tee.

Figure 1.--Work order for 3-inch line abandonment.

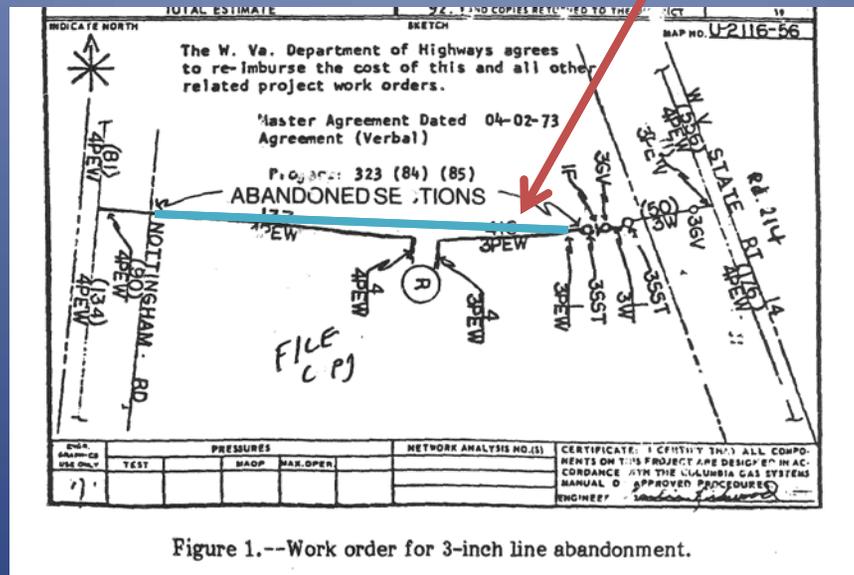
- To solve the pressure problems the operator reconnects previously abandoned pipeline.
- No work order is prepared.

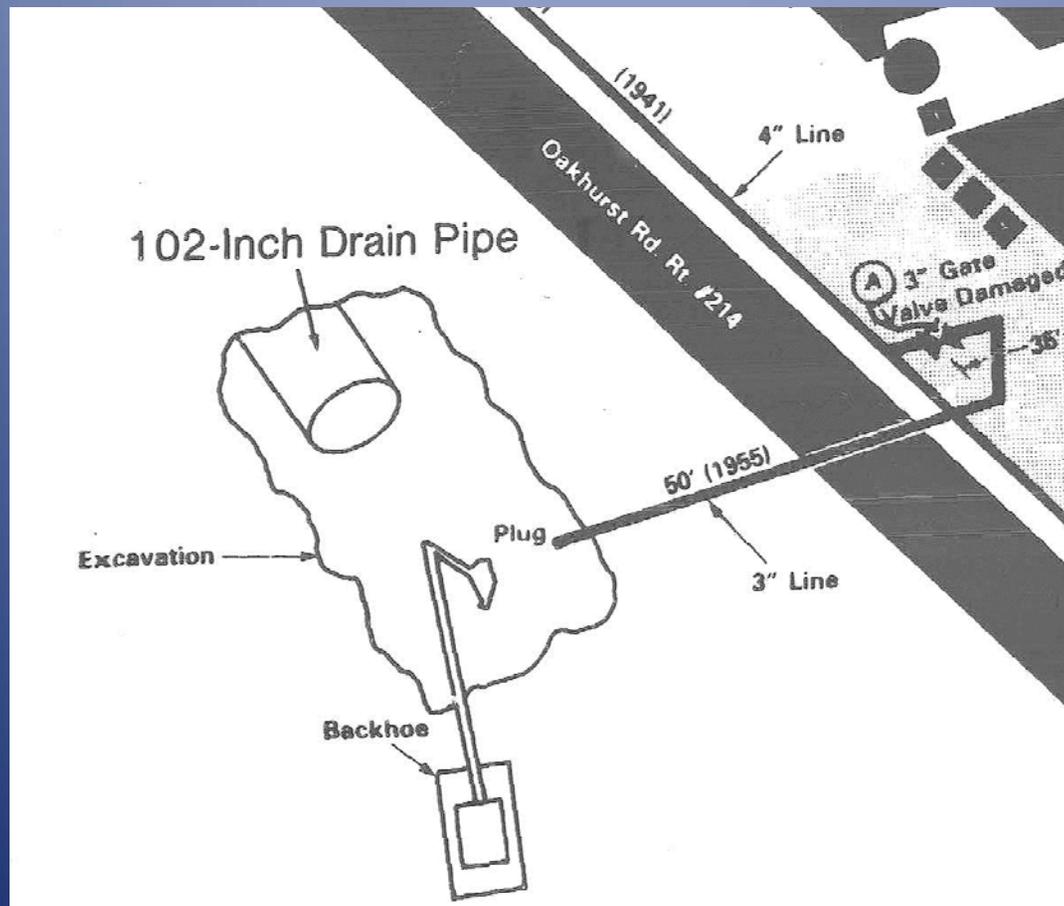
# The damage

- 11:15 am backhoe hits the 50 foot stub.

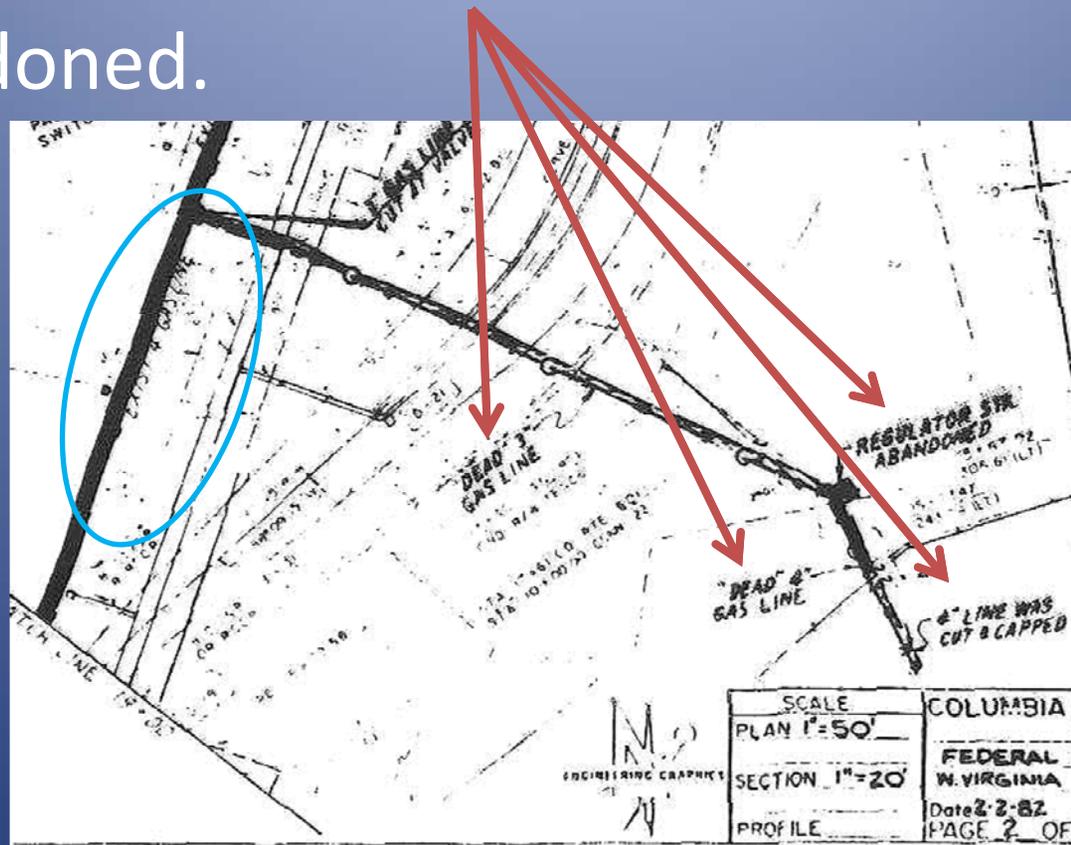
# Contractor map

- Contractor had information the line was abandoned.

- Maps were confusing.
- The foreman who left the stub did so because it was easier than digging up the 7 foot deep valve in the parking lot.
- He felt it would be out of the way of the construction. The engineering office was not told.

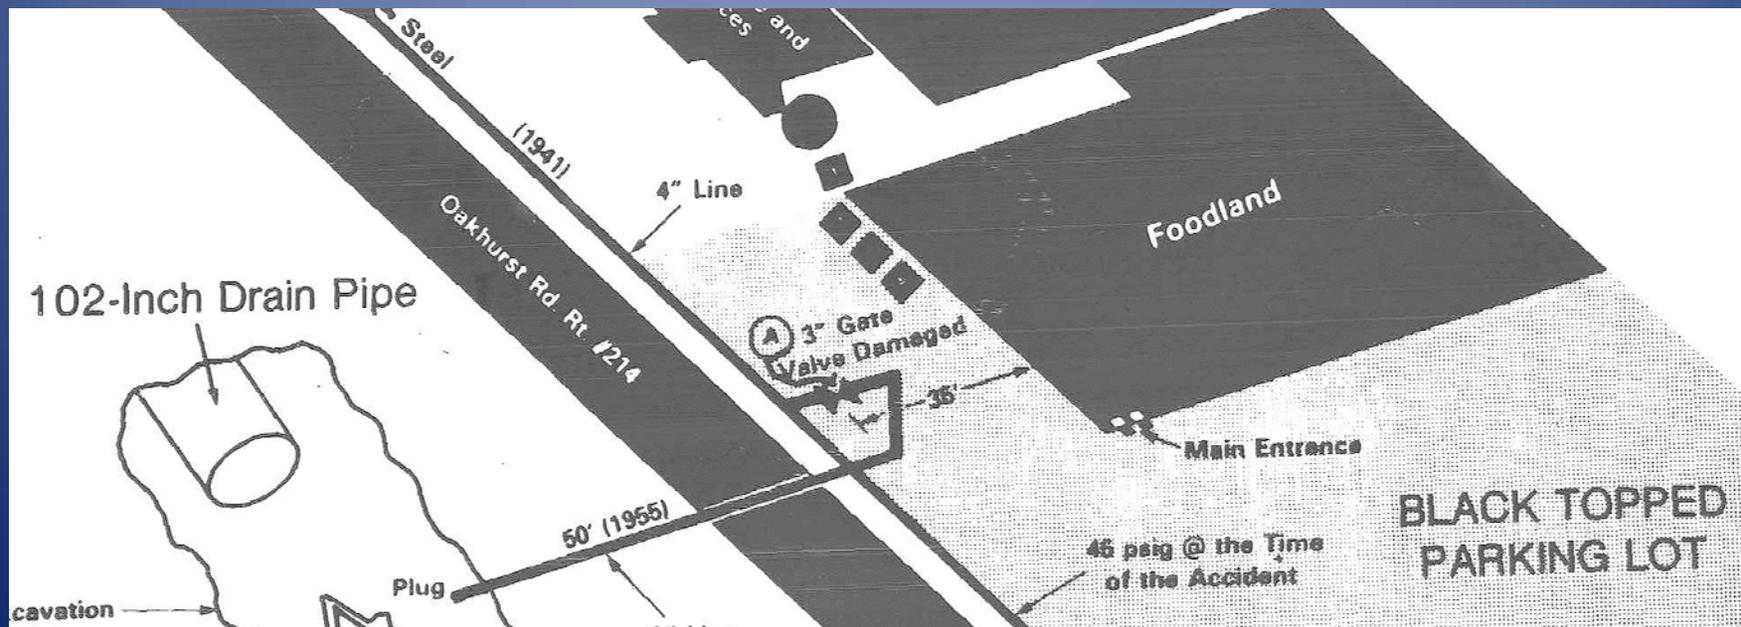
# Broken gate valve

- Backhoe operator is unaware that the line has pulled and broken a cast iron gate valve in parking lot.

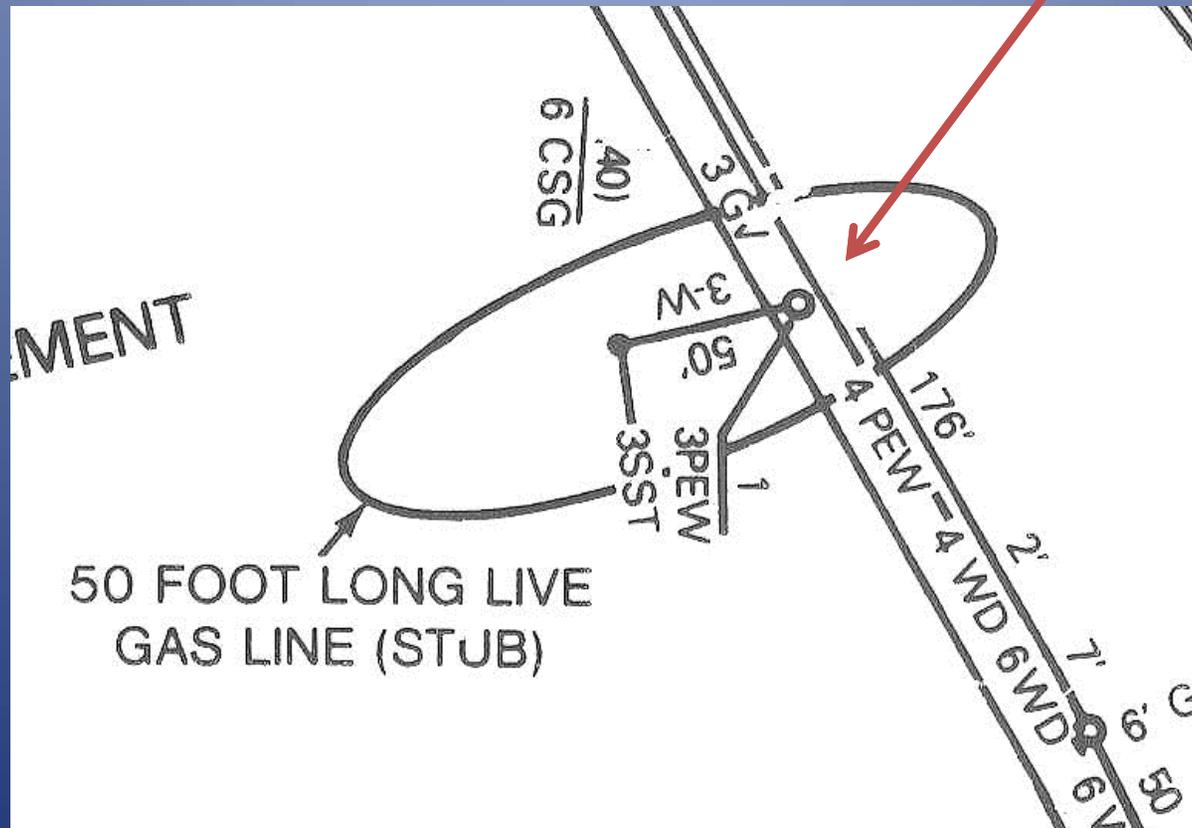
# Gas at valve boxes

- Valve boxes are over or near the gate valve.

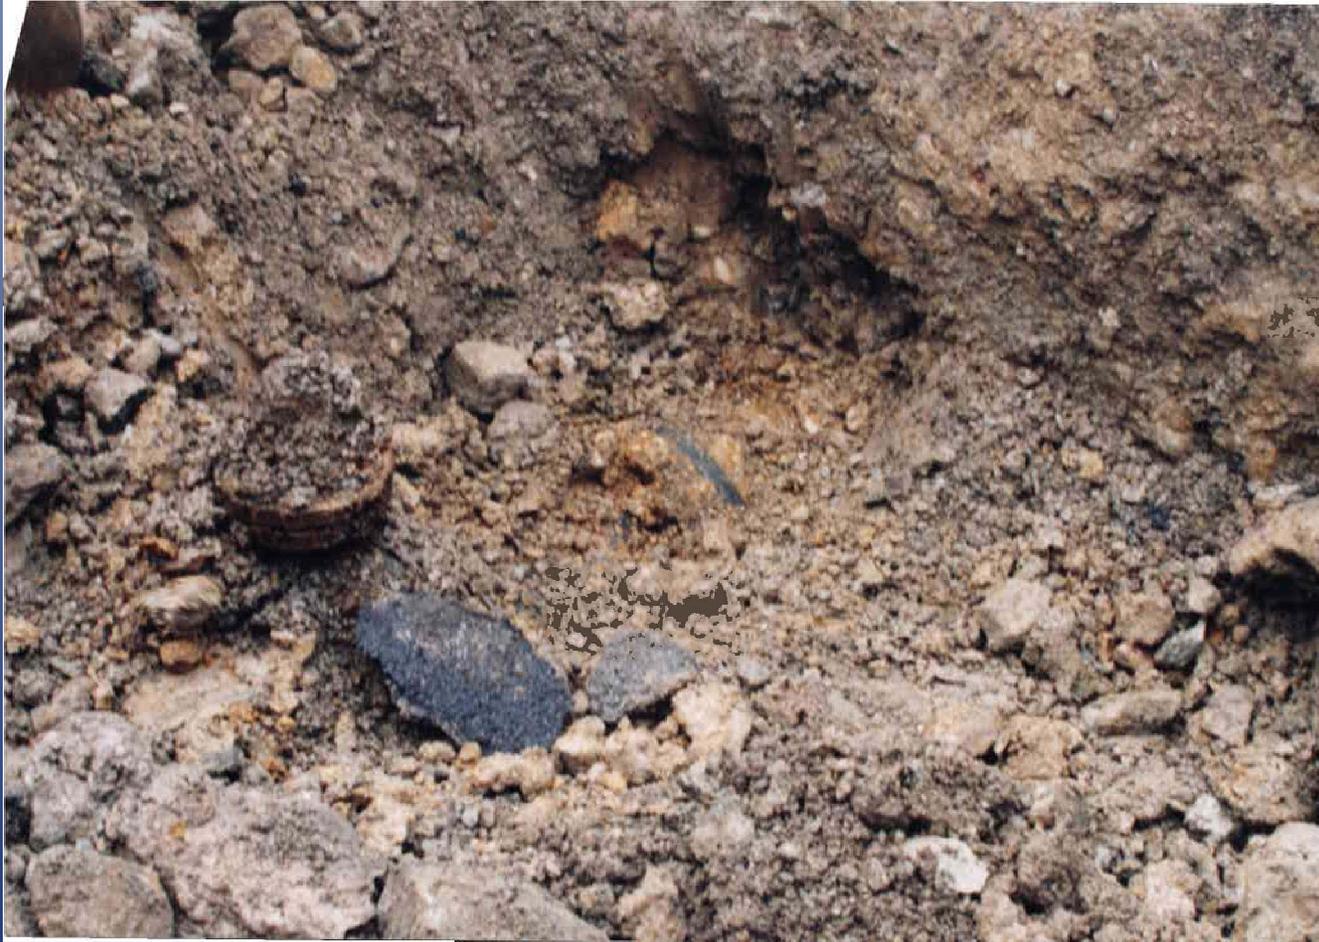
# Water valve

- Valve is uncovered and attempted to close.
- Valve is already closed. Later it is learned that this is a water valve.

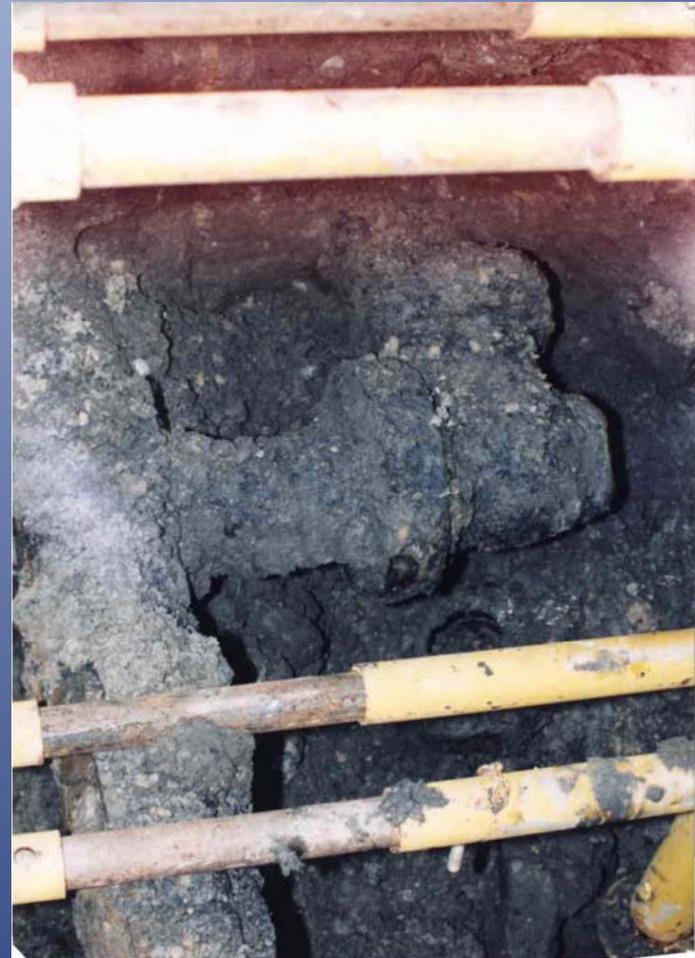
# Gas Valve details

- Depth is not indicated on maps.
- Valve is actually laying on its side.
- When finally excavated valve is 7 feet deep.

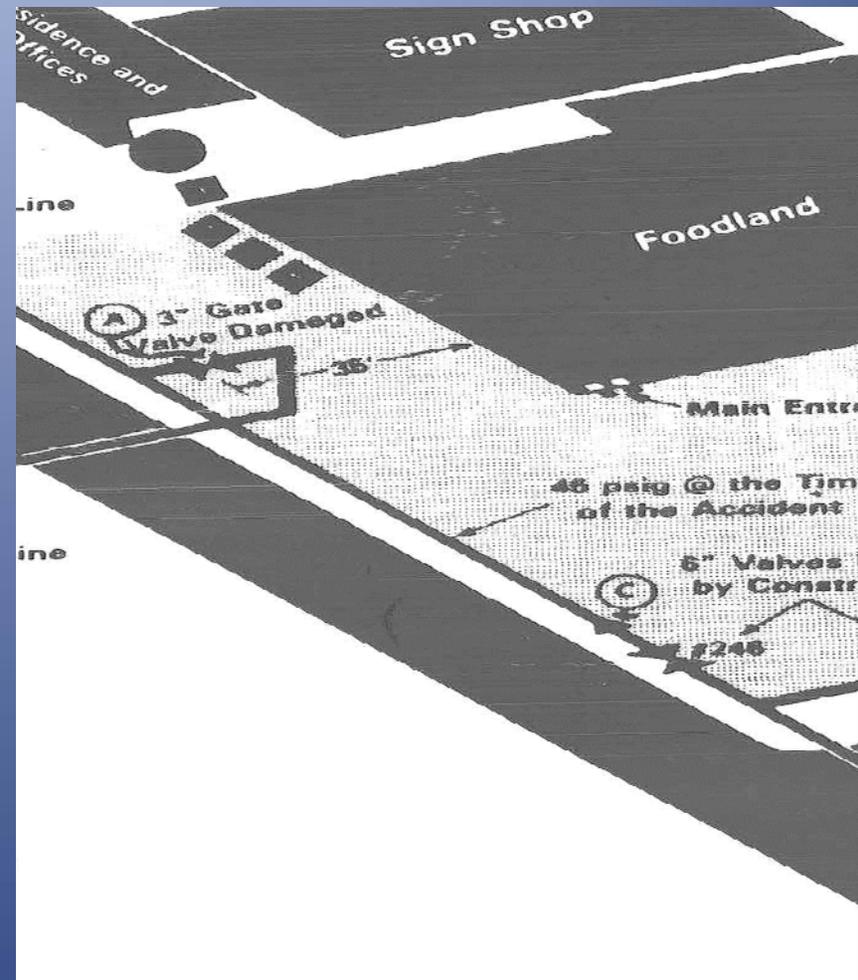
- Crew decides leak is on the 4-inch main.
- Attempt to find valve 246.
- Valve is buried under construction supplies.
- Crew uses metal detector to try and locate.

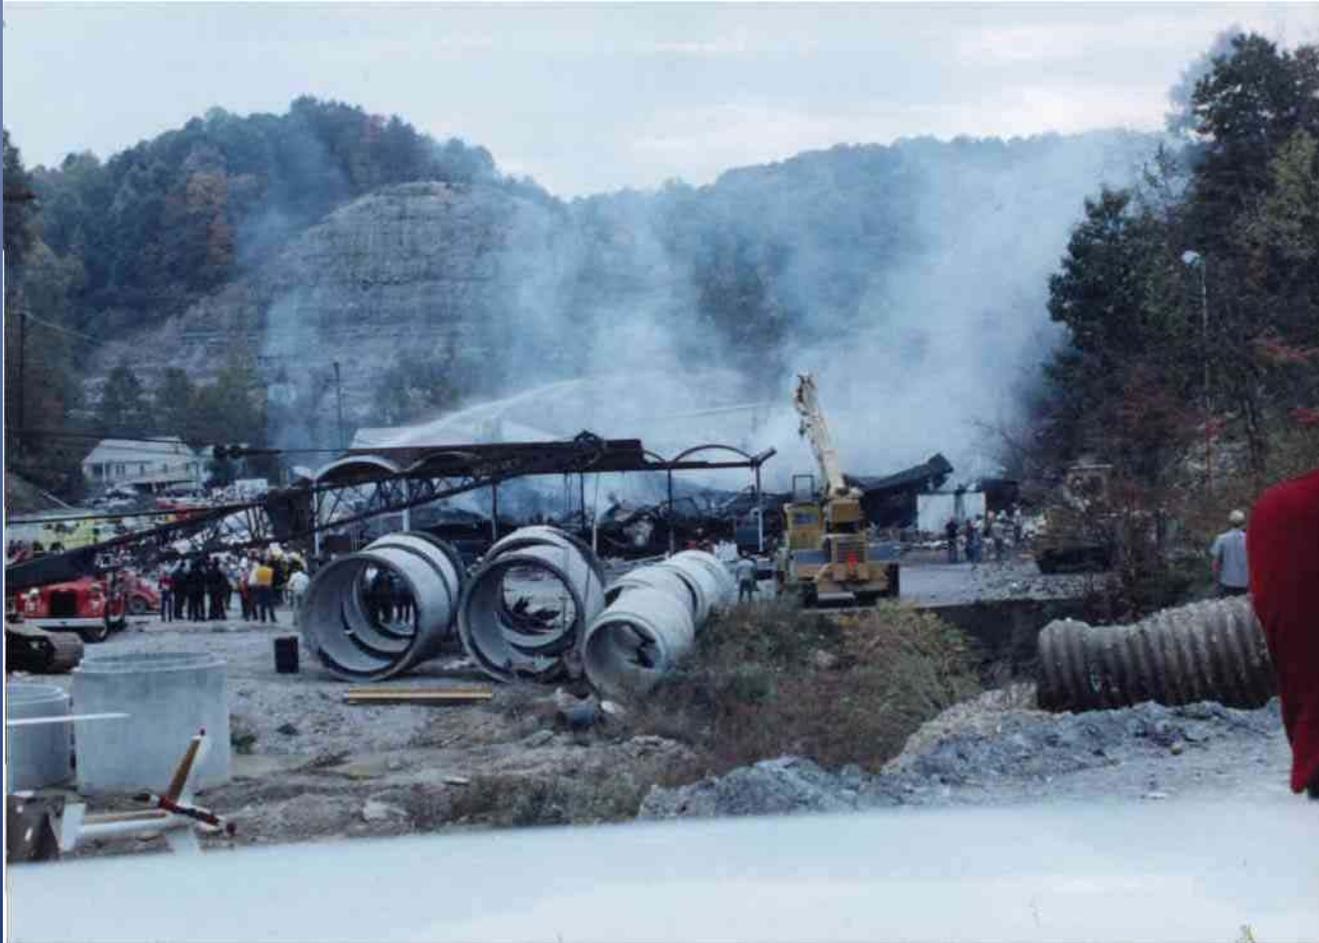
1:52 pm – Foodland explodes.

- 18 people are in the store at the time of the explosion.
- Roof is blown up into the air and falls back on the store area.
- It is partially supported by the shelving units, allowing people inside to crawl to safety.
- Fires start in Foodland.
- Gas ignites at the valve, flames burn across road and parking lot.

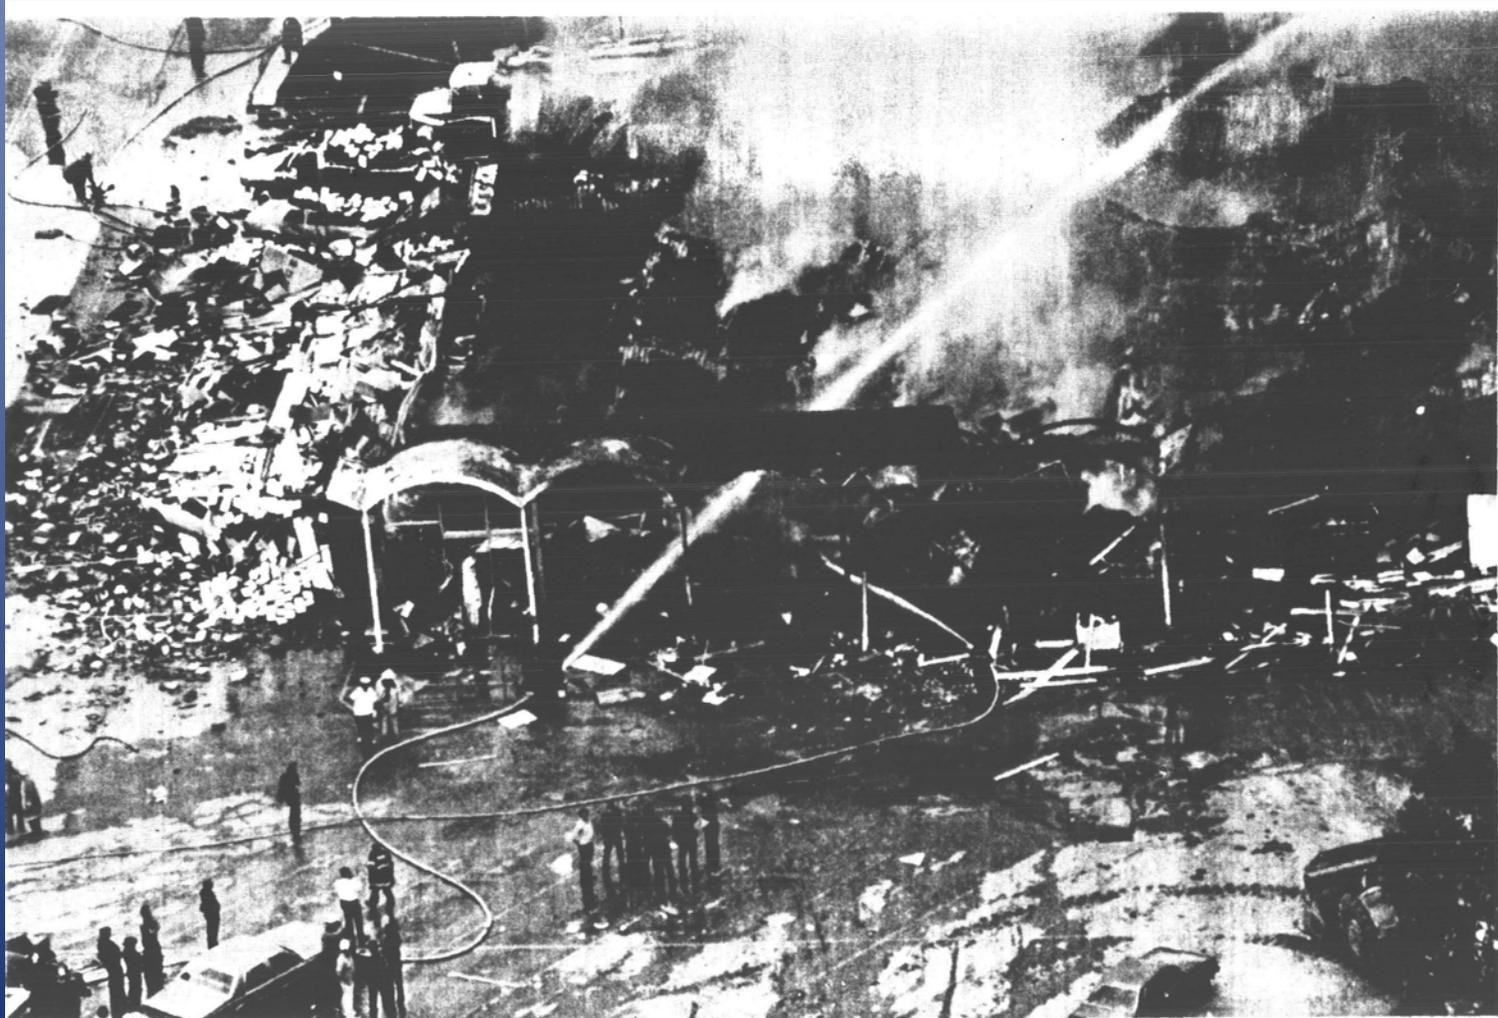
Figure 14.--Photograph of Foodland Supermarket showing roof partially supported from beneath.

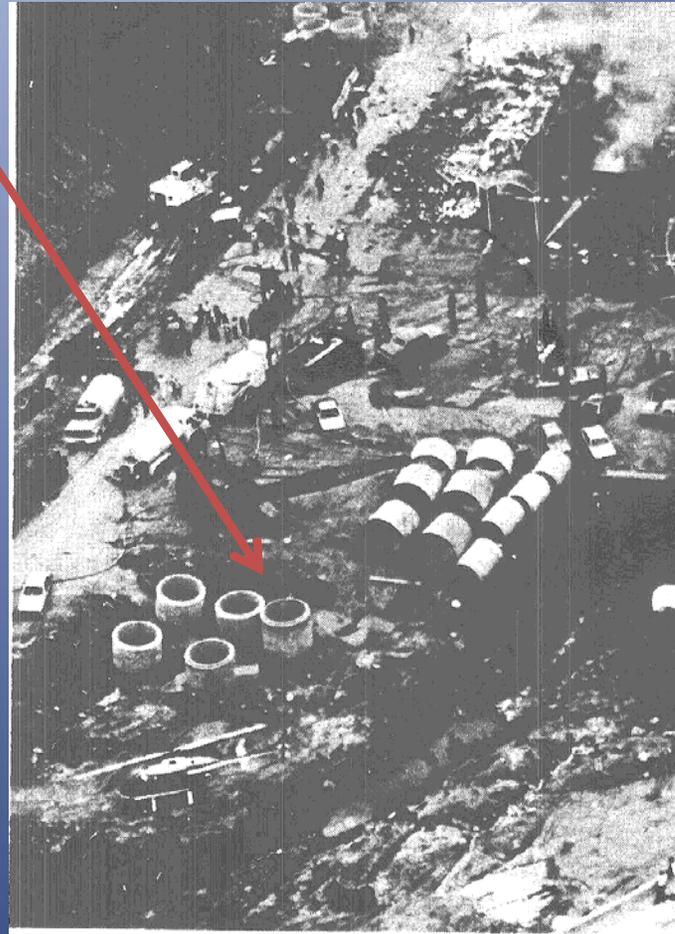
# Valve 246

- Buried and inaccessible
- Marker over valve had been knocked down and along a dirt road made by the construction company.

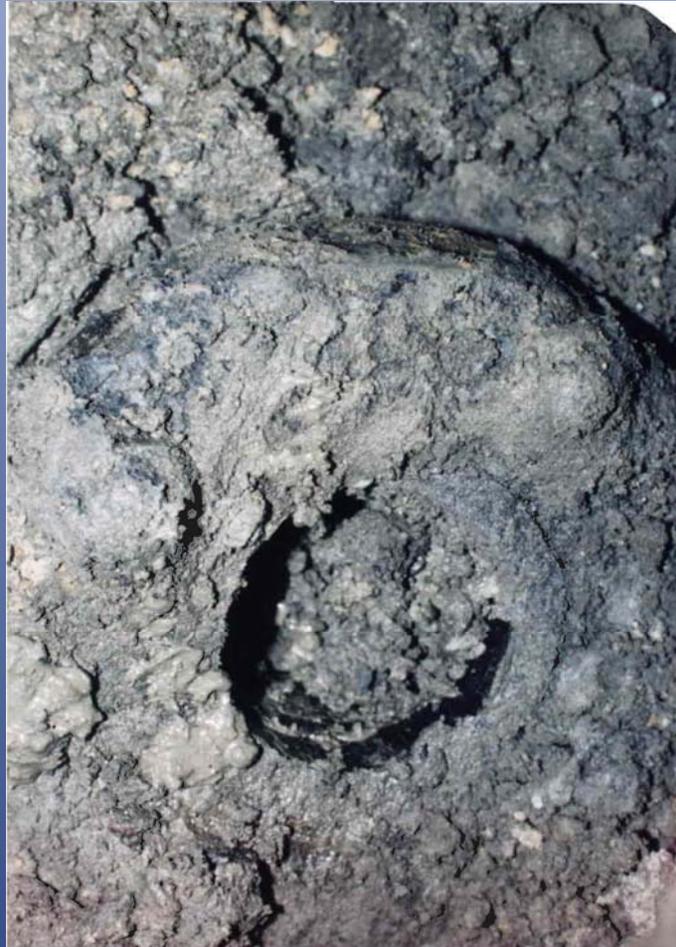
# Broken flange

- Gate valve buried 7 feet deep.
- Valve was fully open.
- Flange was fractured and separated from the valve body.
- Gas at 45 psi was blowing straight up from the valve.
- Gas vented around 2 water valve boxes in the same area.
