Feature ID	Survey Date	Start MP	End MP	County	State	Survey Type	Habitat Quality	Suitable T&E Habitat?
TDH1SDYA003	9/15/2006	421.8	422.1	Yankton	SD	Site Visit	High	Yes, Dakota skipper

Keystone Pipeline Project

Map 20 of 21
Surveyed
Grasslands

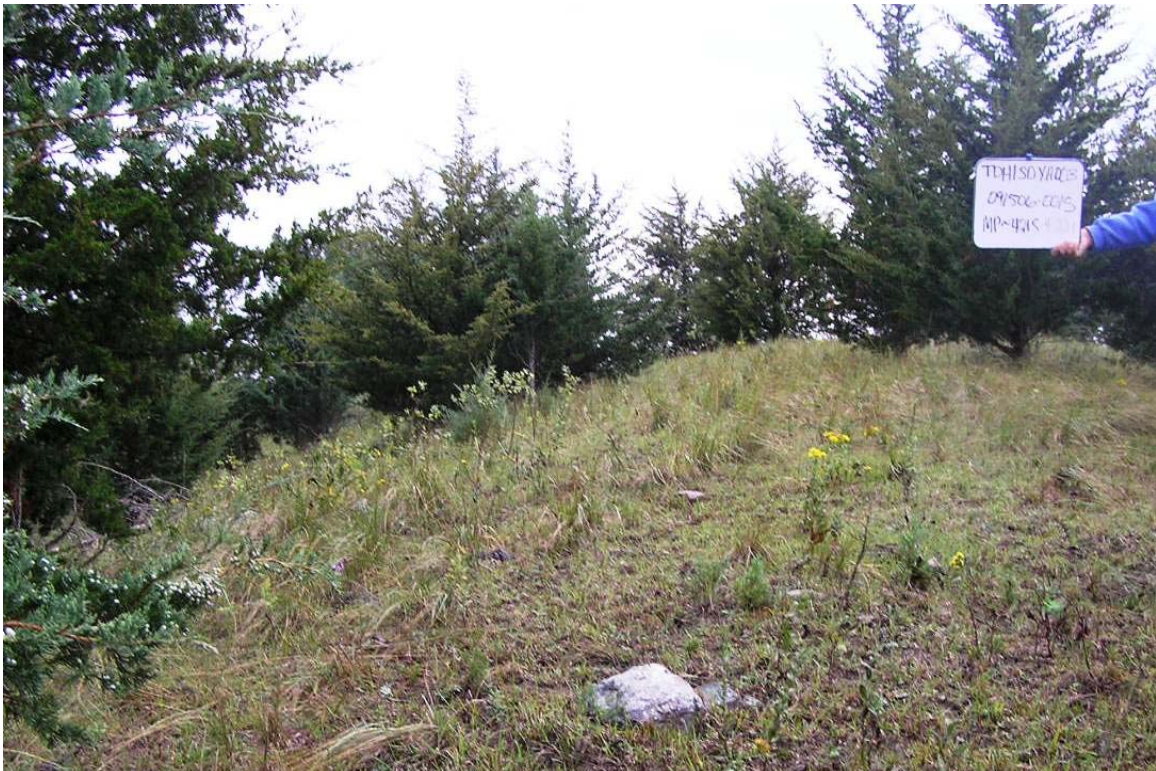
Site Summary. This grassland is at the Keystone pipeline James River crossing. Although this area has ravines filled with cedar (*Juniperus scopulorum*) and a mix of less common broadleaf trees such as box elder (*Acer negundo*) and hackberry (*Celtis occidentalis*), there are ridges between these wooded ravines that have high quality, well protected native grassland. Grasses on these ridges include prairie dropseed (*Sporobolus heterolepis*), Indian grass (*Sorghastrum nutans*), side-oats grama and blue grama (*Bouteloua gracilis*). Native forbs include black Sampson (*Echinacea angustifolia*), cusp blazing star (*Liatris mucronata*), compass plant (*Silphium laciniatum*), and hoary verbain (*Verbena stricta*). Although this area is moderately grazed and has a few exotic weeds such as burdock (*Arctium minus*), it is quality habitat for the Dakota skipper.

Feature TDH1SDYA003: View to the south of a ridge of native prairie.

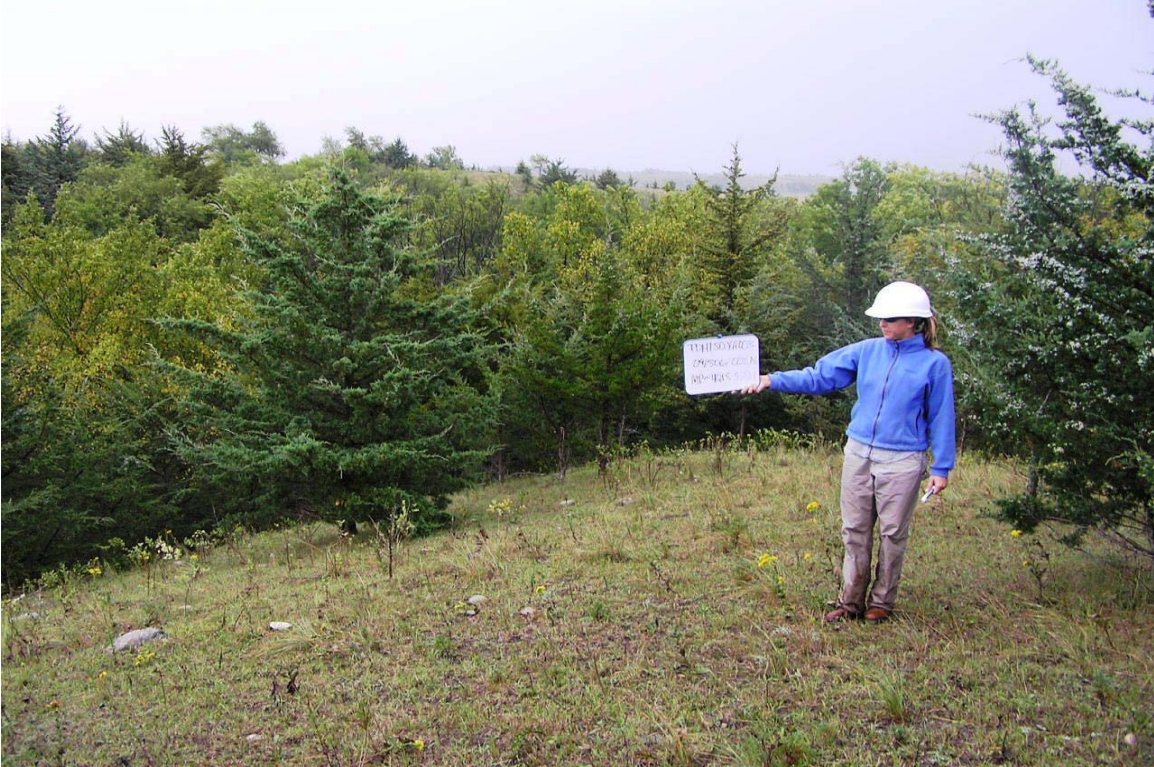
Feature TDH1SDYA003: A ridge of native prairie with trees in the ravines near the James River.

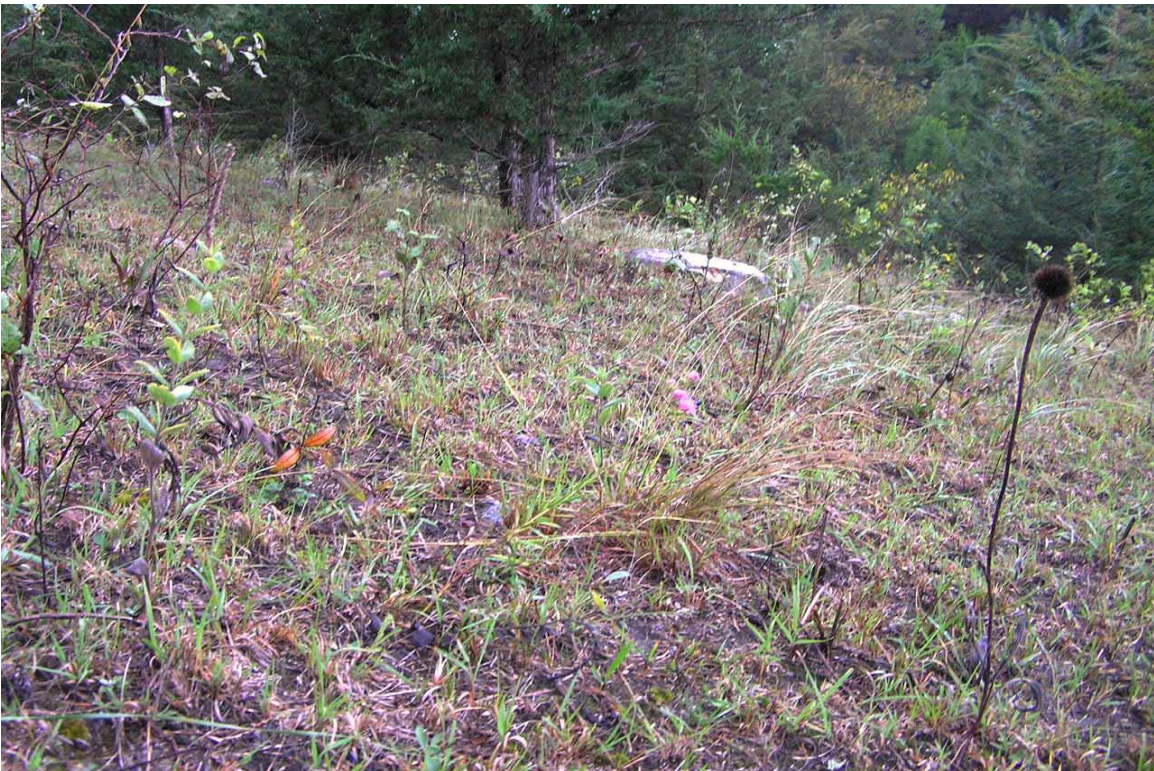
Feature TDH1SDYA003: A close-up of ridge vegetation: black Sampson (*Echinacea angustifolia*) to the right, and a purple cusp blazing star (*Liatris mucronata*) in the center.

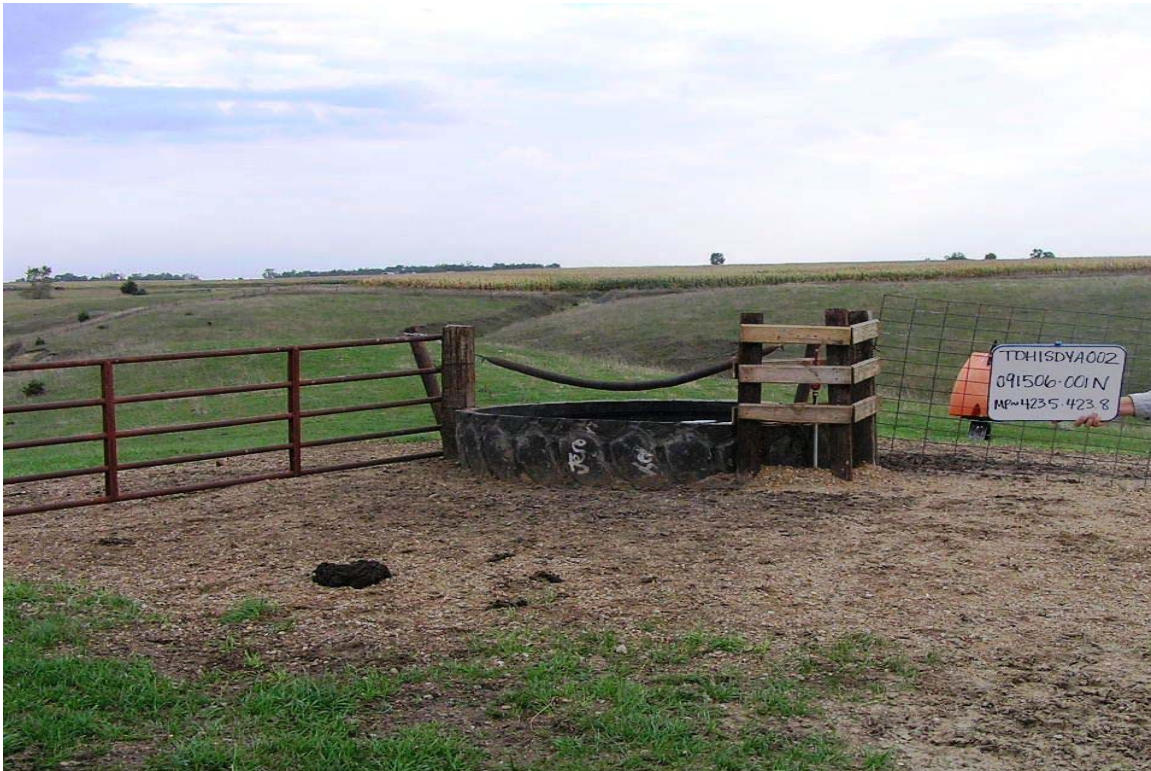
Site Summary: The lowland swales are dominated by smooth brome (*Bromus inermis*) with very few native plants. The slopes of these hills have erosion contours due to heavy grazing. The upland area near center line is heavily grazed (few native forbs). The ridges along the construction corridor are dominated by blue grama (*Boutoula gracilis*) with patches of side-oats grama (*Boutoula curtipendula*), and still contain native prairie with few exotic plants. This site would become a higher quality prairie if the grazing intensity were lowered. Due to the absence of native forbs (heavy grazing), it is currently not a high quality site.

Feature TDH1SDYA002: Heavily trampled water tank at center line, along the ridge.
