Xcel Energy Split Rock to Lakefield Junction 345-kV Transmission Line and Add  
Facilities EL05-023  
Stipulation Update  
Burns and McDonnell Project Number: 40754

Modification: Bald Eagle Management Plan for the Southwest Minnesota Transmission Upgrade Project

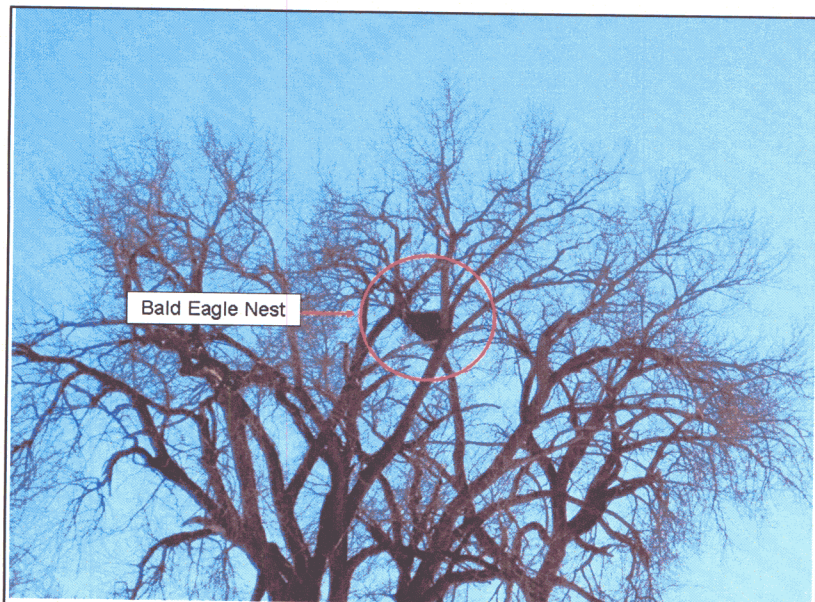
**Figure 4** Newly Observed Bald Eagle Nest Near the Split Rock Substation (photo taken north to south)

A new (likely relocated) bald eagle nest (Figures 4 and 5) is located east of the proposed line along the Big Sioux River (Figure 1). The newly observed nest is located farther from the proposed line relative to the previously observed nest. It is Burns & McDonnell's professional opinion that the newly observed nest was constructed within the last year.

There was no observed activity at or around the nest during the period of observation on December 13, 2007. This also included observations under and near the nest and noted a lack of scat and the remains of prey on the ground. There was the presence of numerous prey tracks (*i.e.*, pheasants, raccoons) in the snow near and around the nest as well as waterfowl on the Big Sioux River. The nest is located immediately southeast and adjacent to a crop field that will be subject to activity throughout the year for agriculture purposes (Figure 6). The crop field was used in 2007 for corn production; therefore a considerable amount of activity took place near the nest during the building process. Additionally, the nest is now closer to the Burlington Northern/Santa Fe Railroad and Interstate 90. These factors did not deter the eagle(s) from constructing the nest in this location. There is an existing transmission line in the area that does not appear to have had an adverse effect on the bald eagles in the area. The continued presence of the
