Cracks in onshore wind power foundations

Causes and consequences

Elforsk rapport 11:56

January 2012

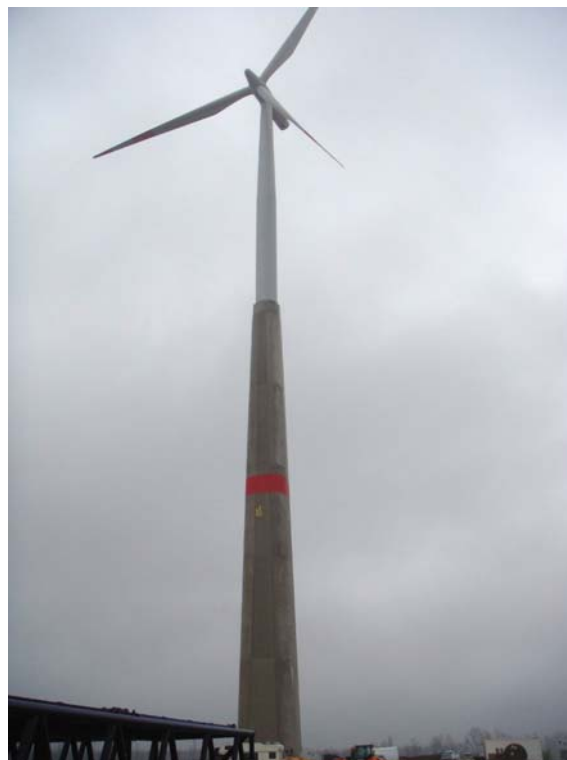
The structural concepts and the production techniques which are used for the concrete part of the hybrid concrete and steel towers are with a few exceptions similar to those of the concrete towers.

Figure 7 – Hybrid concrete and tubular steel tower.

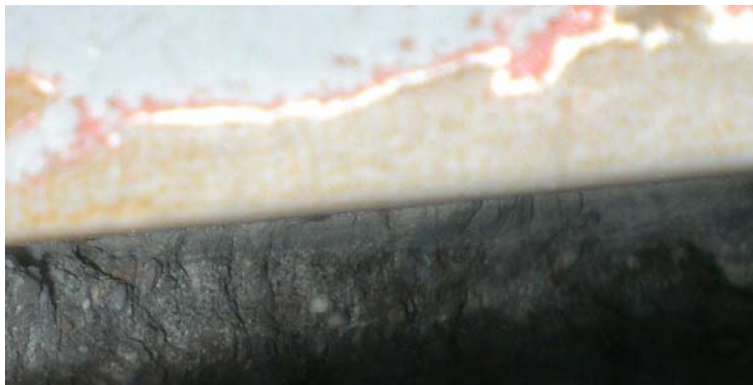
Some other damages associated with the defect mortar grout are reported by [9], for instance: soft layer due to separation in mortar, air inclusion inside the mortar and below the flange and non-uniform grouting material.

Figure 30 – Weak mortar grout caused by separation of the mortar, [9].

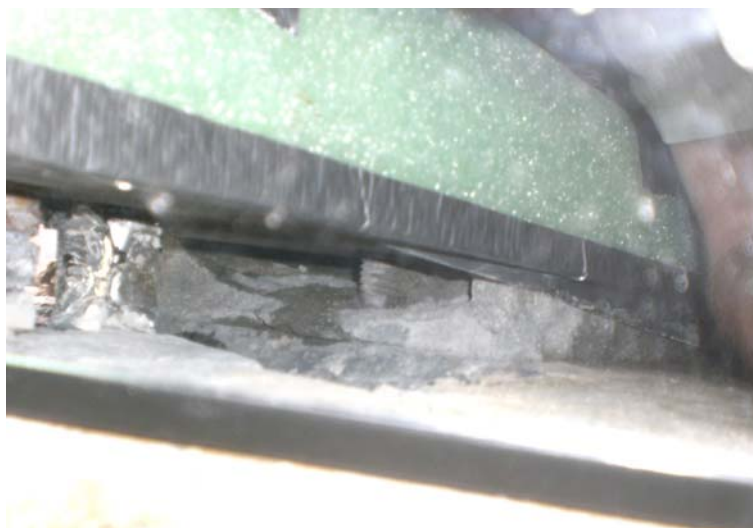
Figure 31 – Inclusion of air voids inside the mortar grout under the flange, [9].

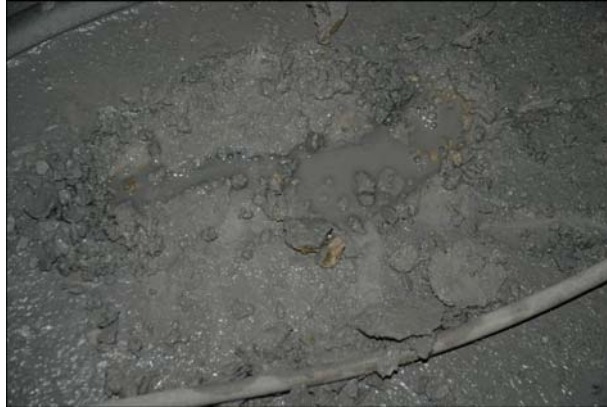
Figure 40 - Spalling (s) due to the cracks, with out-flowing water, [15].

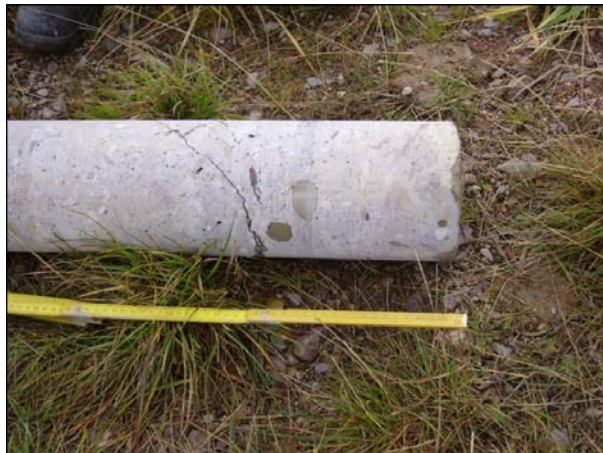
The foundations of two wind power turbines were core-drilled. The drilling was carried out through the height of the foundations. As it was feared the punching cracks, as described above, were observed at the bottom of the foundation, Figure 42.

Figure 42 - Crack approximately 30 cm from the bottom of the foundation, [15].

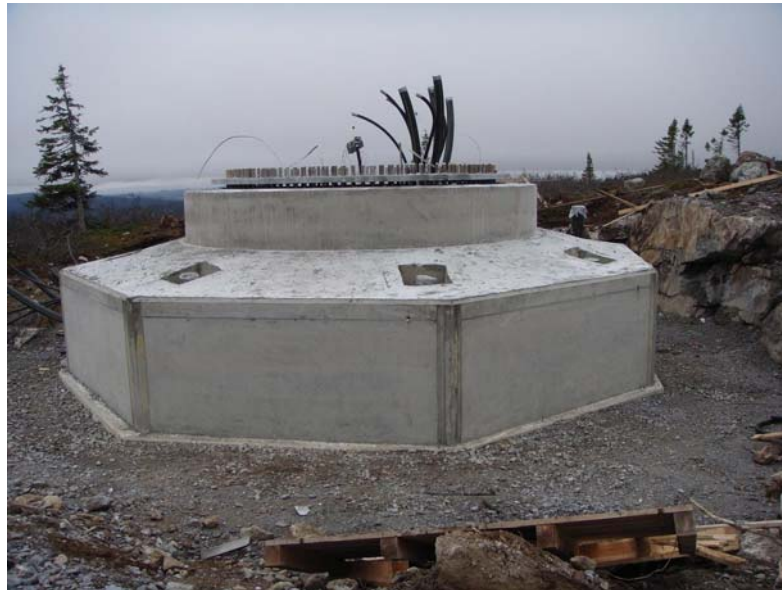
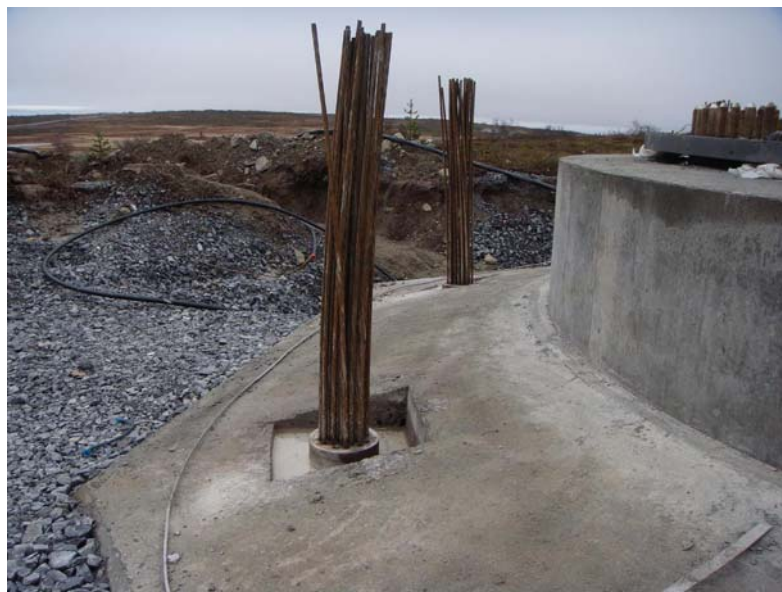
Figure 1 – Footing founded on the bedrock. The footing is anchored to the bedrock. Please notice the load spreading plate which is anchored by the stud bolts. The tower flange will be mounted on the plate. Please also notice that the photos do not refer to the same object. However, the objects are in the same site and principally identical.

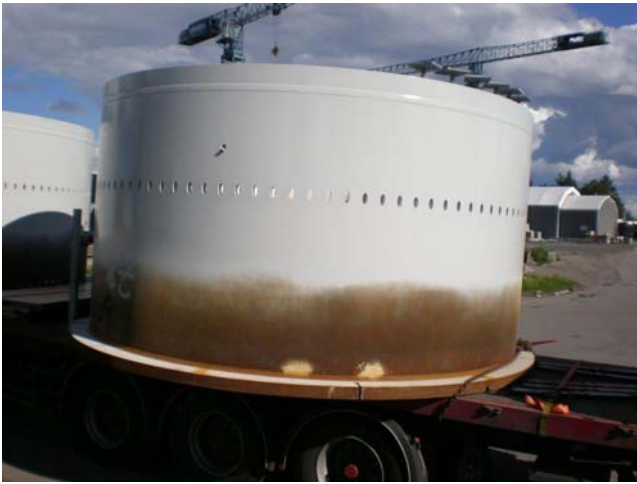
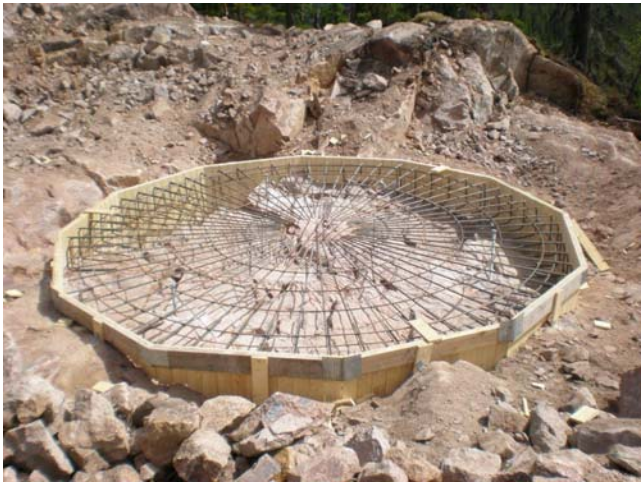
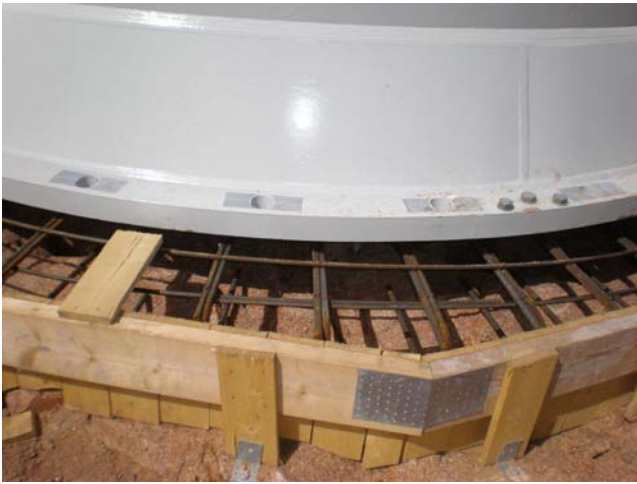
Figure 2 – Insert rings are also used for foundations on the bedrock.
