# Memo

To: Chairman Nelson, Vice-Chairman Fiegen, Commissioner Hanson  
From: Joshua Williams  
CC: Patricia Van Gerpen, Kara Semmler, Nathan Solem  
Date: 03/19/2012  
Re: SDPUC Pipeline Safety Staff Report on the Spearfish Pipeline Incident in Docket PS12-001

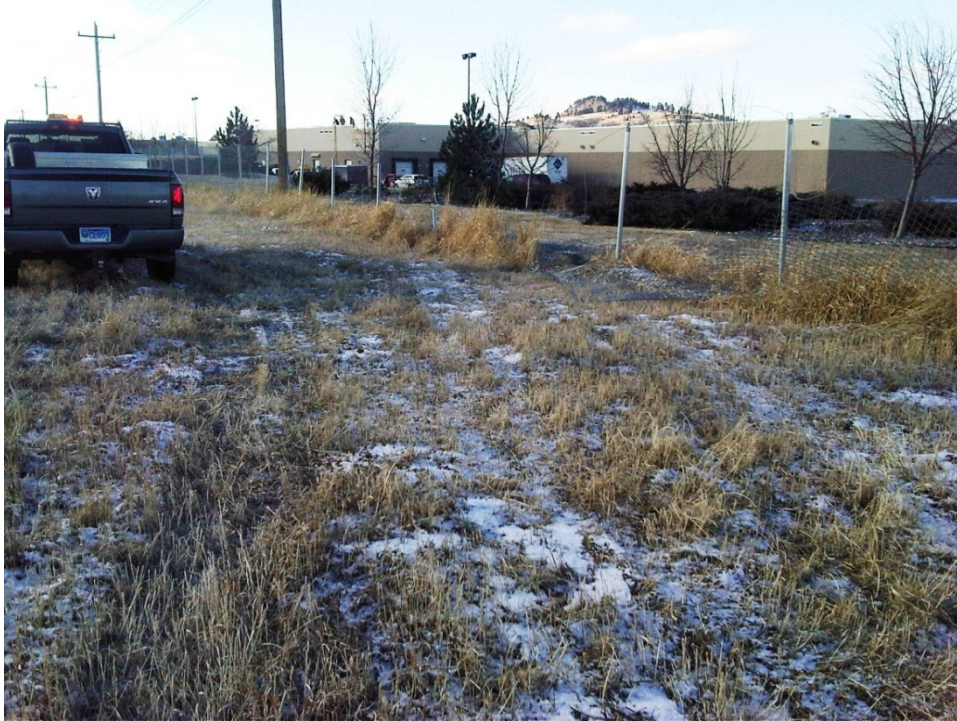
**Figure 2 Path of the Trailer from Interstate 90 to Wal-Mart**

The trailer, owned by MCS Trucking, traveled approximately 600' to the building through a chain link fence several trees and eventually into the building. Although there were snow flurries in the area that

morning, the road conditions were clear. The temperature was around 10 deg. F and the wind was blowing around 10-15mph. The following figures show the path of the trailer to the building.

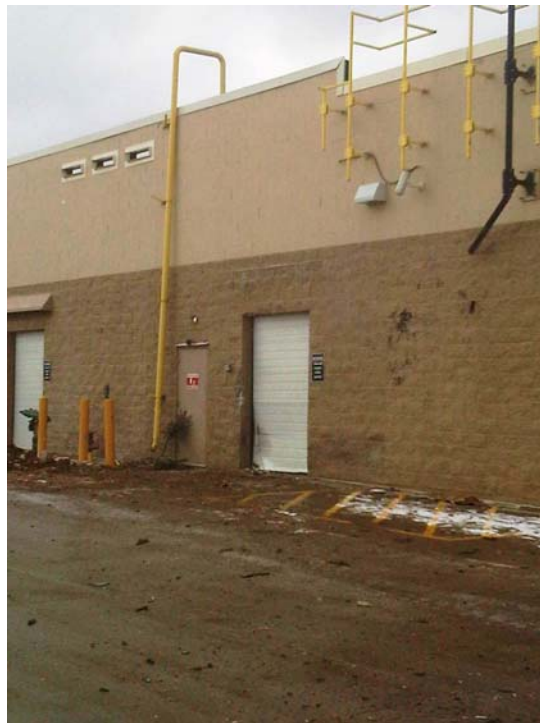
**Figure 5 Customer Piping and Building Damage**

There were no injuries or deaths associated with this incident, but the property damages were estimated to be around \$100,000. The wall of the building was damaged in several places. These figures show the building damage.

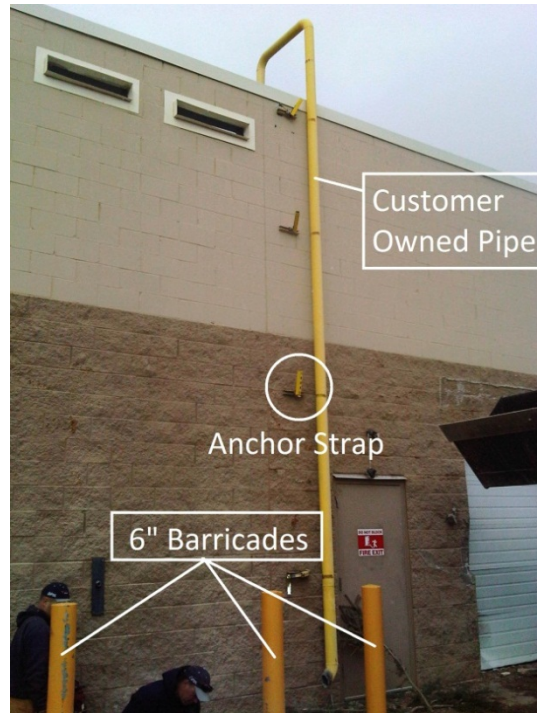
**Figure 8 Damaged Piping**

The force of the impact was such that all the support straps on the customer owned piping broke and even the mechanical units on the top of the building were shifted. The meter set had three 6" concrete barricades in place to protect it. The tongue of the trailer impacted the utility owned piping and the piping sheared off at the riser. The tongue was able to get behind the barricades while the logs were stopped by the barricades. The following photos illustrate the damage to the customer and utility owned piping.

The direct cause of the gas release was the tongue of the pup trailer impacting the meter piping at the riser.

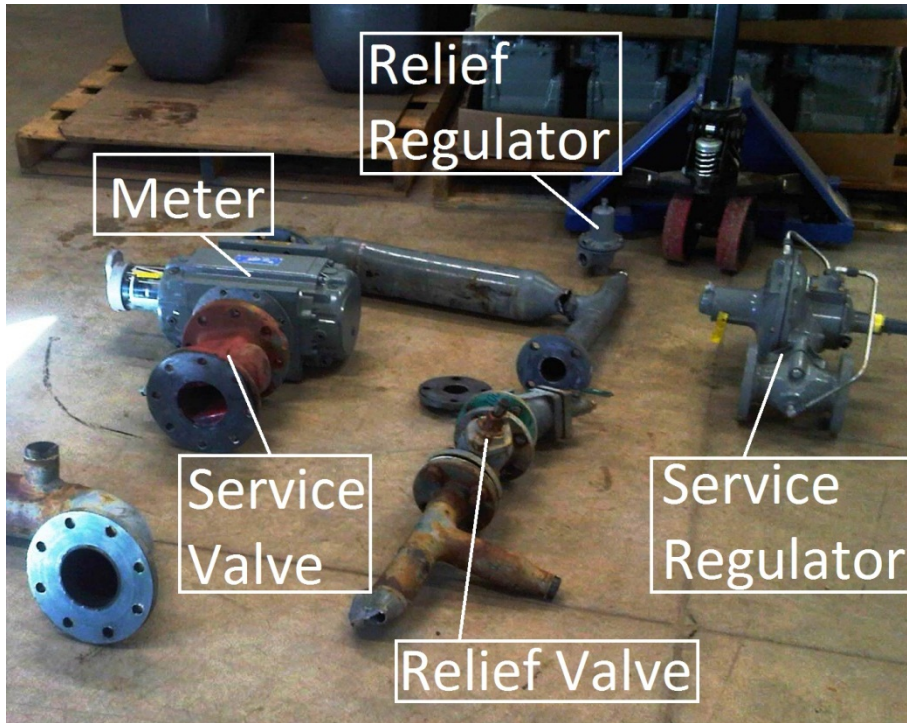
**Figure 12 Damaged MDU Pipe Components**

After the 2" line was pinched off to stop the flow of gas to the broken meter set, MDU crews removed all the damaged equipment so it could be inspected and replaced everything including the riser, valves, relief, and meter with new components. The following figures show damaged equipment broken down for inspection as well as the new equipment installed. The damaged equipment was broken down and inspected at the Spearfish shop.

- \* All damaged equipment was removed and replaced including the service riser, meter, and all valves.
- \* There was damage to the downstream customer owned piping and HVAC equipment.
- \* Gas service will remain shut-off until City Building Inspectors can okay the repair of the customer owned piping and equipment.
