MAOP/MOP Verification

Natural Gas Transmission & Hazardous Liquids Pipelines

Eric Kirkpatrick, P.E.
Structural Integrity Associates
April 4, 2013
SD/ND/WY Pipeline Safety
Operators Training

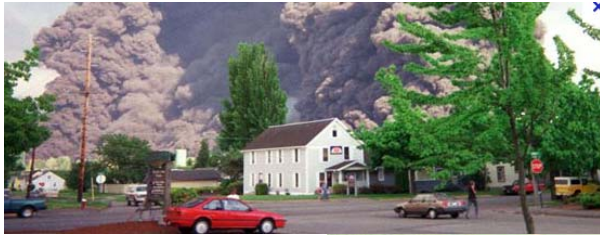
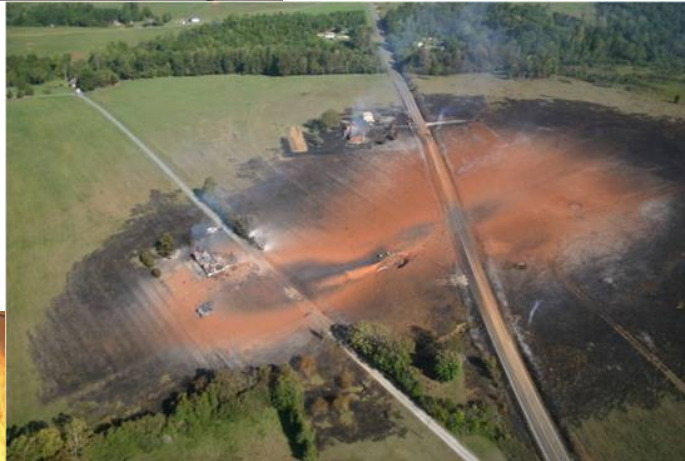
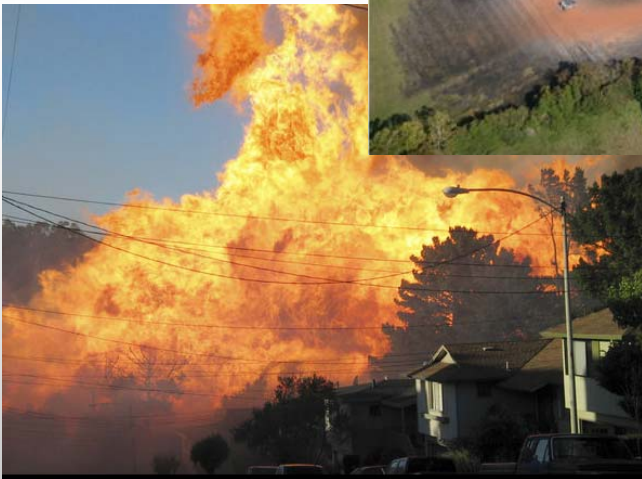
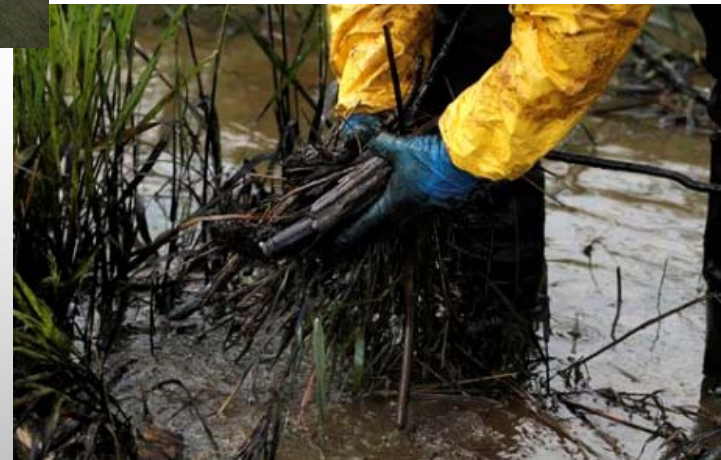
June 10, 1999

Olympic Pipe Line Company pipeline rupture

- 3 killed
- 8 injured
- \$10 Million fine
- \$75 Million settlement to parents of 2 boys

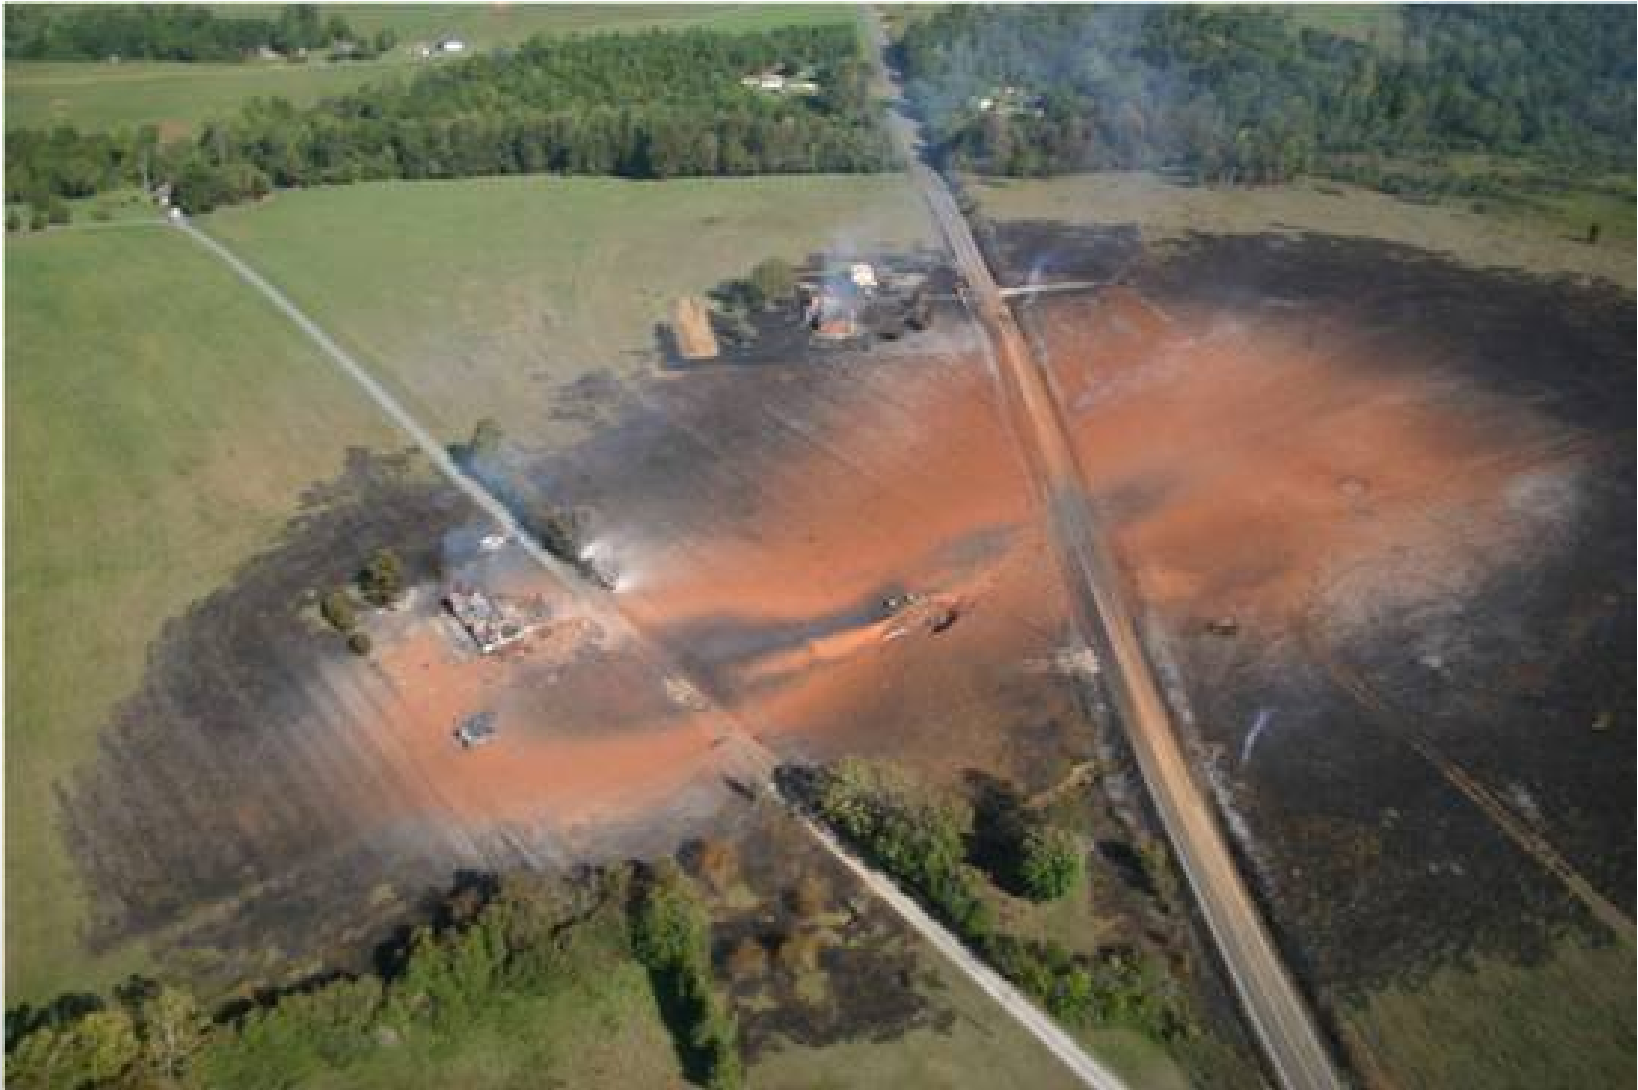
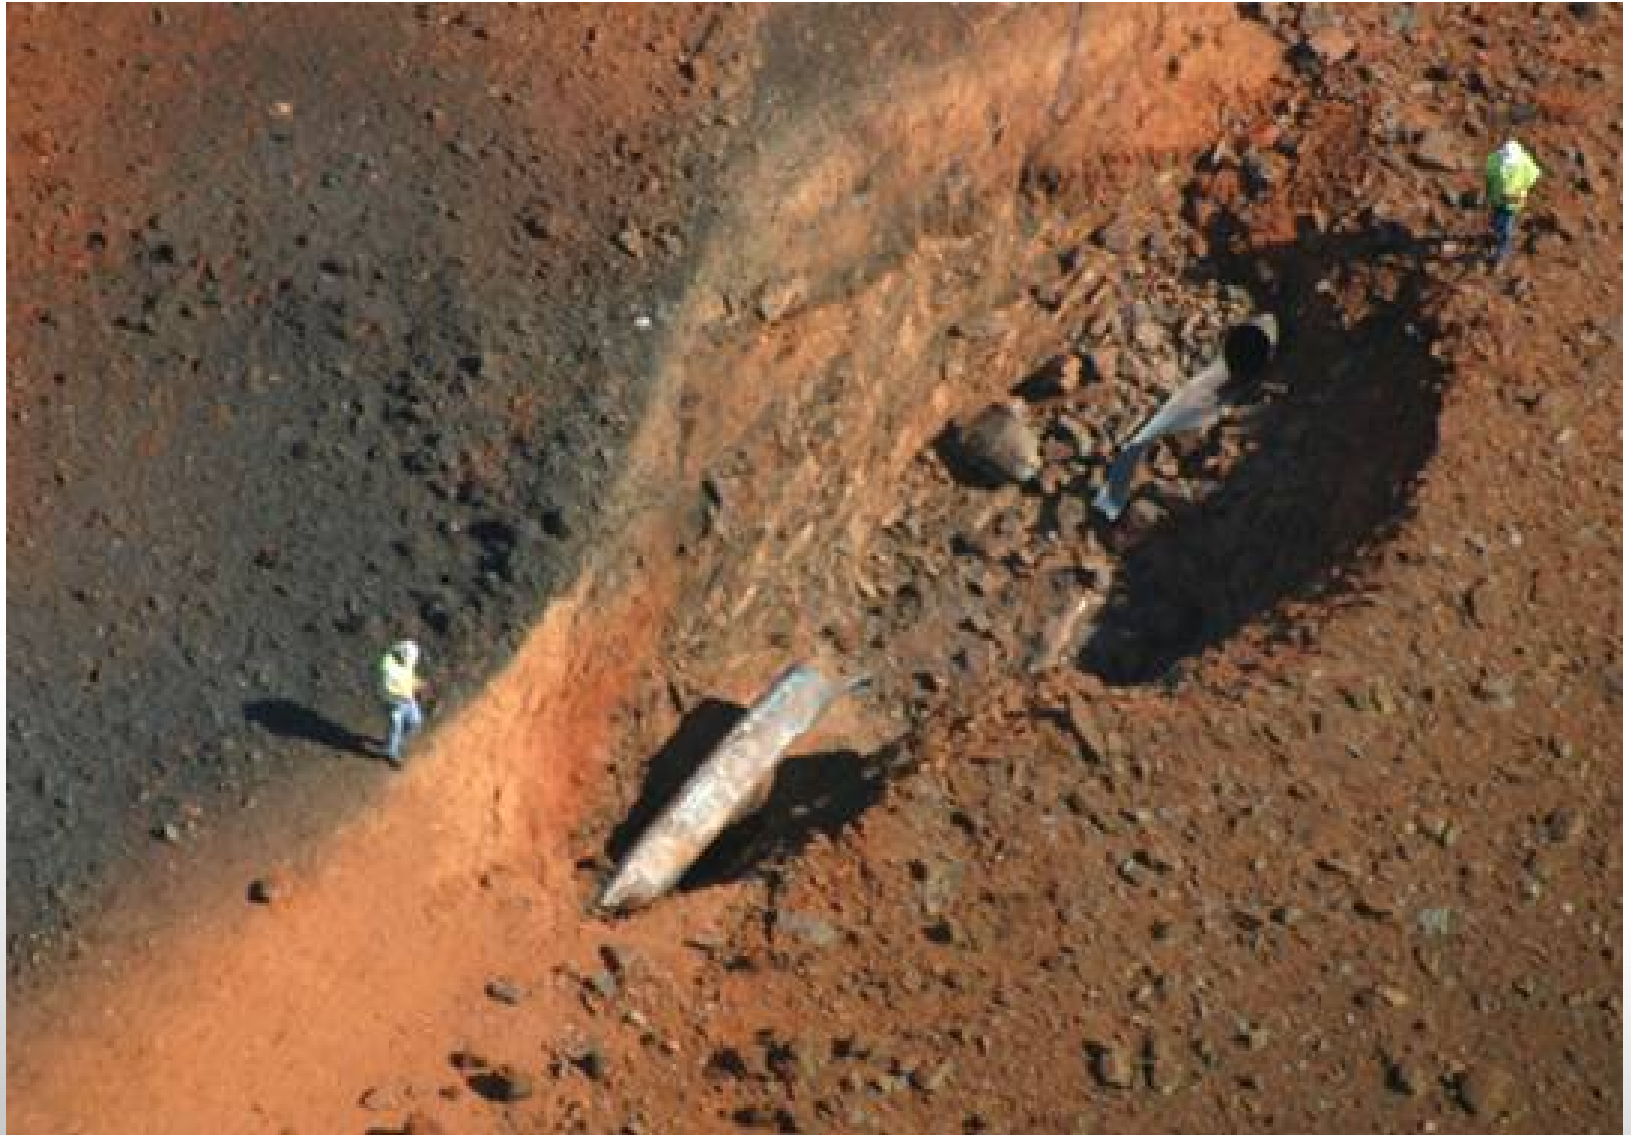
September
14, 2008

Williams Pipeline
Appomattox,
Virginia

5 Injuries, two structures damaged

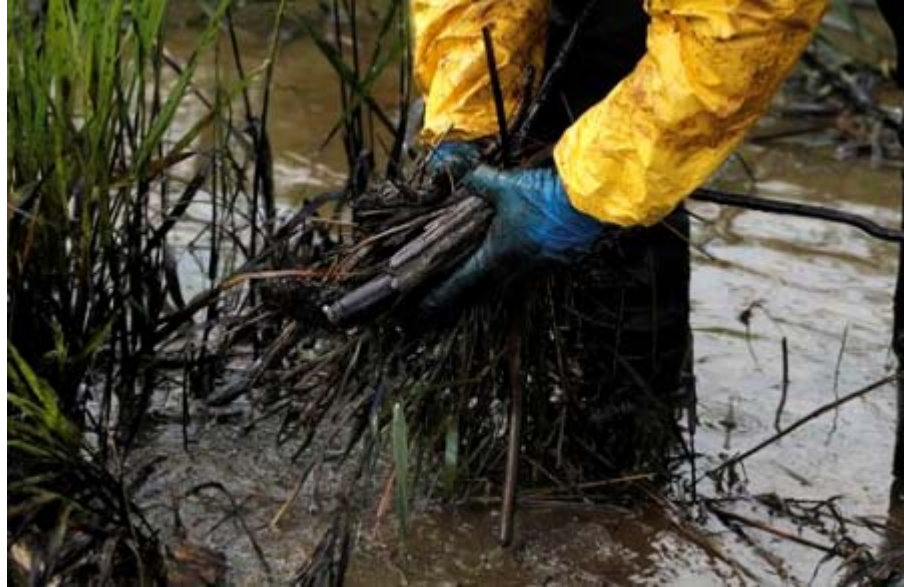
Exxon Yellowstone River Leak

- Montana, July 2011
- 1,500 barrels of oil into the Yellowstone River
- \$135 million in cleanup costs
- March 26, 2013 - \$1.7 Million fine proposed by PHMSA

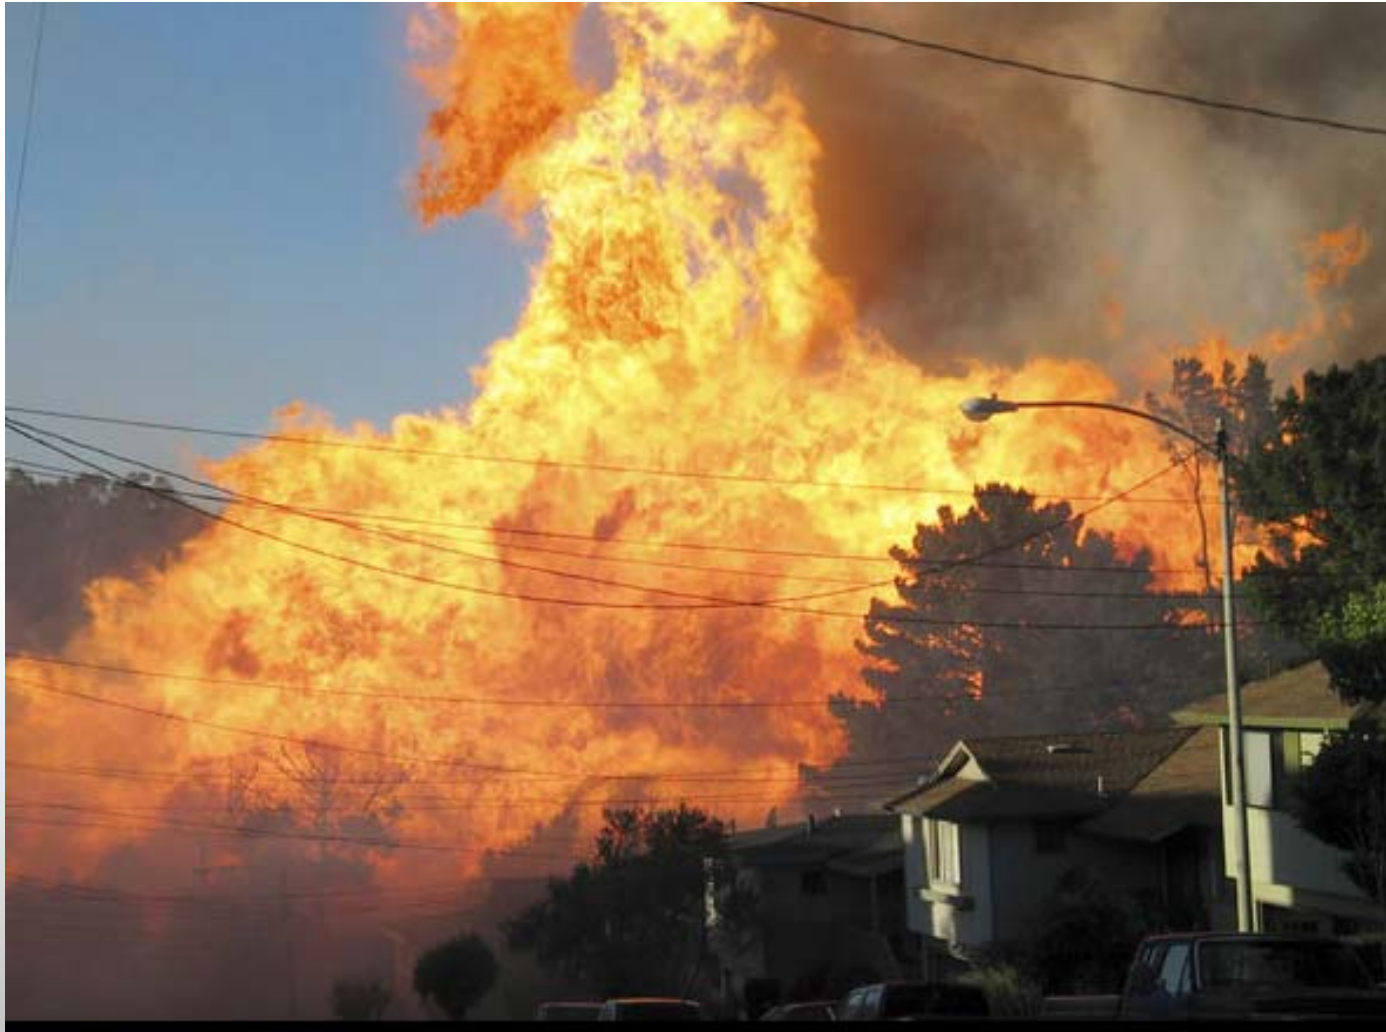
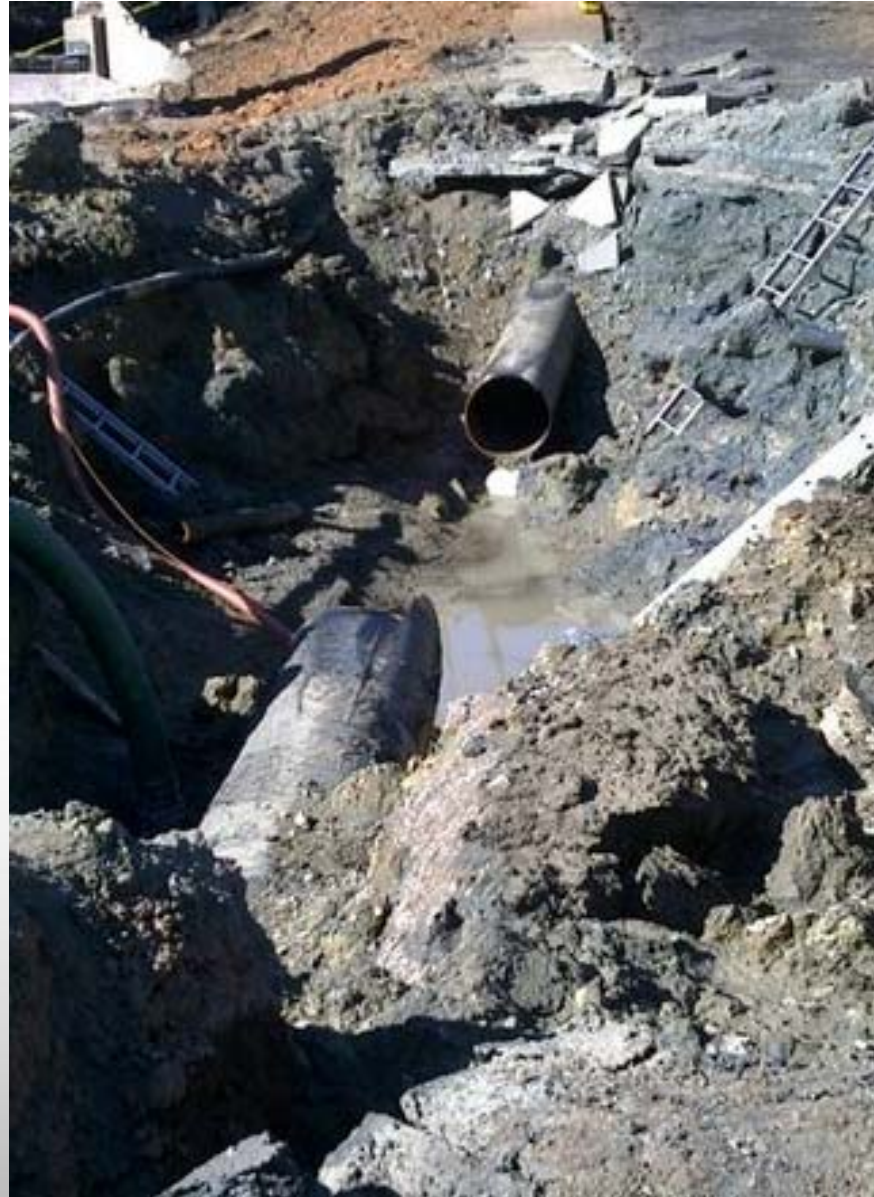
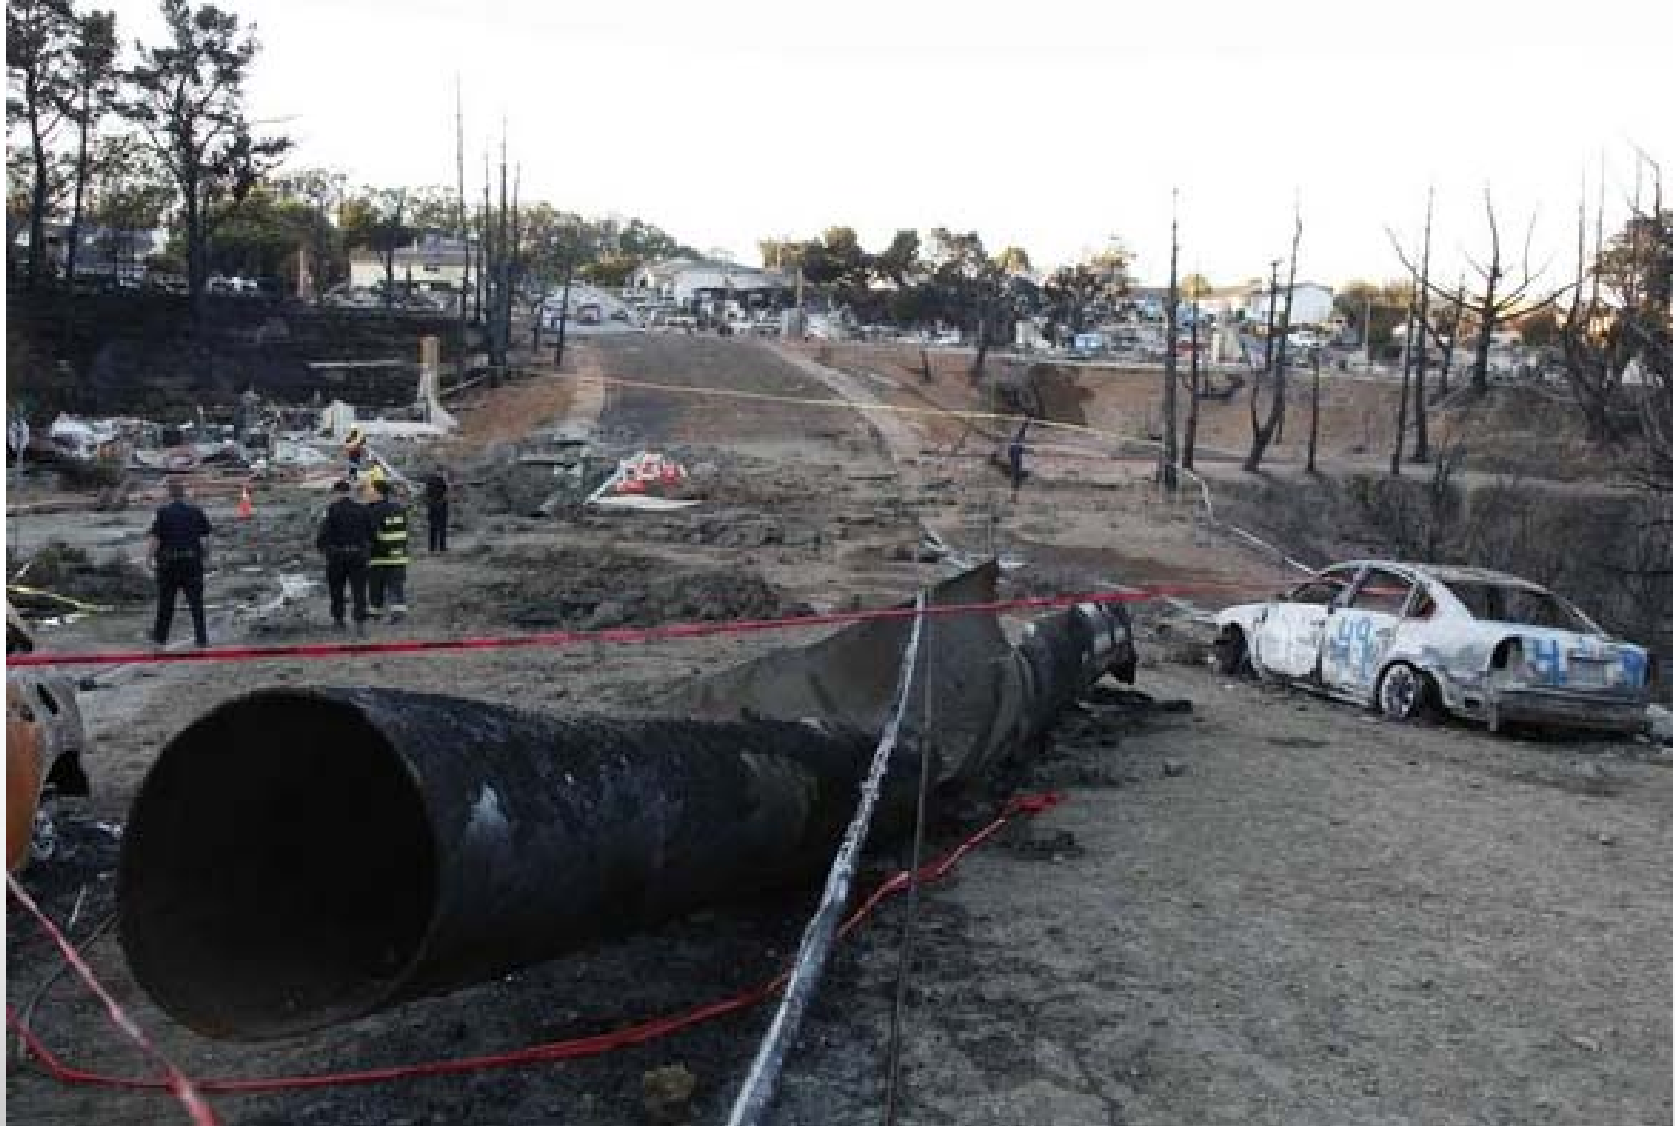
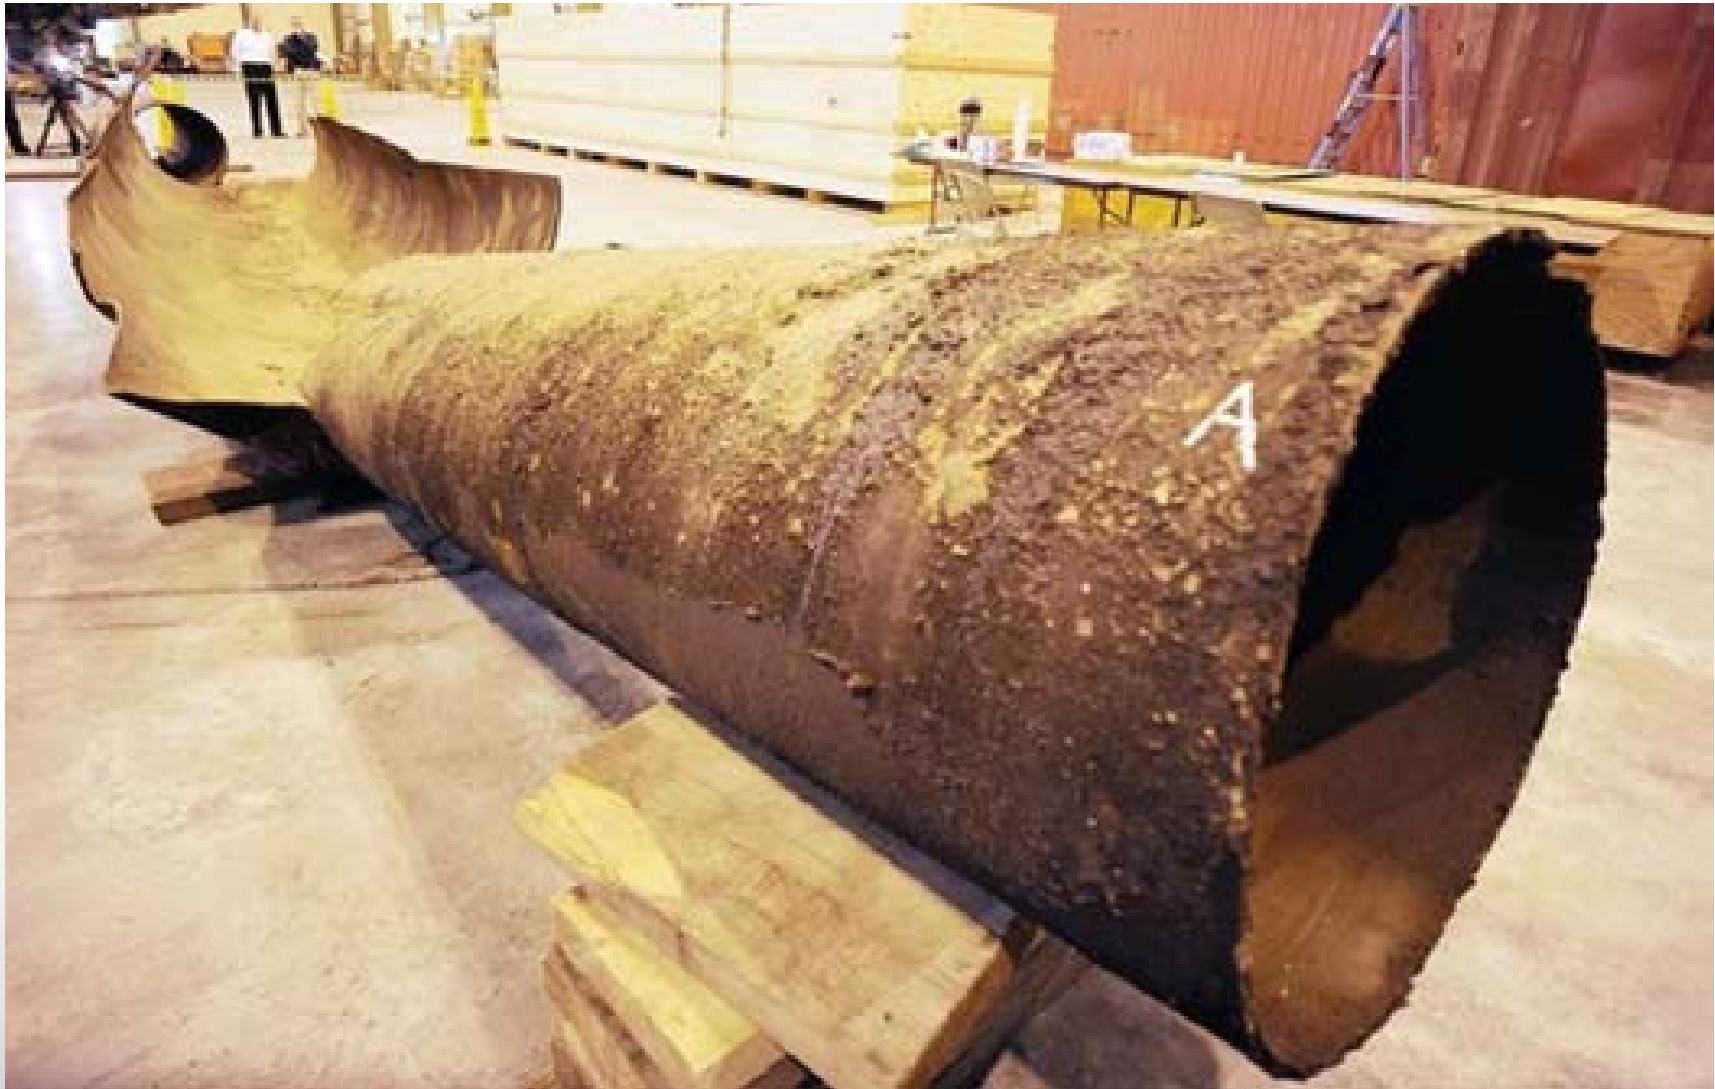
September 9, 2010 Pipeline Rupture – San Bruno, CA

Long Seam

- Type of System: 30-inch natural gas transmission pipeline installed 1956
- MOP established by historical operating pressure
- Fatalities/Injuries: 8 fatalities, (60 injuries)
- The resulting fire destroyed 37 homes and damaged 18.
- Pressure: 386 psig at time of rupture. MOP of 375 psi
- Longitudinal fracture of pipe
- Unknown Pipe Specifications – did not conform with any generally accepted QC and welding standards
- Recommended elimination of use of Historical Operating Pressure to establish MOP and requirement of pressure test

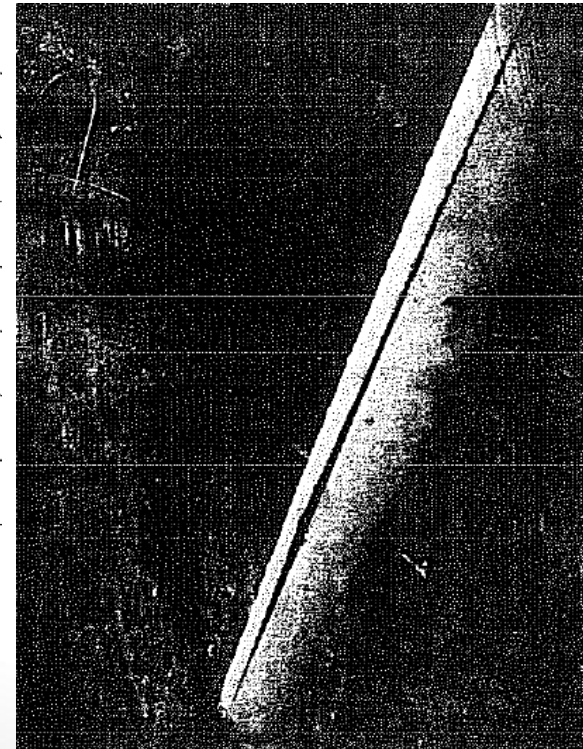
TYPE FAILURE AND DESCRIPTION Split in longitudinal seam

PIPE DATA: SIZE 12-3/4" O. D. x 0.203" W. T. x GRADE 5LX-42

FAILURE CAUSED BY Lack of fusion

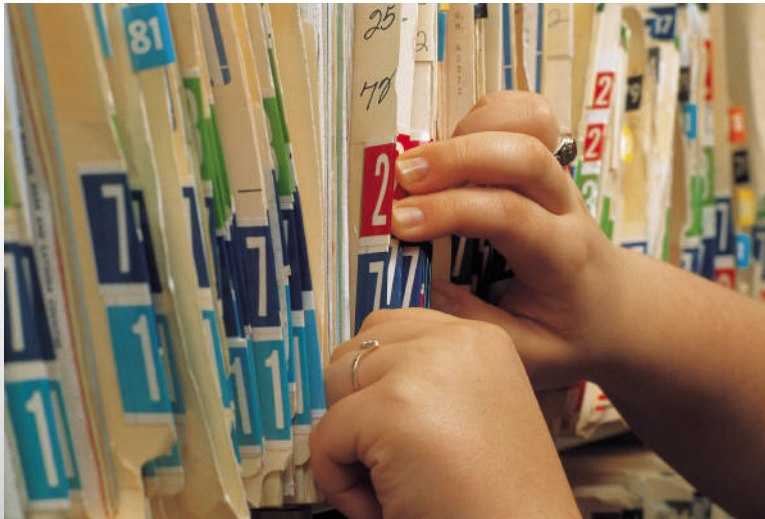
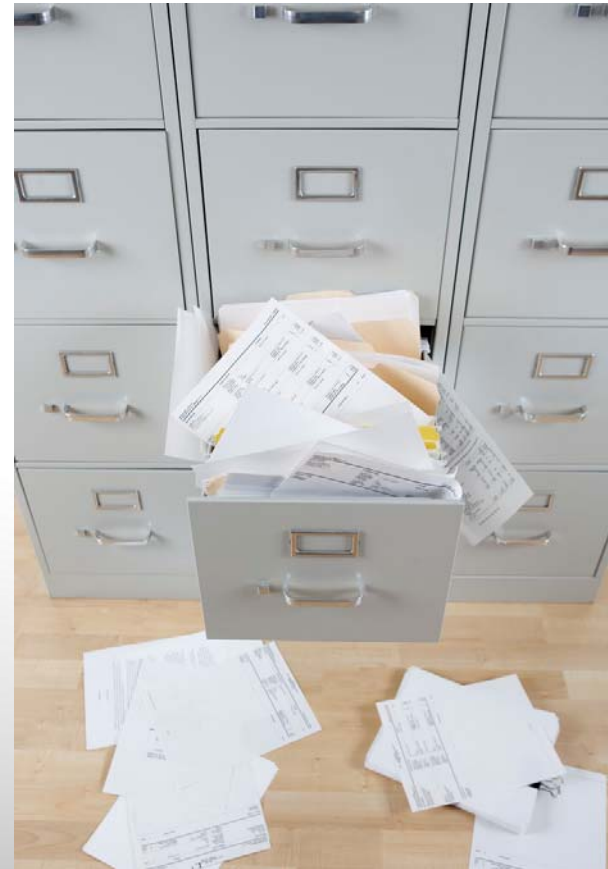
What Records are Applicable? Where are they?

Record Category	Date of Construction/Operation	Pipe Grade / Yield Strength	Pipe Nominal Diameter	Pipe Wall Thickness	Pipe Longitudinal Joint Type	Appurtenance: ASME/ANSI Rating	Appurtenance: Manufacturer Max Pressure
As-Built: Report	X		X	X	X		
As-Built: Drawing	X	X	X	X	X	X	X
Bill-of-Material		X	X	X	X	X	X
Mill Test Report		X	X	X	X

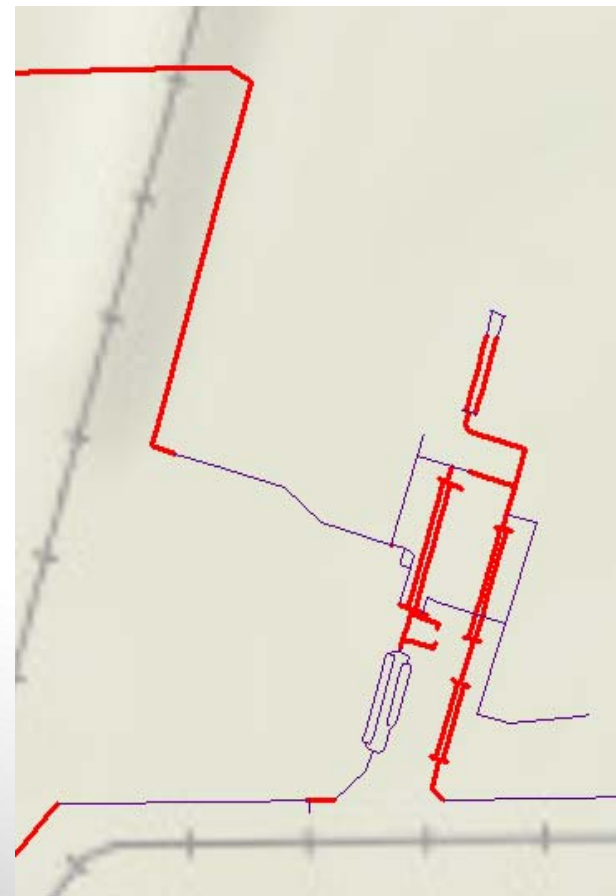
Time	Pressure	Deg. F
9:00 am	1276.1	45 F
10:00 am	1276.1	42 F
11:00 am	1274.1	40 F
12:00 pm	1273.1	40 F
1:00 pm	1272.1	40 F
2:00 pm	1271.1	38 F
3:00 pm	1270.1	36 F
4:00 pm	1269.1	32 F

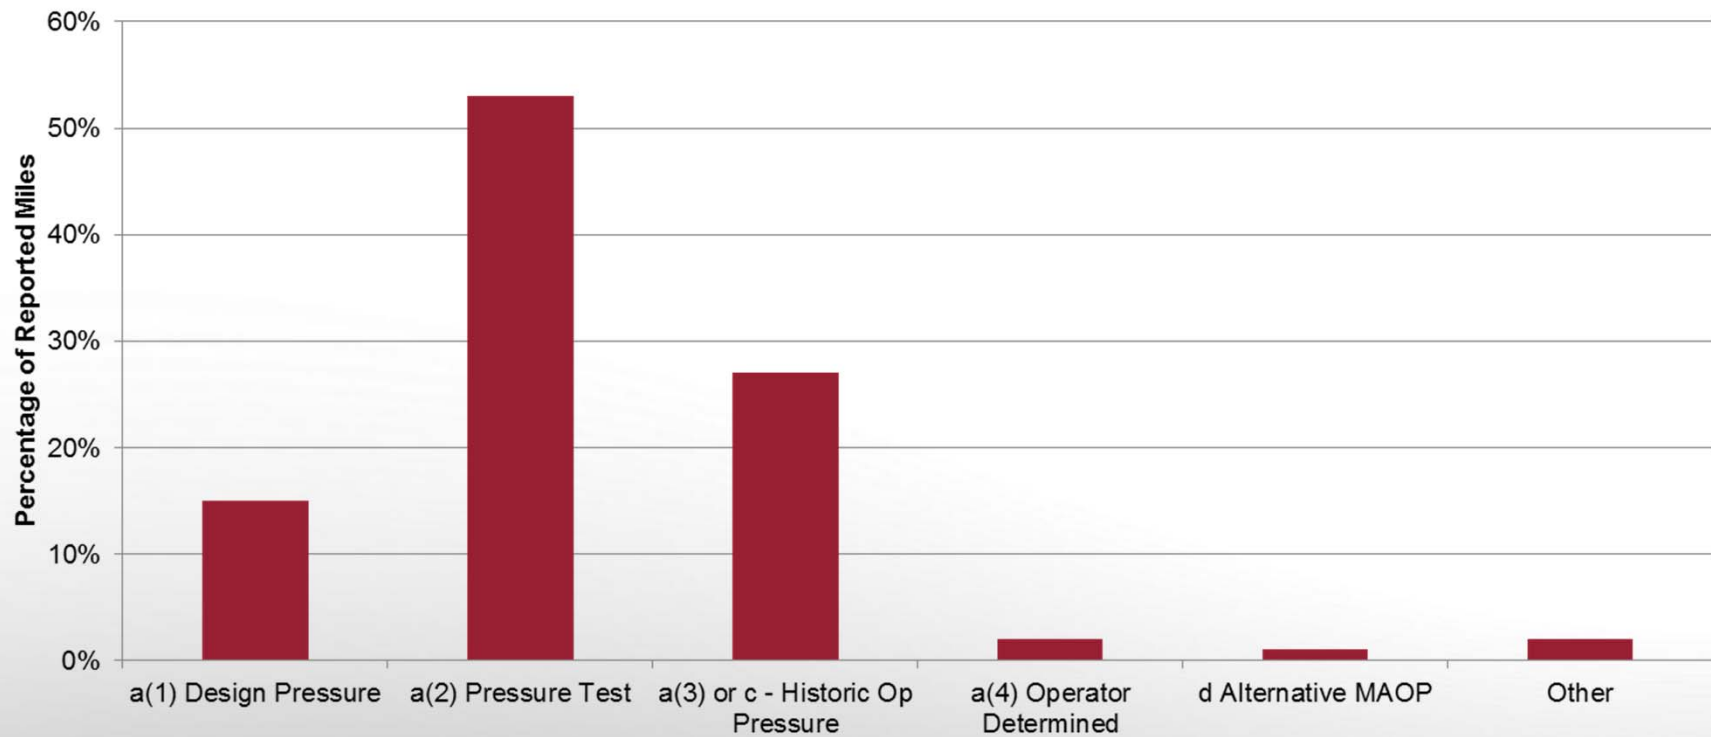
AGA Member Survey - 44 Companies 192.619 Reporting Method

Part Q - Gas Transmission Miles by §192.619 MAOP Determination Method														
	(a)(1) Total	(a)(1) Incomplete Records	(a)(2) Total	(a)(2) Incomplete Records	(a)(3) Total	(a)(3) Incomplete Records	(a)(4) Total	(a)(4) Incomplete Records	(c) Total	(c) Incomplete Records	(d) Total	(d) Incomplete Records	Other ¹ Total	Other Incomplete Records
Class 1 (in HCA)														
Class 1 (not in HCA)														
Class 2 (in HCA)														
Class 2 (not in HCA)														
Class 3 (in HCA)														
Class 3 (not in HCA)														
Class 4 (in HCA)														
Class 4 (not in HCA)														
Total	Calc	Calc	Calc	Calc	Calc	Calc	Calc	Calc	Calc	Calc	Calc	Calc	Calc	Calc
Sum of Total row for all "Total" columns							Calc							
Sum of Total row for all "Incomplete Records" columns							Calc							
Grand Total							Calc

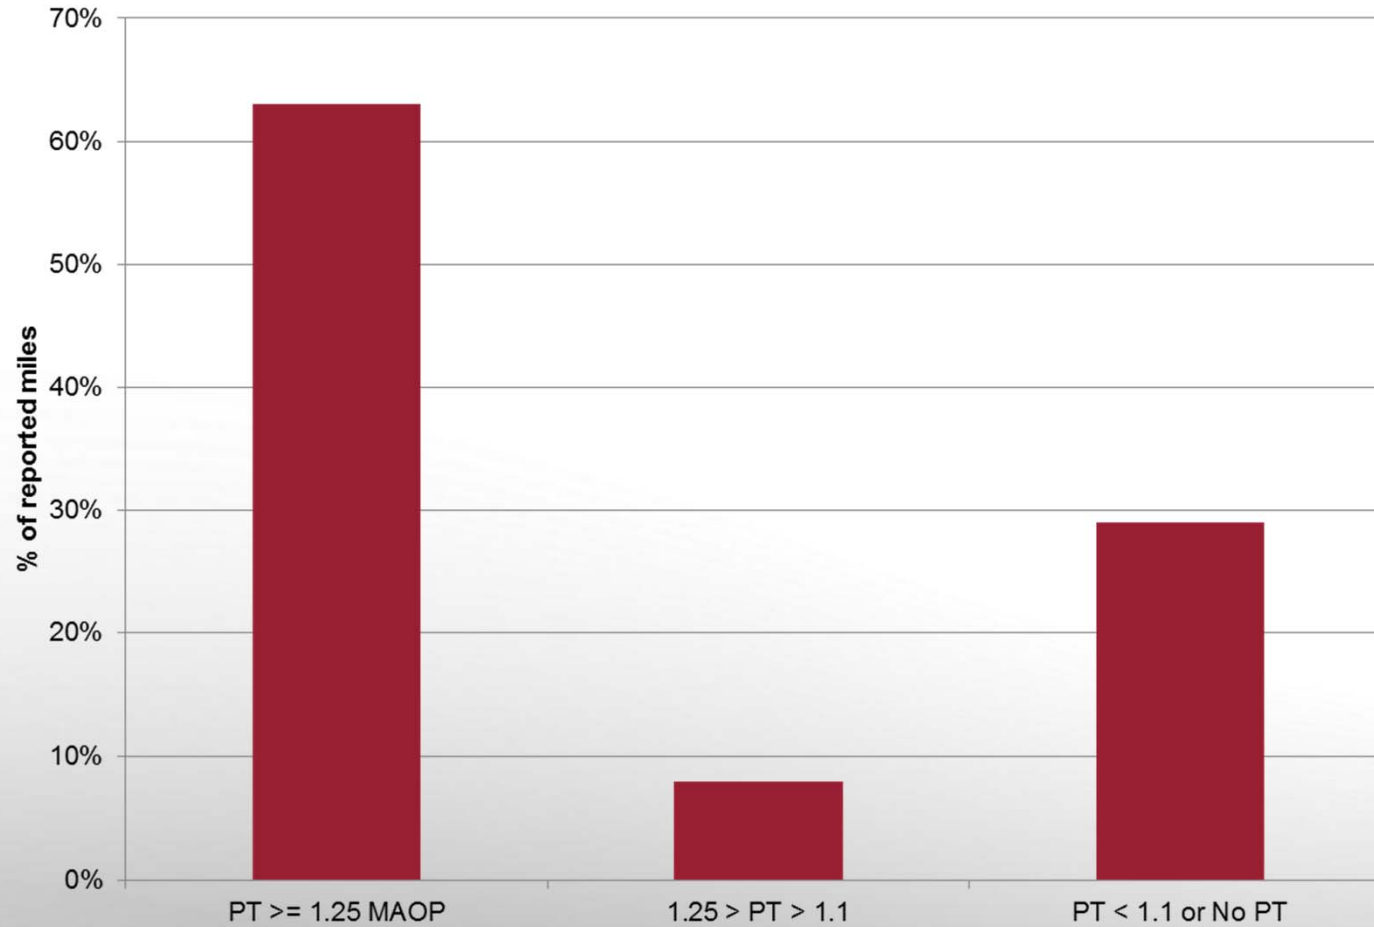
AGA Member Survey - 44 Company Pressure Test vs. MAOP

Part R – Gas Transmission Miles by Pressure Test (PT) Range and Internal Inspection						
Location	PT ≥ 1.25 MAOP		1.25 MAOP > PT ≥ 1.1 MAOP		PT < 1.1 or No PT	
	Miles Internal Inspection ABLE	Miles Internal Inspection NOT ABLE	Miles Internal Inspection ABLE	Miles Internal Inspection NOT ABLE	Miles Internal Inspection ABLE	Miles Internal Inspection NOT ABLE
Class 1 in HCA						
Class 2 in HCA						
Class 3 in HCA						
Class 4 in HCA						
in HCA subTotal	<i>Calc</i>	<i>Calc</i>	<i>Calc</i>	<i>Calc</i>	<i>Calc</i>	<i>Calc</i>
Class 1 not in HCA						
Class 2 not in HCA						
Class 3 not in HCA						
Class 4 not in HCA						
not in HCA subTotal	<i>Calc</i>	<i>Calc</i>	<i>Calc</i>	<i>Calc</i>	<i>Calc</i>	<i>Calc</i>
Total	<i>Calc</i>	<i>Calc</i>	<i>Calc</i>	<i>Calc</i>	<i>Calc</i>	<i>Calc</i>
PT ≥ 1.25 MAOP Total		<i>Calc</i>

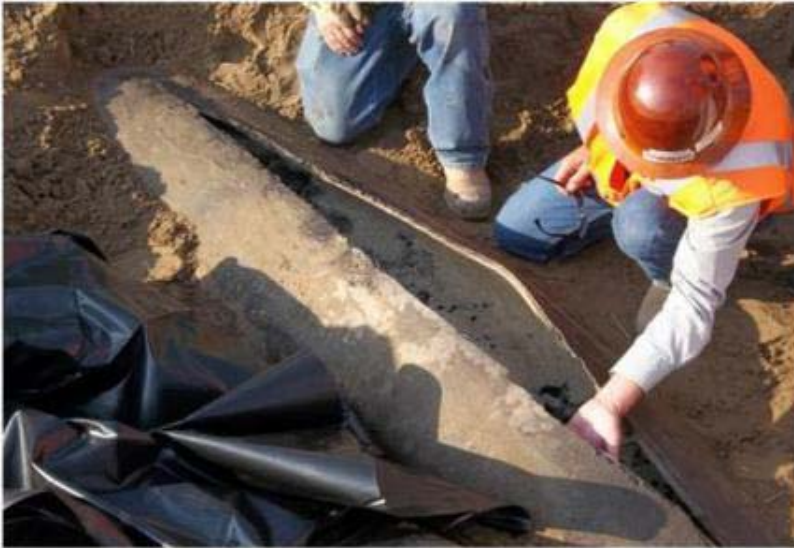
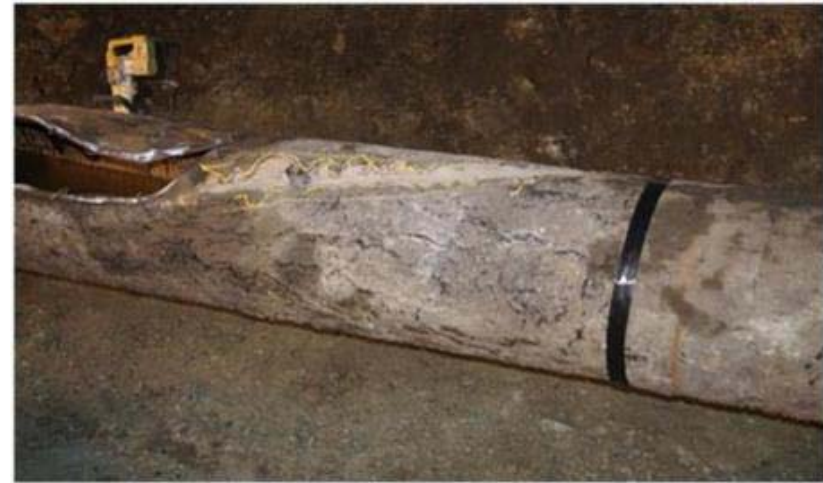
PG&E - 2 Ruptures in two years of testing

- 998 psig at rupture (95% SMYS)
- Seam Failure - Hot Crack and Incomplete Seam weld
- 550 psig at rupture (400 MAOP)
- External damage
