PROJECT: KEYSTONE PIPELINE PROJECT	
TYPICAL FLUME BRIDGE CROSSING	
PROJECT: TROW	DATE:
NO.:	REVISION:
9	DATE: 12/2006
DRAWING NUMBER: K-00-P-7000-300	CHECKED BY: JTG
DRAWN BY: ALS	APPROVED BY: RG
TYPICAL DATE: Mar. 12 Mar. 2009 - 4:00pm

PREPARED BY: TROW ENGINEERING CONSULTANTS, INC.
1300 Metropolitan Boulevard, Suite 200
Tallahassee, Florida 32310
Phone: 1-850-385-5441
Fax: 1-850-385-5223

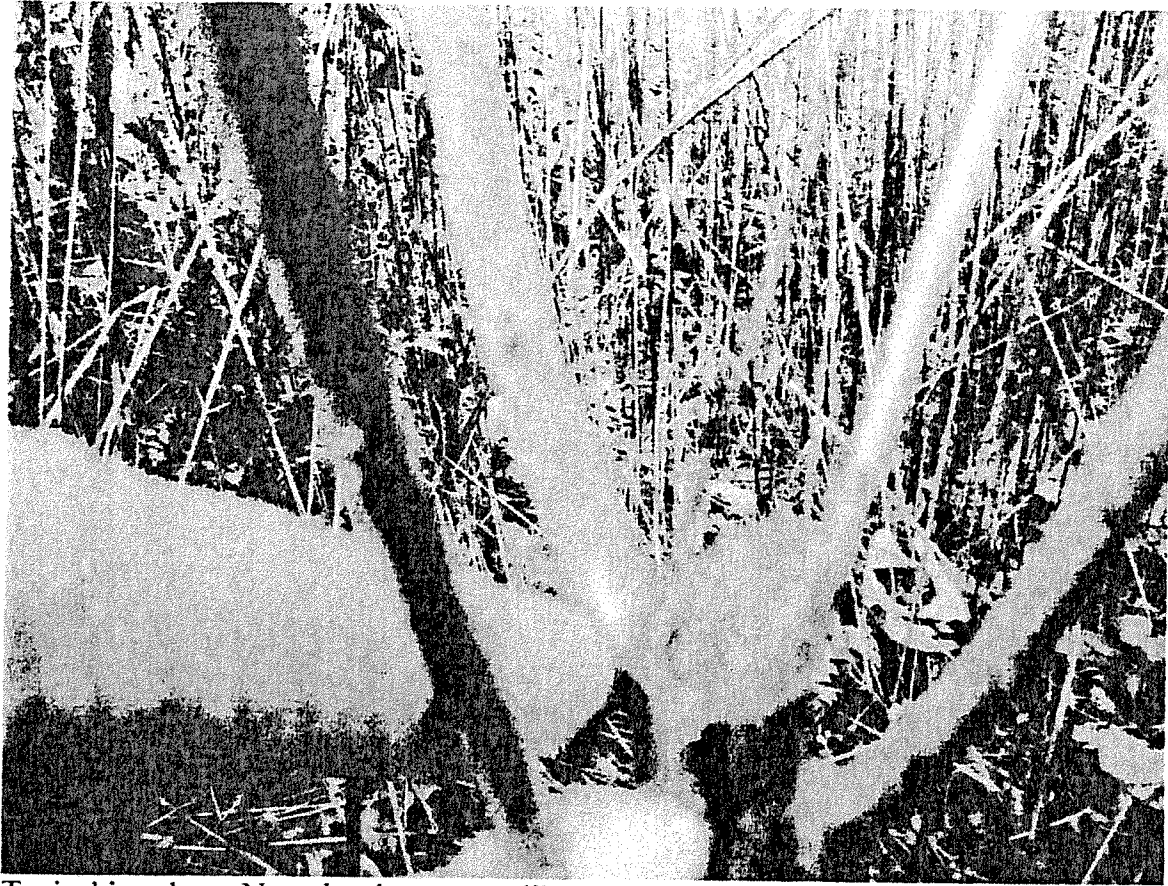
Typical ice-shear. Note the clean, razor-like cut.

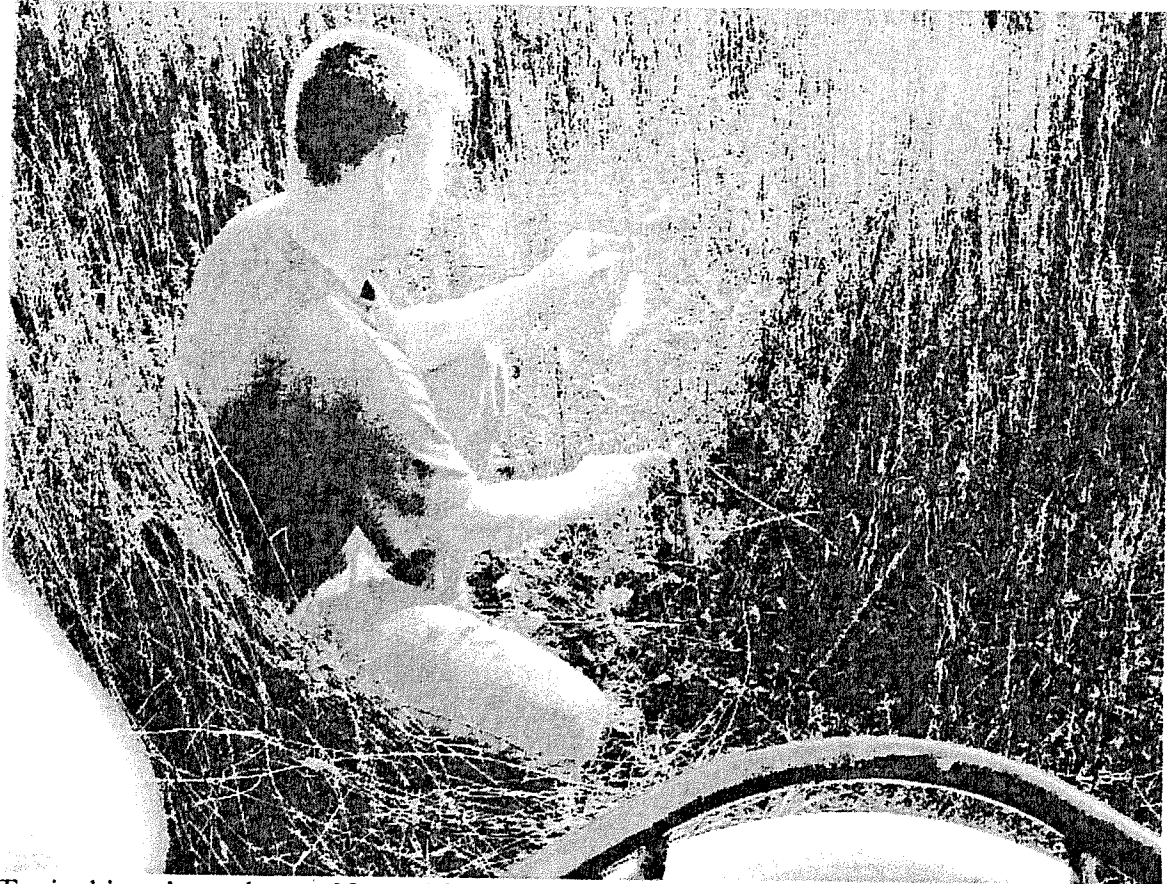
Typical ice-sheared tree. Note: Right index finger at shearline, left index finger near top of re-growth.
