# Attachment 2

Re: Hessler Analysis

Complaint Exhibit  
Amber Christenson  
Linda Lindgren  
Timothy Lindgren

## Hessler and Associates Report

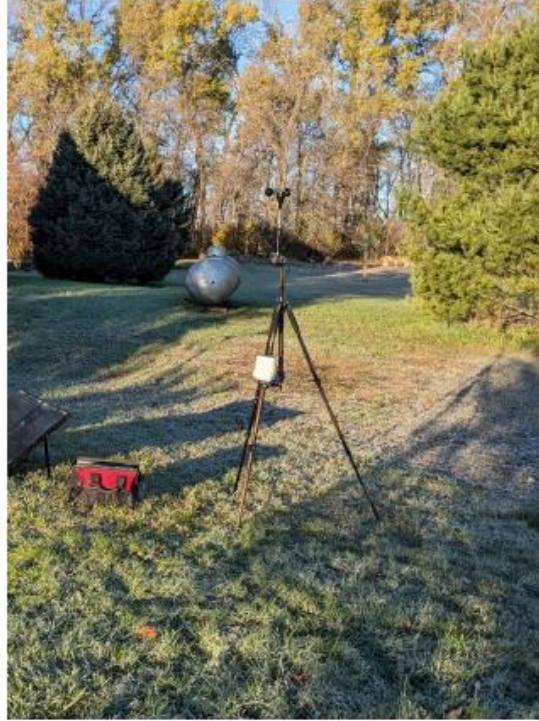
Mr. Hessler refers to Ms. Christenson’s trees as ‘barren’. The trees were leaved. This photo is from page 28 of the Epsilon report. Epsilon’s numbered page 6-12.

Figure 6-7 Epsilon Meteorological Instrumentation – Location 6 - HOBO
