Iowa Department of Natural Resources

Plastic Water Line Survey Results

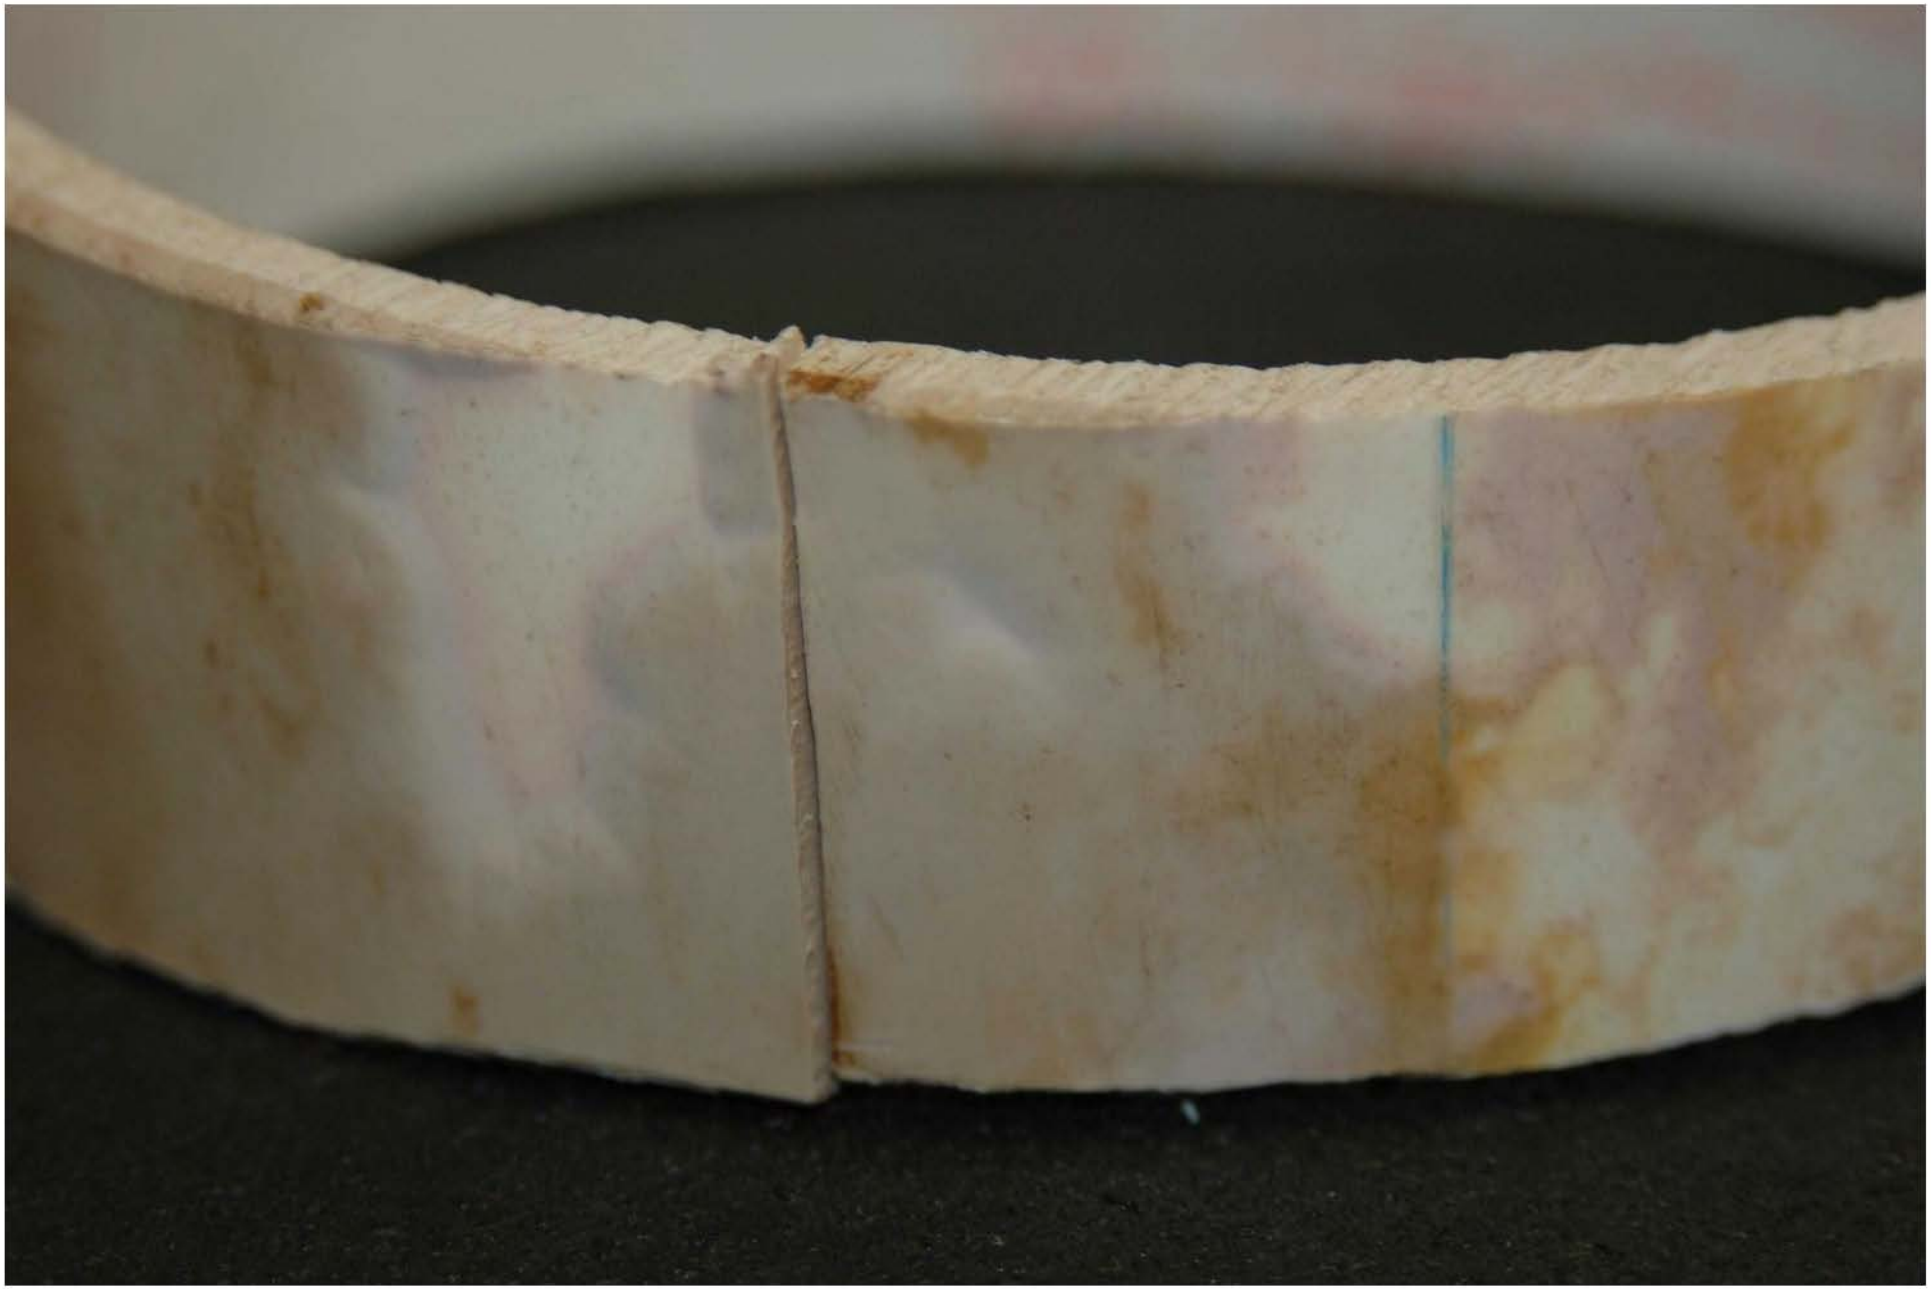
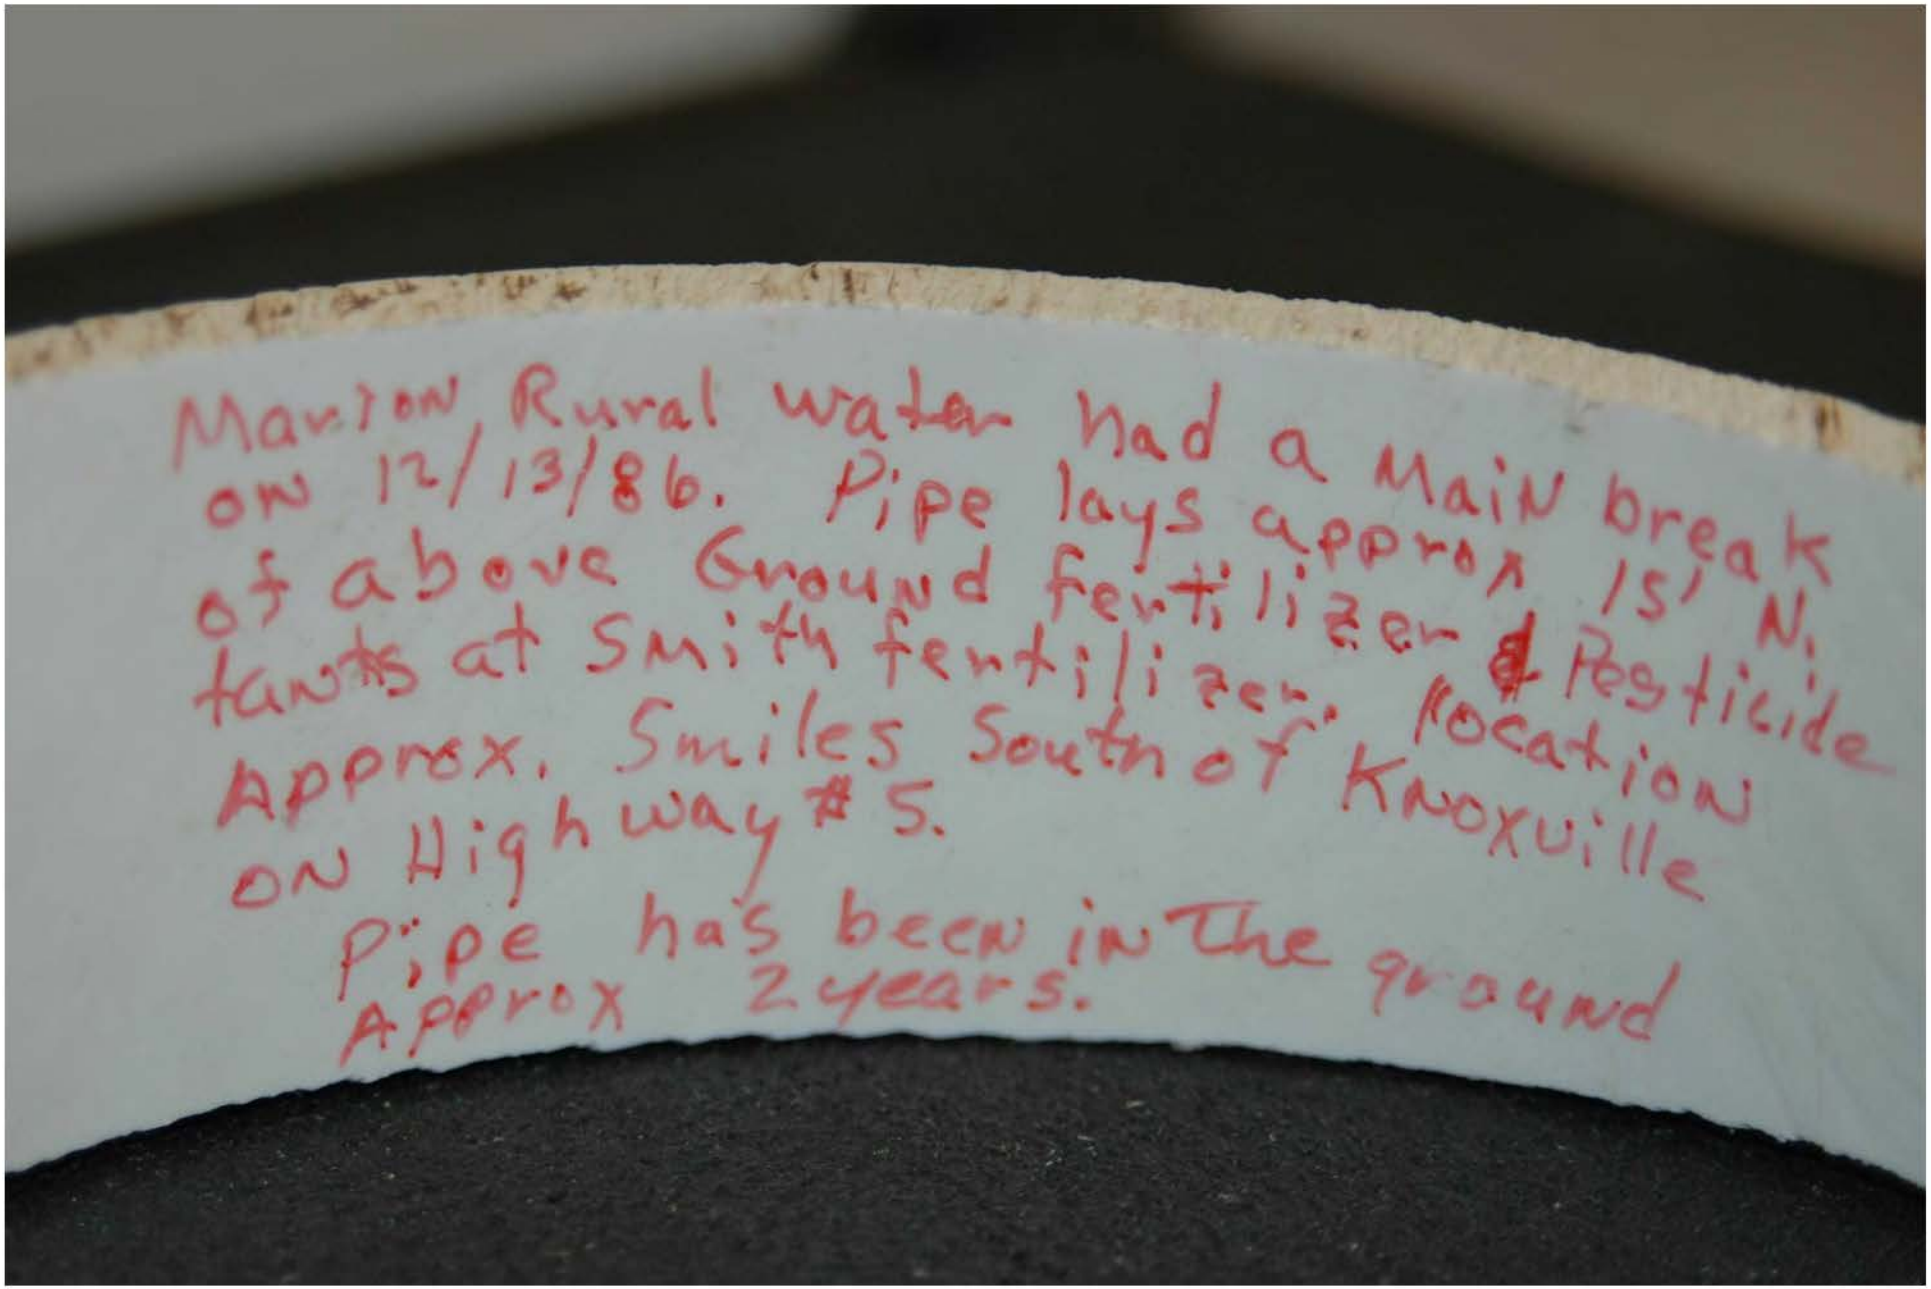
Marion Rural water had a Main break
on 12/13/86. Pipe lays approx 15' N.
of above Ground fentilizer & Pesticide
tanks at Smith fentilizer. Location
Approx. 5miles South of Knoxville
on Highway #5.
Pipe has been in the ground
Approx 2 years.

- It is speculated the plastic water line was weakened by the fertilizer and pesticide.
- Pesticides commonly use petroleum based solvents.
- The pictures show a plastic water line can be impacted at locations other than the joints.
- The pipe was 6 inch diameter and SDR 26 (Standard Dimension Ratio).

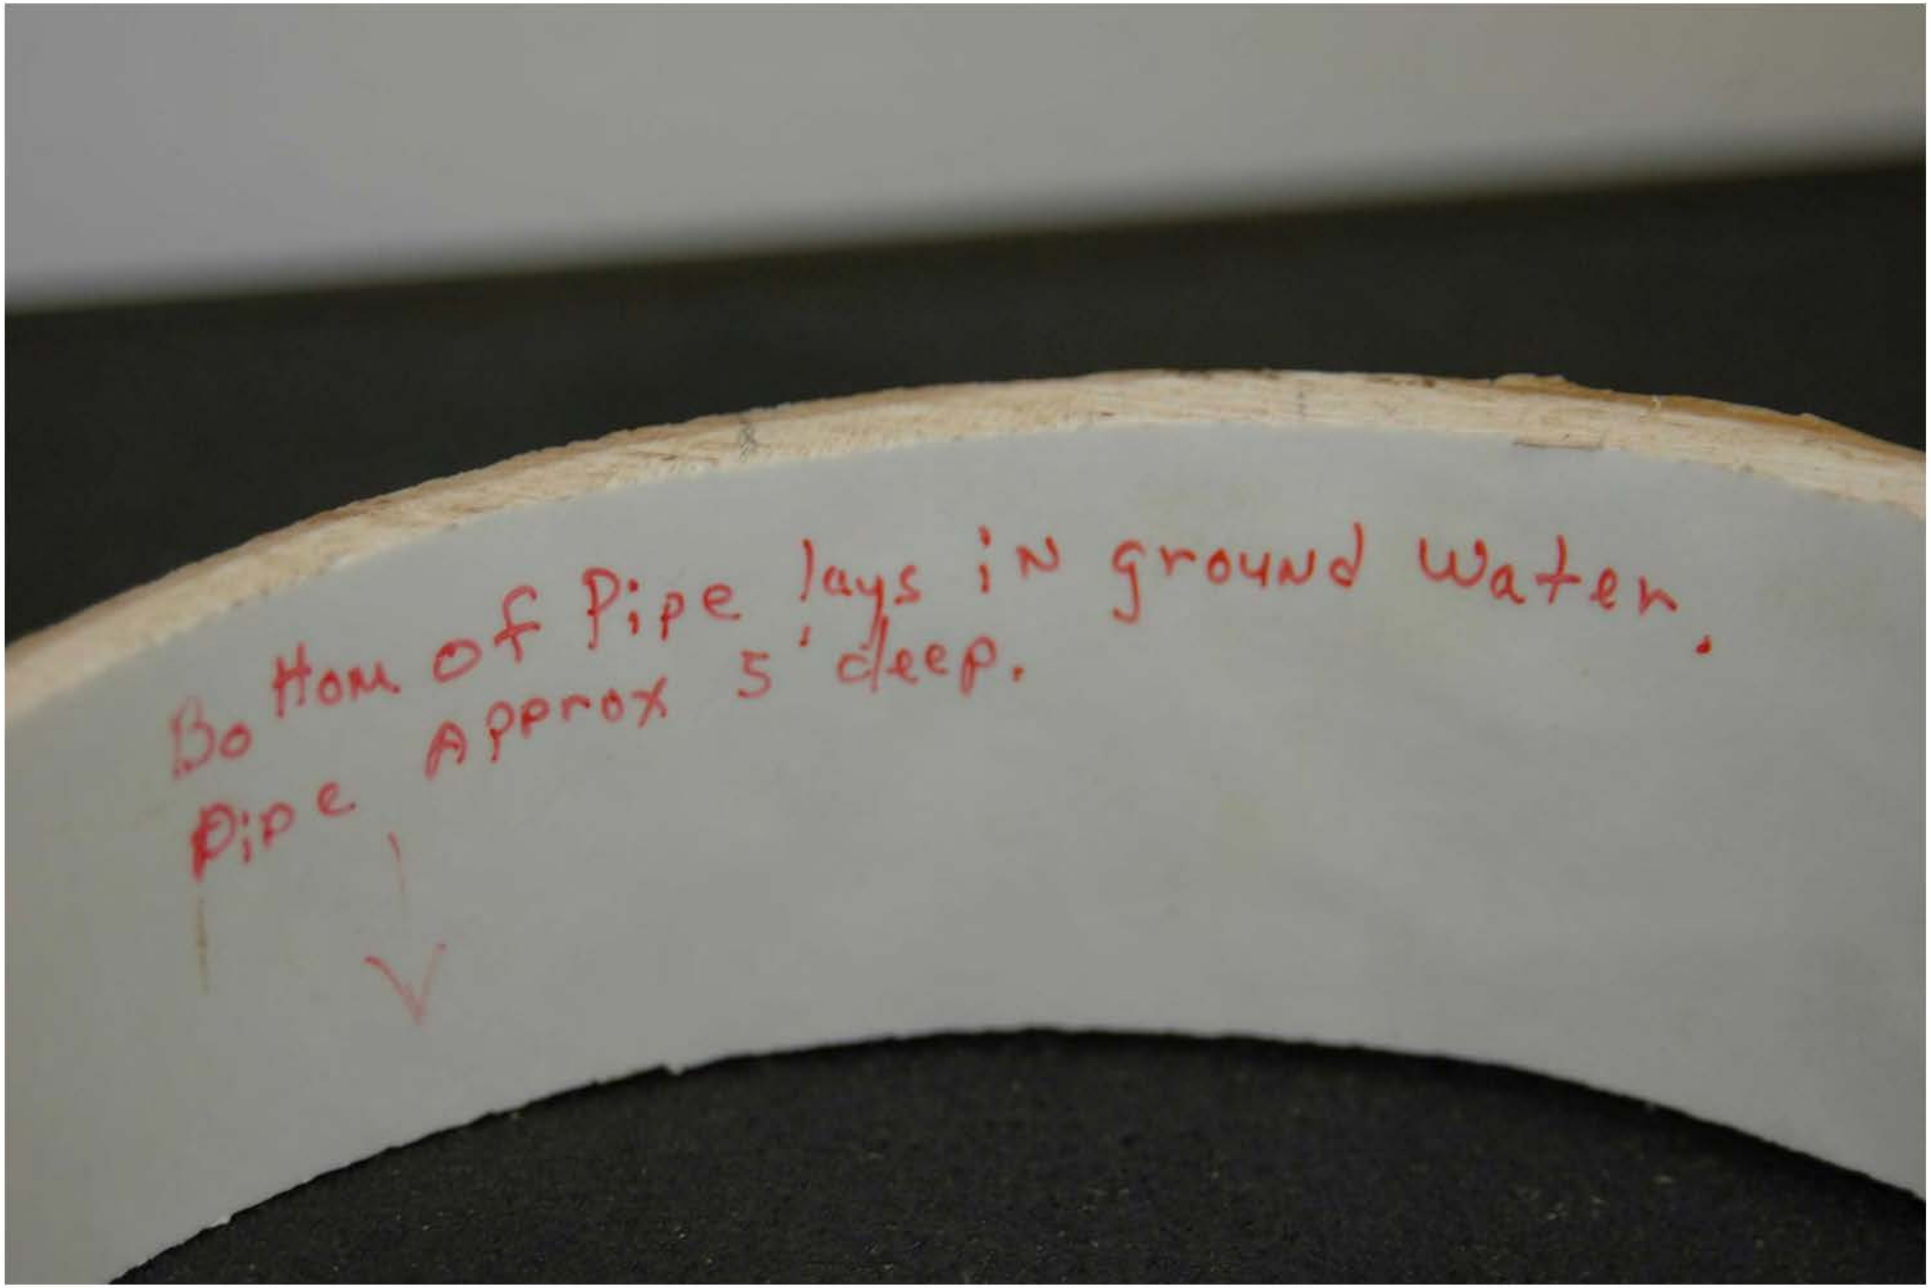
Bottom of Pipe lays in ground water.
Pipe Approx 5' deep.
