Report Number 122412-1

Issued: December 24, 2012
Revised:

A Cooperative Measurement Survey and Analysis of Low Frequency and Infrasound at the Shirley Wind Farm in Brown County, Wisconsin

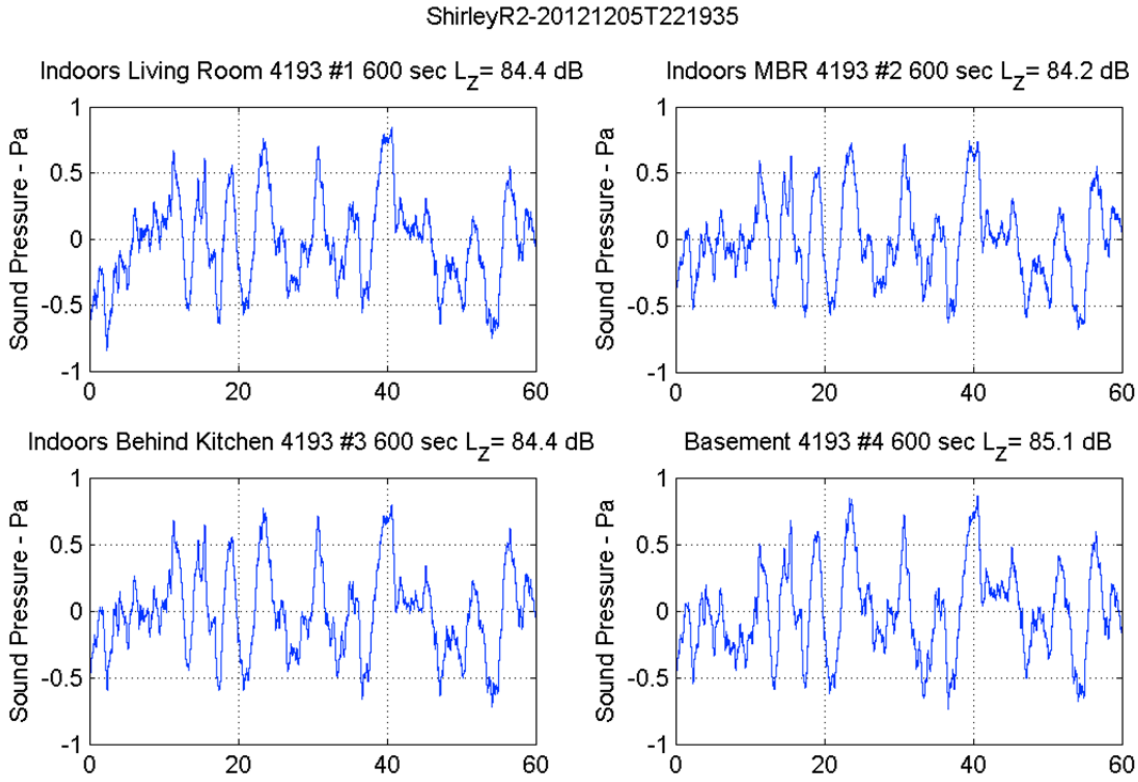
Figure **2** shows a sample of raw data collected during windy conditions at Residence R2. Note that apparently wind-driven very low frequency pressure fluctuations are well synchronized and nearly equal in amplitude at four disparate locations within the home.

Figure 2. First Minute of Raw Data Collected at R2 On Dec 6 Starting 00:19:35. Note very low frequency fluctuations are nearly equal at four locations.

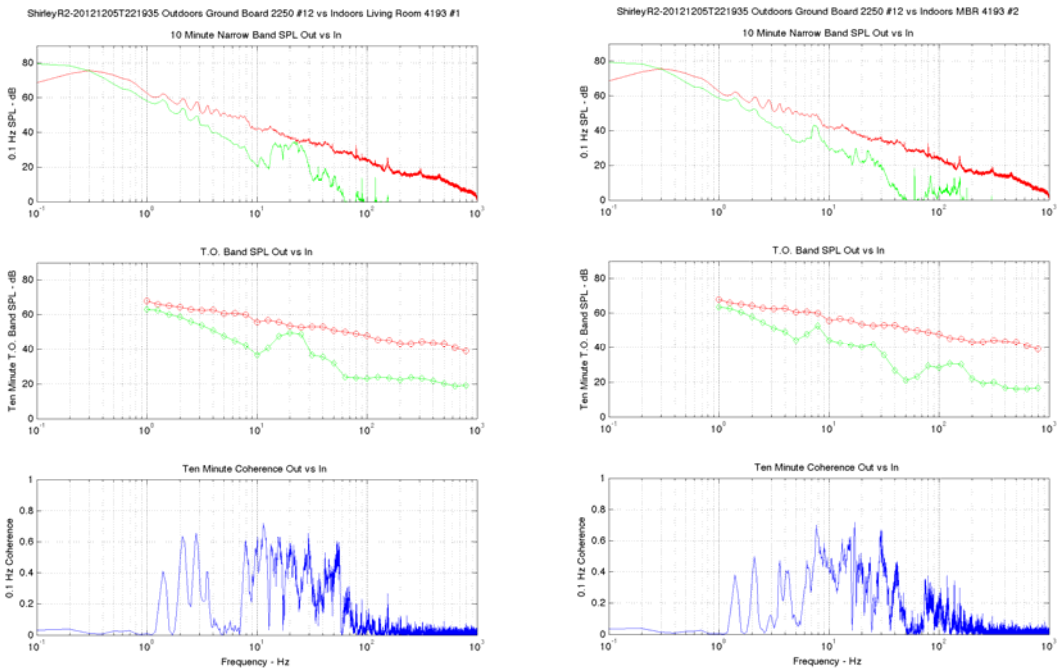
Figure 3. Low Frequency (0.1-1,000 Hz) Spectra and Coherence from Two Rooms in R2 measured 12/6/12 starting 00:19:35 showing differences in detail and well correlated low-order blade-pass harmonics. Red curve is measured outdoors between turbines and home.

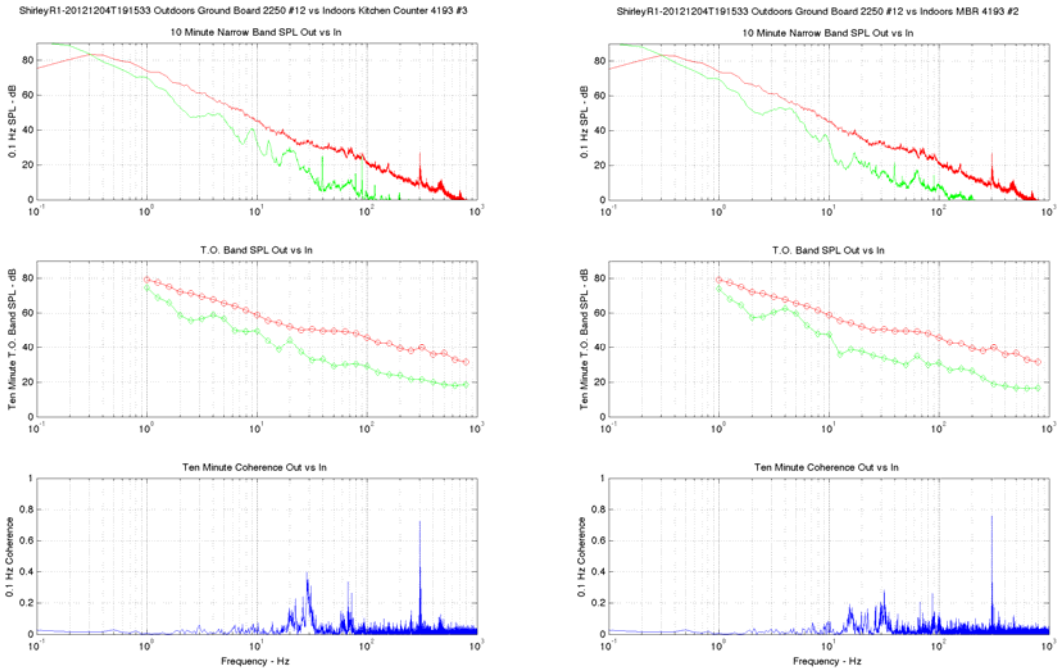
Figure 4. Low Frequency (0.1-1,000 Hz) Spectra and Coherence from Two Rooms in R1 measured 12/4/12 starting 21:15:33 showing differences in detail and poorly correlated low-order blade-pass harmonics. Red curve is measured outdoors between turbines and home.

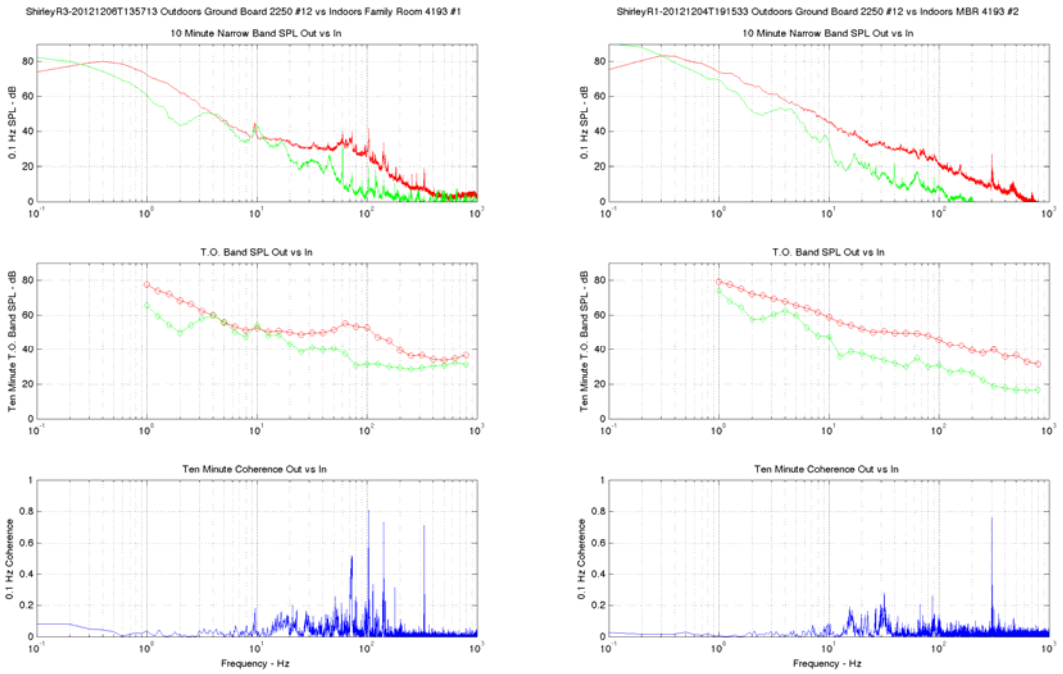
Figure 5. Low Frequency (0.1-1,000 Hz) Spectra and Coherence from Two Rooms in R3 measured 12/6/12 starting 15:57:13 showing differences in detail, poorly correlated low-order blade-pass harmonics and well correlated tones from passing vehicle exhausts. Red curve is measured outdoors between turbines and home.

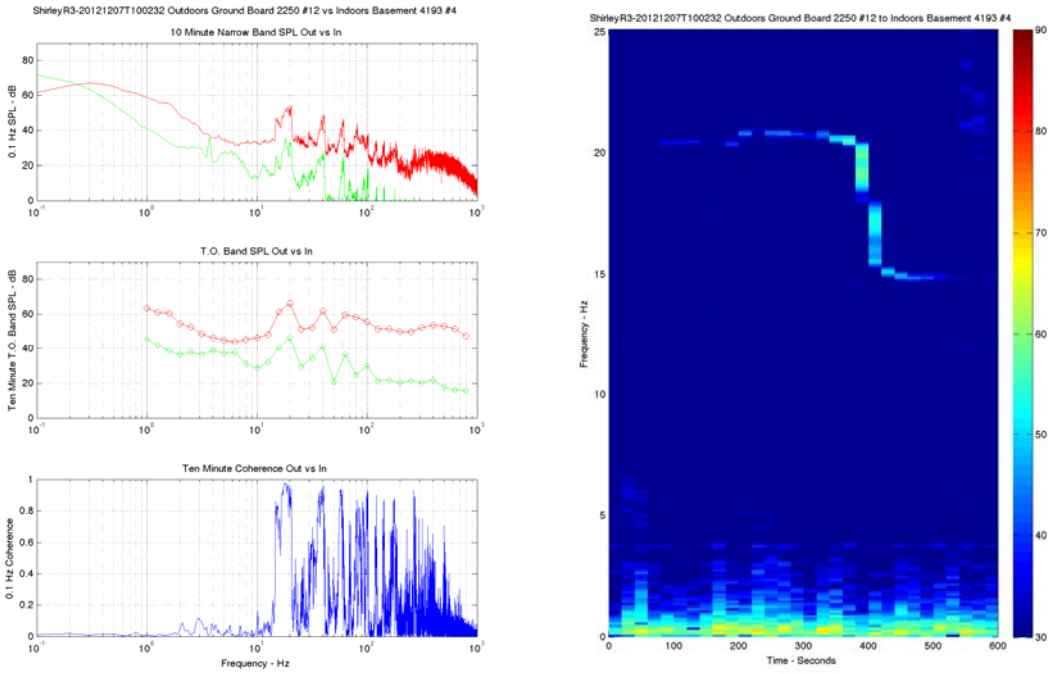
Figure 6. Low Frequency Spectra and Outdoor-Indoor Cross Spectrograph in Basement of R3 with Helicopter flyover. Note Doppler shift of rotor tone from 20.5 Hz on approach to 15 Hz receding. Also note high coherence of the helicopter rotor blade harmonics. Note very low coherence of turbine blade frequencies below 10 Hz, suggesting most of the infrasound is general atmospheric pressure fluctuation and wind force on the residence.

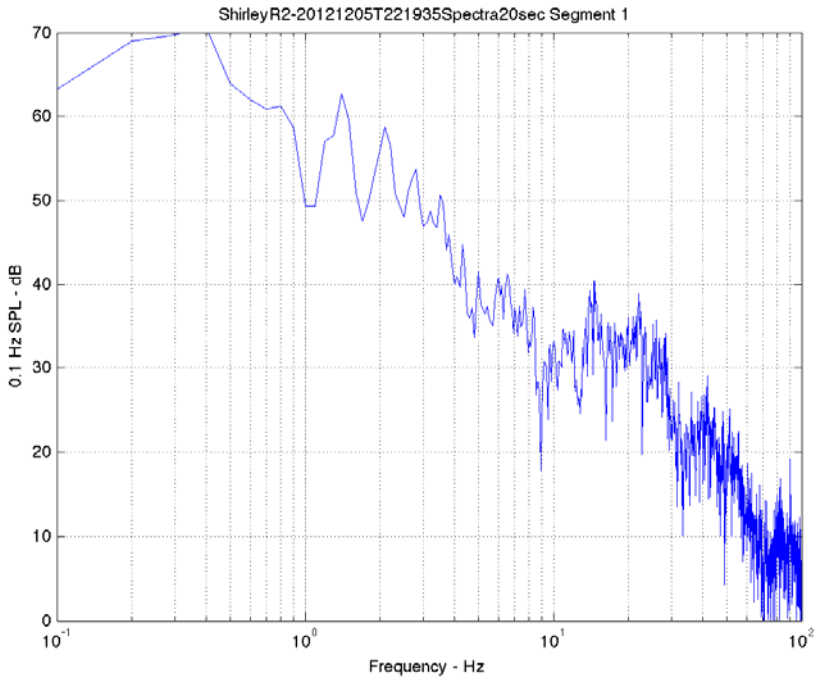
Figure 7. Short (20 sec) duration spectrum with best defined turbine blade harmonics, multiples of 0.7 Hz. Overall SPL of the Blade Pass Signal is 70 dB.

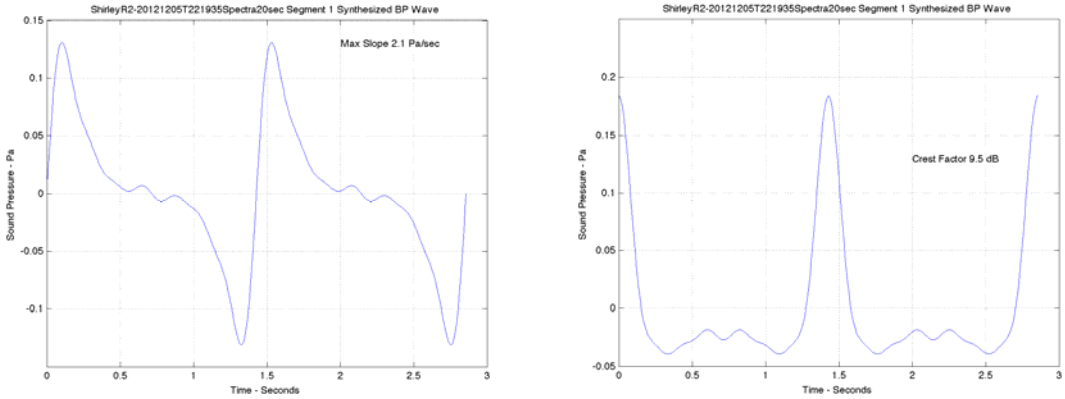
Figure 8. Turbine blade-pass waveforms synthesized from the harmonic series shown in Figure 7. Peak-to-peak SPL of the left-hand, more probable signal is about 82 dB.

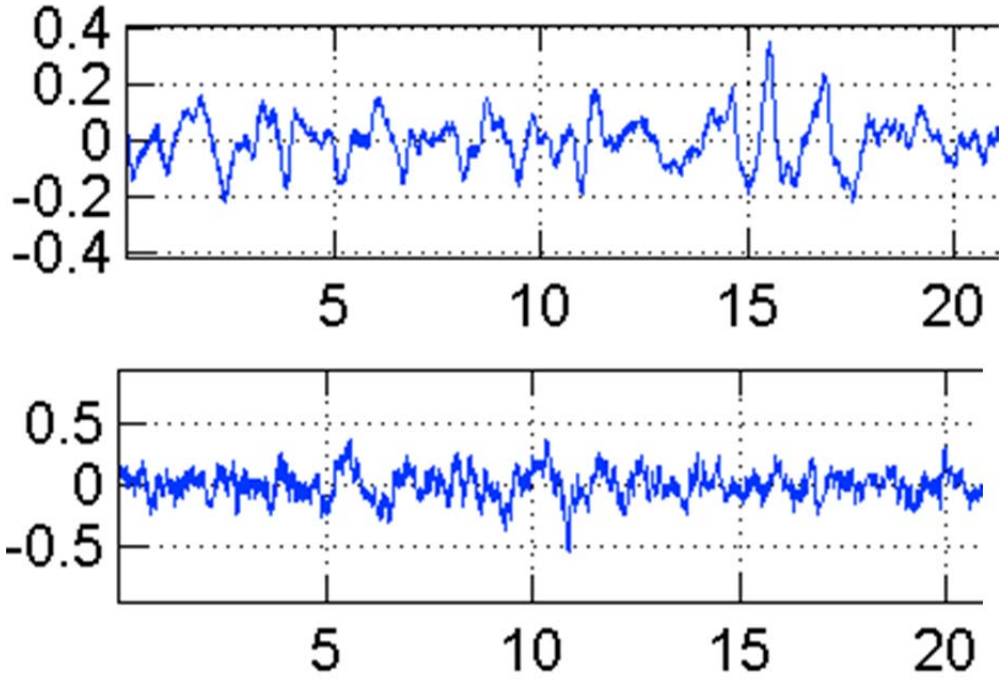
Figure 9. 0.5 Hz Phaseless High-Pass Filtered Waves Indoors (upper) and Outdoors at R2, Corresponding to Spectrum of Figure 7. Note repetitive waves indoors, similar to left-hand synthesized example. Note transient event indoors at 15.5 seconds unrelated to outside noise.

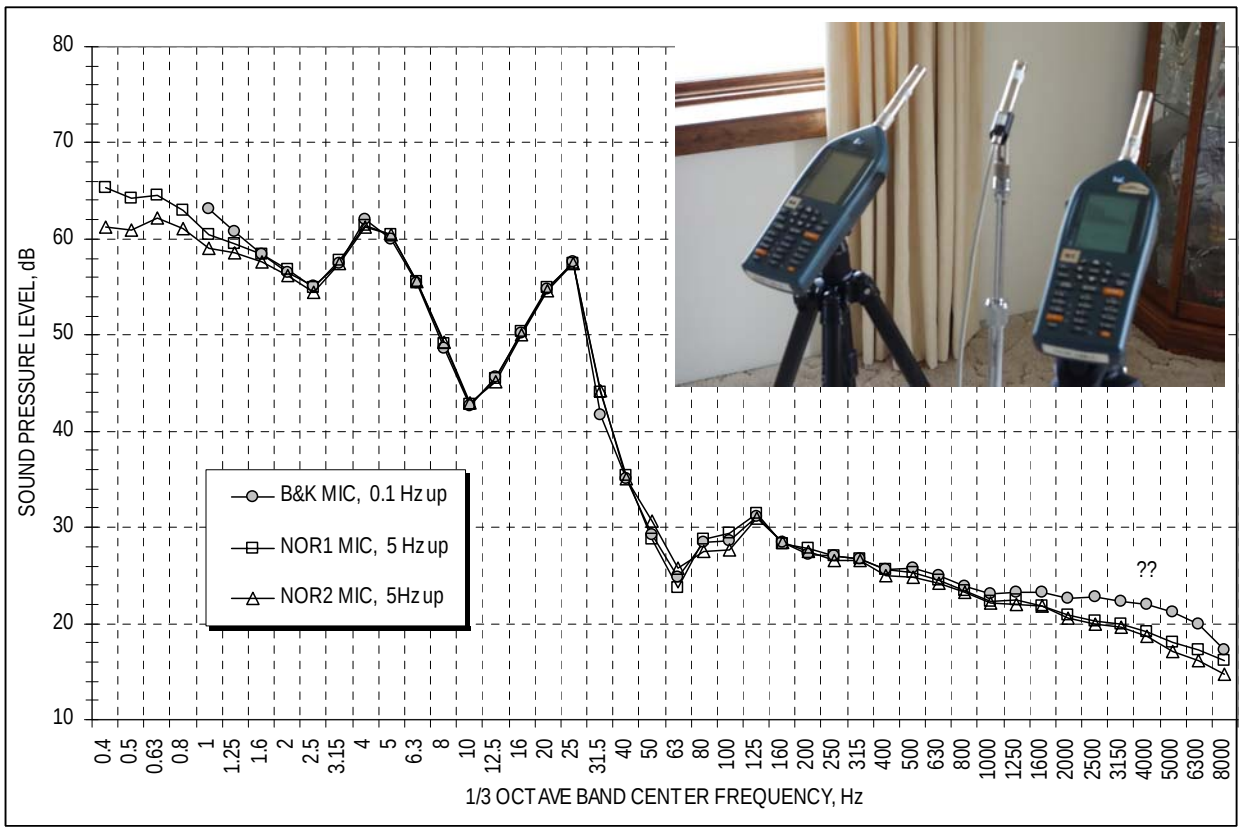
Figure 2.1 *Instrument Calibration Check Relative to High Performance ChIA System*

Two NOR140 units were set-up in the living room of residence R2 adjacent to the high performance ChIA microphone, which is rated accurate from 0.1 Hz to 20,000 Hz. The results of a 10-minute run between the three systems, along with a photograph of the set-up, are shown below. It is clear from the test that the NOR140 off-the-shelf unit can be used with confidence down to about 2 Hz; significantly better than its 5 Hz rating.

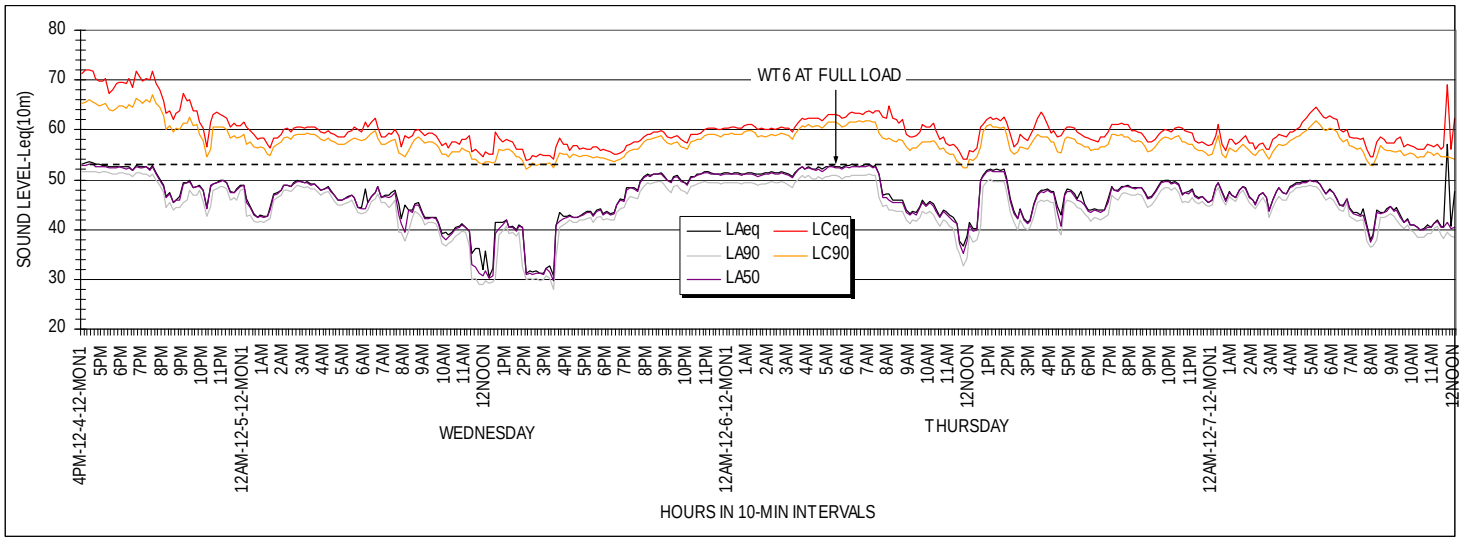
Figure 3.1 *Monitor 1 Results*

Calculations indicate that the turbine is at full power when the sound pressure at the monitor is approximately 53 dBA. In general, the plot shows when the unit was near or at full power and when it was off (e.g. around midday on Wednesday when the sound level dropped to about 31 dBA).

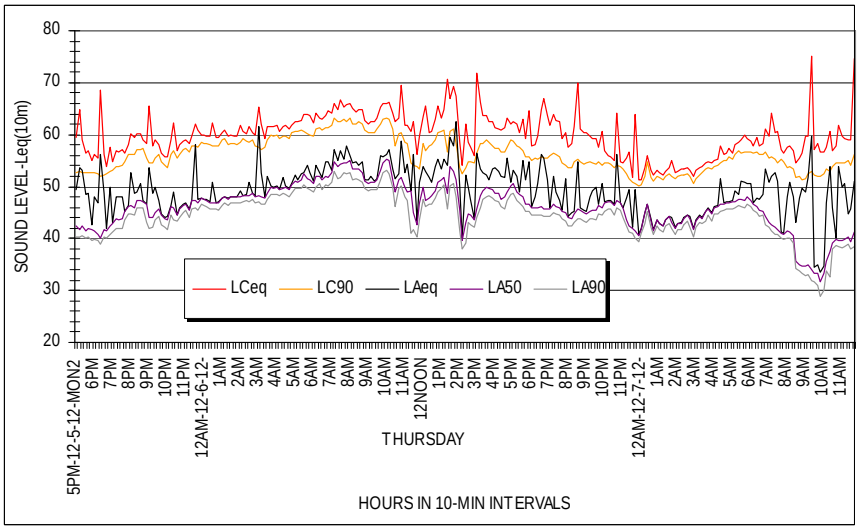
Figure 3.2 *Monitor 2 Results*

The second long-term logger, Monitor 2, which was located in front of the residence at R2, was not as useful because it was strongly influenced by extraneous, contaminating noise from traffic on Glenmore Road. Nevertheless, the results are given below in Figure 3.2.

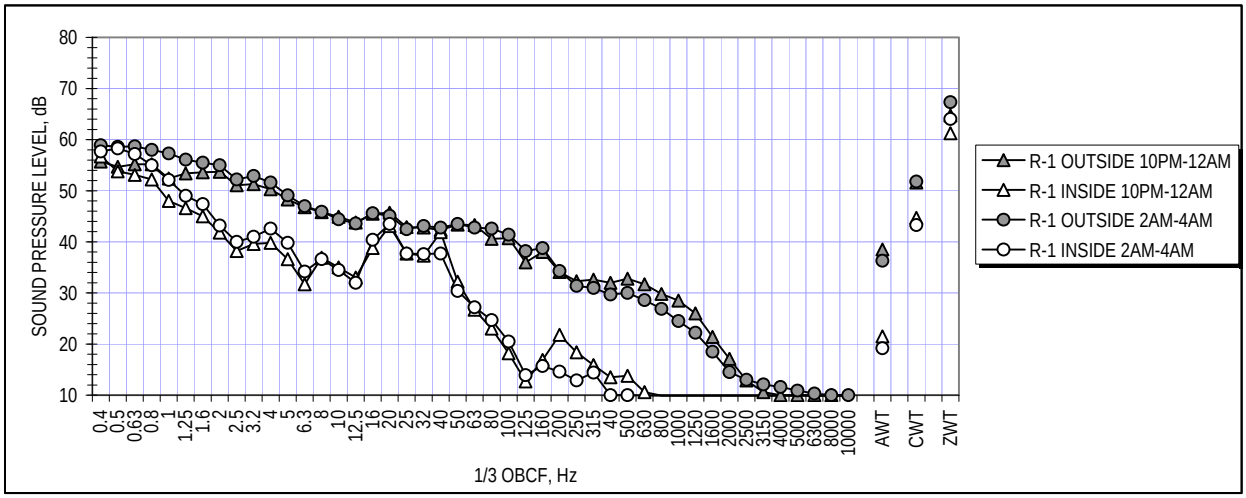
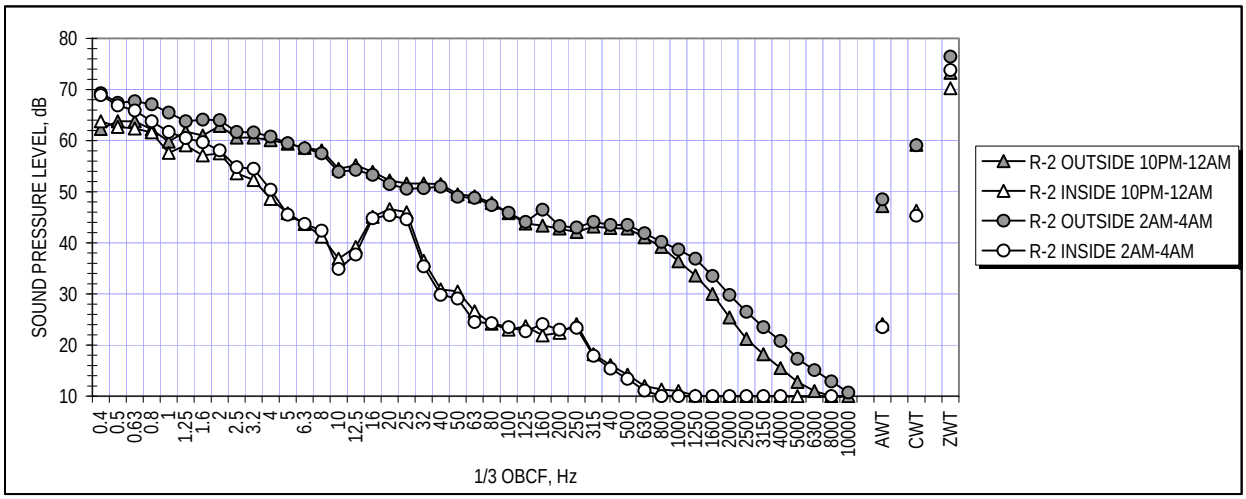
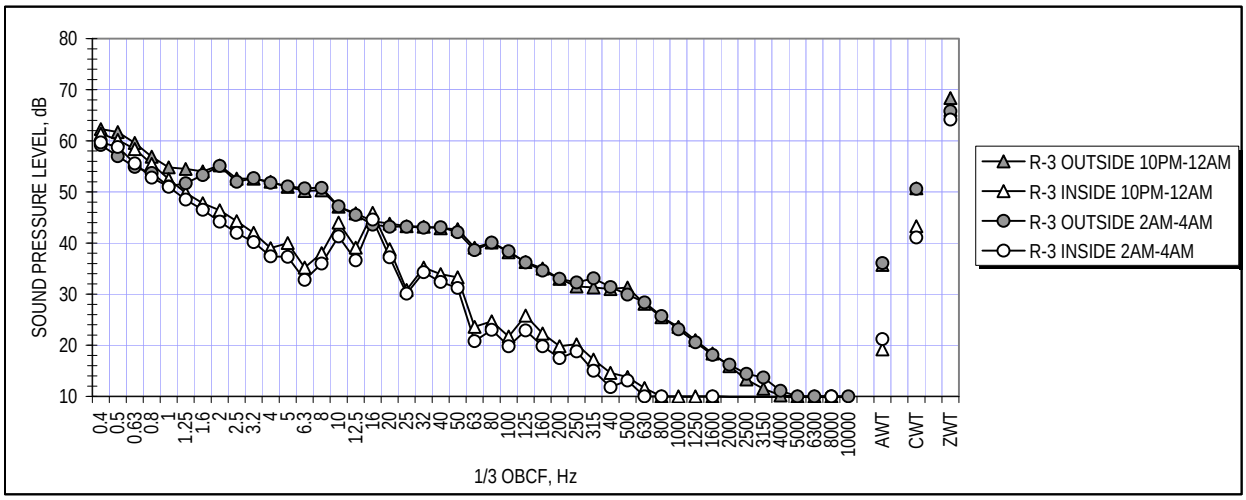
Figure 4.1 *Inside/Outside Sound Levels during Project Operation*

These figures are 10-minute L50 samples made simultaneously outside and inside of the three residences between 10 p.m. and midnight and between 2 and 4 a.m. The measured levels below 1 or 2 Hz may be pseudo noise, or false signal noise from the wind blowing over the microphone, even though the microphone was placed on a reflective ground board under a 7" hemispherical windscreen to minimize this effect. The plotted outdoor levels are the raw measurement results obtained on the reflective ground plane and should be reduced by 3 dB to reflect a standard measurement 1.5 meters above grade. Maximum levels occur at R-2 as one would expect, since it is closest to the turbines and the location where wind turbine noise was most readily audible.

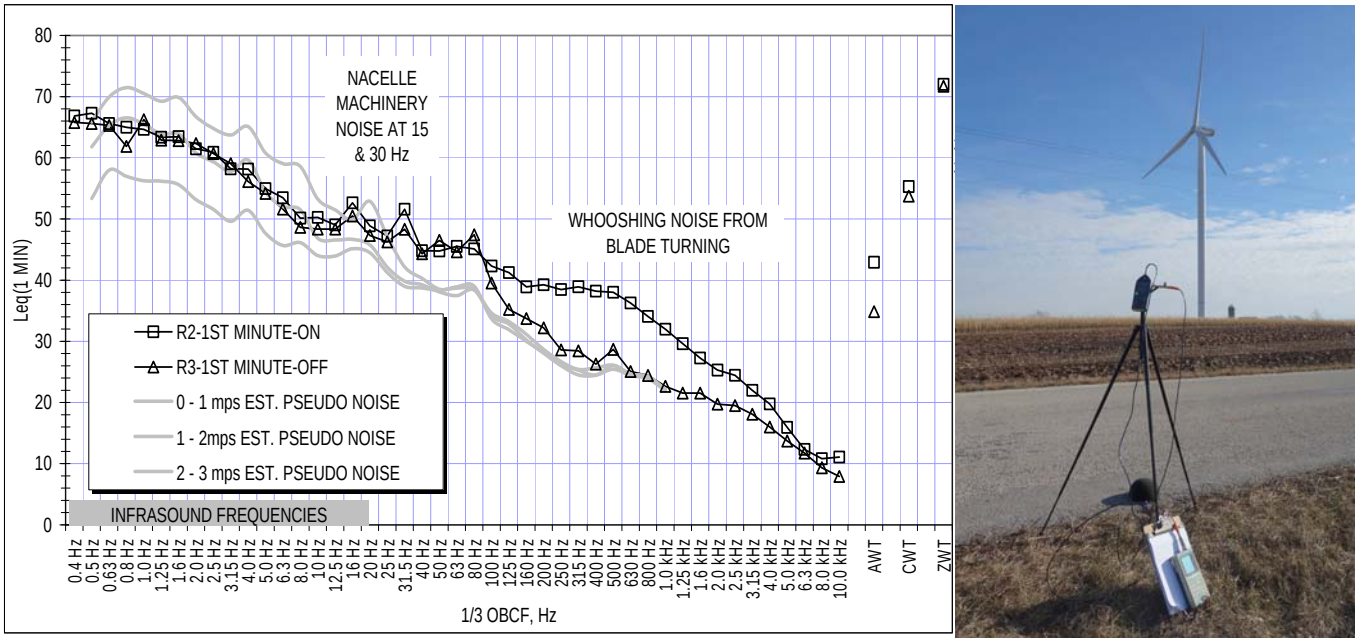
Figure 5.1 *On/Off Sound Levels Outdoors during Project Operation*

One could conclude that the wind turbine was not producing any low frequency noise since the spectra are essentially equal from 0 to 12.5 Hz; however, despite measuring on a hard surface using a hemispherical windscreen, the low end of both spectra appear to be pseudo, or false-signal noise based on some recent empirical tests of windscreen performance carried out in the Mohave Desert (in support of a new ANSI standard that is being developed for measuring in windy conditions). The objective of this testing was to evaluate measured low frequency sound levels in a moderately windy environment without any actual source of low frequency noise. The on/off measurements of WTG8 show that the levels below about 20 Hz coincide with the sound levels measured in the desert in the presence of a light 1 to 2 m/s wind. Consequently, all that can be concluded is that the low frequency emissions from the turbine were substantially lower in magnitude than the distortion effect produced from a nearly negligible amount of airflow through a 7" windscreen and across the ground-mounted microphone.

The overall reduction in audible sound of 8 dBA is attributable to eliminating the "whoosh" sound, which is clearly seen to occur in the higher frequencies; generally from about 200 to 2000 Hz.

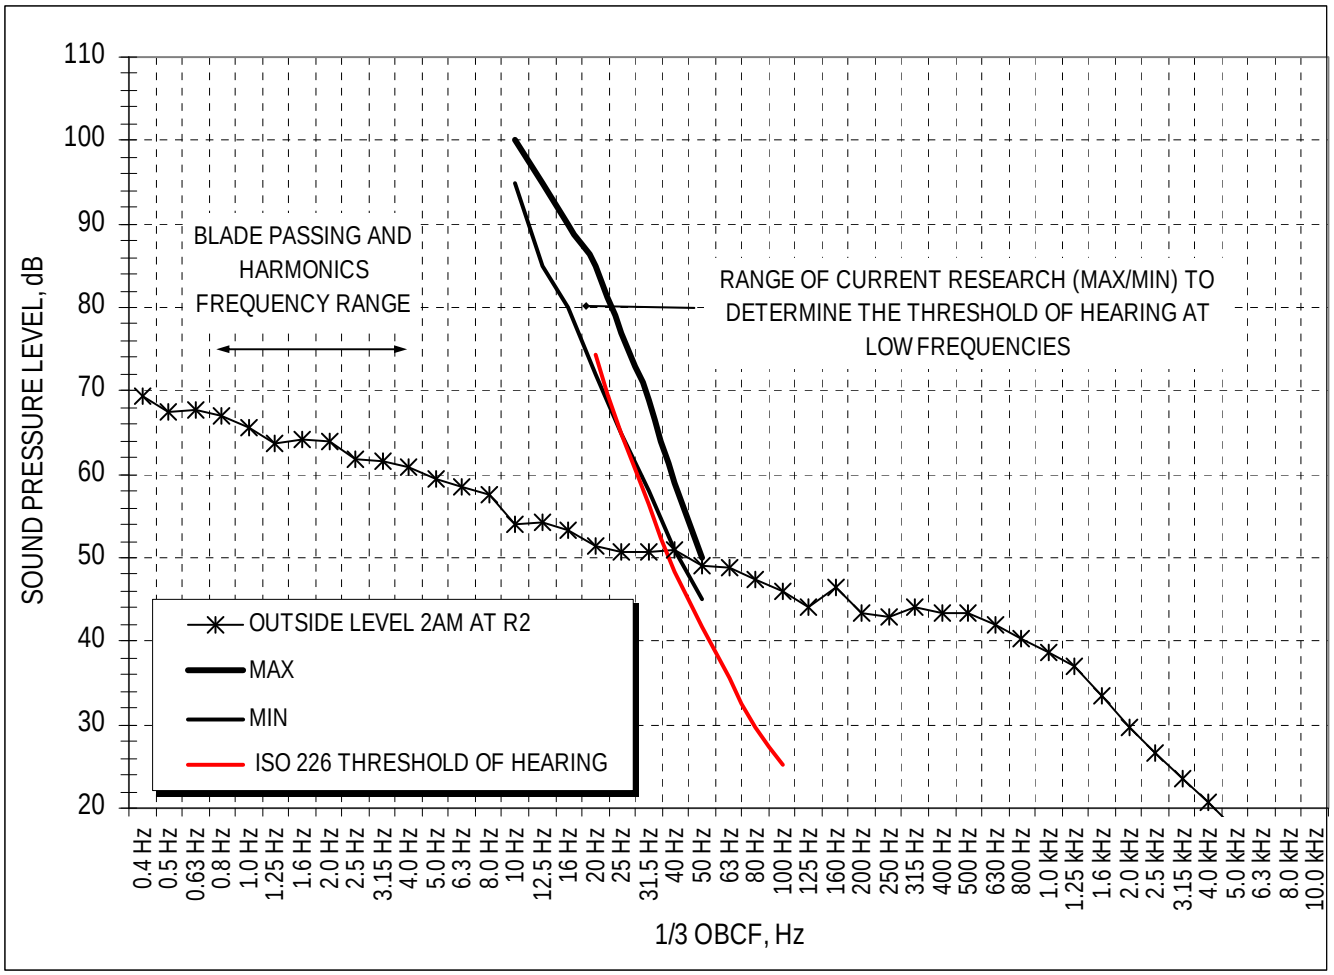
Figure 7.1 *Measured Project Sound Level Compared to Threshold of Hearing*

The industry response to claims of excessive low frequency noise from wind turbines has always been that the levels are so far below the threshold of hearing that they are insignificant. The figure below plots the exterior sound level measured around 2 a.m. on a night at R2 during full load operation compared to the threshold of hearing. In the region of spectrum where the blade passing frequency and its harmonics occur, from about 0.5 to 4 Hz, the levels are so extremely low, even neglecting the very real possibility that these levels are elevated due to self-generated pseudo noise, that one may deduce that these tones will never be audible. What apparently is needed is a new Threshold of Perception.

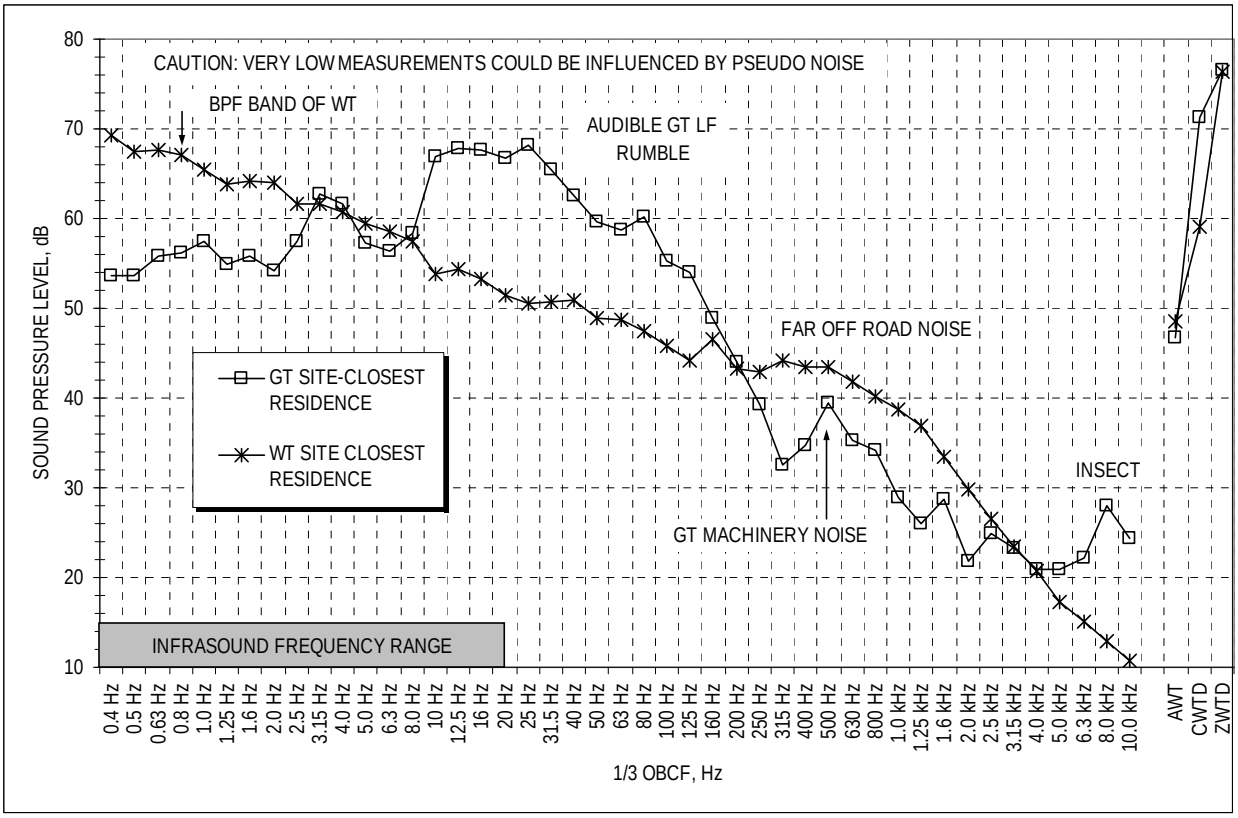
Figure 7.2 *As-Measured Wind Turbine Spectrum Compared to Gas Turbine Sound Level*

The study also showed that a wind turbine is indeed a unique source with ultra low frequency energy. The next figure plots the same R2 data above compared to a more commonly recognized low frequency noise source, an open cycle industrial gas turbine complex sited too close to homes. These two sources of electrical energy production, assuming the low end of the wind turbine measurement is actually due to the turbine rather than pseudo noise, have about the same A-weighted and Z-weighted overall sound levels.

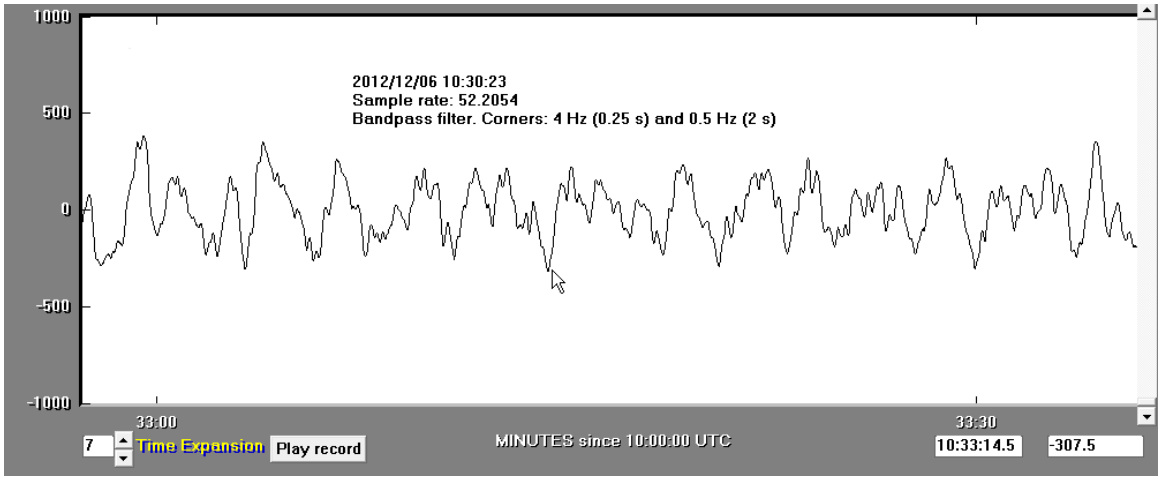
The sample seismometer graph below shows the time varying waveform inside R2, the closest home at 121206 3:33 am with several turbines turning. Signal is filtered to pass the blade pass frequency and first four harmonics. Peak levels were 0.2 to 0.3 Pa (living room; scale shown approximately in milliPa), about 80 to 83 dB peak.

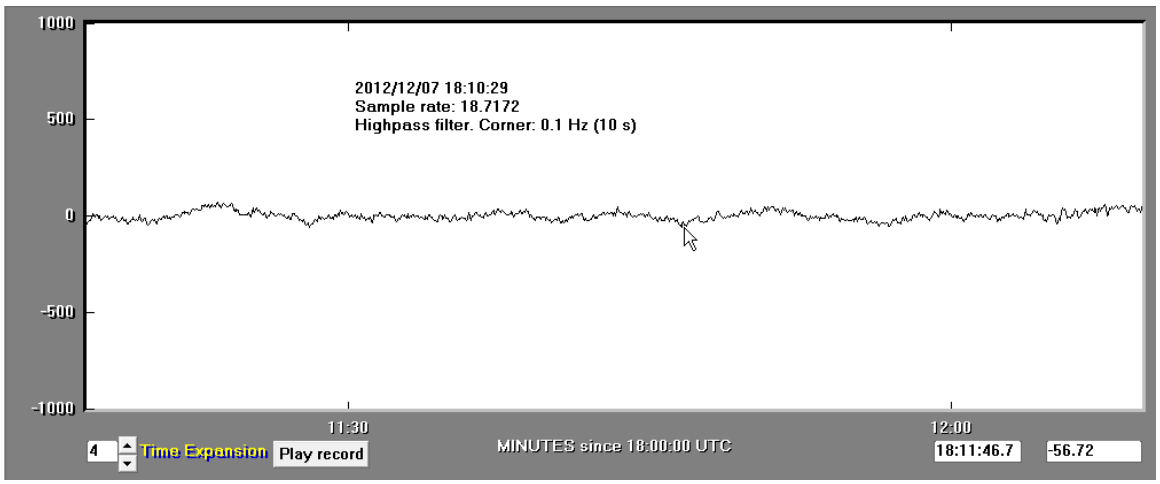
At R3 on 121207 110pm winds were light and the neighbors described the conditions as "tolerable" with no real problems. The sample seismometer graph below shows the time varying waveform for that period inside R3, the farthest home away in the testing. Peak levels were roughly 0.05 Pa (living room; scale shown approximately in milliPa), or about 50 dB peak. These results are preliminary and roughly similar to Dr. Walker's infrasonic data.

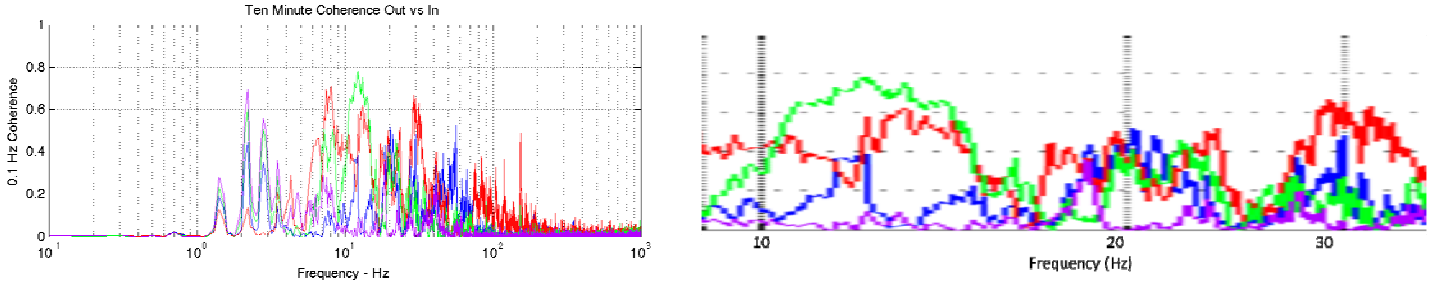
Figure 1a, b: R2-5T212420--coherence with outdoor-ground plane microphone; Living Room-Blue, Master Bed Room- Red, Behind Kitchen- Green, Basement-Purple, b is an expanded view from 9` Hz to 35 Hz

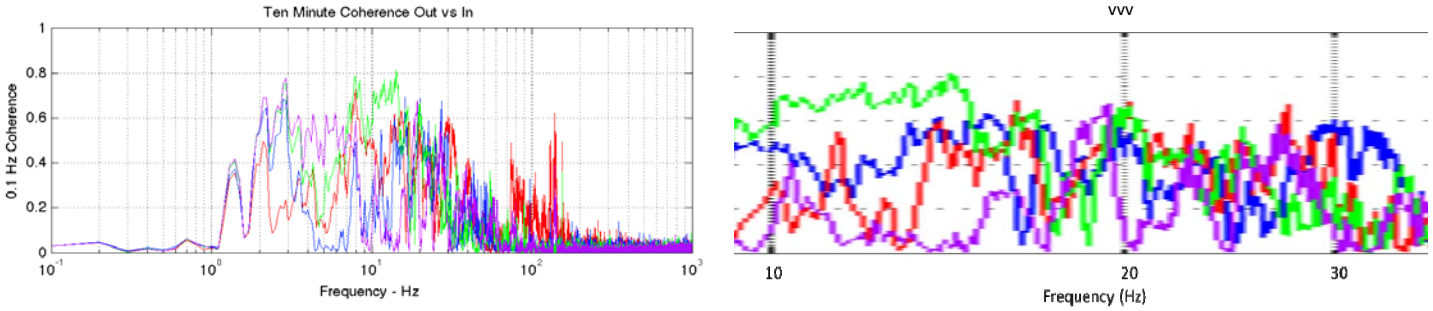
Figure 2a, b: R2-5T204657--coherence with outdoor, ground-plane microphone; Living Room-Blue, Master Bed Room-Red, Behind Kitchen- Green, Basement-Purple, b is an expanded view from 9 Hz to 35 Hz

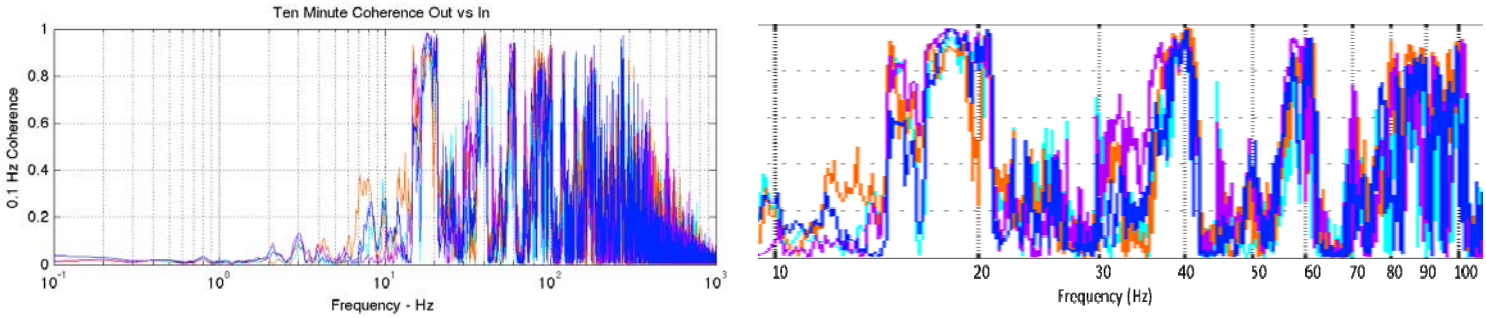
Figure 3a, b: R2-5T204657; Living Room-Blue, Upstairs Bed Room- Orange, Family Room- Turquoise, Basement-Purple, b is an expanded view from 10 Hz to 100 Hz. Note the strong coherence from 20 through at least 80 Hz that resulted from a nearby Helicopter.

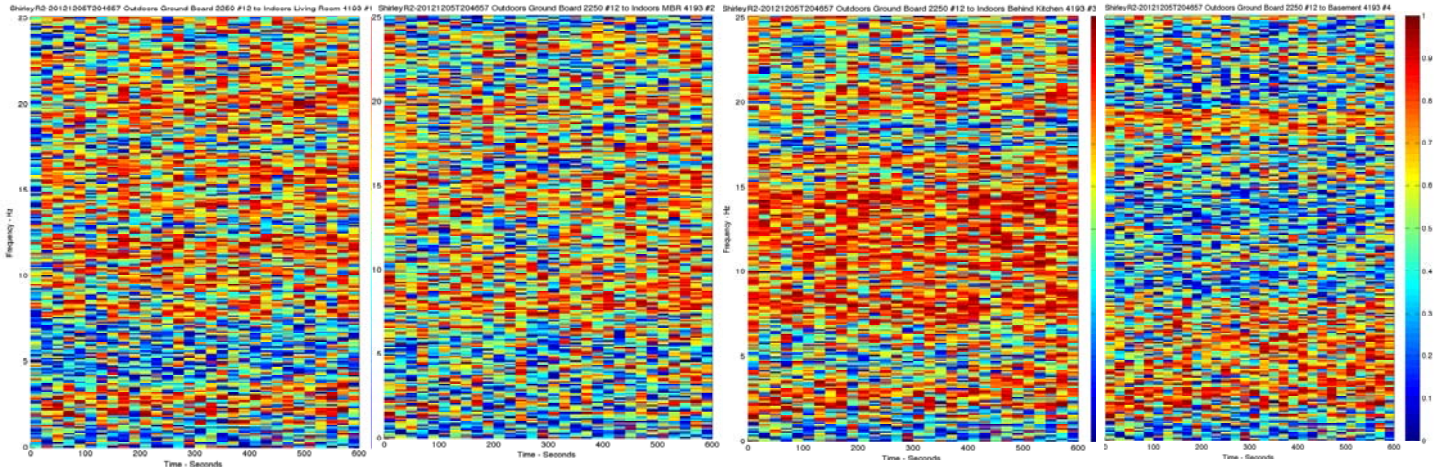
Figure 4a,b,c,d- Coherence with the outside ground microphone and the four inside microphones in the locations indicated. Note the Basement (4d) which does not have walls coincident with outside shows high coherence at the wind turbine blade passage frequency for several harmonics and almost no coherence above about 8 Hz where the at or above ground walls are resonant.

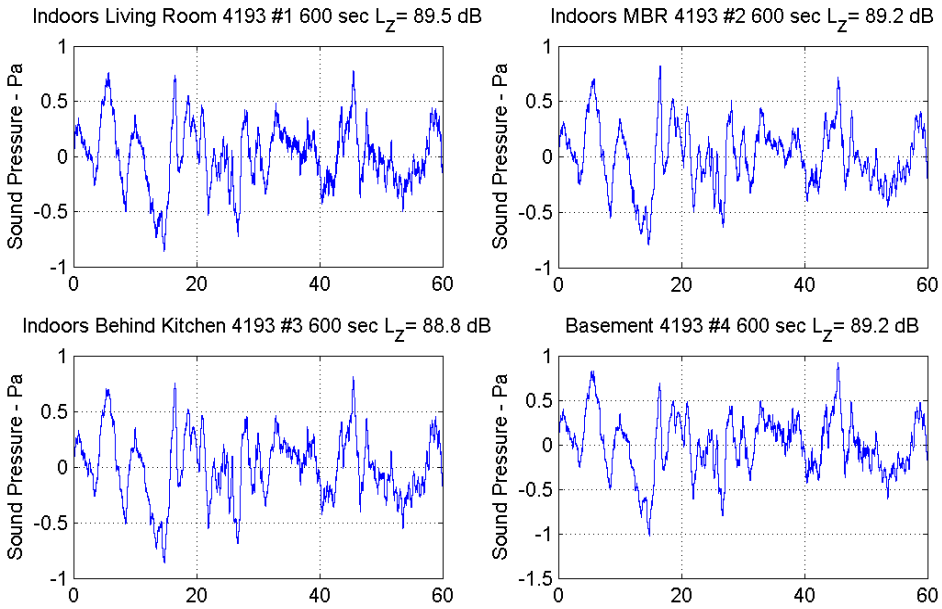
Figure 5- First of the ten minute period of 5T212420. Note that the SPL is very similar for all indoor locations.
