National Transportation Safety Board

Natural Gas Distribution Pipeline Leak and Resulting Multi-Story Structures Explosion
Harlem, New York

Operations Group Factual Report

DCA-14-MP-002

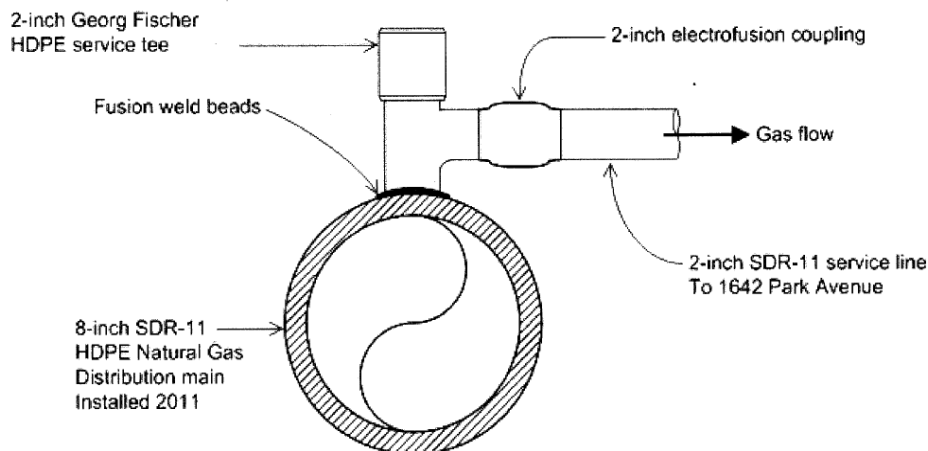
The 2-inch HDPE service pipe installation to 1642 Park Avenue was tied in to the segment of the new 8-inch HDPE gas main with a fusion-tapped service saddle tee as shown in figure 4.

Figure 4: Drawing shows cross section of 2-inch service saddle tee assembly electrofused on top of the 8-inch HDPE gas main at 1642 Park Avenue.

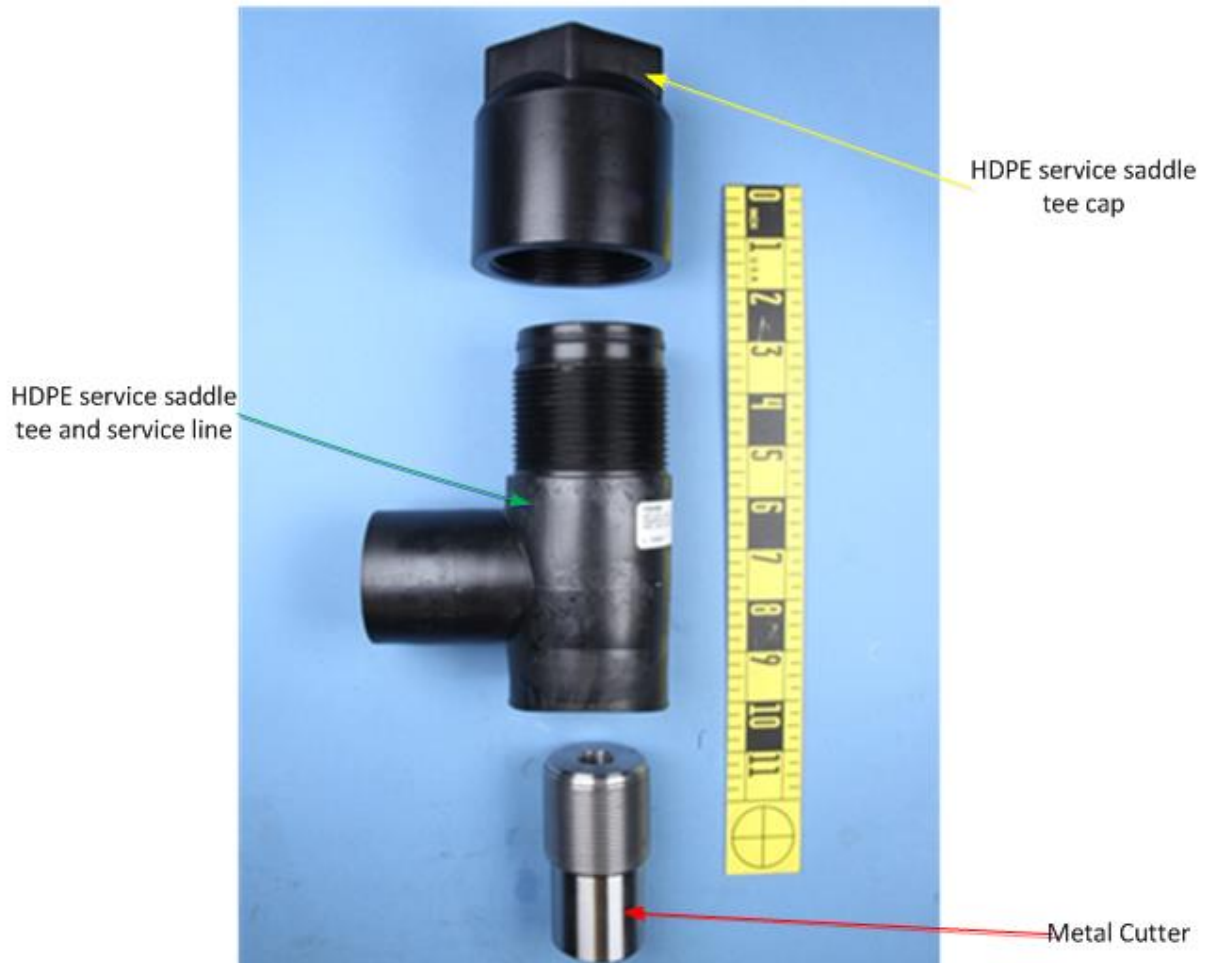
Figure 5: Gas service saddle tee components showing HDPE cap, saddle tee and metal cutter

The installer told investigators the work crew would go inside the property basement and shut the meter service valve. They would then remove the saddle cap and metal cutter and install an adapter on the service tee to attach the air supply line (figure 5). They would pressure test the service line to at least 90 psi, or more to the limit of the pressure gauge, then isolate the line from the pressure source and observe the line pressure for 15 to 20 minutes. If the pressure held, they would release the air from the service line, screw down the metal cutter to cut the hole in the 8-inch HDPE gas main, then retract the cutter and reinstall the cap.
