# U.S. Department of Transportation

## Office of Pipeline Safety

### Daily Construction Inspection Report

Date : 01/30/2013 Hours Worked : 9  
 Weather: Sunny Temp. Low 45 High 65  
 Owner/Operator: Transcanada/Keystone XL Spread 2  
 Contractor Michels

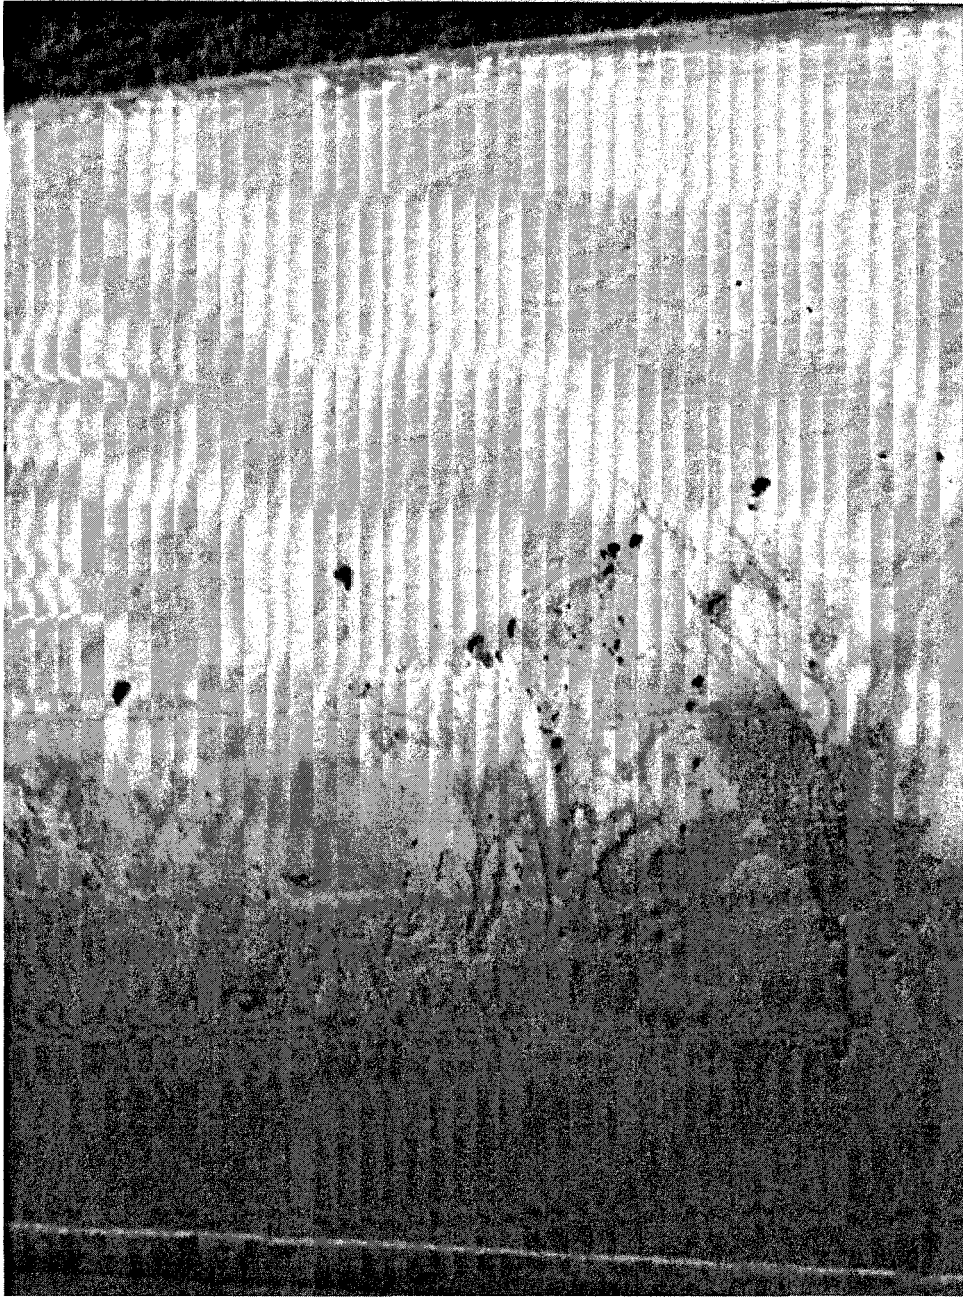
Observed Activity : Anomaly and DCVG digs \_\_\_\_\_

**Comments** Interviewed Cathodic Protection Crew about overall program. I was advised the plan had been submitted to PHMSA. The line is currently being protected by temporary anodes until project has been commissioned and then will be protected by impressed current. Observed anomaly dig #GC-1-140000058 @ MP 133.72. This anomaly did not require a cut out. Observed DCVG dig #235 @ MP 153.8. Discovered lots of rock damage spots on upper half of pipe. After further examination it was determined to excavate pipe back in both directions until clean pipe was discovered. Pipe was lightly blasted and recoated. Jeeping procedures showed no more anomalies and line was backfilled. \_\_\_\_\_
