U.S. Department of Transportation Pipeline and Hazardous Materials Safety Administration	Original Report Date:	08/05/2010
	No.	20100166 - 17790 ----- (DOT Use Only)

ACCIDENT REPORT - HAZARDOUS LIQUID PIPELINE SYSTEMS

3. Zip Code:	57349
4. City:	Howard
5. County or Parish:	Miner
6. Operator-designated location:	Milepost/Valve Station
Specify:	358.3
7. Pipeline/Facility name:	Roswell Pump Station

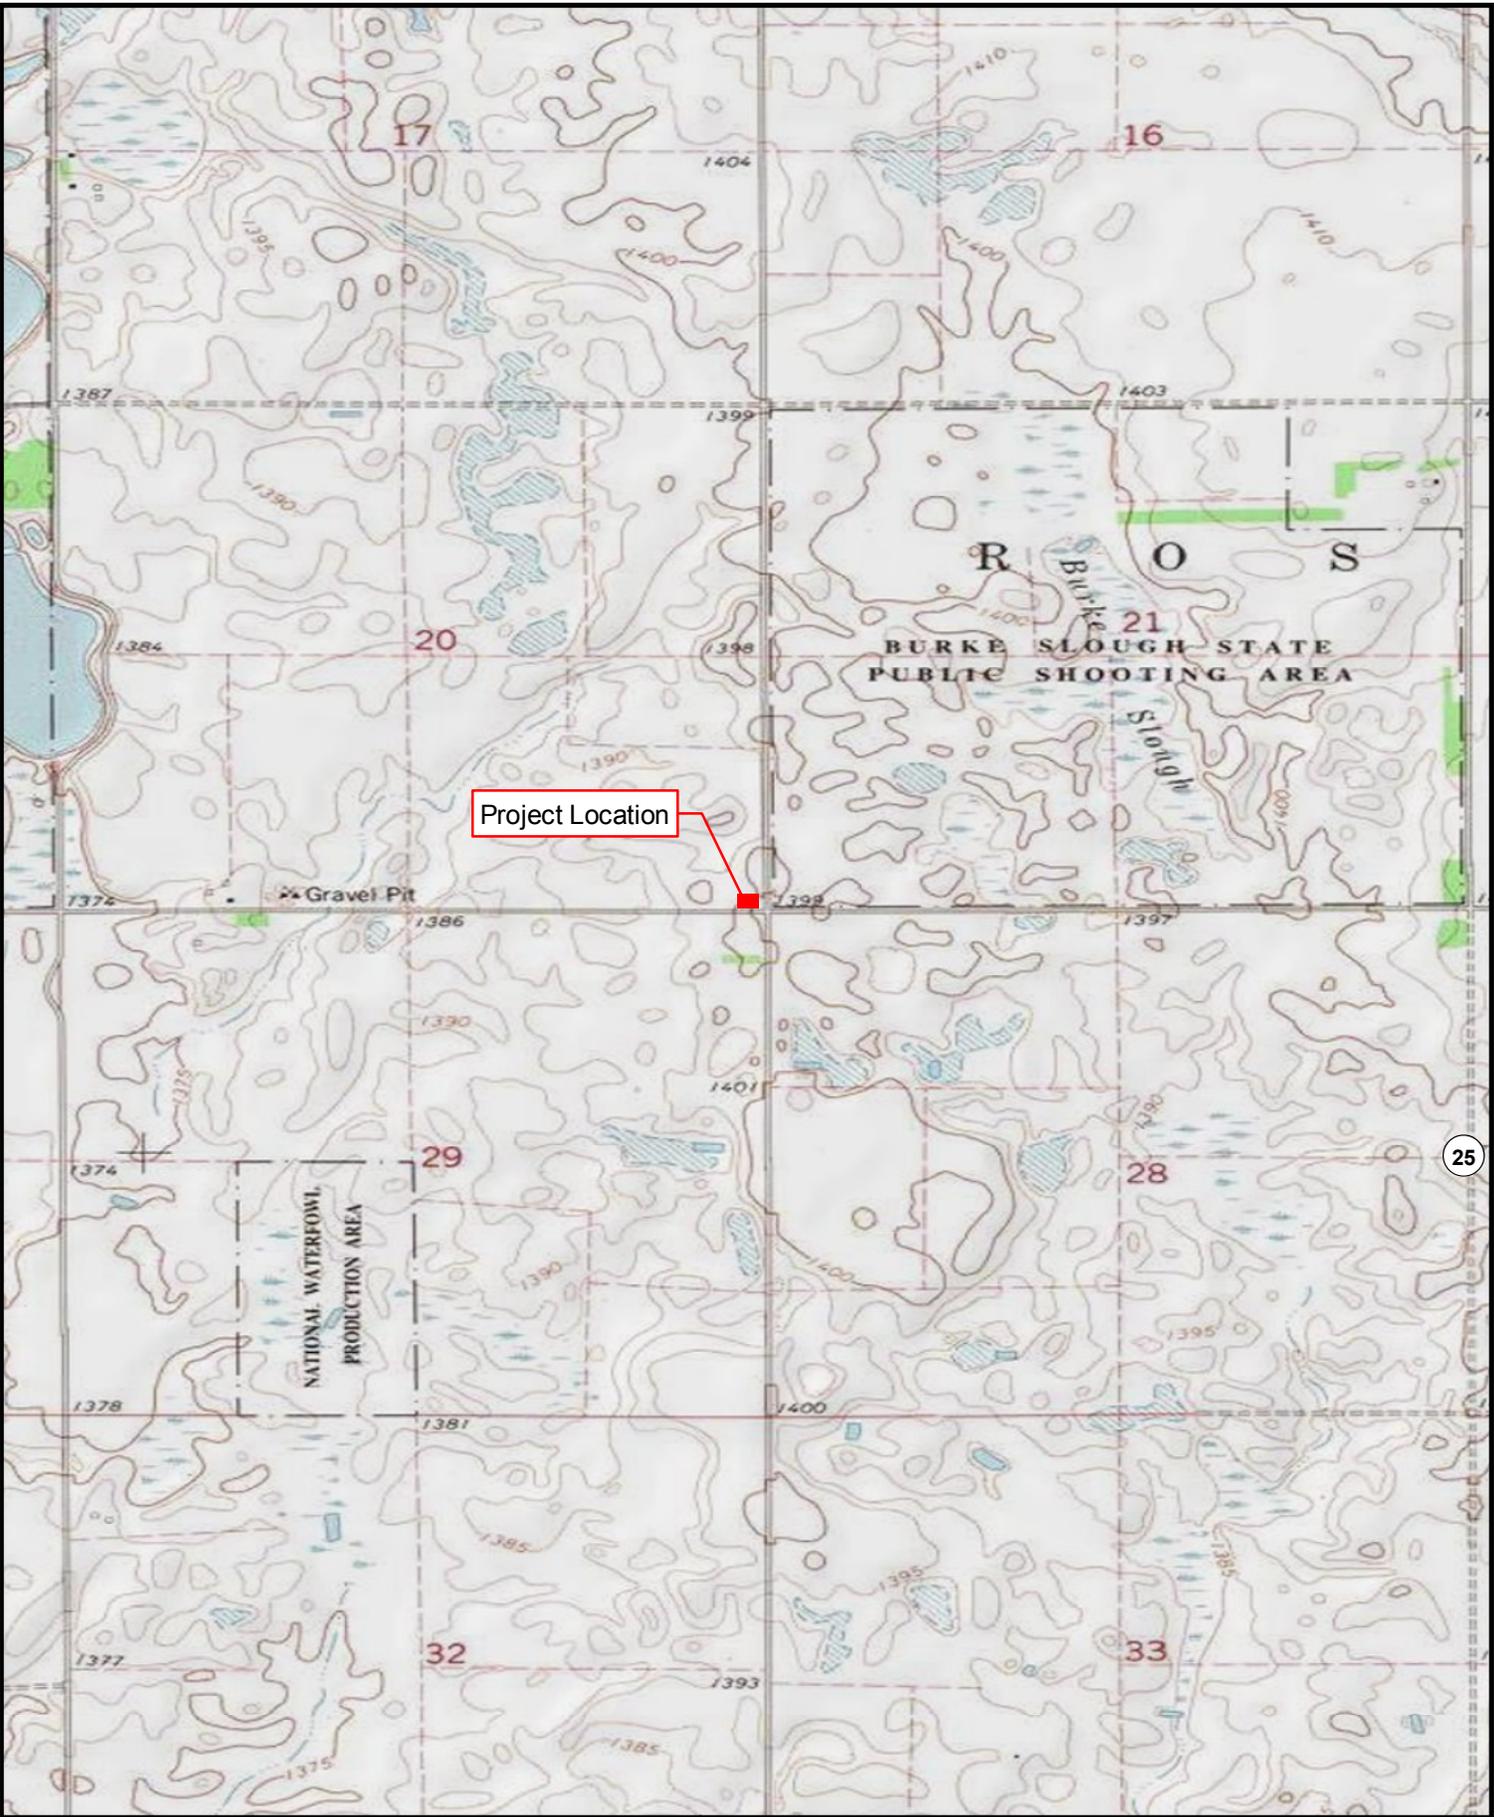
The location of the release is a pump station owned and operated by TransCanada Keystone Pipeline, LP (TransCanada). The pump station is in a rural area located at 42592 236th Street near the intersection with 426th Avenue (Figure 1), approximately three miles south of Roswell, South Dakota. The release of petroleum was entirely contained on TransCanada property.

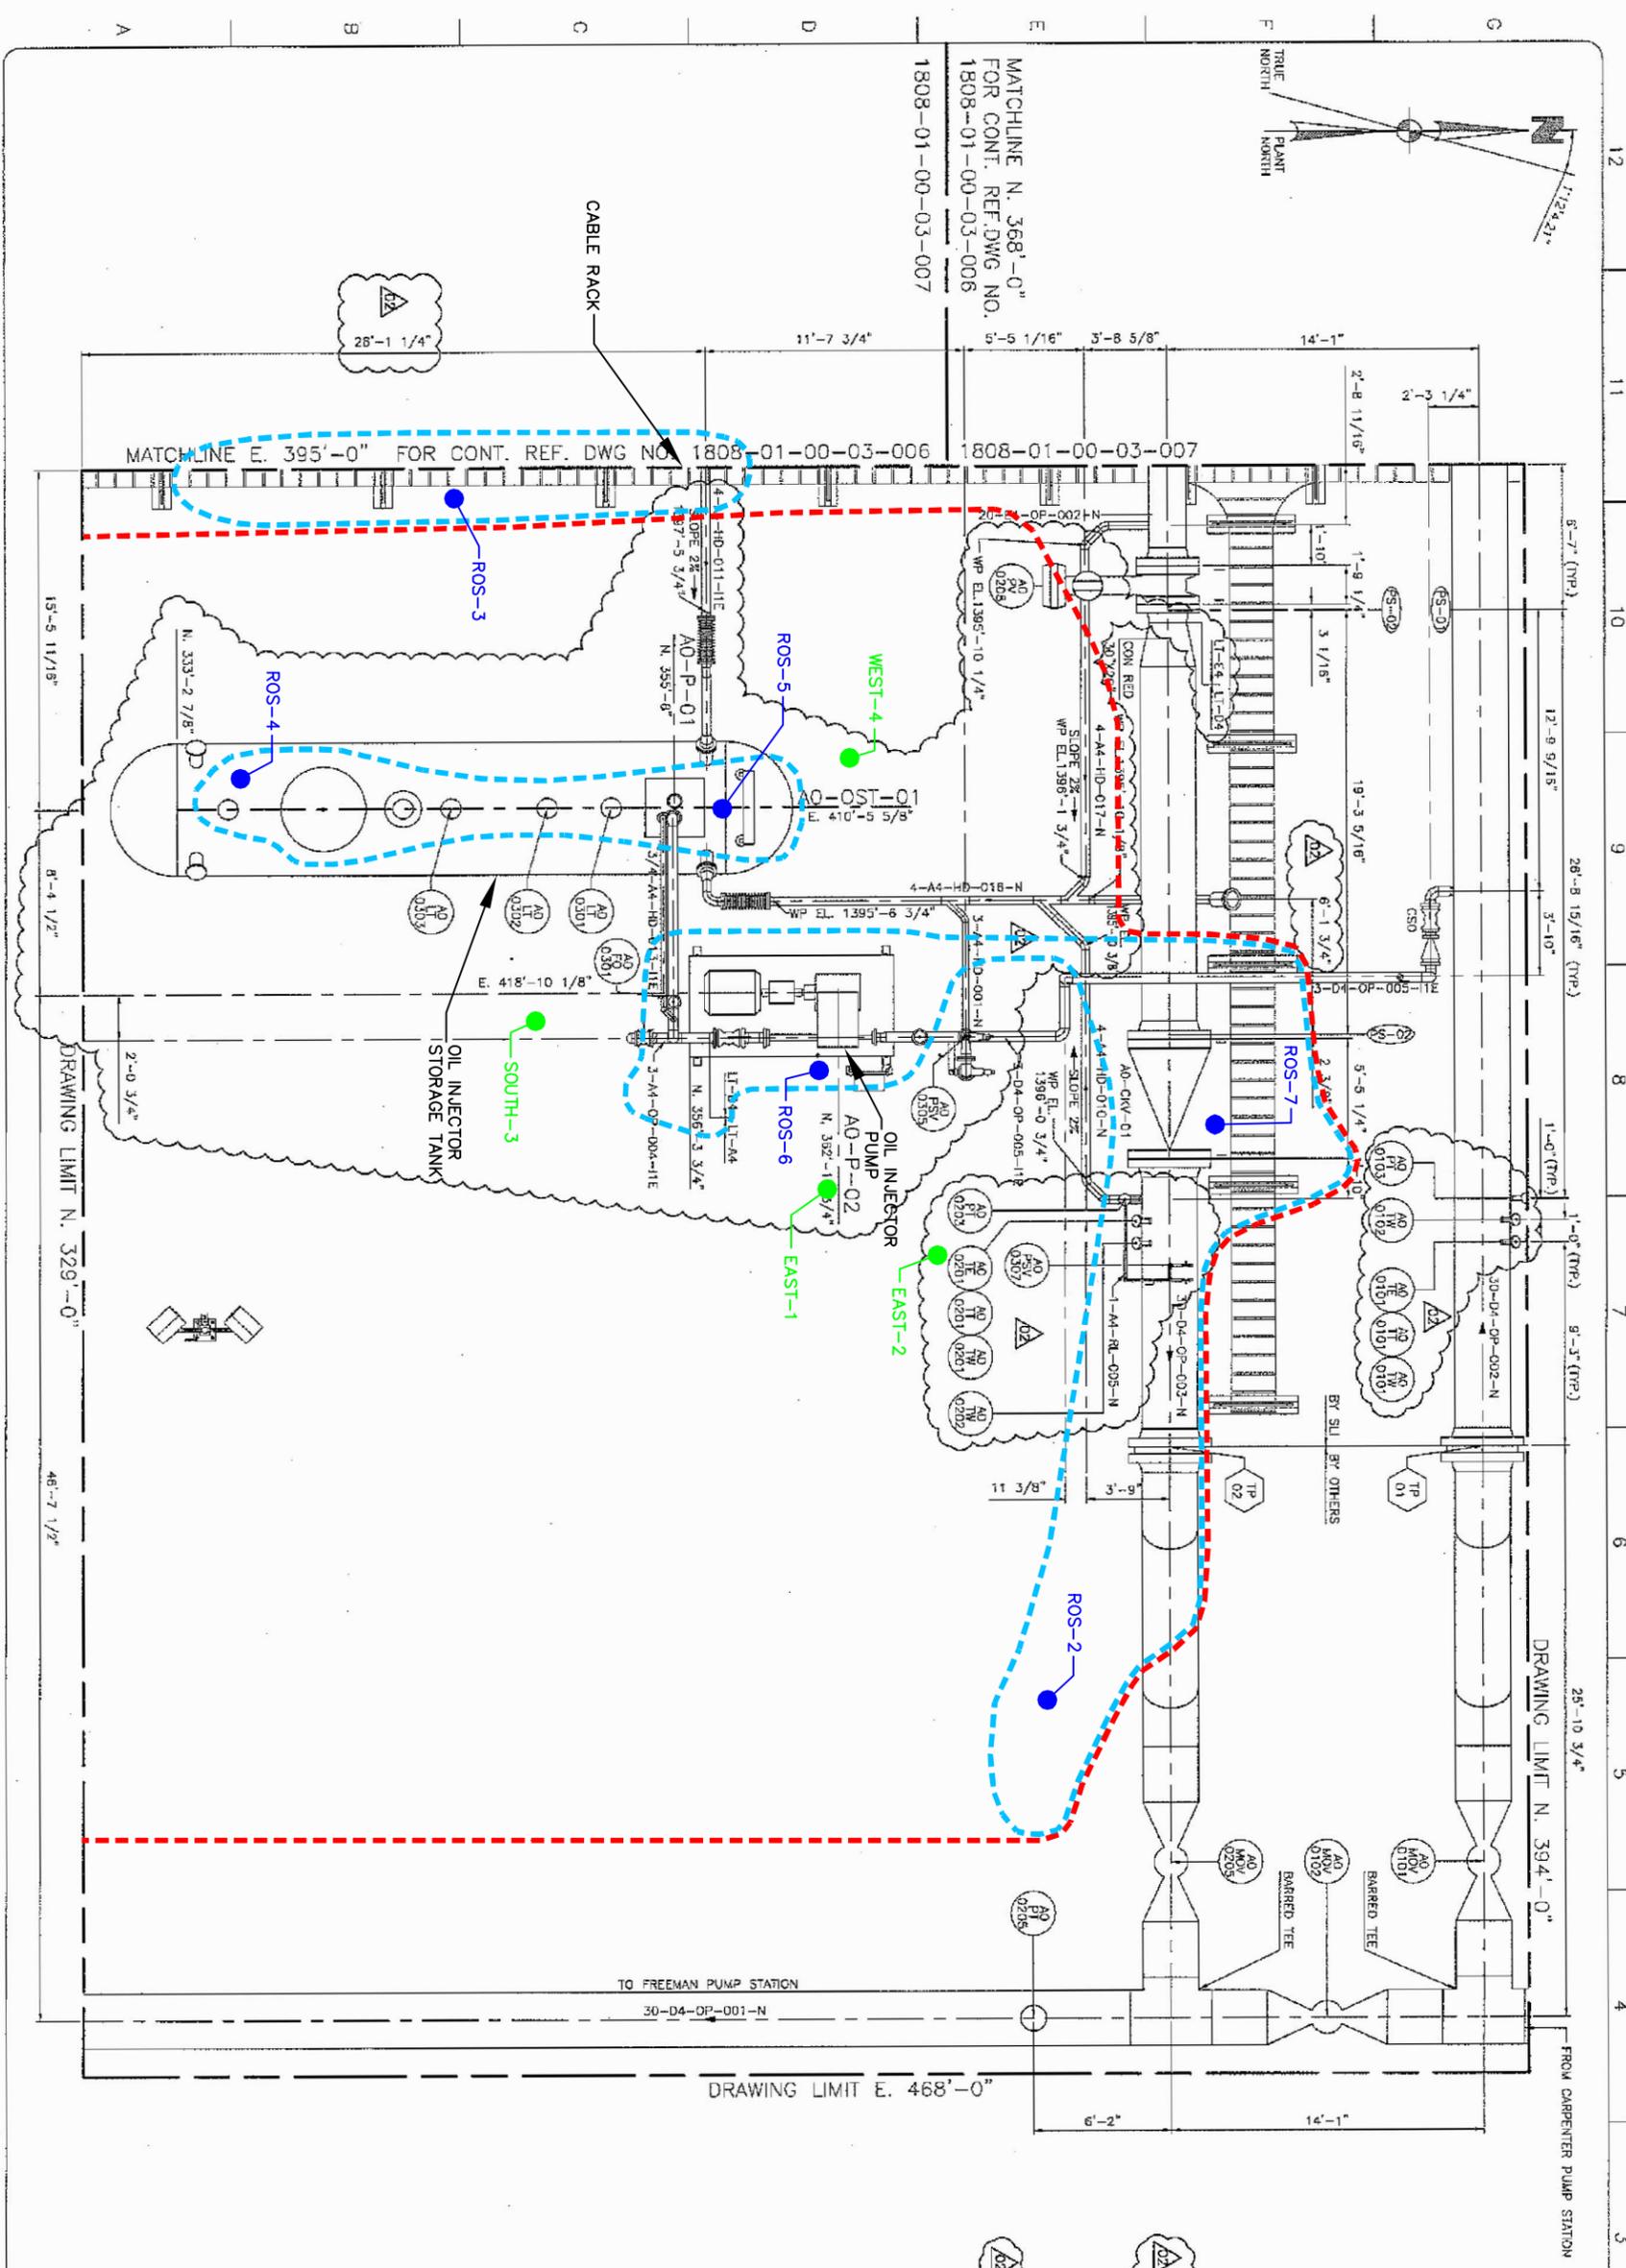
FIG NO. 2

Soils were screened using a photoionization detector (PID) with 10.6 eV lamp after excavation and hydrovac removal activities to determine the required limits of excavation. In addition, the scraped surface yard was screened using the PID. This included four potholes locations dug to confirm clean conditions. Confirmation soil samples were collected at eight locations after excavation was completed. Sampling and PID screening locations and excavation areas are shown in Figures 2 and 3. Confirmation sample ROS-8 is a composite of three discrete samples collected in the south grass mowed area as shown in Figure 2.

URRS SOIL SAMPLING, PID SCREENING LOCATIONS & EXCAVATION AREAS
TRANSCANADA KEYSTONE PIPELINE
ROSWELL, SOUTH DAKOTA
