**ACCIDENT REPORT - HAZARDOUS LIQUID
PIPELINE SYSTEMS**

3. Zip Code:	58017
4. City:	Brampton
5. County or Parish:	Sargent
6. Operator-designated location:	Milepost/Valve Station
Specify:	MP ND 216.7
7. Pipeline/Facility name:	Ludden Pump Station

A release occurred at the Ludden Pump Station on the 3/4" pipe nipple under the thermal relief valve located on the facility discharge piping. A root cause analysis has been conducted and the failed fitting investigation performed. The fatigue failure of the 3/4" pipe nipple occurred as a result of excessive vibratio. Results have been provided to PHMSA.

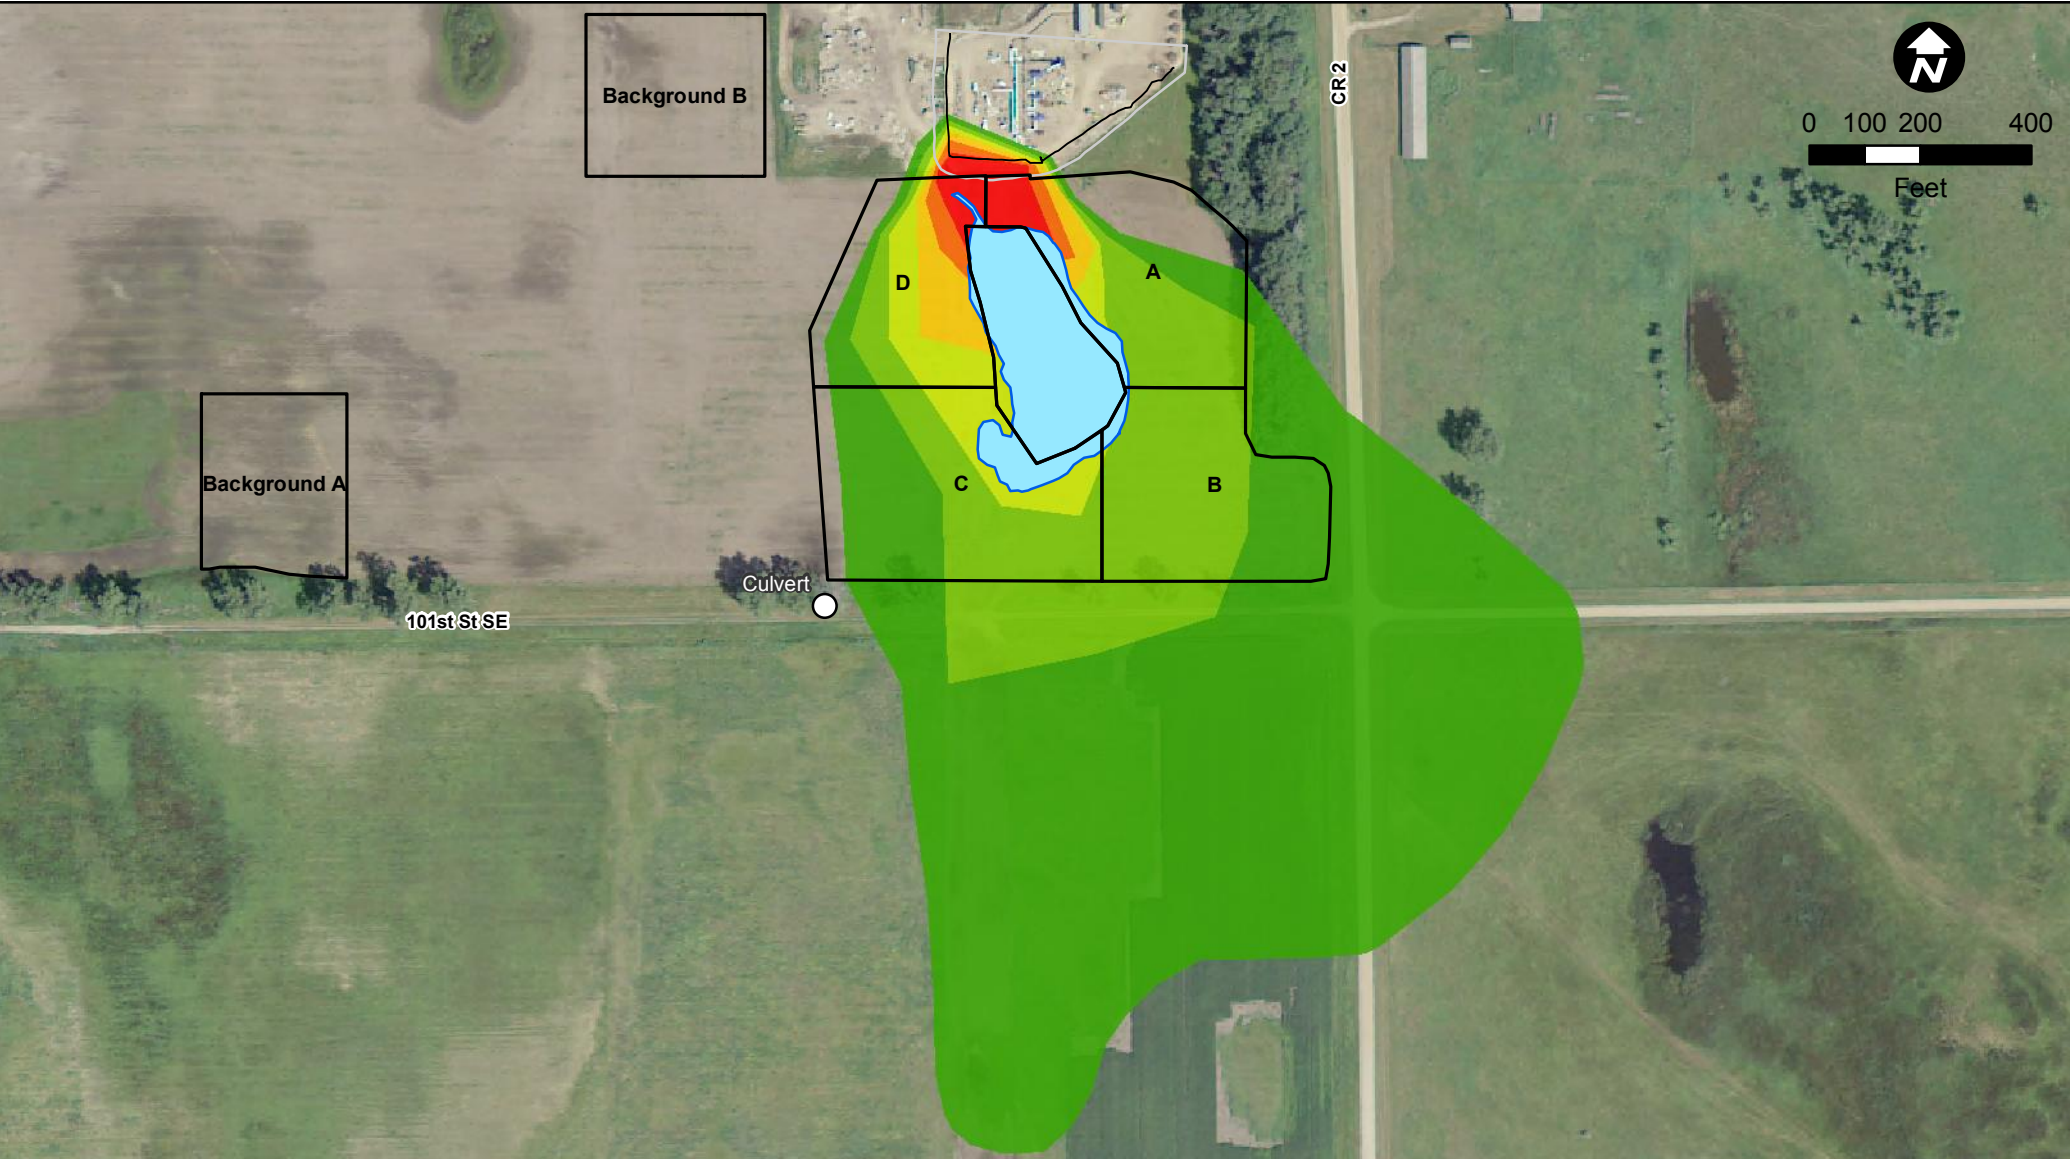
Figure 1. Land Farm Sample Locations - October 20, 2011

The land farmed area was resampled on October 20, 2011. The sample locations are shown on Figure 1 and the results are summarized on Table 1. Analytical results continued to show total extractable hydrocarbon (TEH) concentrations in soils below North Dakota Department of Health (NDDH) clean-up levels at all sampling locations.

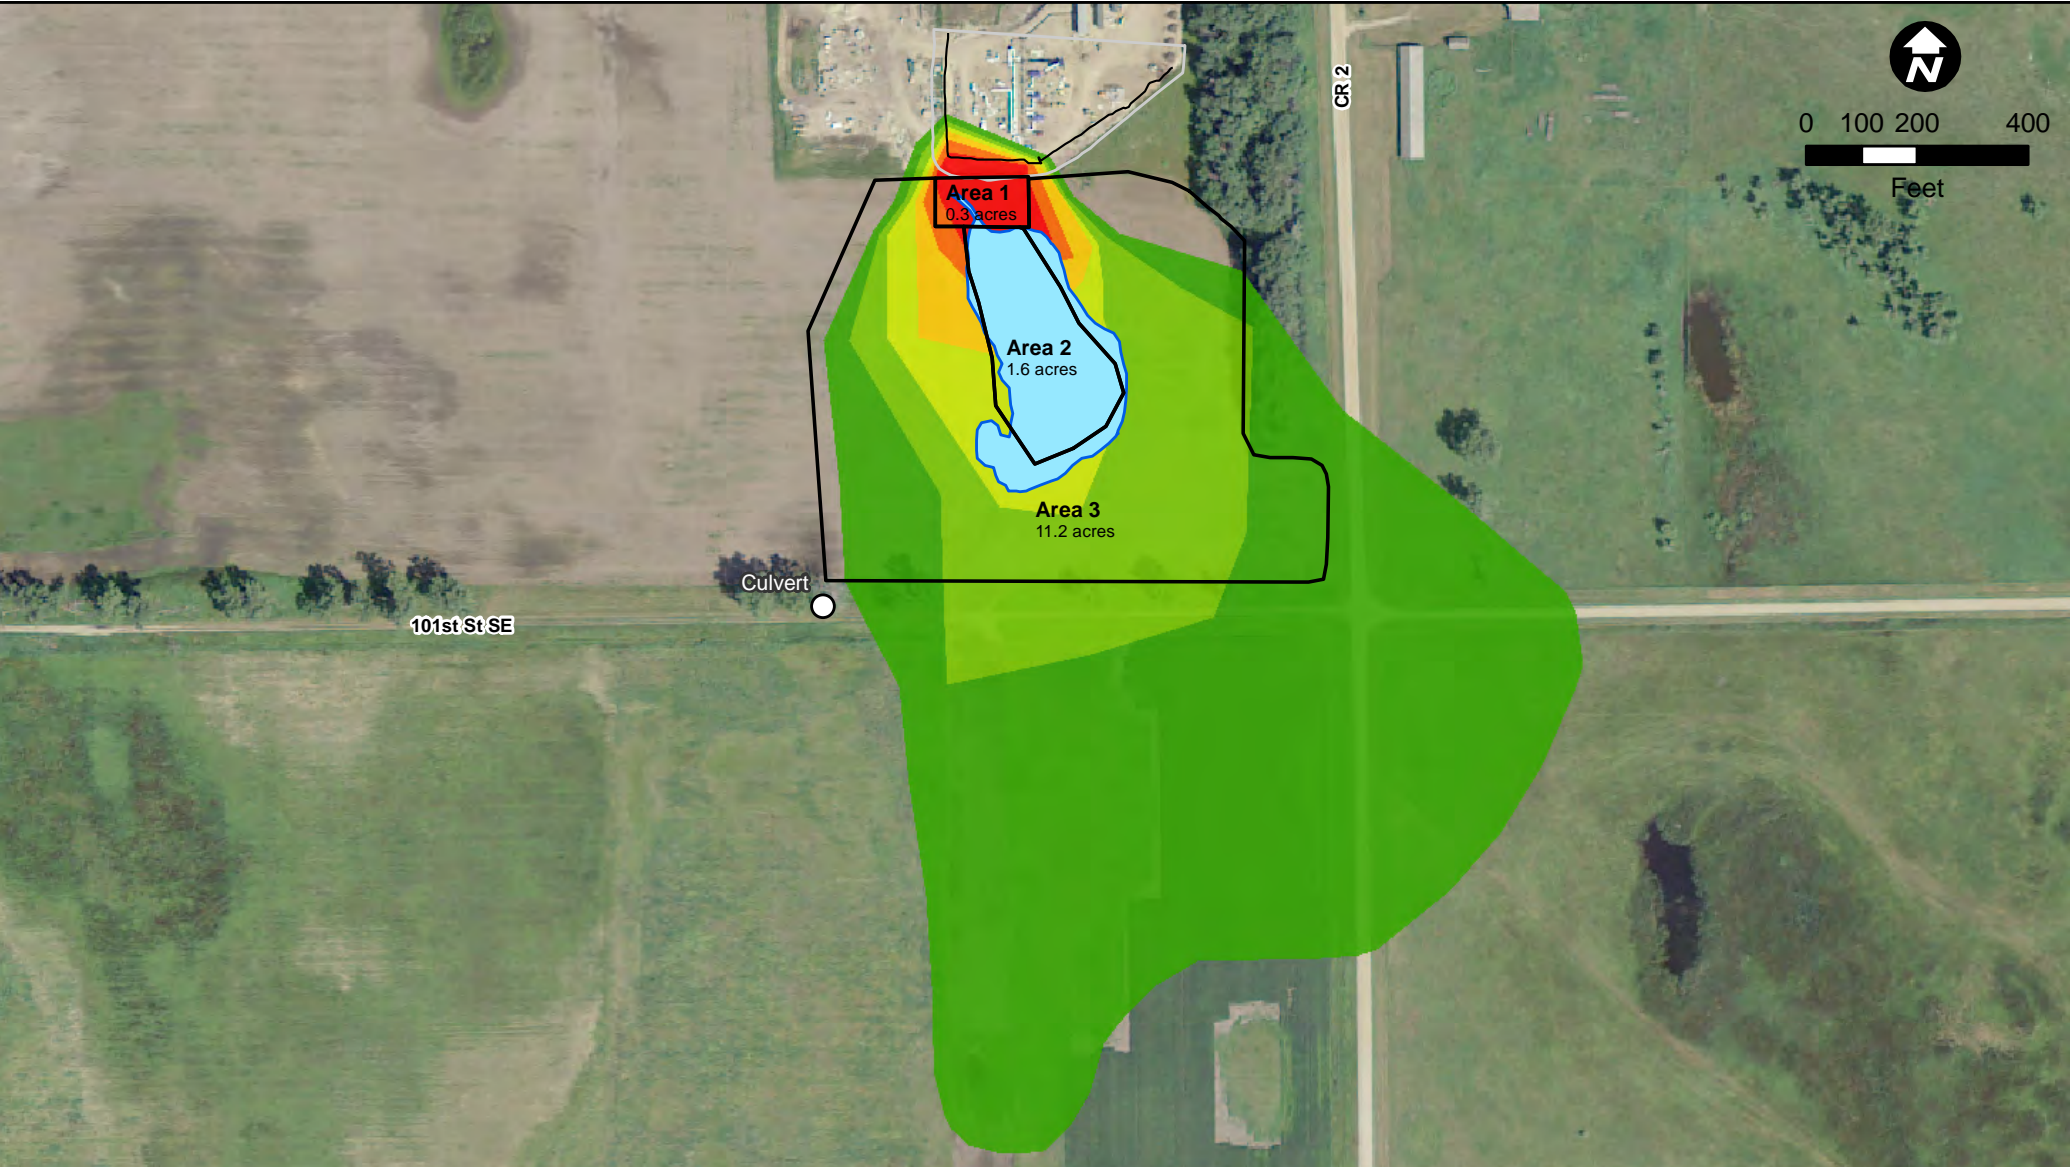
Figure 7. Land Farm Areas

For treatment calculations, the off-site area is divided into three areas as shown in **Figure 7**. Areas 1 and 3 are the non-flooded areas that have oil impacts and decreasing amounts of oil toward the south of Area 3. Area 2 is impacted and ponded water exists in this lower wetland area of the south field. Area 2 is included for in-situ treatment of the water. Based on the areas outlined in **Figure 7** the following are the associated contaminated volumes assuming a 2 inch depth for Area #1 and 1 inch depth for Areas #2 and #3:

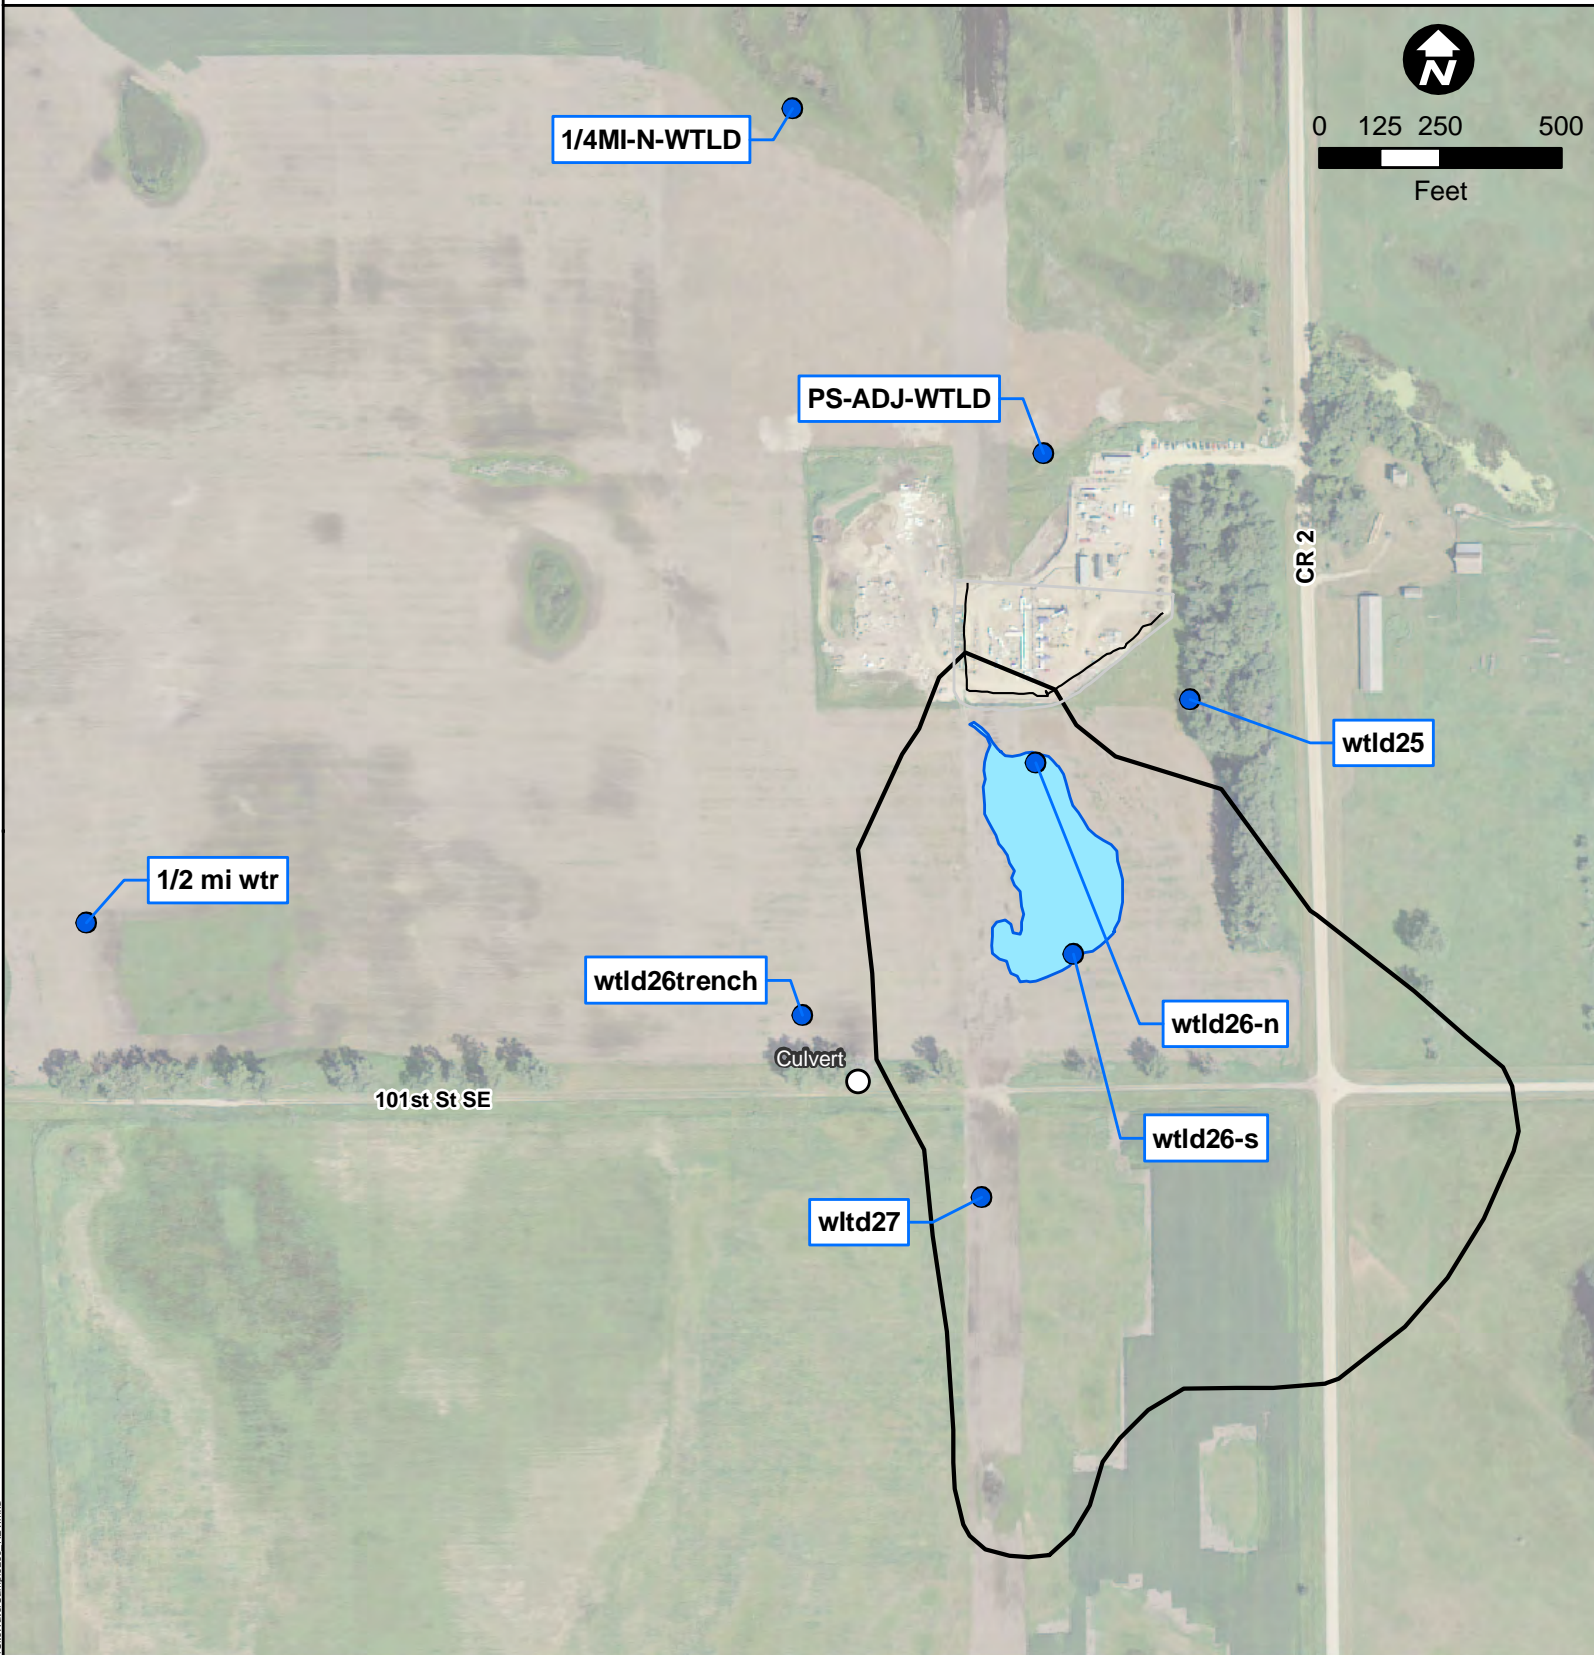
Figure 6. Off-Site Water Sampling Locations

Surface water samples were collected from three downwind wetlands and two potential downstream drainage locations on May 13, 2011 for BTEX and TEM. The same locations were resampled on May 16, 2011 for ammonia nitrogen and a suite of metals requested by North Dakota Department of Health (NDDH), which included aluminum, antimony, arsenic, barium, beryllium, boron, cadmium, chromium, copper, lead, nickel, selenium, silver, thallium, and zinc (Metals Suite). Two upwind wetlands were also sampled for background purposes on May 16, 2011 for BTEX, TEM, ammonia nitrogen, and the Metals Suite. All sample locations are presented in **Figure 6**. The wetland immediately south of the pump station that received oil misting was also sampled for total suspended solids, pH, and total phosphorus. All surface water sample locations were resampled on June 30, 2011 and August 2, 2011 for BTEX, TEH, TEM, and the Metals Suite. The analytical results are summarized in **Table 2A, 2B, 2C**, respectively and complete analytical reports are provided in **Appendix C**.

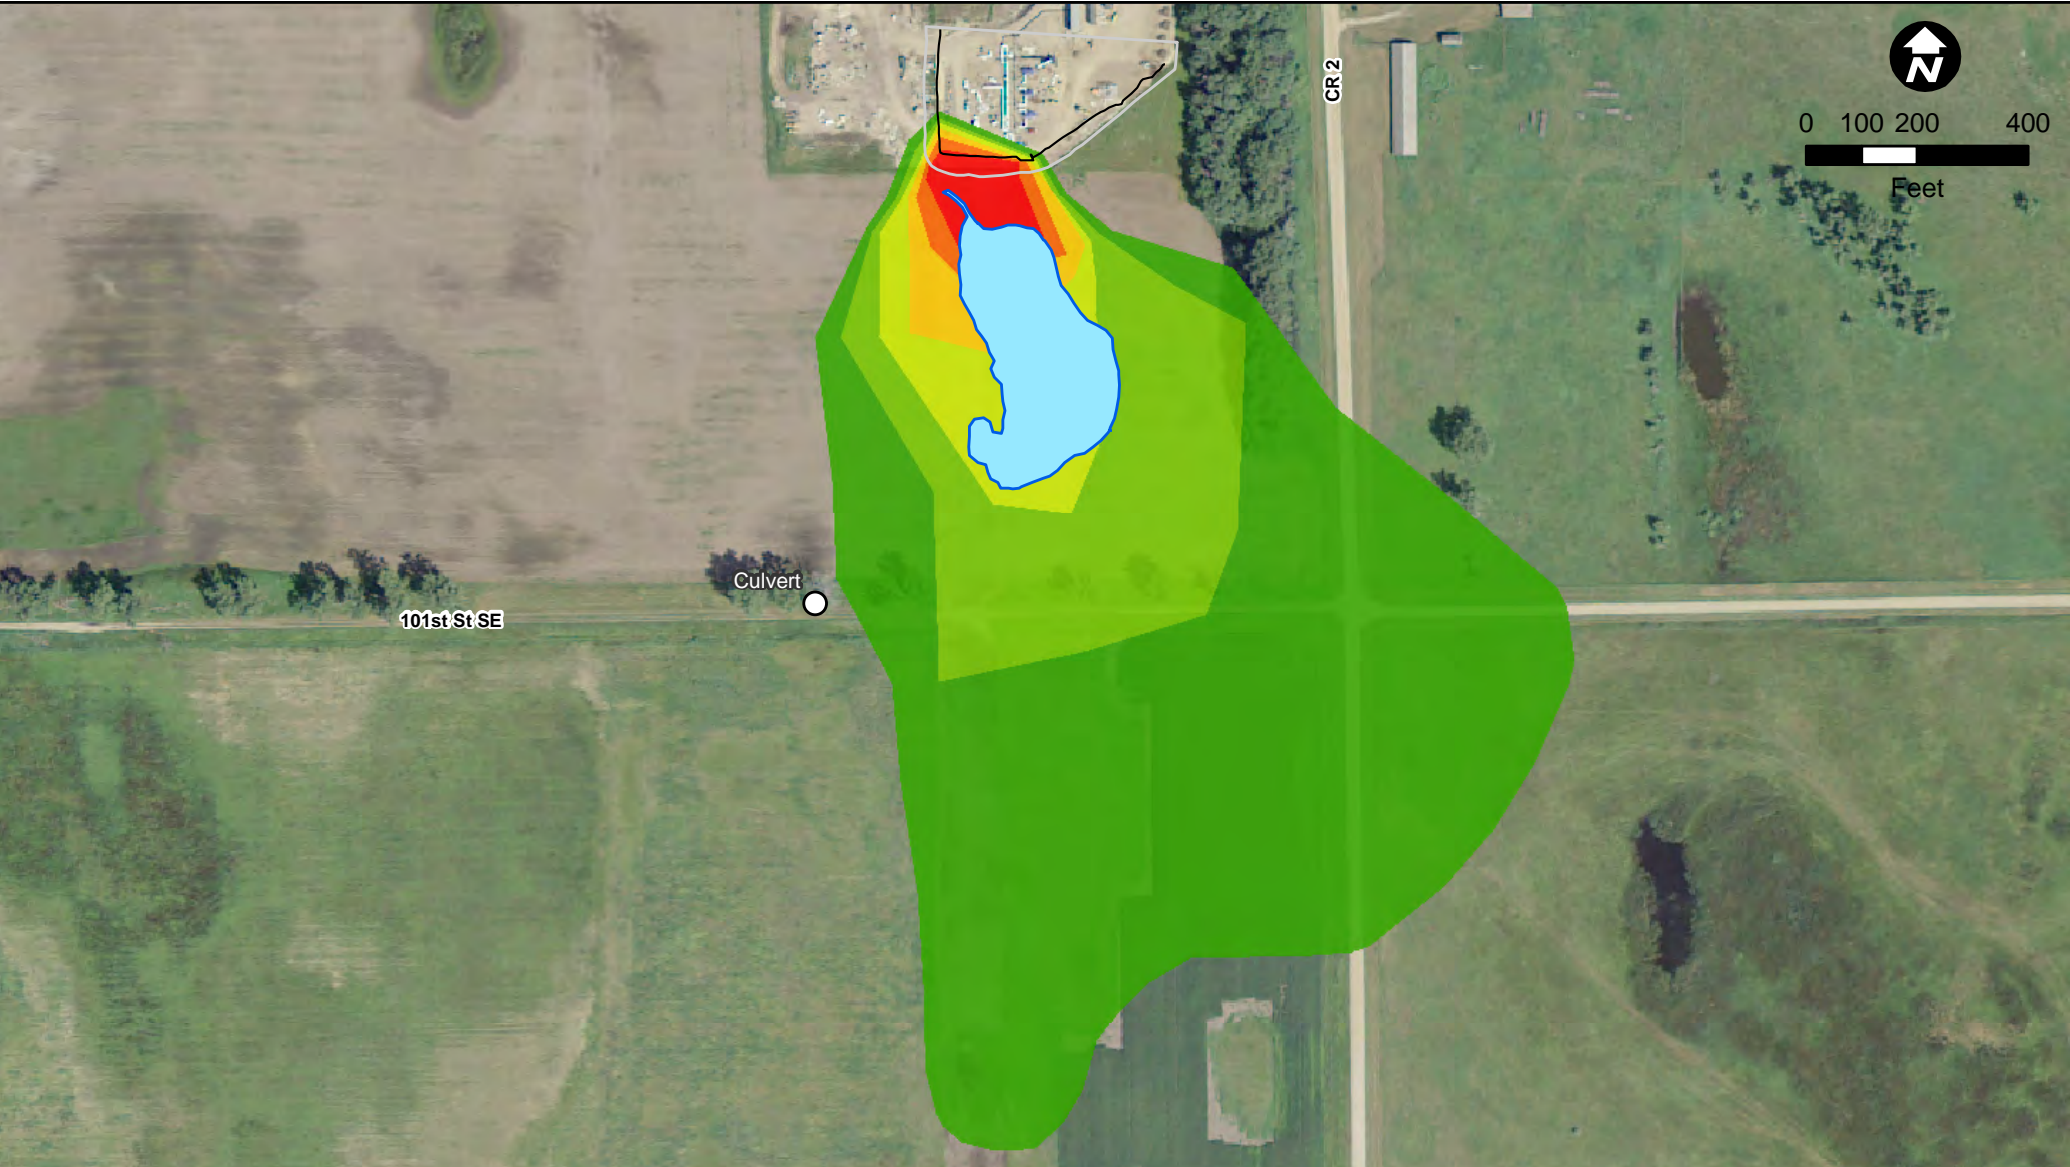
Figure 4. Oil Misted Areas

The off-site area has been designated as the farmed agricultural property to the south of the pump station which was impacted by residual oil mist from the release (**Figure 4**).

The term “Sporadic” as used by NOAA covers a percentage range from 1 to 10 percent. For the purposes of this project, “Sporadic” was split into “Sporadic-Low” (1-5%) and “Sporadic-High (6-10%). The results of the SCAT Assessment are presented in **Figure 4**.

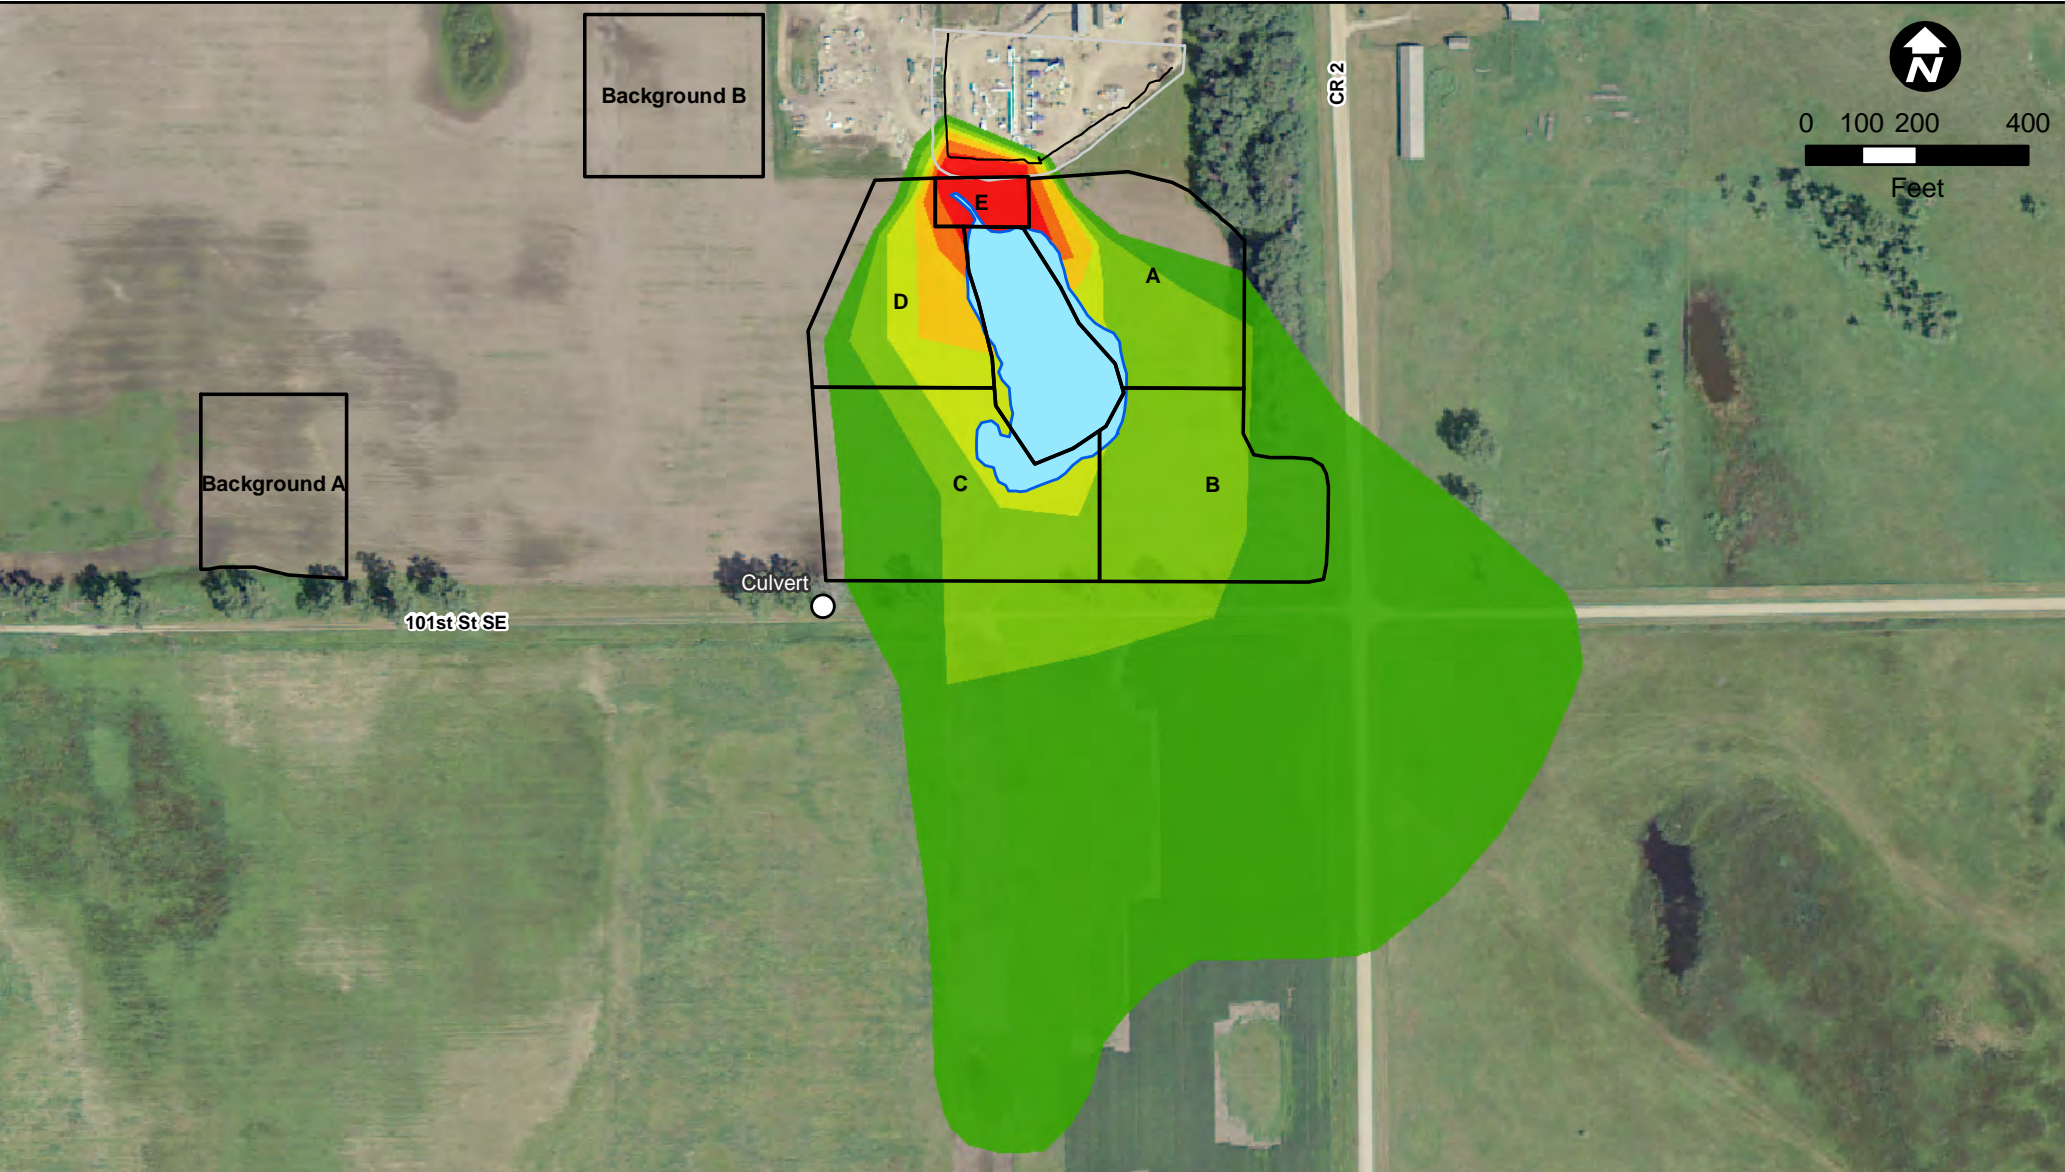
Figure 8. Land Farm Sample Locations

Based on total volume, the land farm area was divided into four parts (**Figure 8**) and sampled on May 15, 2011 for TEH, TEM, pH, nitrate nitrogen, total phosphorus, and total organic carbon. For the May 15, 2011 land farm soil samples, the excavated area that is labeled as Area E in Figure 8 was divided equally between Areas A and D. Two background area samples were also collected. Each area included four to six discrete samples that were composited to represent each area. Analytical results are summarized in **Table 3** and complete analytical results are included in **Appendix C**.

On July 1, 2011, the area labeled as Area E on **Figure 8** was fertilized with 20-0-0 lawn fertilizer at a rate of 1.2 pounds per 1,000 square feet and tilled using a rear tine garden tiller.
