Intensive Historic Building Survey and Evaluation for the Brookings County Substation to SD/MN Border Segment of the CapX 2020 Brookings County to Hampton 345 kV Transmission Line Project

Volume 1 of 2

Prepared by:
Kevin (Lex) Palmer – Principal Investigator
HDR Engineering, Inc.
701 Xenia Avenue South, Suite 600
Minneapolis, MN 55416

September 2013

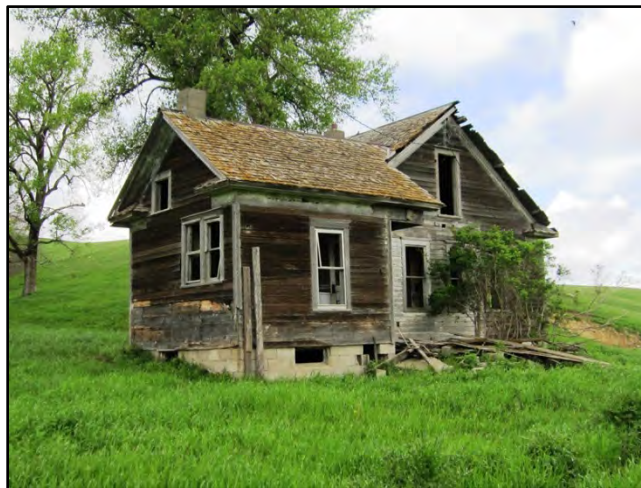
The farm residence (Figure 3-27, Building 1 on site map) is a two story Folk Victorian building constructed circa 1900 on a partially raised CMU foundation, likely locally produced in Brookings. The portion of the foundation that is raised along the south elevation features basement-level fixed windows with missing framing and glazing. The house features an L-shaped floor plan, wood clapboard wall cladding, and a cross-gabled roof featuring boxed eaves with returns. The roof is clad with wood shingles and features two interior CMU chimneys at both gable ends. The south primary façade has a collapsed front porch originally placed in the corner of the L-shaped floor plan. The primary entry features a three-panel door with a missing upper light. The south elevation fenestration is comprised of three wood frame double-hung windows with lintels, and a fixed gable end window that is missing the glazing. The west elevation fenestration bears two wood double-hung and one fixed gable end windows that are missing their muntins and glazing. The east elevation has two wood frame double-hung windows with missing glazing. The north elevation has two double-hung windows, and two gable end double-hung windows, along with a door opening with a missing door.

Figure 3–27. Folk Victorian residence Building 1 south primary façade and east elevation.

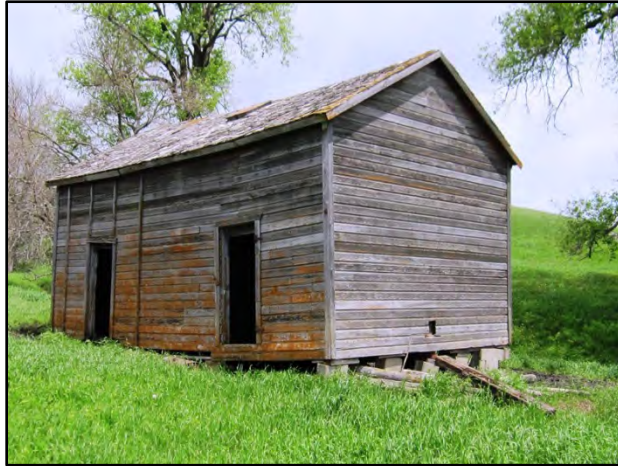
The granary (Figure 3-28, Building 2 on site map) is a rural vernacular-style building constructed circa 1920 on a CMU foundation with a rectangular floor plan, wood clapboard wall cladding, and a side gable

roof clad with wood shingles. The west roof aspect contains a grain port covered with a square metal hatch. The primary west elevation wall opening comprises two wood frame doorways with missing doors.

Figure 3–28. View to northeast of granary Building 2 west primary façade and south elevation.

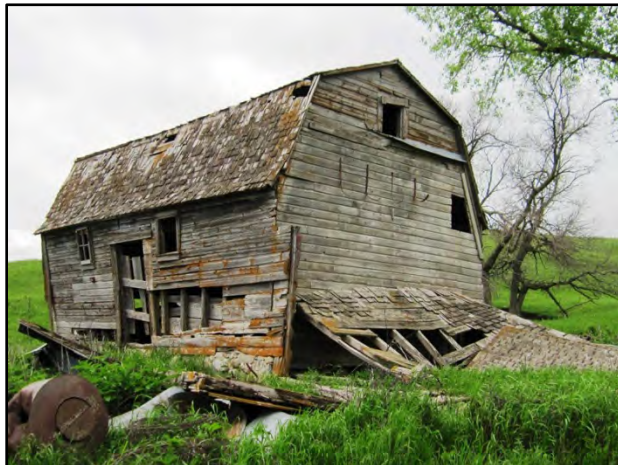
The Wisconsin style dairy barn (Figure 3-29, Building 3 on site map) constructed circa 1910 on a concrete and field stone foundation, has horizontal wood board cladding, and a gambrel roof clad with wood shingles. None of the windows has any glazing remaining, and the muntins are missing or are partially intact. The primary south elevation fenestration comprises a doorway partially boarded over, a wood frame four-light window, and a wood frame fixed window. The west elevation fenestration comprises a square wood frame hayloft opening on the gable end and a vertical board door. The north elevation has a wood fixed window opening. The east elevation has a gable end wood frame fixed window. The east elevation has a collapsed wood frame storage canopy covered with wood shingles. The barn has deteriorated and is listing to the south.

Figure 3–29. Wisconsin style dairy barn south primary façade and east elevation.

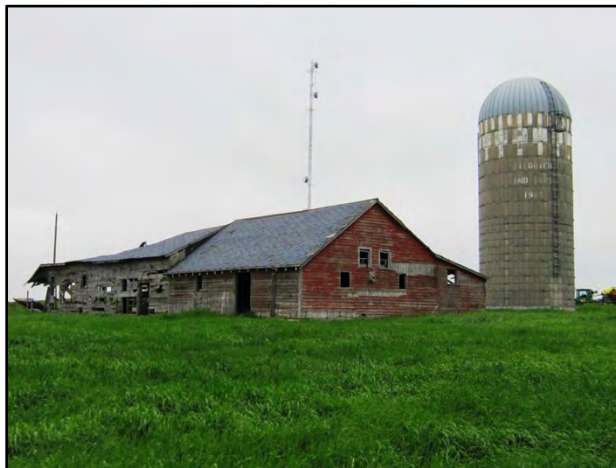
Building 1 (Figure 3-30, and see site map) is a rural vernacular style barn constructed circa 1910 on a concrete foundation with a rectangular floor plan, wood clapboard wall cladding, and a side gable roof clad with composition shingles. It is in poor condition, with the windows missing their glazing and the building is collapsing. The north primary façade wall openings comprise two upper wall wood window openings and two lower wall wood windows openings. The east elevation wall openings include a vertical wood board plank door and a window opening. The remainder of the east elevation has collapsed. The south elevation has also collapsed. The west elevation wall openings include three boarded-up doors, two vertical wood plank doors, a boarded up loft opening, a boarded up window and a window opening. A collapsed shed roof extension is attached on the north corner of the west elevation.

Figure 3–30. View to southwest of barn (Building 1) north primary façade and east elevation, and concrete stave silo constructed in 1965 by Diedrich and Sons.

An adjacent concrete stave silo was constructed in 1965, based on the painted logo by “Diedrich and Sons 1965”. The concrete stave silo (Figure 3-30, Building 2 on site map) has a concrete foundation with a round floor plan, concrete stave cladding bound by metal hoops, and a domed roof formed from crescent-shaped metal panels. A metal tube silage port appears along the west aspect of the silo. Two rows of decorative alternately painted concrete blocks appear beneath the metal dome. A metal access ladder is installed on the east aspect of the silo. The silage chopper house is missing from the bottom of the silage port.

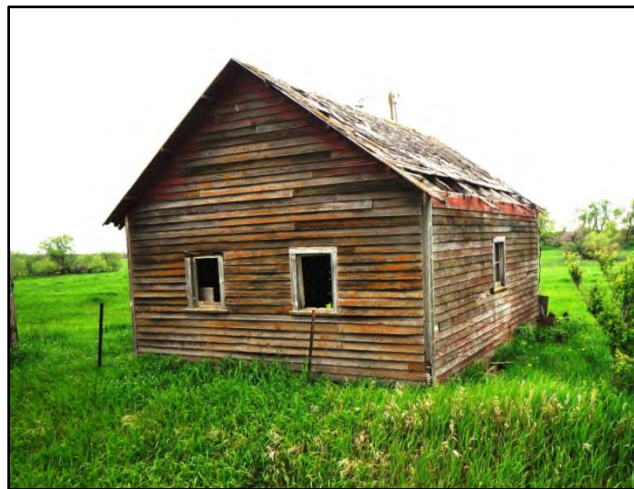
The residence or outbuilding (Figure 3-31, Building 1 on site map) was constructed circa 1910 on a wood post and pier foundation with a rectangular floor plan, has wood clapboard wall cladding, and a front gable roof clad with wood shingles. The east elevation fenestration comprises two wood frame openings without sash or glazing. The south elevation has one wood frame opening without sash or glazing. The west elevation has two wood frame doorways without doors. The north elevation fenestration includes a wood fixed window and a wood 2/2 light window, both without glazing.

Figure 3–31. View to southeast of historic age residence north and east elevations.

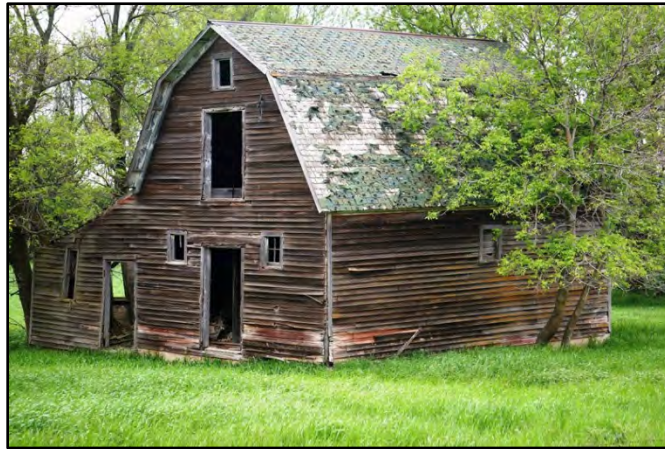
The small vernacular style barn (Figure 3-32, Building 2 on site map) has a concrete foundation with a rectangular floor plan, and wood clapboard cladding. The gambrel roof is clad with wood shingles overlaid with deteriorating composition asphalt shingles, and has a shed roof extension to the west. The primary south façade wall openings feature a wood primary doorway and a second story wood hayloft opening, both without doors. Two wood 2/2 light fixed windows flank the primary doorway. Another wood fixed window without any sash appears above the second story hayloft doorway. The shed extension to the west also has a wood frame doorway without a door and a wood frame window opening

without a sash on the south primary facade. The west and north elevations were not visible from the ROW. The east elevation has a boarded-up wood window opening.

Figure 3–32. View to northwest of historic age barn (east) Building 2 east primary façade and north elevation.

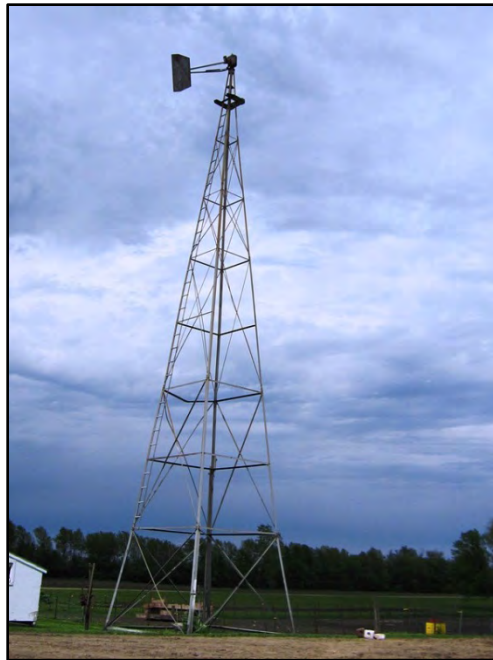
Building 13 (Figure 3-46 and see site map) is a historic age Monitor brand windmill produced by the Baker Manufacturing Company. It has four metal braces that form a triangular configuration that are held in concrete footings. The vanes are missing on the top and the tail is still present. An access ladder is located on the northwest side.

Figure 3–46. View to northeast of windmill (Building 13).

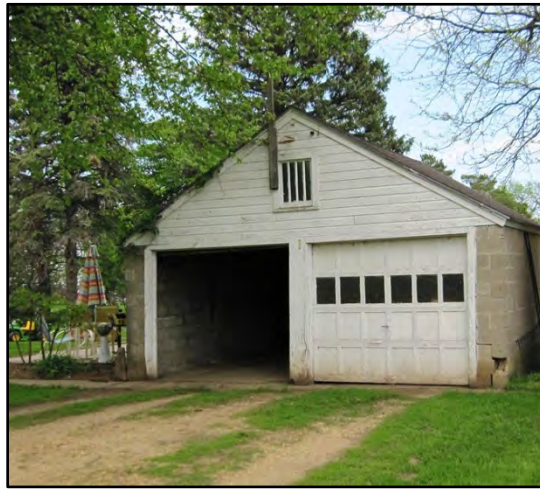
The detached two-car garage (Figure 3-48, Building 2 on site map) is a vernacular style building constructed circa 1940–1950 on a concrete foundation with a rectangular floor plan and a front gable roof clad with composition shingles. The building west primary façade has concrete masonry unit cladding on the lower wall and horizontal wood clapboard siding on the upper wall, and the remaining elevations are clad with concrete blocks. The primary west façade has a wood accordion vehicle door with six lights, an open vehicle bay missing its door, and a fixed wood window with four mullions in the gable end. The north elevation has no fenestration. The east elevation has a gable end wood fixed window with four vertical mullions. The south elevation has a wood four-panel door. The building is poorly constructed and is exhibiting structural issues.

Figure 3–48. View to northeast of garage Building 2 west primary façade and south elevation.

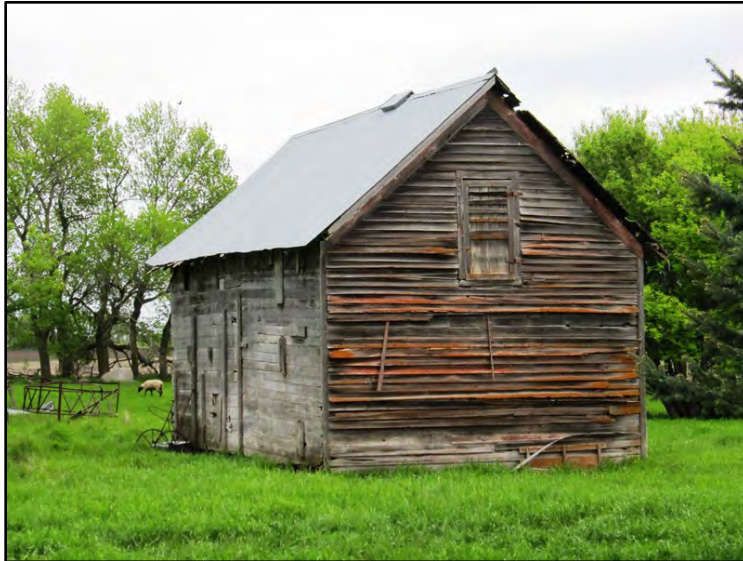
The granary (Figure 3-50, Building 4 on site map) is a vernacular structure constructed circa 1920 on a field stone foundation with a rectangular floor plan and wood clapboard wall cladding. The side gable roof has exposed rafter tails, and the metal panel clad roof is punctured with a metal hatch on the ridgeline. The primary south façade has a centrally placed wood door. The west and east elevations have a gable end wood door.

Figure 3–50. View to southeast of granary Building 4 west and north elevations.

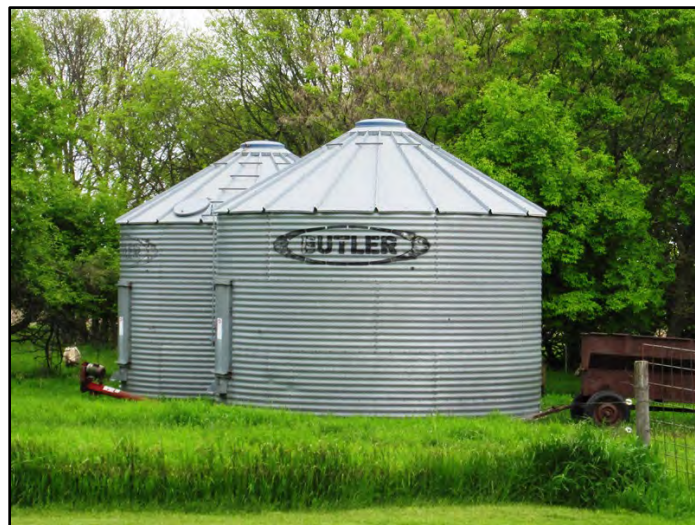
Three modern age grain bins are located on the east portion of the farm. Building 5 is a single metal grain bin, and Building 6 (Figure 3-51 and see site map) is a pair of adjacent Butler brand metal grain bins.

Figure 3–51. View to east of Building 6, two modern age Butler grain bins.

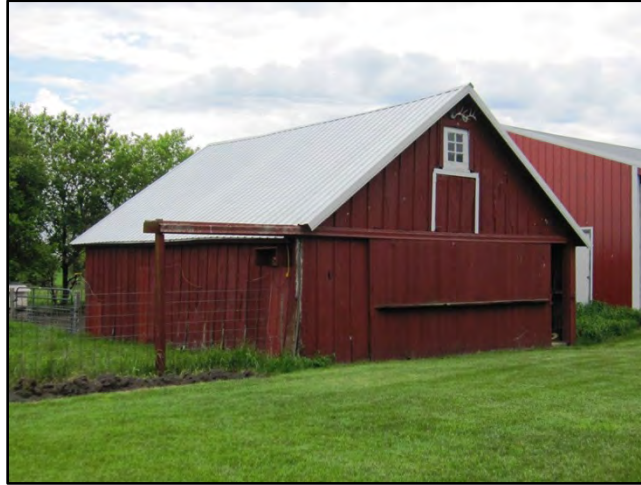
Building 7 (Figure 3-52 and see site map) is a historic age vernacular style machine shed constructed circa 1920–1940 on a wood post and pier foundation with a rectangular floor plan, vertical wood clapboard wall cladding, and a front gable roof clad with standing seam metal panels. The primary north

façade wall openings include a vertical wood board sliding track door, a vertical wood board loft door above the sliding door, and a fixed 2/2/2 wood window in the gable end. The east elevation wall has a small window without framing or glazing. The south and west elevations have no fenestration.

Figure 3–52. View to southwest of machine shed Building 7 north primary façade and east elevation.

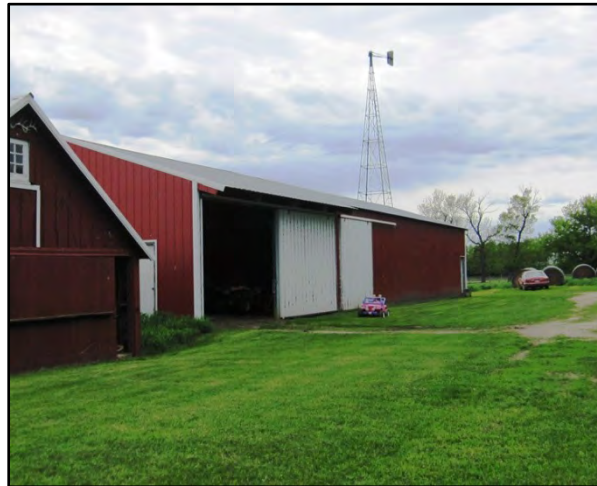
Building 8 (Figure 3-53 and see site map) is a modern age standing metal seam-clad machine shed located immediately west of Building 7.

Figure 3–53. View to southwest of Building 8.

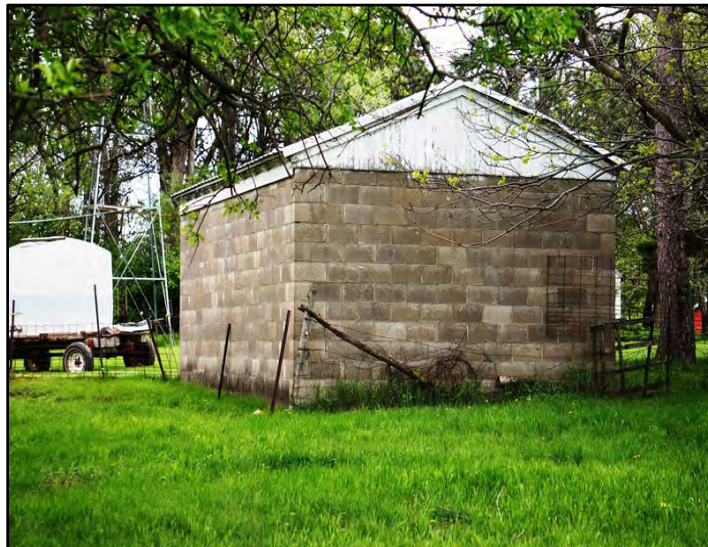
Building 1 (Figure 3-54 and see site map) is a vernacular style pump house or garage constructed circa 1960 on a concrete foundation with a rectangular floor plan, concrete masonry unit wall cladding with vertical wood clapboard wall cladding in the gable ends, and a side gable roof clad with metal panels. The south elevation has a wood four-panel door. The north and west elevations have no fenestration. The east elevation was not visible and could have a garage door that would confirm if the building is a pump house or single car garage.

Figure 3–54. View to southeast of Pump house Building 1.

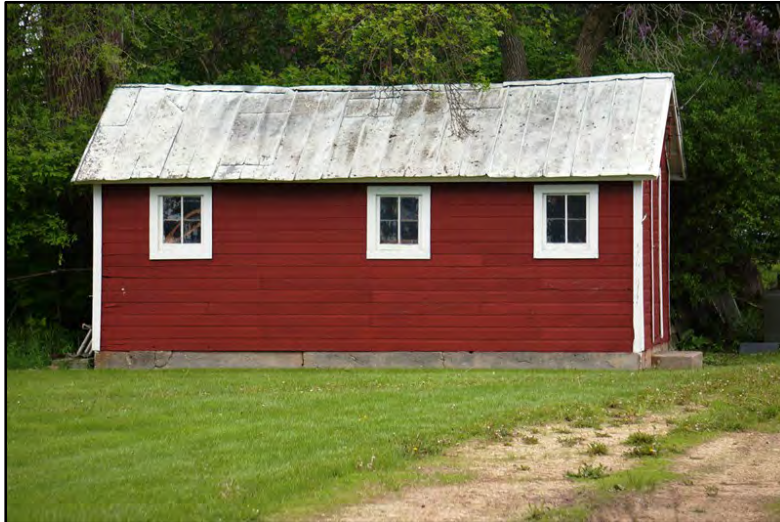
Building 3 (Figure 3-56 and see site map) is of unknown function dating to circa 1910, with a rectangular floor plan on a concrete foundation, wood horizontal board siding, and a front-gabled roof clad with standing metal seam panels. The south primary façade has a wood plank door. The west elevation has three wood fixed 2/2 light windows. The north and east elevations were not visible from the ROW.

Figure 3–56. View to east of Building 3 west elevation.

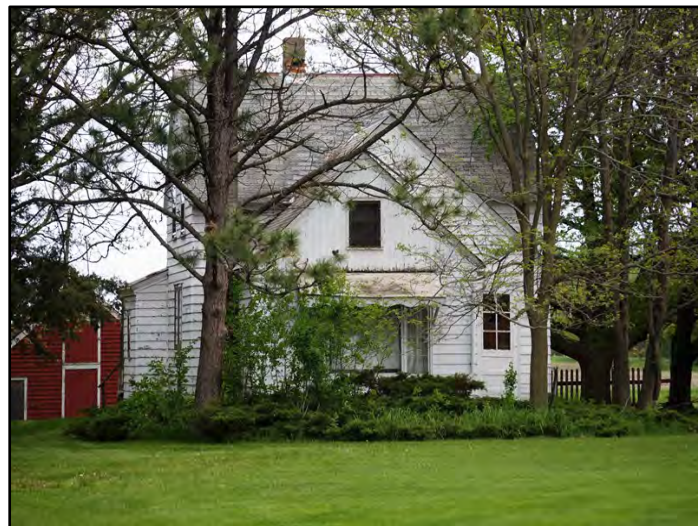
The farm residence (Figure 3-57, Building 4 on site map) is a two-story rural vernacular style building constructed circa 1890 with an irregular square floor plan, horizontal and vertical wood clapboard wall cladding, and a cross gable roof punctured with a centrally placed brick chimney and clad with composition shingles. The west primary façade ground floor wall fenestration includes a metal door with six lights and a picture window flanked by 2/4 sidelights placed beneath a shed-roof porch overhang. The second floor wall opening is a fixed window on the gable end. The remaining elevations were not visible from the ROW.

Figure 3–57. View to east of residence Building 4 constructed in 1890, west primary façade.

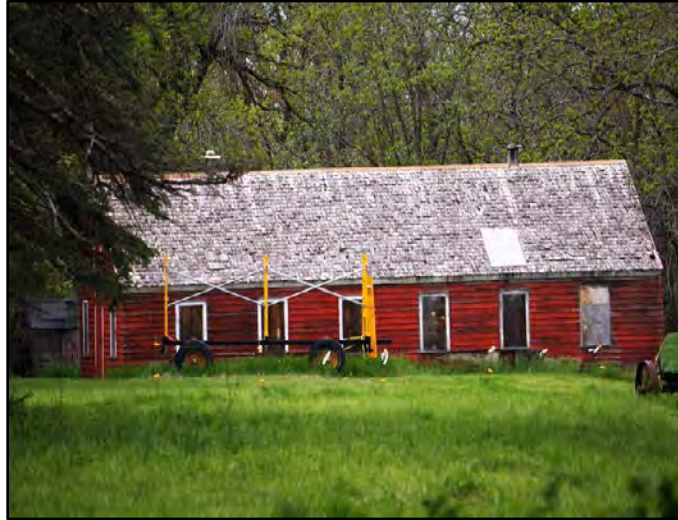
Building 5 (Figure 3-58 and see site map) is an agricultural vernacular style building of unknown function constructed circa 1910–1920 with a rectangular floor plan, horizontal wood cladding, and a front gable roof clad with wood shingles. The west primary façade has a centrally-located wood door flanked by wood windows on the north and south. The south elevation has a series of six symmetrically spaced boarded-up windows. The east and north elevations were not visible from the ROW.

Figure 3–58. View to north of Building 5 south elevation.

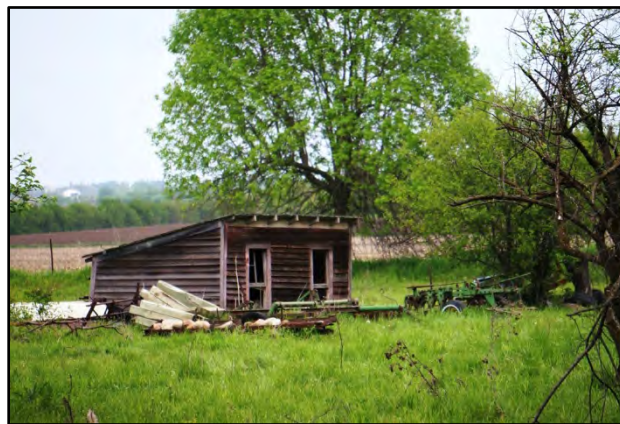
Building 6 (Figure 3-59 and see site map) is a vernacular style chicken coop constructed circa 1920 with a rectangular floor plan, wood clapboard siding, and a shed roof. The south primary façade has two wood window openings. The north and east elevations were not visible from the ROW.

Figure 3–59. View to northeast of chicken coop Building 6 south primary façade and west elevation.

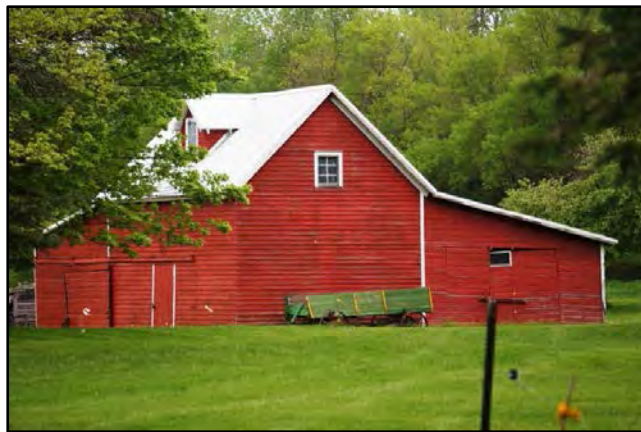
The granary (Figure 3-60, Building 7 on site map) is a two-story vernacular style building constructed circa 1900 with a two-part square floor plan, horizontal wood clapboard wall cladding, and a side gable roof and shed roof clad with metal panels. A shed-roof extension has been placed on the south and east elevations. The primary north façade ground floor wall opening is a vertical plank wood door and a horizontal wood plank door on a top sliding track, and a second story 2/3 fixed wood window in a front gable dormer. The south elevation has no wall openings. The west elevation ground floor has a horizontal wood plank door bearing a window with missing glazing, and a 2/3 fixed wood window in the gable end. The east and north elevations were not visible from the ROW.

Figure 3–60. View to northeast of granary west primary façade and south elevation.

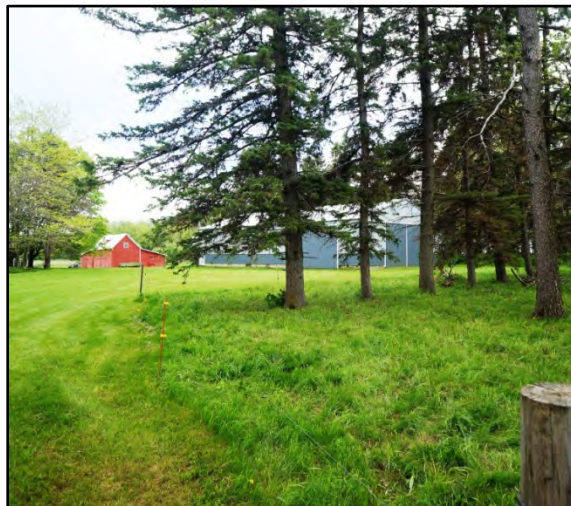
Building 8 (Figure 3-61 and see site map) is a modern age metal panel-clad machine shed located on the southwest portion of the property.

Figure 3–61. View to southeast of Building 8 on the right. Building 7 is in the rear, to the left.

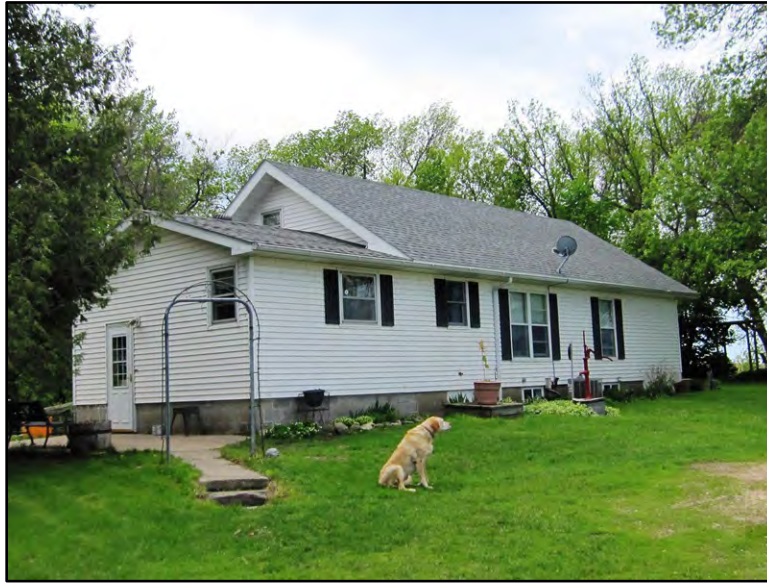
The 1-1/2 story farm residence (Figure 3-62, Building 1 on site map) is a remodeled rural vernacular style building constructed circa 1910 on a concrete foundation with a lower-level addition on the east elevation placed on a concrete block foundation. The residence has a rectangular floor plan, replacement vinyl wall cladding, and a two-part front-gable roof clad with composition shingles. The north elevation has two basement-level metal sliders, and the upper wall has two metal single-hung windows, a set of paired metal double-hung windows, and one metal double-hung window, all which are flanked by faux storm shutters. The east elevation fenestration includes a metal door with 12 upper lights and a single-hung metal window, and a metal single-hung window in the gable end. The south elevation fenestration includes two basement level metal slider windows. The upper wall has a metal three-part oriel window and a sliding glass door on the original portion of the residence. A wood deck is attached to the wall. The east addition south wall has a single-hung metal window. The west primary façade has a centrally-located metal panel door that is flanked by paired metal double-hung windows with faux storm shutters, with a metal single-hung window in the gable end.

Figure 3–62. View to southwest of residence Building 1 north and east elevations. The east addition is on the left.

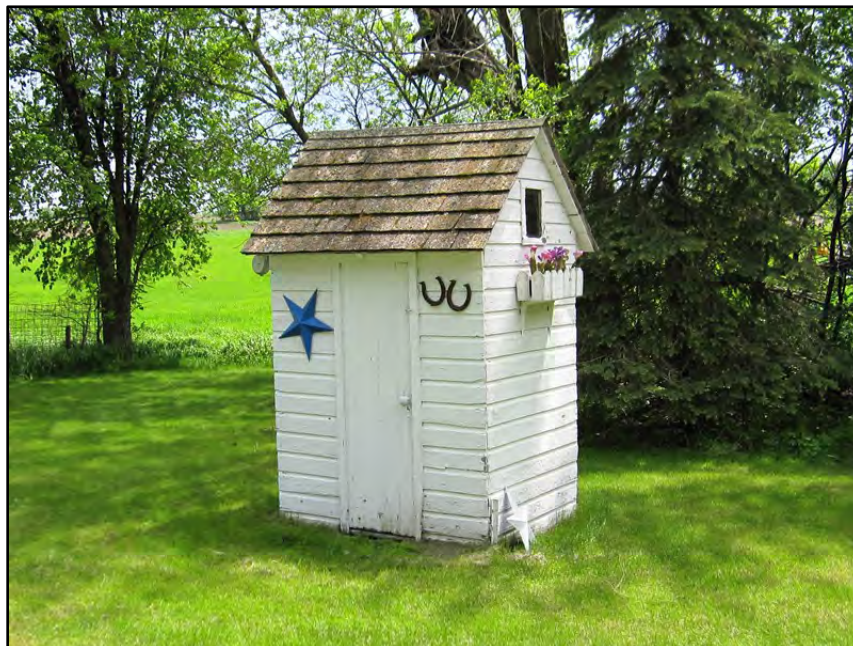
Building 2 (Figure 3-63 and see site map) is a rural vernacular style privy constructed circa 1910 with no foundation, a square floor plan, horizontal wood clapboard wall cladding, and a side gable roof clad with composition shingles. The primary north façade has a vertical wood plank door. The east and west elevations have a wood fixed window in the gable ends.

Figure 3–63. View to southeast of privy north façade and west elevation.

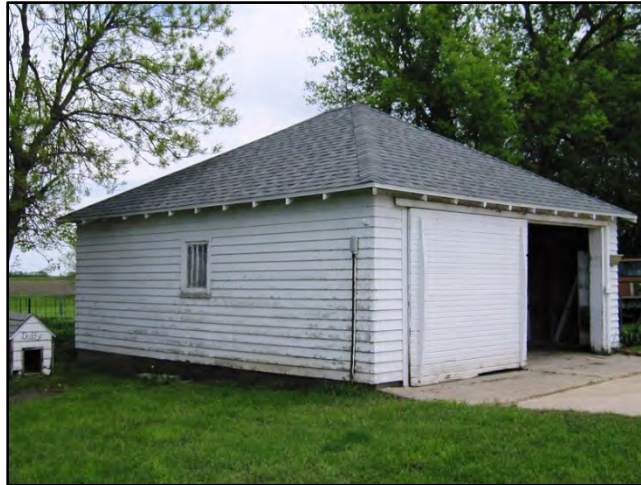
The garage (Figure 3-64, Building 3 on site map) is a vernacular style building constructed circa 1920–1930 on a concrete foundation with a rectangular floor plan, wood clapboard siding, and a hipped roof clad with composition shingles and exposed rafter tails. The primary west façade has a single wood sliding track door. The north elevation has a fixed wood window with four vertical mullions. The east and south elevations each have two fixed four-light windows.

Figure 3–64. View to southeast of garage Building 3 west primary façade and north elevation.

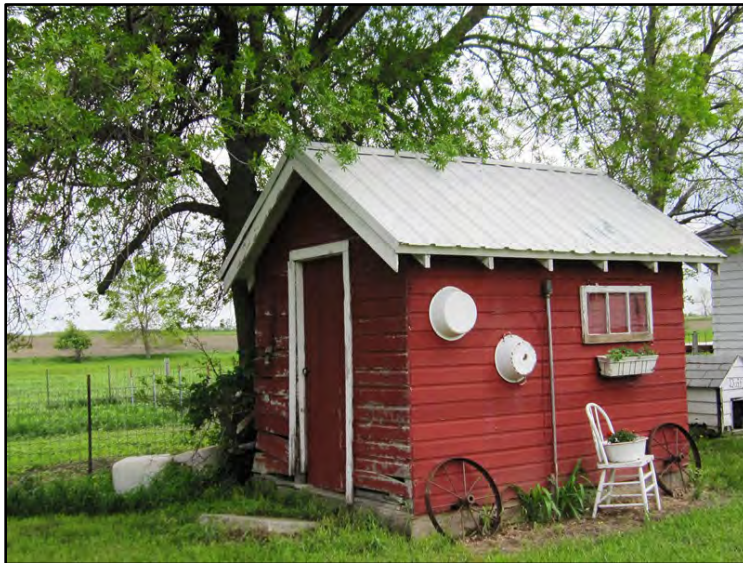
Building 4 (Figure 3-65 and see site map) is a vernacular style pump house constructed circa 1920–1930 on a concrete foundation with a rectangular floor plan, horizontal wood clapboard wall cladding, and a front gable roof with exposed rafter tails that is clad with standing seam metal panels. The primary north façade has a vertical wood board door. The south elevation has a wood window with four vertical lights. The west and east elevations have no fenestration.

Figure 3–65. View to east of pump house Building 4 north primary façade and west elevation.

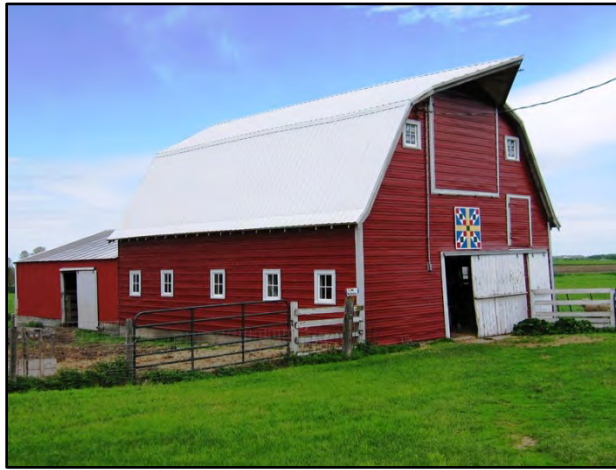
The two-story Wisconsin style dairy barn (Figure 3-66, Building 5 on site map) constructed circa 1920 on a concrete block foundation has a rectangular floor plan, replacement metal wall cladding, and a gambrel roof clad with standing seam metal panels. A one-story metal-clad addition with a metal front-gabled roof has been placed on the north elevation, and has a sliding metal track door on the west elevation. The primary south façade has an original vertical wood board sliding track door on the first story. The second story features a decorative quilt design artwork and a replacement metal loft door. The gambrel roof gable end has a larger horizontal metal loft door flanked by 2/2 light fixed wood windows and a hay hood. The west elevation has five metal 2/2 light windows. The north and east elevations have metal windows.

Figure 3–66. View to northeast of barn Building 5 south primary façade and west elevation.

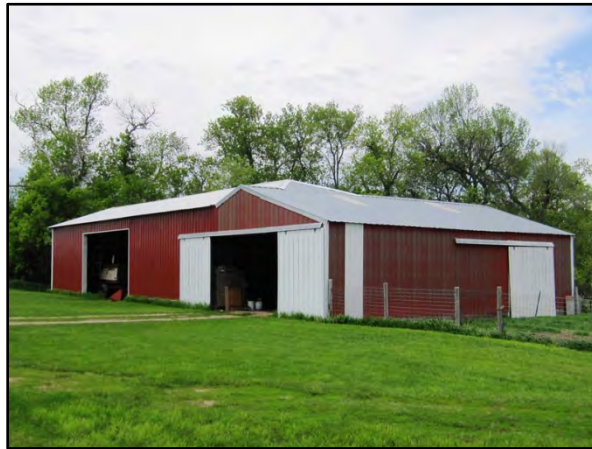
Building 6 (Figure 3-67 and see site map) is a modern age standing metal seam clad machine shed.

Figure 3–67. View to northwest of Building 6 machine shed south primary façade and east elevation.

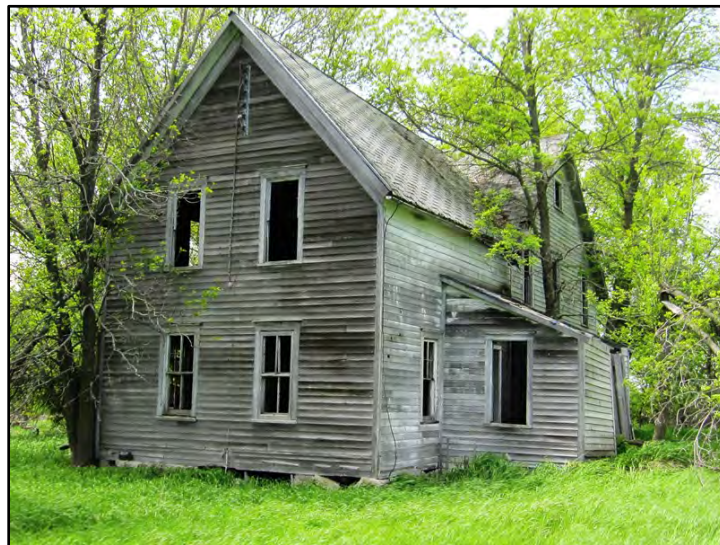
The farm residence (Figure 3-68, Building 1 on site map) is a two-story Folk Victorian style building constructed circa 1900 on a field stone foundation with a modified rectangular floor plan, wood clapboard wall cladding, and a cross gable roof clad with wood shingles. The south primary façade first floor bears a collapsed porch on the eastern portion, which formerly featured turned wood columns. The south façade fenestration comprises three wood two-light windows with lintels and a vertical orientation. The south façade second story bears three window openings without sash. One window appears on the gable end. The west elevation has two wood double-hung windows on the first floor and a single window in the second floor gable end. The north elevation has a kitchen window opening and door on the eastern segment, and three symmetrically spaced windows on the first and second floor on the western segment. The north elevation also has a gable end window opening. The east elevation has a two-light window on the first floor and two gable end window openings on the second story.

Figure 3–68. View to northeast of Midtounne Folk Victorian style residence Building 1 south façade and west elevation.

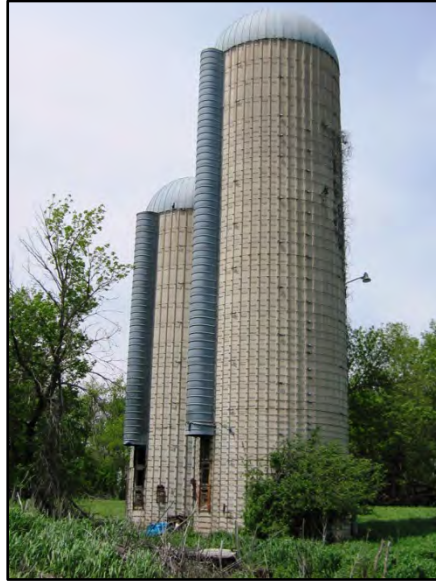
Two adjacent concrete stave silos (Figure 3-69, Building 2 on site map) are located on the southeast side of the site and appear to be from the 1960s or 1970s. The west silo is lower than the east silo. Both silos

have a concrete foundation with a round floor plan, concrete stave wall cladding bound by steel hoops, and domed roofs formed from crescent-shaped metal panels. Metal tube silage blower ports are located on the west aspect of both silos. A demolished barn foundation is located immediately south of the silos.

Figure 3–69. View to north of Building 2 Midtounse concrete stave silos south and west elevations.

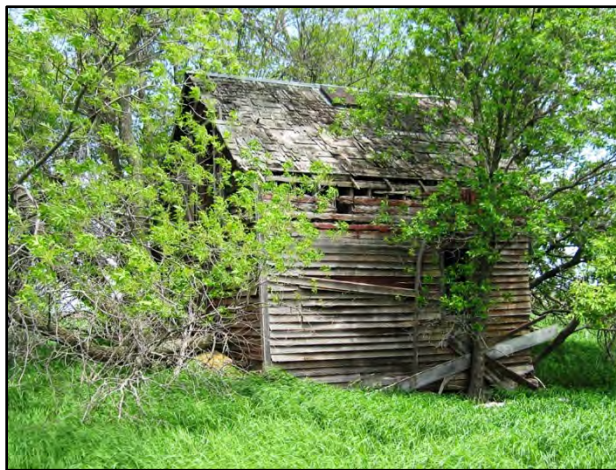
The rural vernacular style granary (Figure 3-70, Building 3 on site map) has a field stone foundation with a rectangular floor plan, wood clapboard wall cladding, and a front gabled roof clad with wood shingles. The roof has a metal-covered grain hatch in the south aspect. The east elevation wall opening comprises a doorway in the southeastern corner. The south elevation fenestration includes a wood frame double-hung window without any glazing. The west elevation wall opening comprises a gable end vertical board door. The north elevation has a wood horizontal board shed addition that has collapsed.

Figure 3–70. View to northeast of Building 3 Midtounse granary south and west elevations.

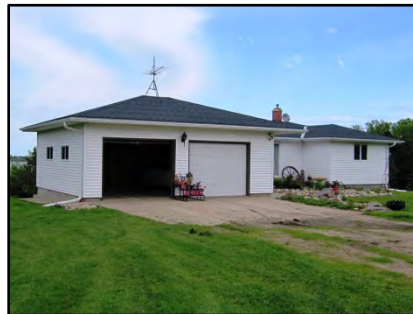
Site BK00001274 was recorded at an unknown date as an abandoned farmstead with a two-story residence constructed in 1890. This and any other historic age building on the site have been demolished since that time. A barn and silo that appears on the Project aerial imagery has been demolished. A modern age machine shed (Figure 3-72, Building 2 on site map) and modern residence (Figure 3-71, Building 1 on site map) are now the only buildings on the site. An interview with the owner confirmed that the current residence is of recent construction.

Figure 3-71. View to east of current residence Building 1 west primary façade and north elevation.

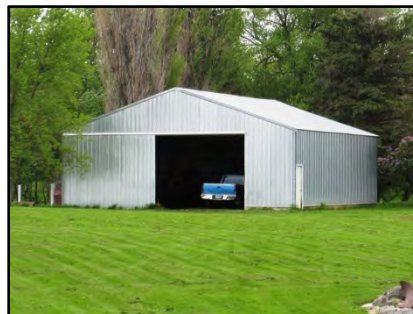
Figure 3-72. View to west of Building 2 modern age machine shed.

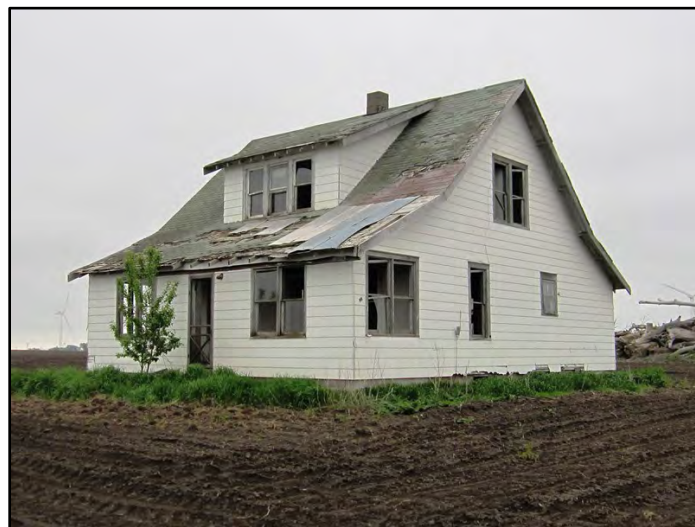
The farm residence (Figure 3-73 Building 1 on site map) is a two-story Craftsman style building constructed circa 1910 on a concrete and concrete masonry unit foundation with a modified rectangular floor plan, asbestos wall cladding, and a steeply pitched side gable roof clad with composition asphalt shingles. An interior concrete block chimney projects from the center of the roof ridgeline. The west primary façade fenestration is comprised of wood-frame paired double-hung windows on the ground floor, which flank a central doorway. The second floor features a shed roof dormer with three adjacent wood-frame double-hung windows. The north elevation ground floor wall openings consist of paired wood frame double-hung windows in the northwest corner. The second story has paired wood-frame double-hung windows in the gable end. The east elevation has a projecting sun porch beneath a shed roof. The sun porch has three adjacent wood-frame double-hung windows and a six-light wood door. The second story has a shed dormer with paired wood-frame double-hung windows. The south elevation ground floor wall openings consist of three adjacent wood-frame double-hung windows with paired wood-frame double-hung windows in the gable end.

Figure 3–73. View to southeast of Building 1 residence north façade and west elevation.

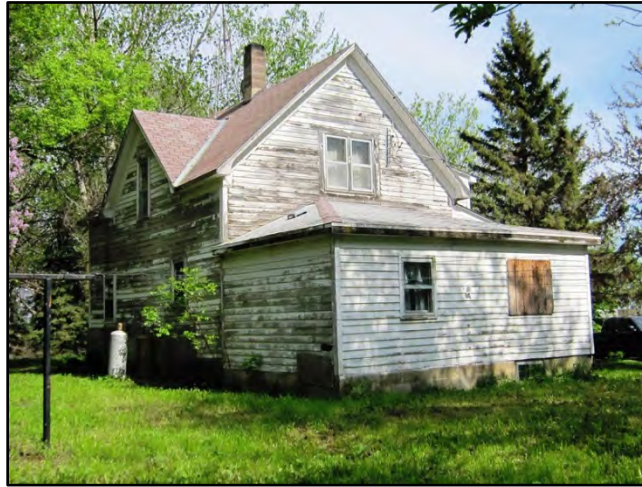
The farm residence (Figure 3-74, Building 1 on site map) is a two story rural vernacular style building constructed circa 1910 on a concrete block foundation with a modified rectangular floor plan, wood clapboard wall cladding, and a cross-gabled roof clad with composition shingles. The building massing has a two-story segment on the east with a cross-gable roof, and a one-story segment on the west that has a combination flat and partial hipped roof. The south primary façade ground floor fenestration includes a metal panel door on the southwest corner and two sets of paired metal-frame sash windows. The second story has one set of paired metal sash windows. The west elevation ground floor fenestration consists of two metal sash windows, one that is boarded up, and two paired metal sash windows on the second story. The north elevation ground floor fenestration includes two metal sash windows, and a metal sash window in the gable end. The east elevation has two fixed metal basement windows, two metal single-hung windows on the first floor, and two paired metal single-hung windows in the gable end.

Figure 3–74. View to southeast of residence Building 1 west and north elevations.

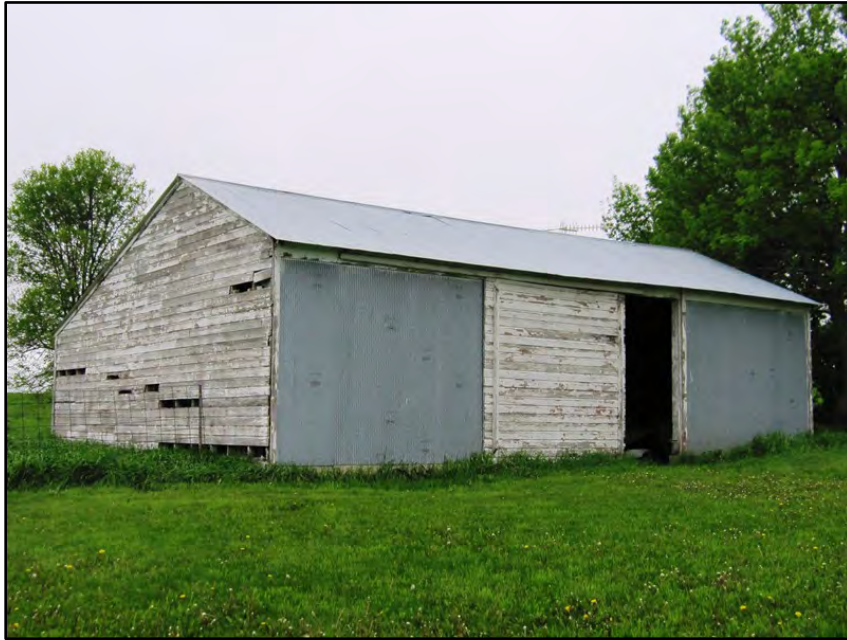
Building 7 (Figure 3-105 and see site map) is a vernacular style building constructed circa 1920 on a wood post and pier foundation with a rectangular floor plan, wood clapboard and corrugated metal panel wall cladding, and a side gable roof clad with corrugated metal panels. The north primary façade wall has a horizontal wood board sliding track door. The east and west elevations have no fenestration. The south elevation wall openings include seven wood 7-light windows, three boarded up windows, and one window with glazing—all are in poor condition.

Figure 3-105. View to southwest of Building 7 north primary façade and east elevation.

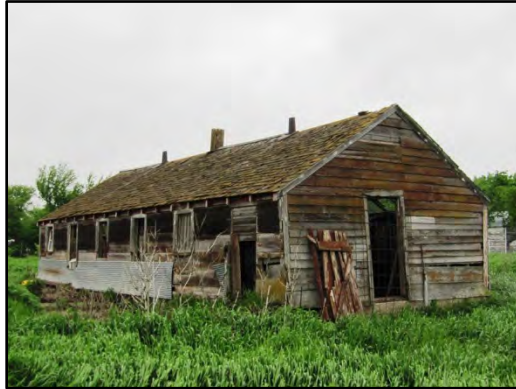
Building 5 (Figure 3-115 and see site map) is a deteriorated rural vernacular style agricultural building constructed circa 1910–1920 on a concrete foundation with a rectangular floor plan and wood clapboard cladding. The side-gable roof exhibits exposed rafter tails, is clad with wood shingles, and has four deteriorated wood vents in the ridgeline. The south primary façade has three deteriorated wood-frame

windows with partial muntins and no glazing, and two deteriorated wood doors partially boarded over. The west elevation has a deteriorated wood Z-door. The north elevation has no wall openings. The east elevation has a wood-frame doorway with a missing door.

Figure 3–115. View to northwest of Building 5 south primary façade and east elevation.

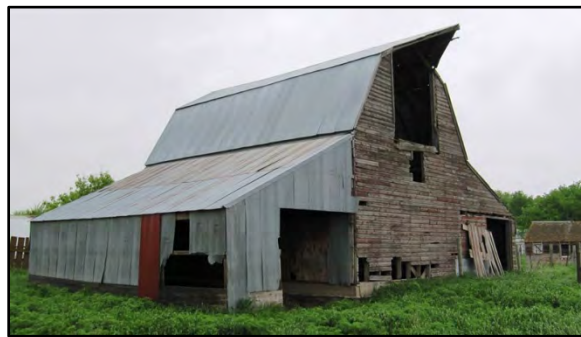
Building 6 (Figure 3-116 and see site map) is a deteriorated two-story transverse-frame style livestock barn constructed circa 1910 on a concrete foundation with an irregular rectangular floor plan, horizontal wood clapboard and corrugated metal panel wall cladding. The building has an L-shaped addition constructed on the west and north elevation which is collapsing. The transverse frame roof is clad with corrugated metal panels and a hay hood projects from the roof on the east primary façade. The east primary façade has a north and south first floor bay without doors. The second story has two uncovered loft openings and the hay hood. The south elevation has an opening cut into the metal panels. The west elevation ground floor has a deteriorated door covered with horizontal wood planks and a vertical wood board door. The second story has two fixed wood windows with vertical mullions in the gable end, one with intact glazing. The north elevation fenestration comprises two wood-frame fixed windows without glazing and a deterioration hole boarded up with horizontal wood planks.

Figure 3–116. View to northwest of Building 6 east primary façade and south elevation.

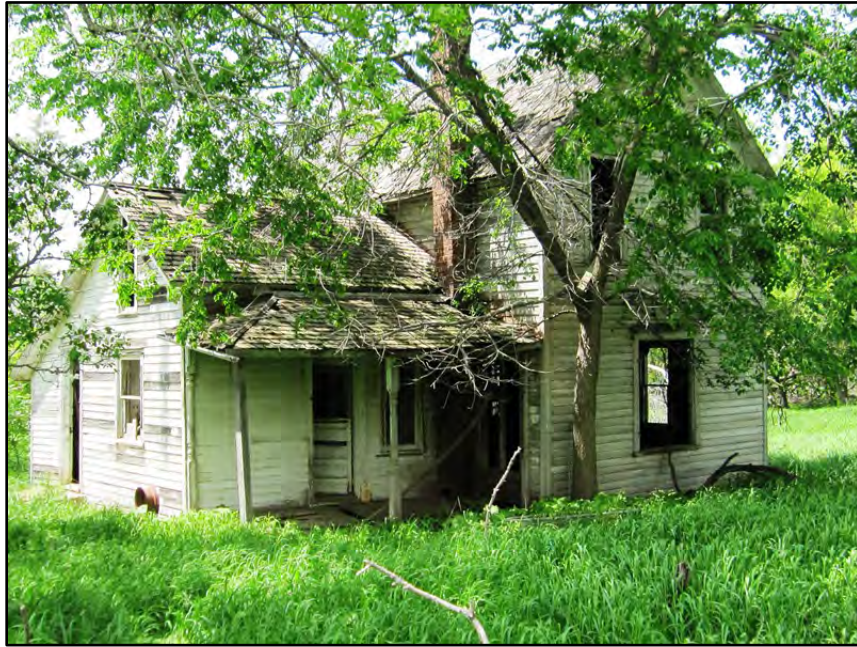
Building 1 (Figure 3-117 and see site map) is a deteriorated two-story rural vernacular style building constructed circa 1900 on a field stone foundation with an L-shaped floor plan, wood clapboard cladding, and a cross gable roof clad with wood shingles. A hipped roof porch is in the joint of the L-shaped floor plan; one supporting porch post is of turned wood. A brick chimney extends through the porch roof in the joint of the L-shaped floor plan. All glazing is missing from every window and door. The east primary façade comprises a shed-roof enclosed porch extension. The east façade fenestration on the ground floor includes a two-panel wood door with an upper light, a wood single-hung window, a wood-frame door with two vertical full-length lights, and another wood single-hung window. The second story wall openings include two wood single-hung windows. The south elevation ground floor has a doorway with a missing door and a wood single-hung window, and the second floor has a wood single-hung window. The west elevation has two wood single-hung windows on the ground and second floor. The north elevation ground floor fenestration includes two wood single-hung windows and a wood single-hung window on the second floor.

Figure 3–117. View to northeast of Building 1 east primary façade and south elevation.

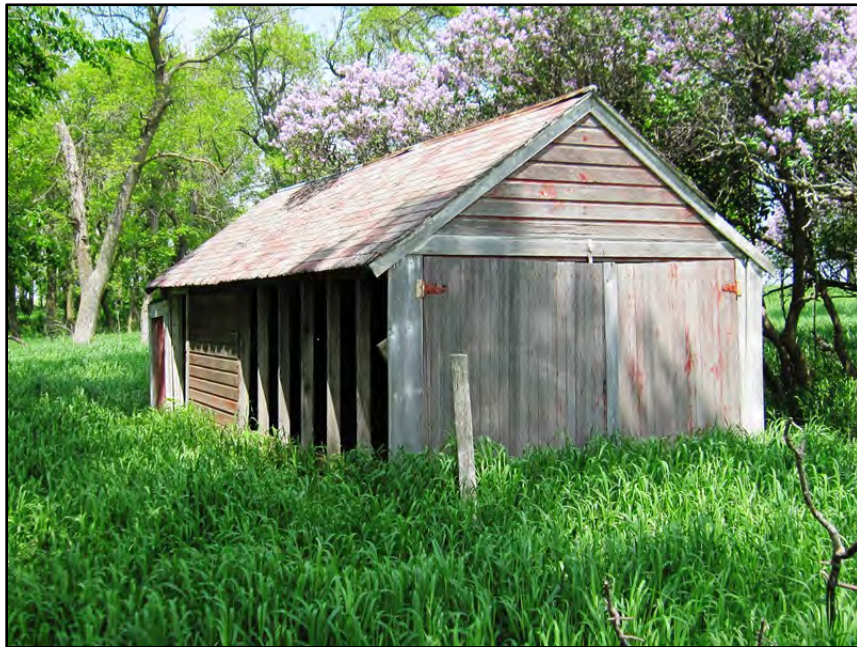
Building 2 (Figure 3-118 and see site map) is a deteriorated rural vernacular style garage constructed circa 1920 on a concrete perimeter foundation with a rectangular floor plan, clad with wood clapboard, and has a front gable roof clad with composition shingles. The south primary façade wall opening is a wood-frame vertical wood plank vehicle door with two leaves. The west elevation has a wood-frame vertical wood plank door and a large portion of the wall cladding is missing. The north elevation fenestration includes a wood fixed 2/2 gable end window. The east elevation has a wood four-light fixed window without glazing and a large portion of the wall cladding is missing.

Figure 3–118. View to north of garage Building 2 south primary façade and west elevation.

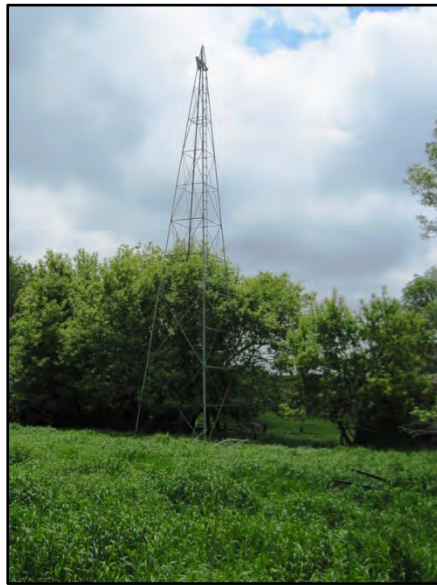
Building 4 (Figure 3-119 and see site map) is a historic age windmill constructed circa 1920–1930. The windmill tower is an open steel frame with four braced angle-steel legs. The top of the windmill has lost its vane and rotor. The windmill still has its metal rung ladder to service the rotor and vanes.

Figure 3–119. View to west of windmill Building 4.

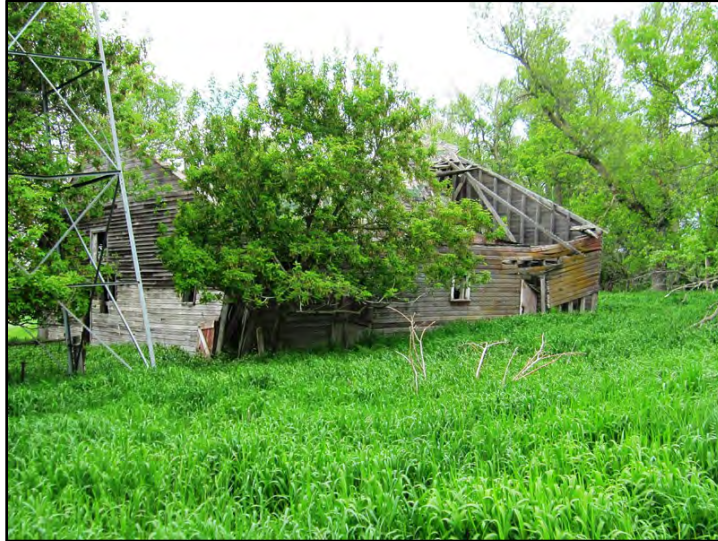
Building 6 (Figure 3-121 and see site map) is a collapsed agricultural building with clapboard siding located north of the windmill.

Figure 3–121. View to northwest of Building 6.

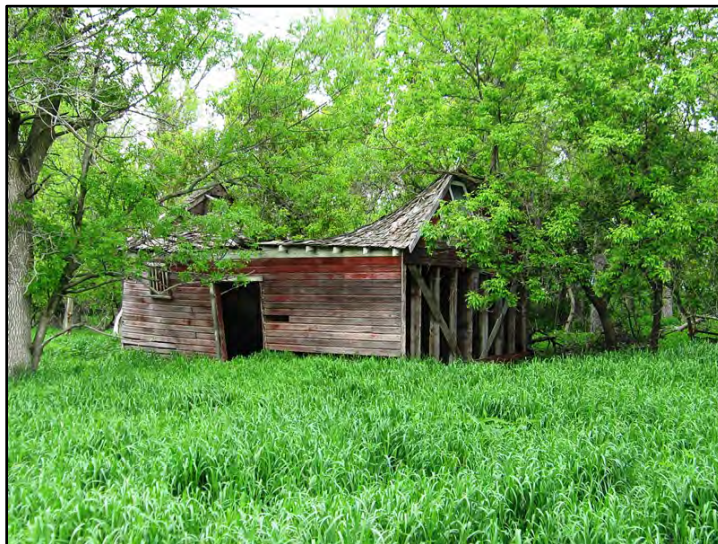
Building 7 (Figure 3-122 and see site map) is a collapsing building that appears to be a granary. It has wood clapboard siding, an intact wood fixed four-light window with vertical mullions, and a side-gabled roof clad with shingles.

Figure 3–122. View to northwest of Building 7.

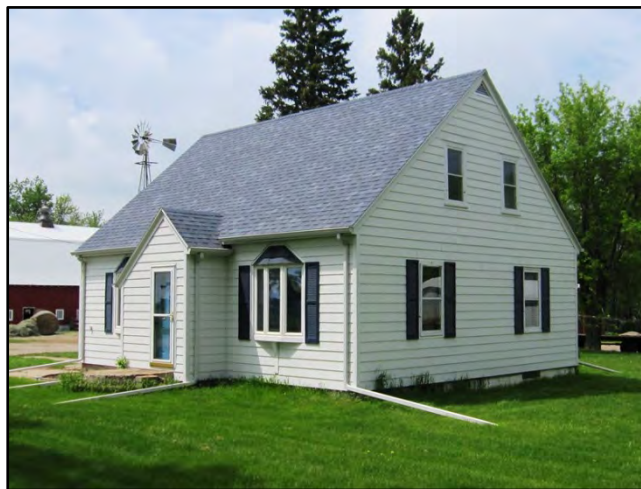
Building 1 (Figure 3-123 and see site map) is a severely remodeled two-story minimal traditional style residence constructed circa 1930–1940 on a concrete foundation with a rectangular floor plan, replacement vinyl wall cladding, and a side gable roof clad with composition shingles. All original windows and doors have been replaced with metal versions. The south primary façade has a front gable mudroom with an English eave containing a metal two-panel door with two upper lights. Two projecting metal-frame oriel windows flank the door with three lights capped with composition shingle-covered crowns. The west elevation ground floor has a hipped roof projection with a metal panel door and a metal single-hung window, and the second story has two metal single-hung windows. The north elevation has three metal single-hung windows. The east elevation ground floor and second story each have two metal single-hung windows.

Figure 3–123. View to northwest of Building 1 south primary façade and east elevation.
