Intensive Historic Building Survey and Evaluation for the Brookings County Substation to SD/MN Border Segment of the CapX 2020 Brookings County to Hampton 345 kV Transmission Line Project

Volume 1 of 2

Prepared by:
Kevin (Lex) Palmer – Principal Investigator
HDR Engineering, Inc.
701 Xenia Avenue South, Suite 600
Minneapolis, MN 55416

September 2013

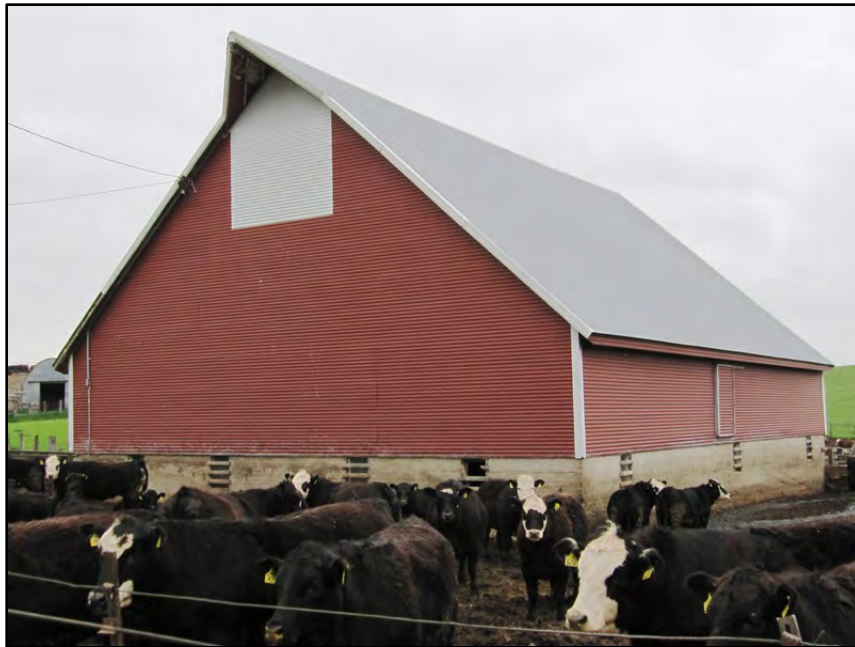
This site was initially recorded and evaluated in 2005 as ineligible for listing in the NRHP. The property is a cattle feed lot with seven buildings. Building 4 (Figure 4-1 and see site map) is a historic age barn that has been heavily modified and lacks integrity of materials and design. The remaining buildings appear to be less than 50 years old. The site does not appear to be eligible for listing in the NRHP.

Figure 4-1. View to south of historic age barn.

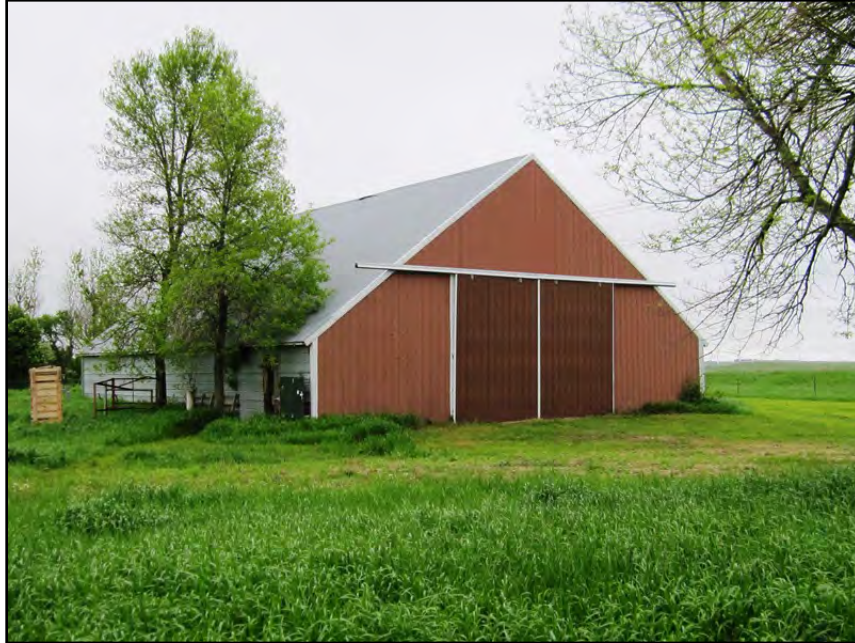
This site was recorded and evaluated in 2005 and 2006 as ineligible for listing in the NRHP. The site was originally documented as having a house and two outbuildings. Two outbuildings appear to be of historic age (Buildings 5 and 7). The site now has seven buildings and five of them are of recent modern age. The site is heavily modified and does not appear to be eligible for listing in the NRHP.

Figure 4–2. view to north of historic age machine shed.

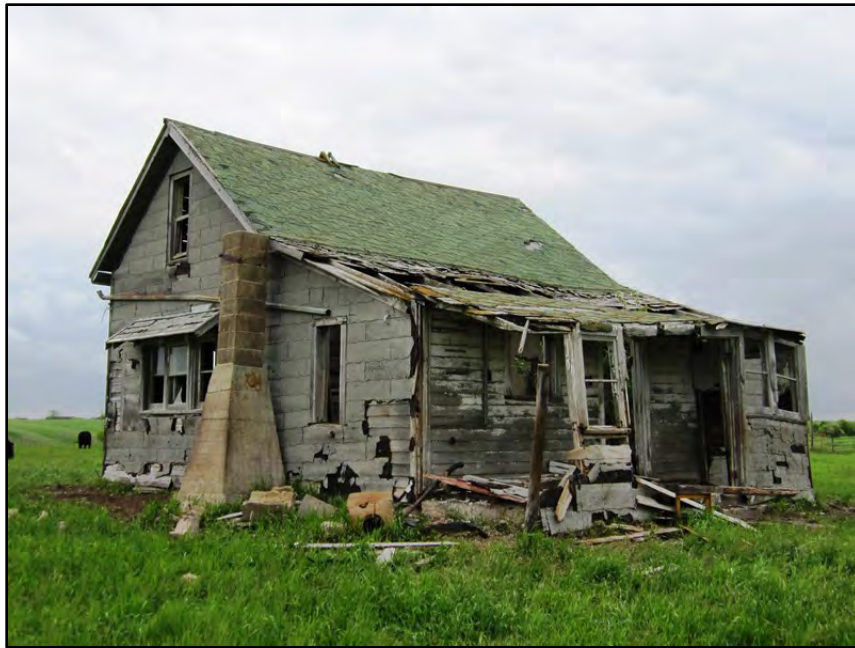
Site BK00002050 was recorded and evaluated in 2006 as ineligible for listing in the NRHP. The site is bordering on becoming an archaeological site, as it has an abandoned deteriorated residence (Figure 4-3 and see site map) and agricultural outbuilding. Cattle are entering the buildings and damaging the original building fabric, and the roofs have holes in them that allow water intrusion. The viewshed to the east is now dominated by the Deep Creek Station power plant completed in 2012, which has affected the site's integrity of setting and feeling associated with an early twentieth century farmstead. The site does not appear to be eligible for listing in the NRHP.

Figure 4-3. View to west of historic age farmhouse.

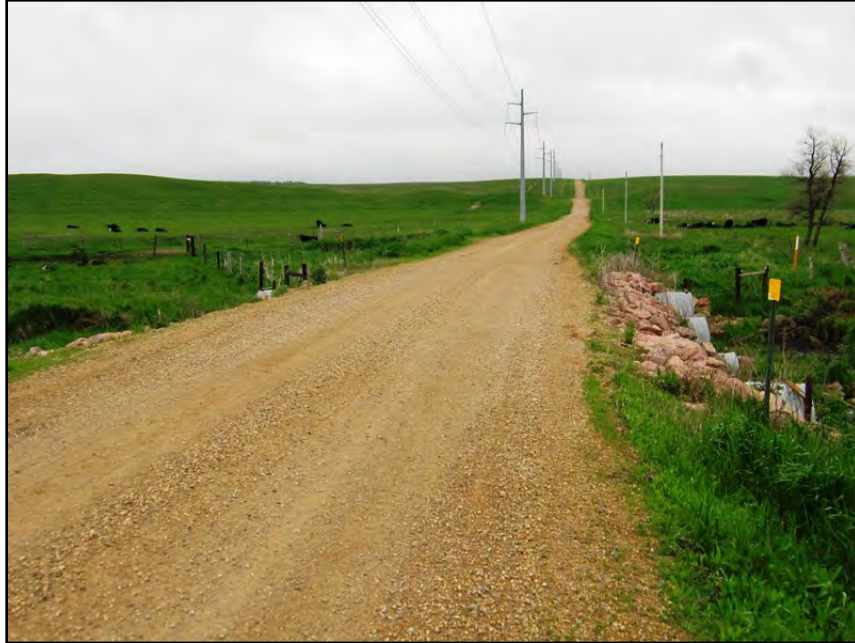
HDR architectural historians re-surveyed this bridge structure to observe its current integrity levels since being initially recorded and evaluated in 2004 as ineligible for listing in the NRHP. The 484th Avenue Bridge is no longer extant, and has been replaced with a series of steel culverts (Figure 4-4 and see site map).

Figure 4–4. View to south of former 484th Avenue Bridge site.

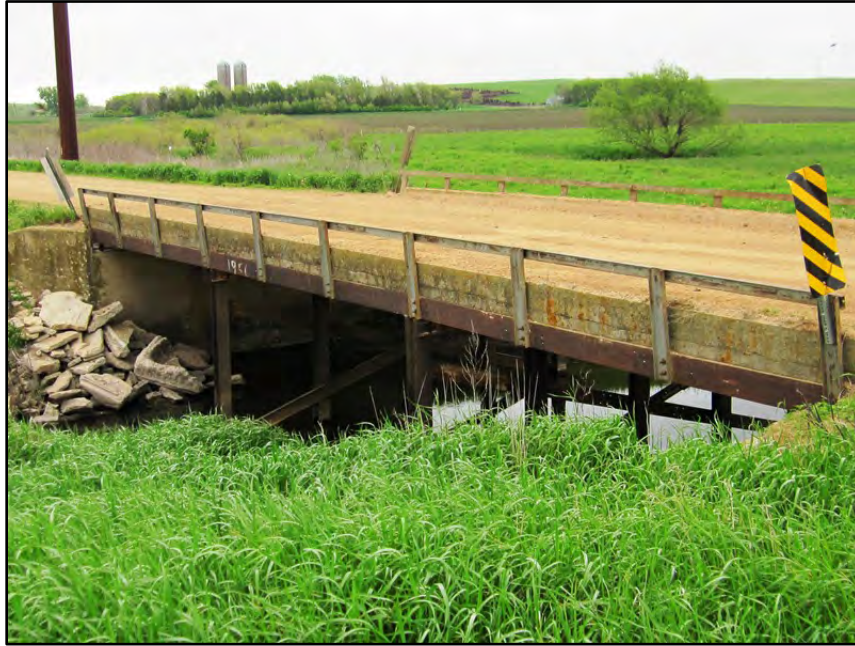
Site BK00002191 is a bridge structure recorded and evaluated in 2004 (Figure 4-5 and see site map). The 207th Street bridge retains the same integrity levels and does not appear to be eligible for listing in the NRHP.

Figure 4-5. view to southeast of 207th Street Bridge.

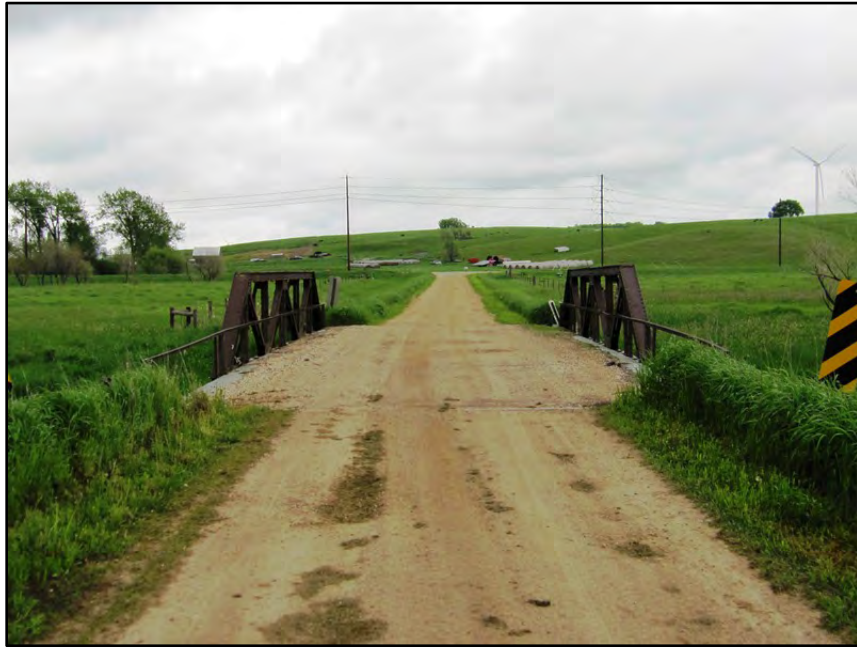
Site BK00002198 is a bridge located on the east branch of Deer Creek recorded and evaluated in 2004 (Figure 4-6 and see site map). The bridge's diminished integrity levels that were cited in the original NRHP evaluation remain the same, and the bridge does not appear to be eligible for listing in the NRHP. The site was doubly recorded by Renewable Technologies in 2004, and has two site records with site numbers BK00000185 and BK00002198.

Figure 4–6. View to east of 206th Street Bridge over east branch of Deer Creek.

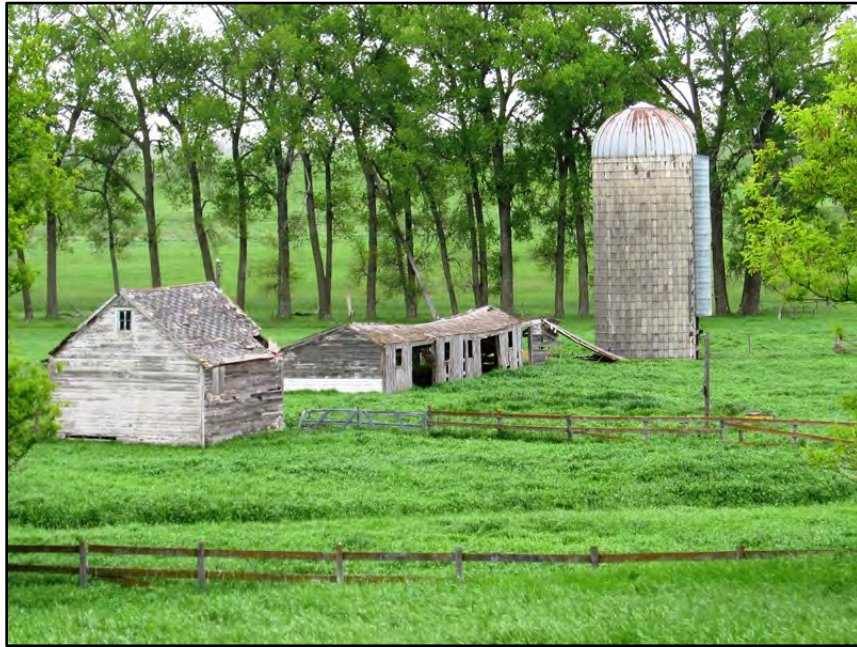
HDR architectural historians re-surveyed this dairy farm site recorded and evaluated in 2006 (Figure 4-7 and see site map). Access to the site is restricted and the property was briefly visited to confirm the previous NRHP evaluation. The site has 14 buildings that have separate site numbers. The buildings are in worse condition seven years later (2013) with many collapsed. The original evaluation as ineligible for listing in the NRHP is still valid.

Figure 4-7. View to east of BK04900006 and BK04900008.

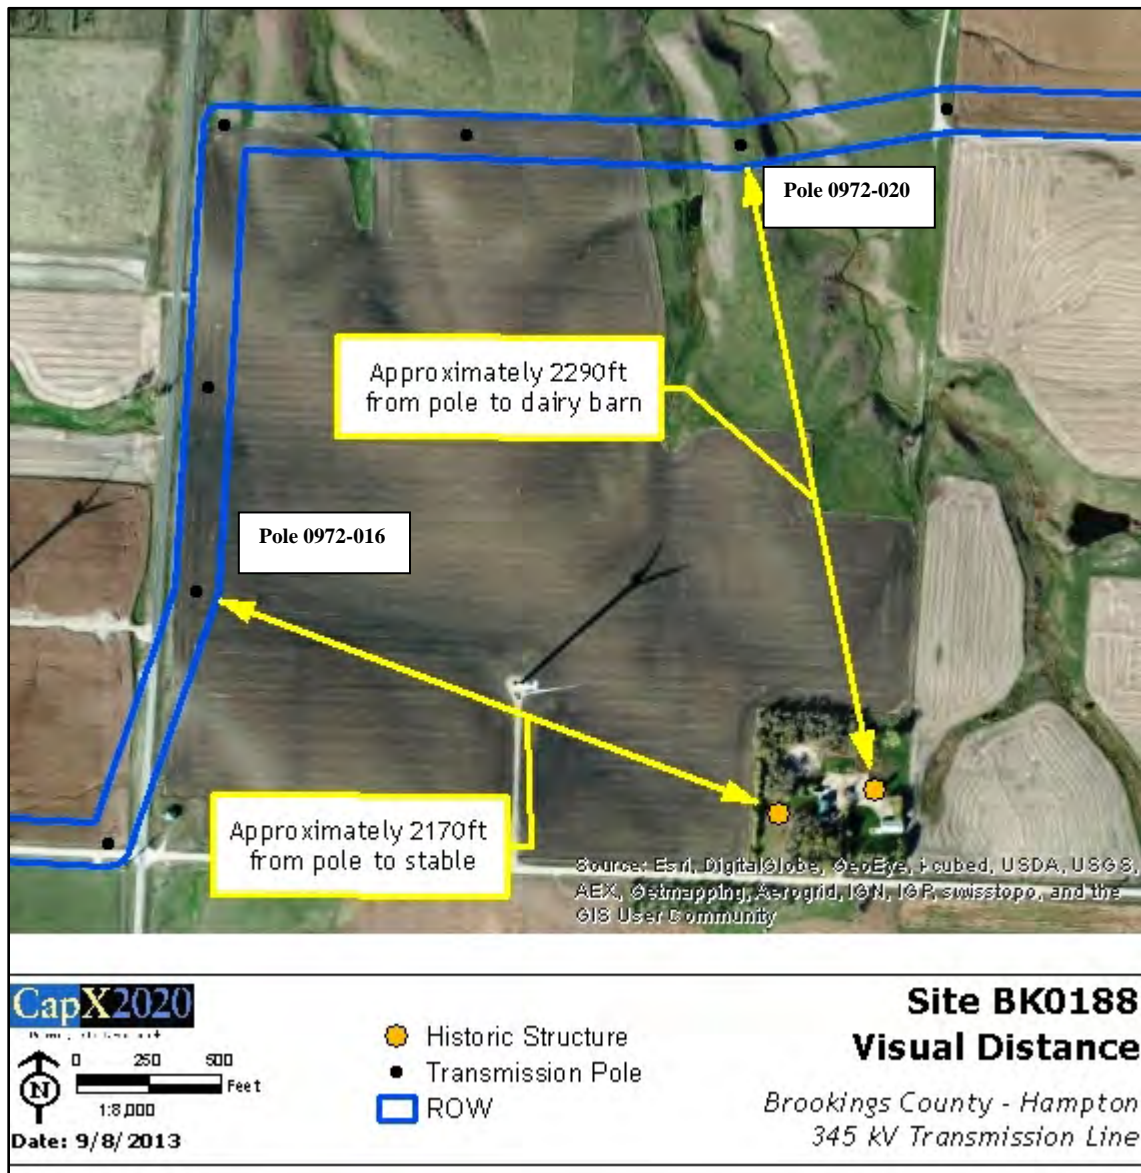
Seven proposed 150-foot-high transmission structures will be located north and west of BK00000188 (refer to Figures 3-17, 3-18, and Figure 5-3). The closest structure (0972-020) to the dairy barn is situated 2,290 feet (0.43 mile) north of the barn. The closest structure (0972-016) to the horse stable is situated 2,170 feet (0.41 mile) west of the stable building. While the proposed transmission lines will not be visible from the barn or stable, the closest proposed structures will be visible to the north and west from the buildings. A wind turbine is located between the transmission line and stable building. The proposed transmission structures may impact this site's integrity of setting and feeling, but the effects do not appear to be adverse to the point it will impact the NRHP eligibility of the barn or stable. The site's integrity of location, design, materials, workmanship, and association will not be impacted.

Figure 5-3. The yellow arrows depict the location of the dairy barn and stable buildings at site BK00000188. The project corridor is the blue line, and the black dots are the proposed transmission line pole locations.

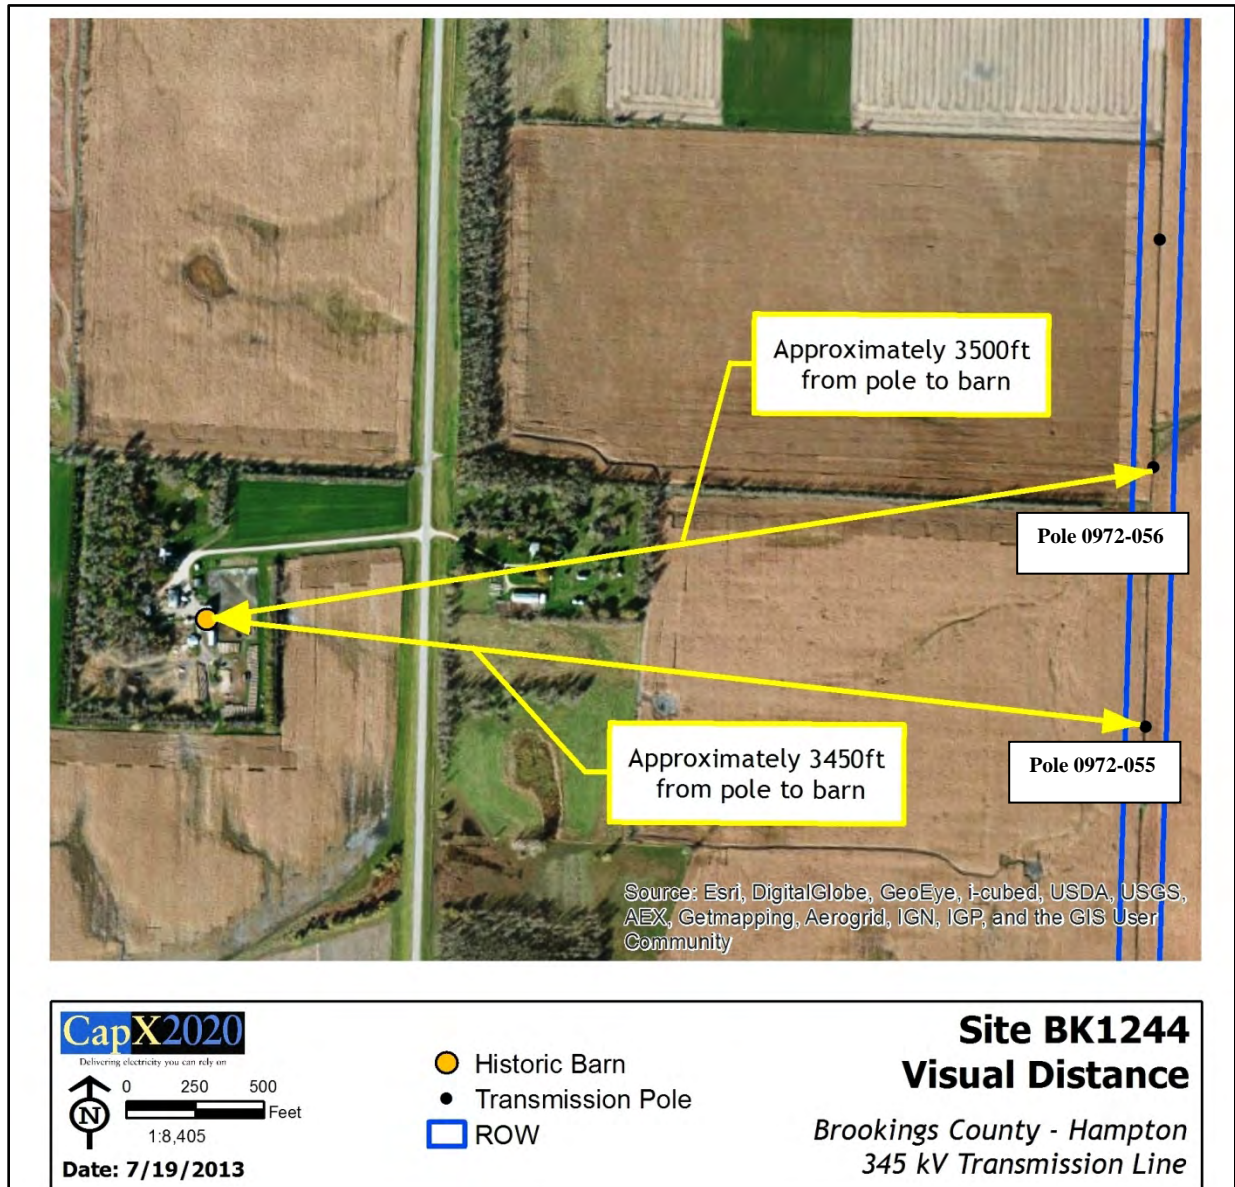
Two proposed 150-foot-high transmission structures will be located east of BK00001244 (refer to Figure 5-4). The closest structure (0972-055) is situated 3, 450 feet (0.65 mile) southeast of the barn. The northernmost structure (0972-056) will be located 3, 500 feet (0.66 mile) from the building. While the proposed transmission lines will not be visible from the barn, the proposed structures will be visible to the northeast and southeast from the building. The proposed transmission structures may impact this site's integrity of setting and feeling, but the effects do not appear to be adverse to the point it will impact the NRHP eligibility of the barn. The site's integrity of location, design, materials, workmanship, and association will not be impacted.

Figure 5-4. The yellow arrows depict the location of the Moen Gothic arch barn at site BK00001244. The project corridor is the blue line, and the black dots are the proposed transmission line pole locations.

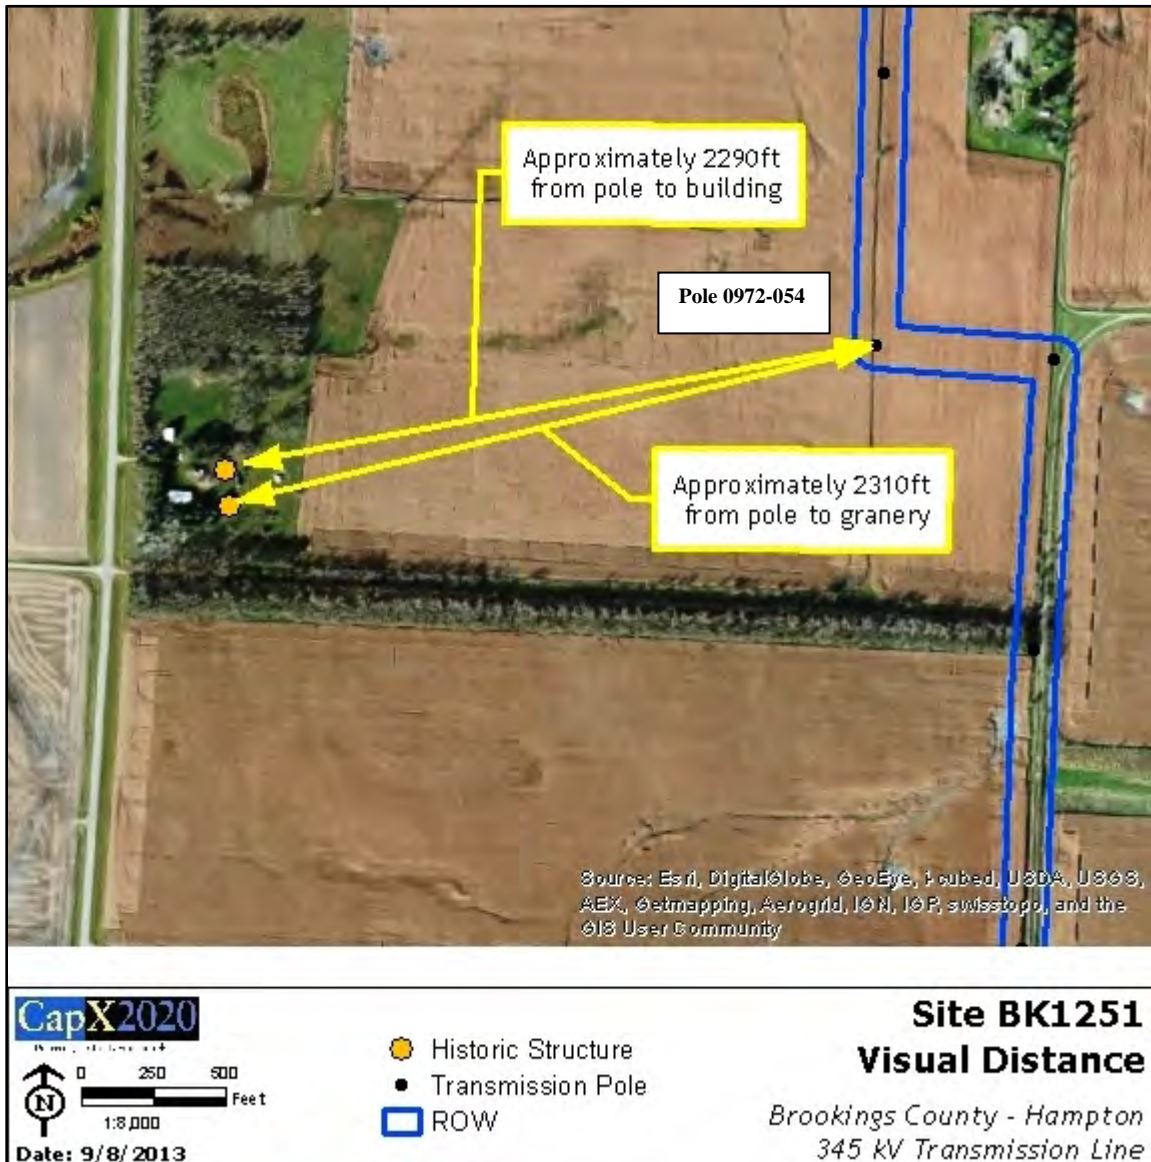
Site BK00001251 is the Hexem farmstead site (Figures 3-54 to 3-61 and Figure 5-5). The seven historic age buildings are NRHP-eligible on a district basis. The closest proposed transmission structure to the eastern buildings (an agricultural structure-Building 5; and granary-Building 7) on the site will be located northeast of the site and would be 150 feet high. The tree windrow on the east side of the property naturally provides screening to east. The closest structure (0972-054) will be 2, 290 feet (0.43 mile) northeast of Building 5, and 2, 310 feet (0.43 mile) from the granary Building 7. Only a portion of the tower will be visible due to the tree cover. The proposed transmission line is unlikely to impact this site's integrity of setting and feeling because the visual effects are screened behind existing vegetation. The site's integrity of location, design, materials, workmanship, and association will not be impacted.

Figure 5-5. The yellow arrow depicts the Hexem farmstead site BK00001251. The project corridor is the blue line, and the black dots are the proposed transmission line pole locations.

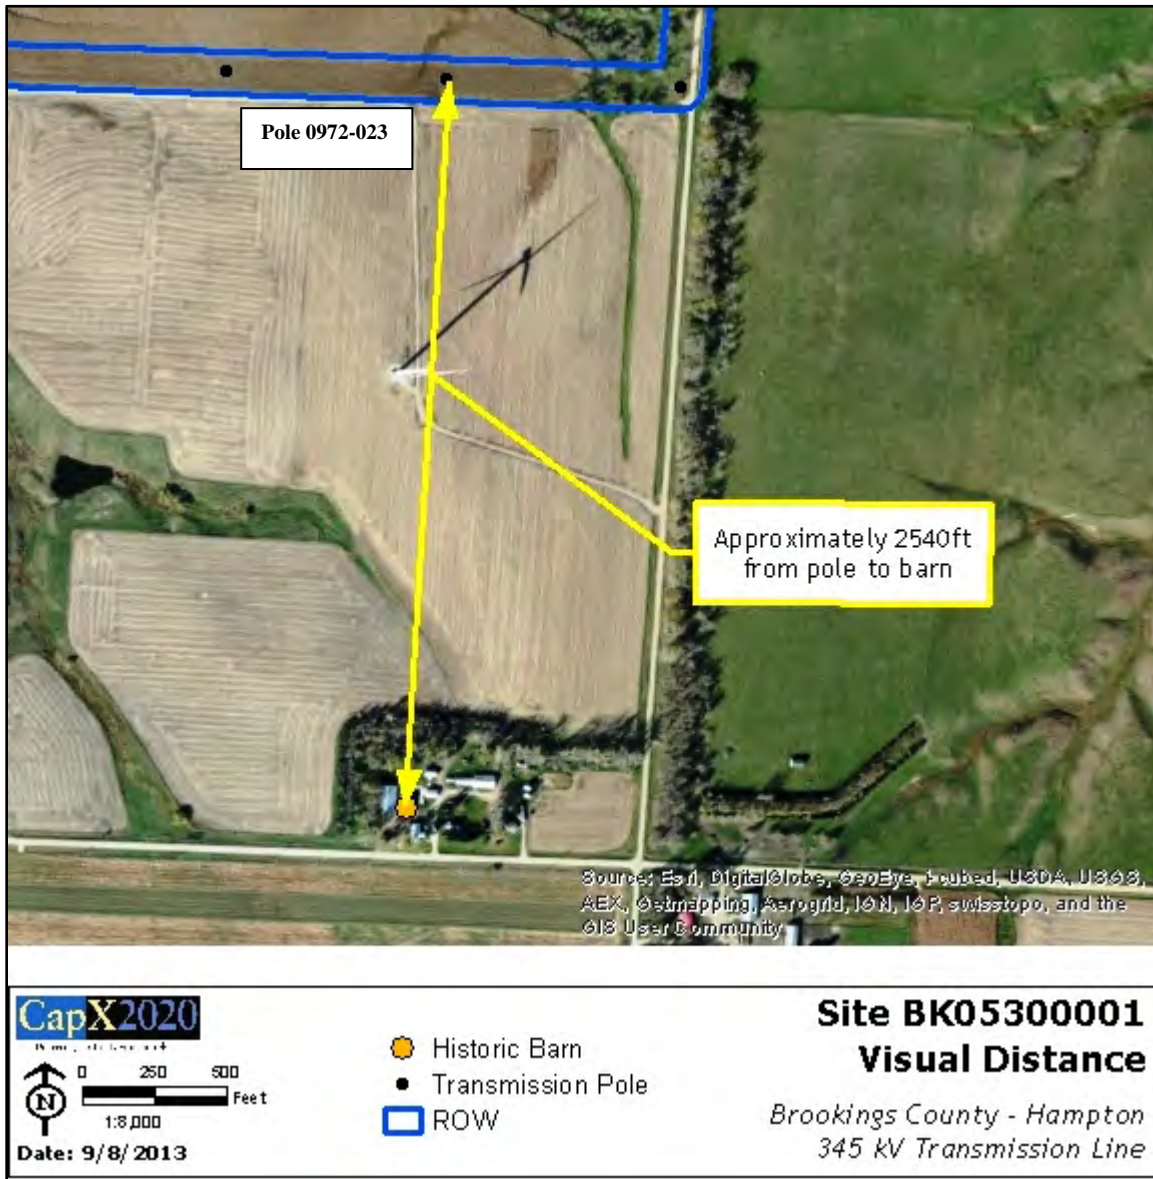
Site BK05300002 is a historic age dairy barn (Figure 3-124 and Figure 5-6) that is NRHP-eligible on an individual basis. The closest proposed transmission structure to the barn on the site will be located 2, 540 feet north of the site and would be 150 feet high. The tree windrow on the north side of the property naturally provides screening between the proposed towers and site, and a wind turbine is located between the barn and the proposed transmission pole. The proposed Pole 0972-023 will be 0.48 mile north of the site. Only a portion of the tower will be visible due to the tree cover. The proposed transmission line is unlikely to impact this site's integrity of setting and feeling because the visual effects are screened behind existing vegetation. The existing wind turbine has already impacted the integrity of setting and feeling. The site's integrity of location, design, materials, workmanship, and association will not be impacted.

Figure 5-6. The yellow arrow depicts the barn site BK05300002. The project corridor is the blue line, and the black dots are the proposed transmission line pole locations.
